# City of Rohnert Park

## Facility Condition Assessment

Final Report

October 17, 2022

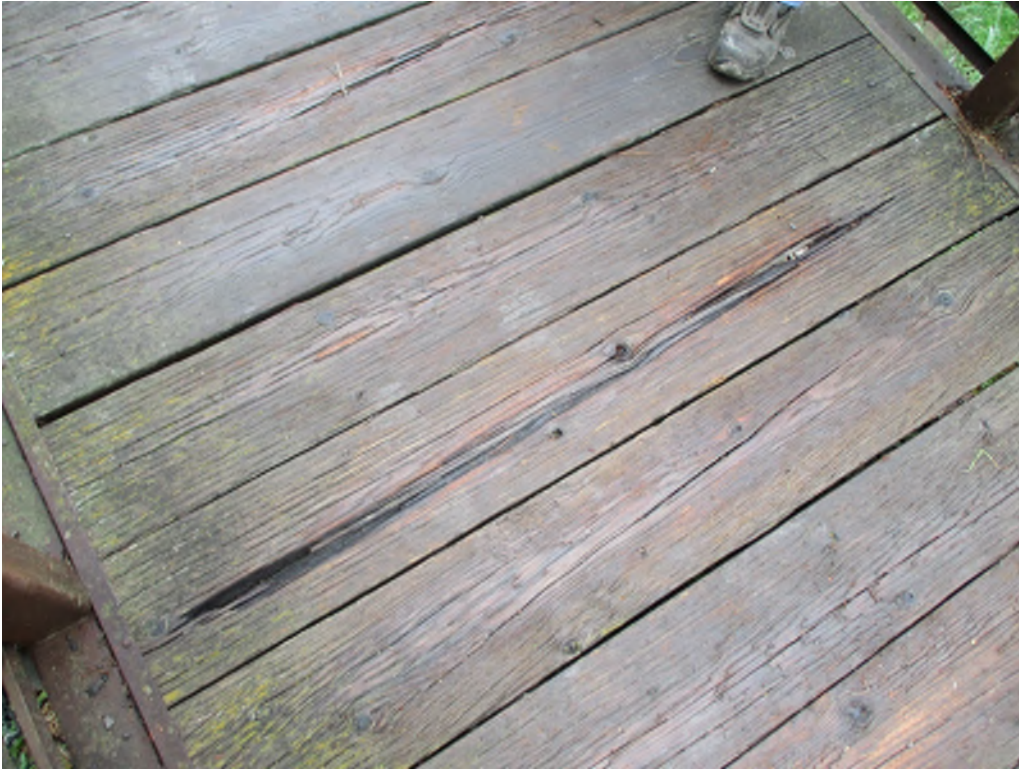
Image 9: Cracked and Rotted Floorboard

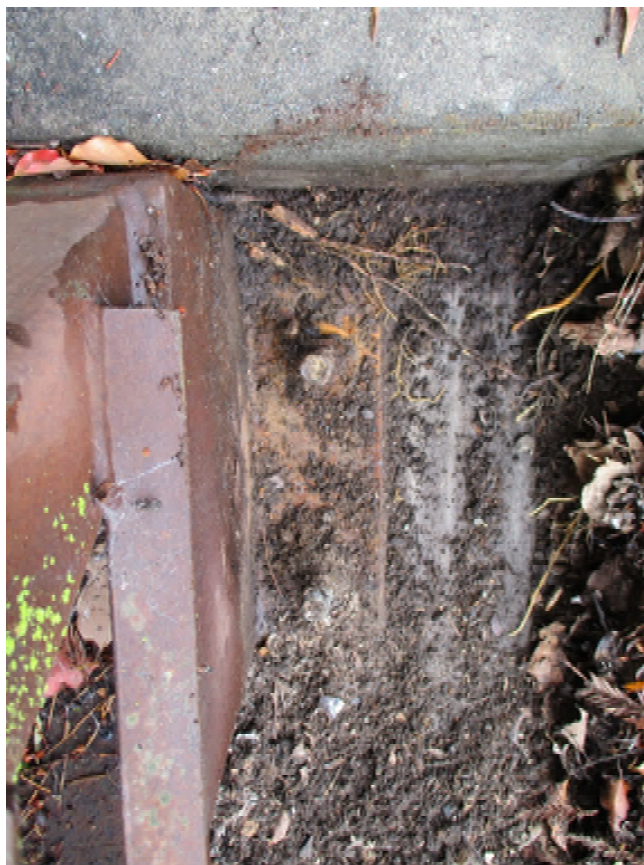
Image 10: Typical Bearing Plate and Anchor Bolt

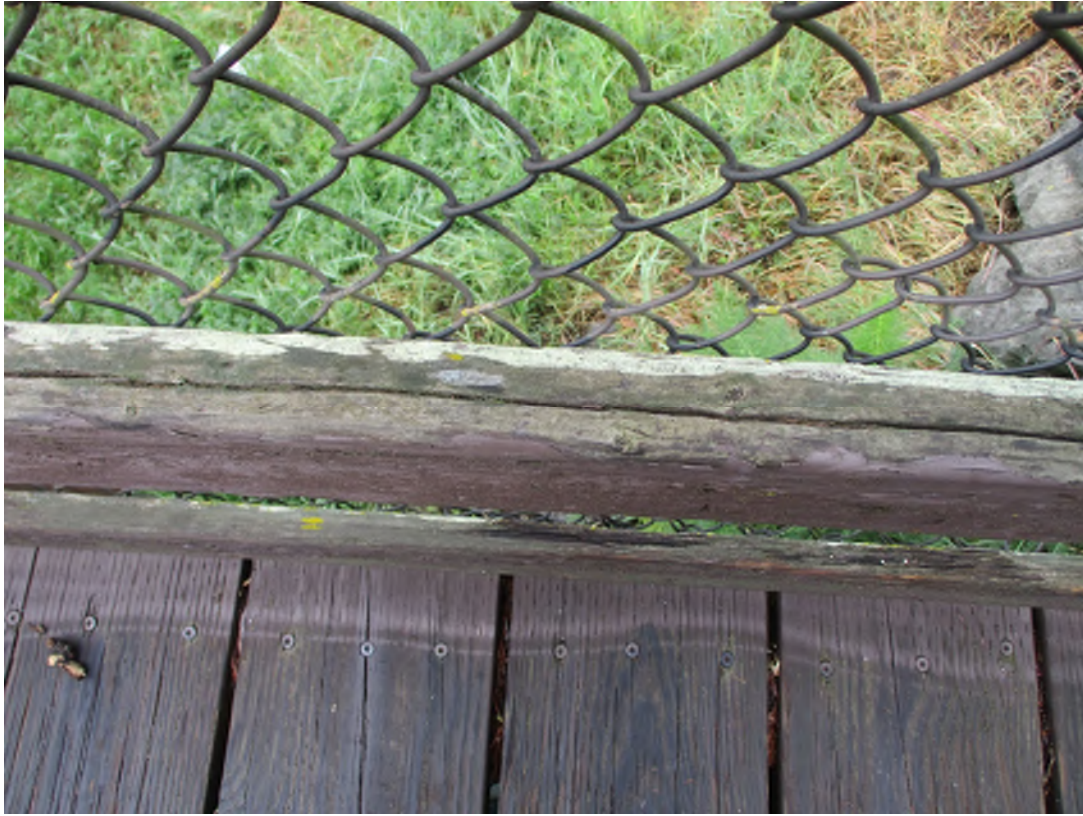
Image 7: Handrail Member Condition

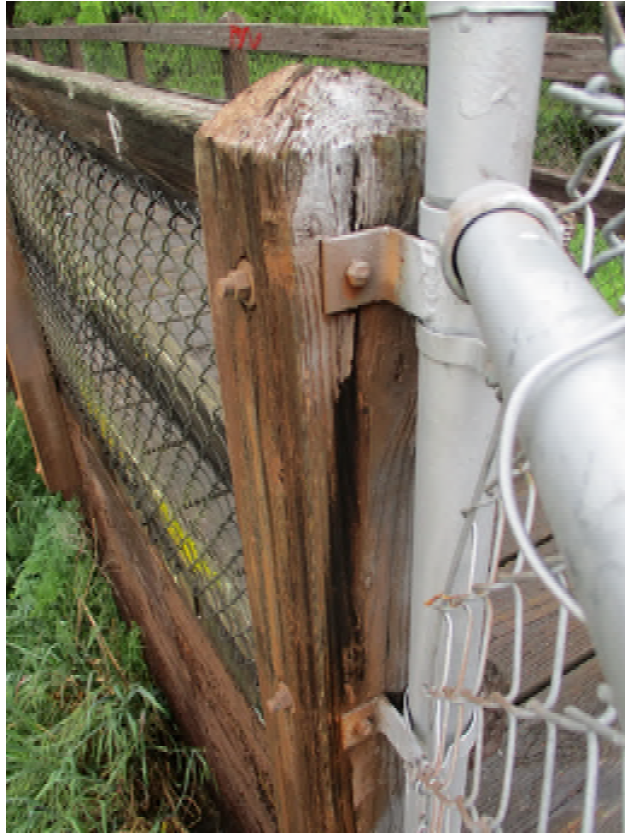
Image 11: Handrail Post Condition

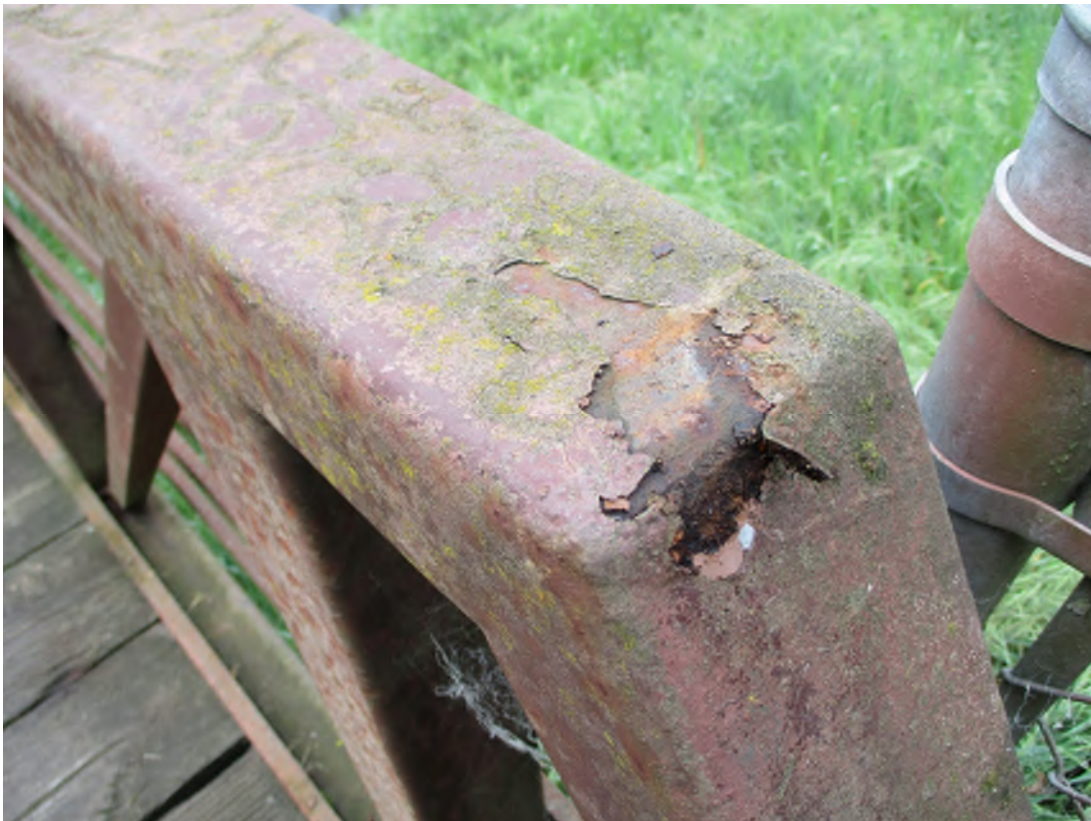
Image 12: Deteriorating Finish

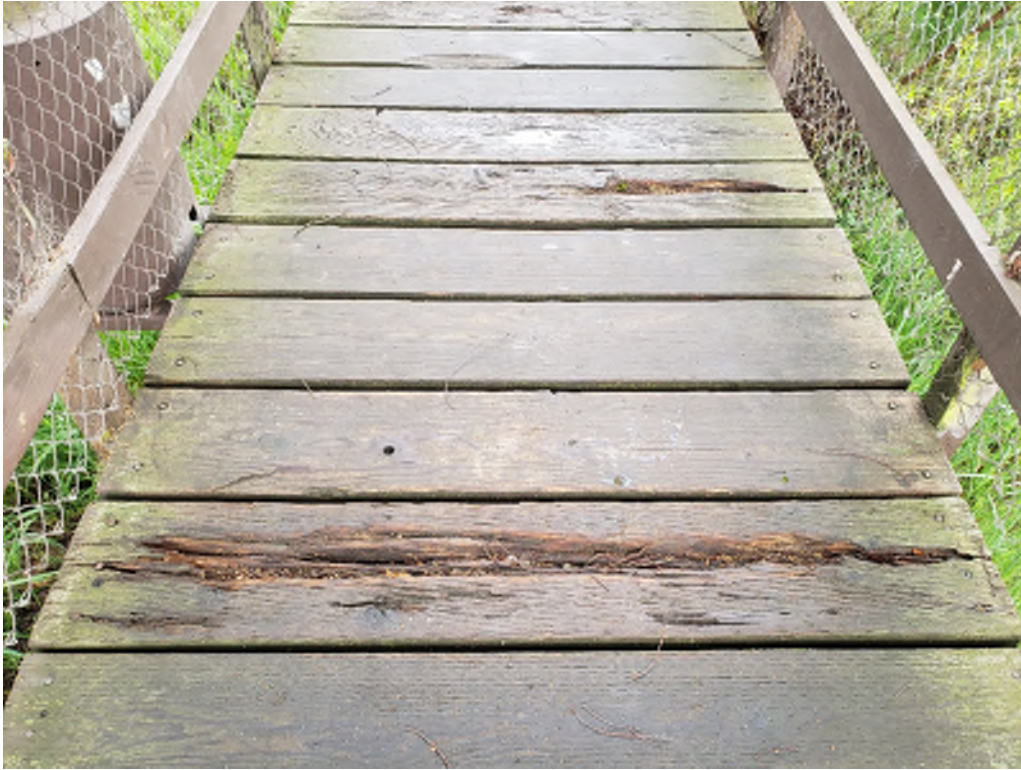
Image 9: Cracked and Rotted Deck Board

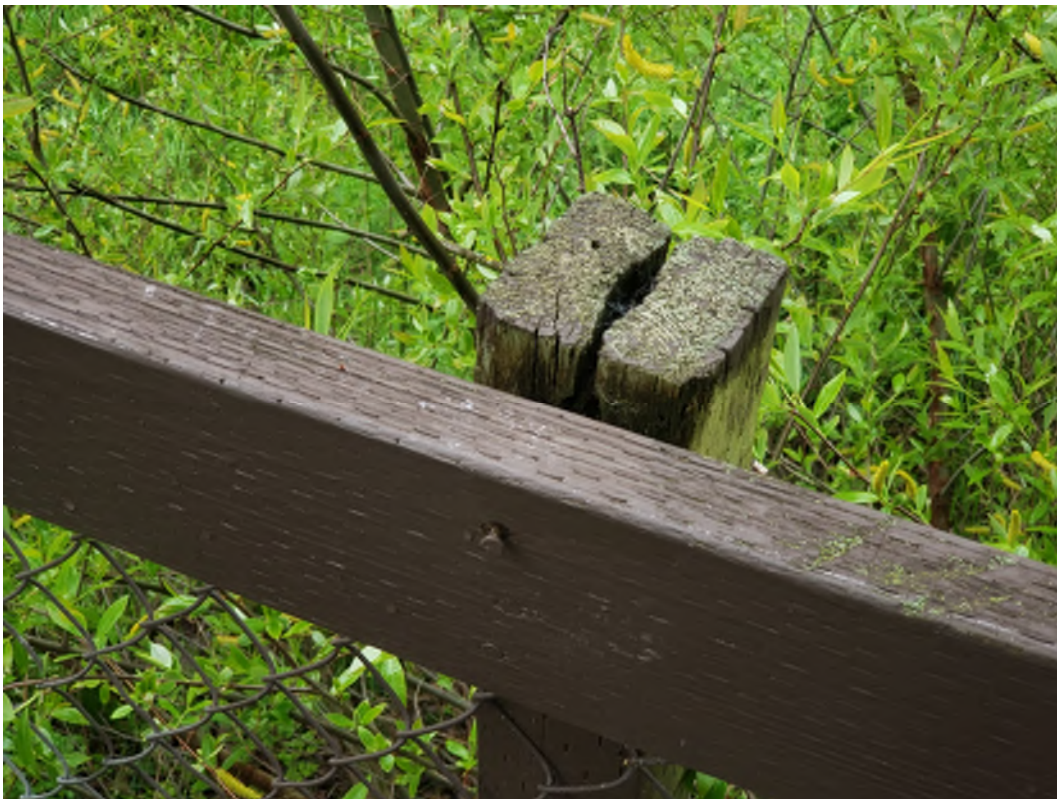
Image 12: Handrail Post Condition

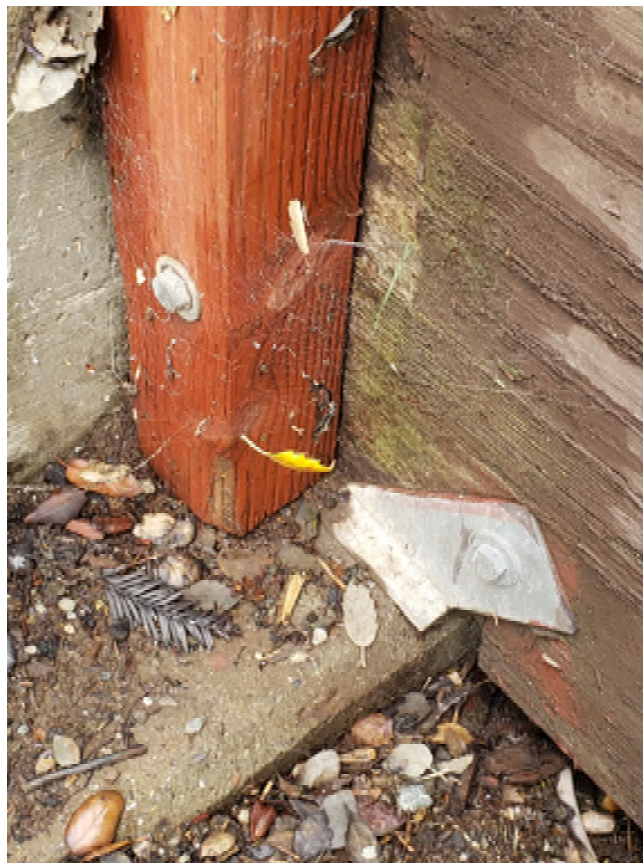
Image 10: Typical Bearing Plate and Anchor Bolt

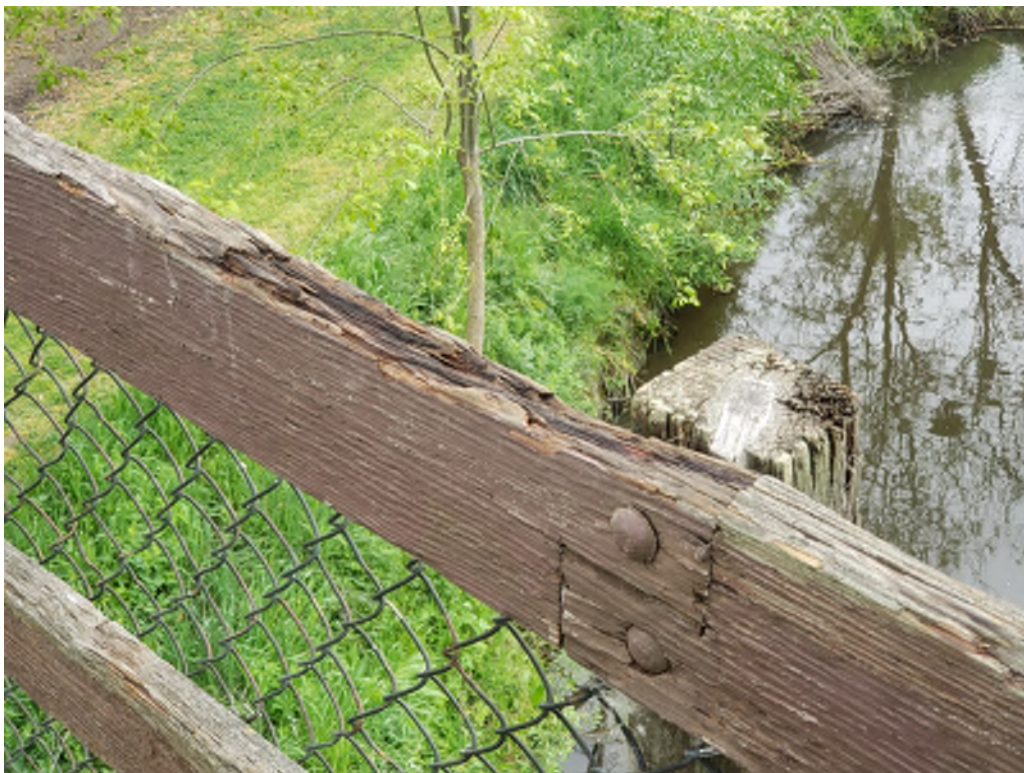
Image 12: Handrail Condition

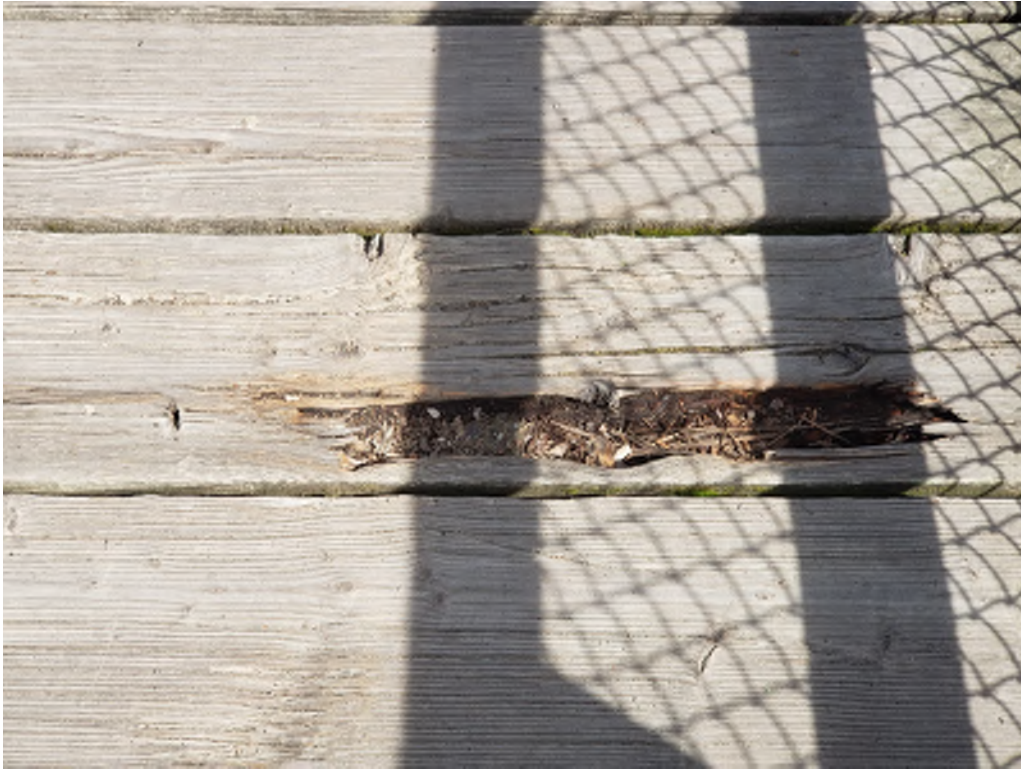
Image 9: Cracked and Rotted Deck Board

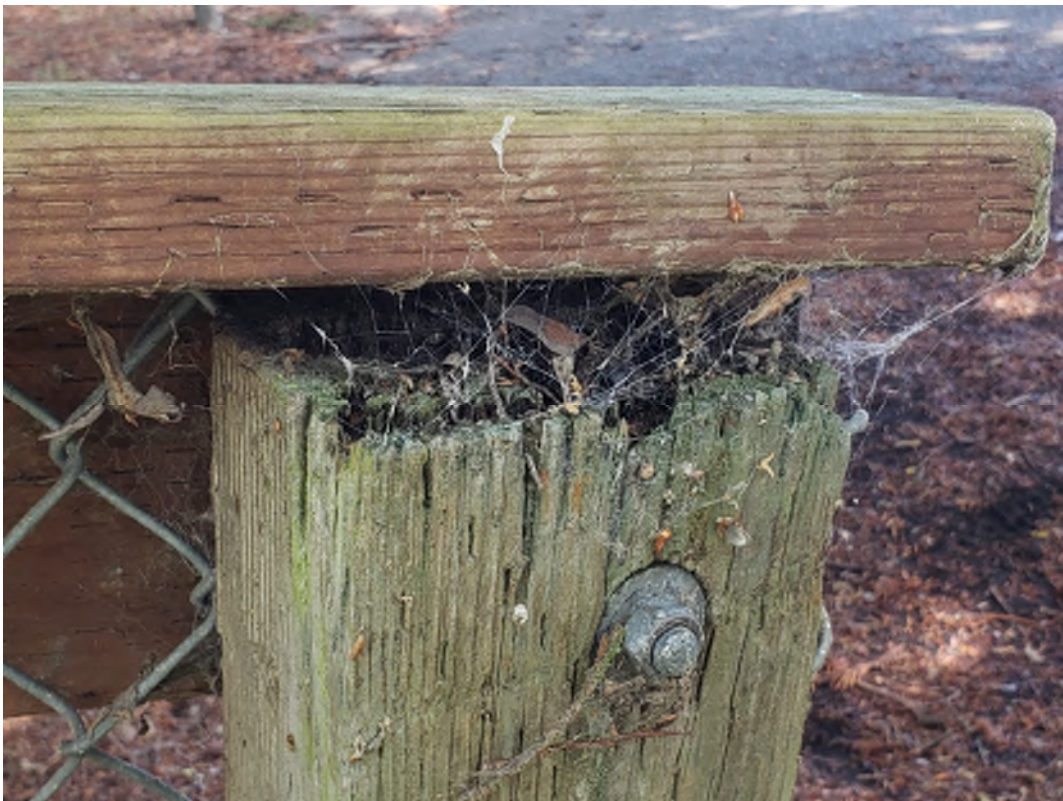
Image 10: Handrail Post Condition

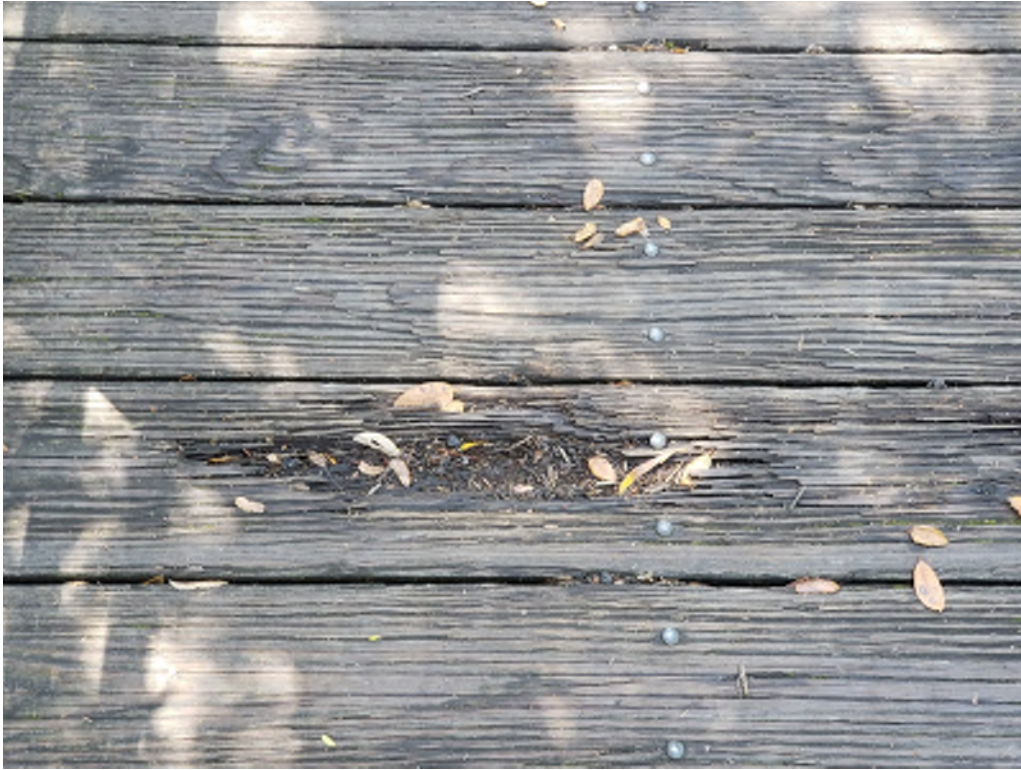
Image 9: Cracked and Rotted Floorboard

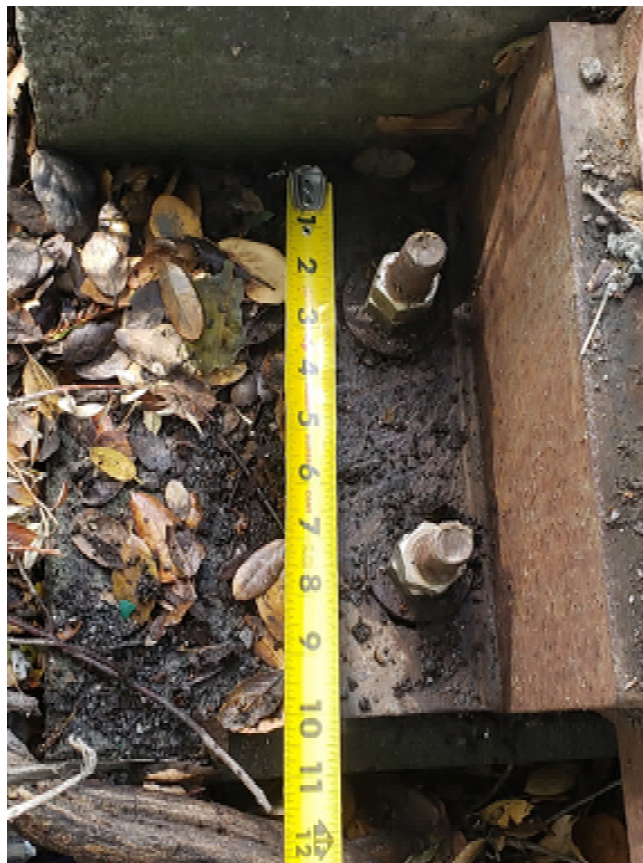
Image 10: Typical Bearing Plate and Anchor Bolt
