# City of Rohnert Park

## Facility Condition Assessment

Final Report

October 17, 2022

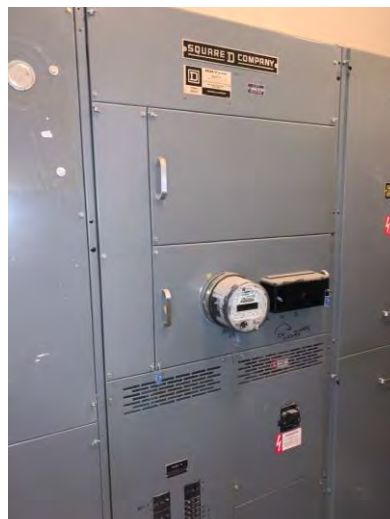
Record ID: 482  
 System: D5020 - ELECTRICAL SERVICE AND DISTRIBUTION  
 Year Installed / Industry Life / Remaining Useful Life: 1992 / 20 / -10  
 Item No.: D5020.10.302  
 Floor/Room: 1 / Electrical Room  
**Priority:** 1  
 Quantity/Unit of Measure: 1/EA  
 Total Deficiency Cost: \$17,750  
 Deficiency Description: *The 400A metered main switchboard is approaching the end of its expected useful life.*  
 Description of Work: *Replace the existing metered main switchboard with a new metered main switchboard.*  
 Comments:

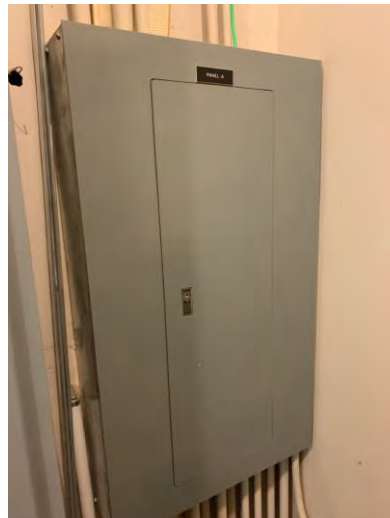
Record ID: 484  
 System: D5020 - ELECTRICAL SERVICE AND DISTRIBUTION  
 Year Installed / Industry Life / Remaining Useful Life: 1992 / 30 / 0  
 Item No.: D5020.30.1008  
 Floor/Room: 1 / Electrical Room  
**Priority:** 1  
 Quantity/Unit of Measure: 1/EA  
 Total Deficiency Cost: \$18,570  
 Deficiency Description: *The 225A (42 ckt, 120/208, 3P) panelboard is at the end of its expected useful life.*  
 Description of Work: *Replace the existing panelboard with a new panelboard.*  
 Comments:

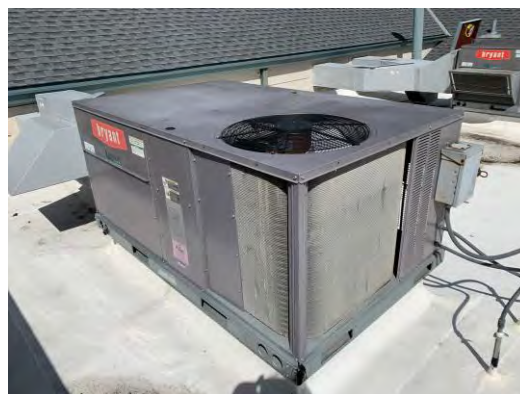
Record ID: 485  
 System: D3030 - COOLING SYSTEMS  
 Year Installed / Industry Life / Remaining Useful Life: 2016 / 15 / 9  
 Item No.: D3030.10.019  
 Floor/Room: Roof  
**Priority:** 7  
 Quantity/Unit of Measure: 1/EA  
 Total Deficiency Cost: \$98,860  
 Deficiency Description: *Packaged AC unit is approaching the end of its expected useful life.*  
 Description of Work: *Provide equipment replacement and installation.*  
 Comments: *Recommend air balance for system on system replacement.*

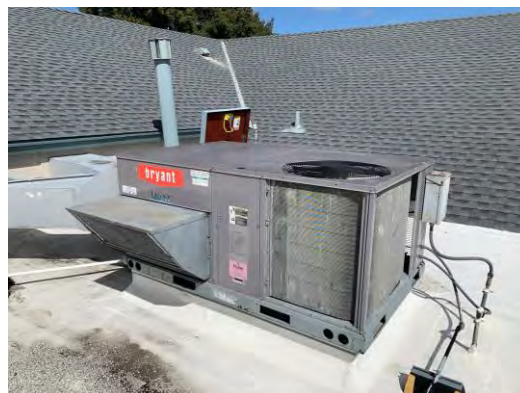
Comments: *Recommend air balance for system on system replacement.*

Description of Work: *Provide equipment replacement and installation.*

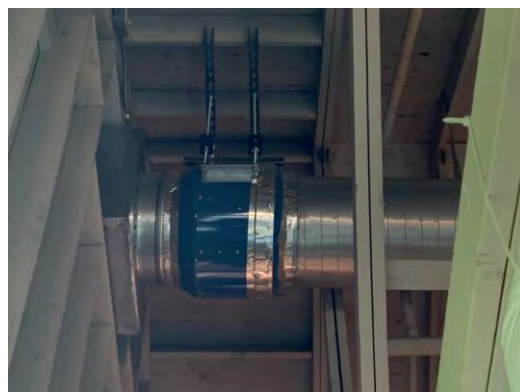
Comments: *Current design of utility exhaust is insufficient for Animal occupants due to noise criteria, ventilation, and thermal comfort. There is a significant need of design options to address this deficiency.*

Description of Work: *Provide equipment replacement with an appropriate system.*

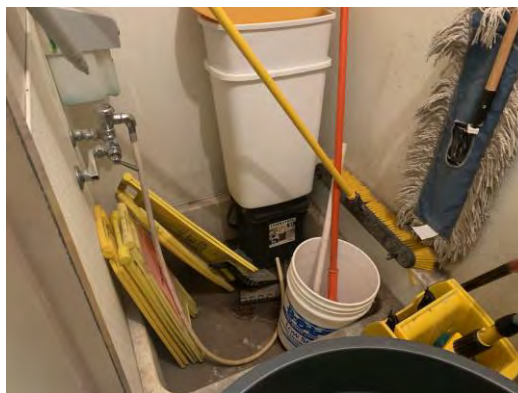
Comments: *Water damage concerns from sink*

Description of Work: *Provide equipment replacement and installation.*

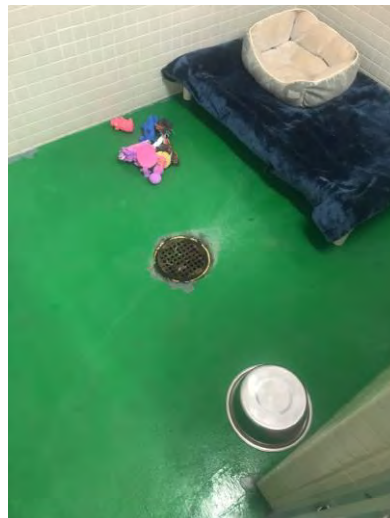
Comments: *Drain grate is stuck. Issues with drainage at inlet. Tried cameraing area, but unable to locate sewer root cause.*

Description of Work: *Repair drainage grate as necessary.*

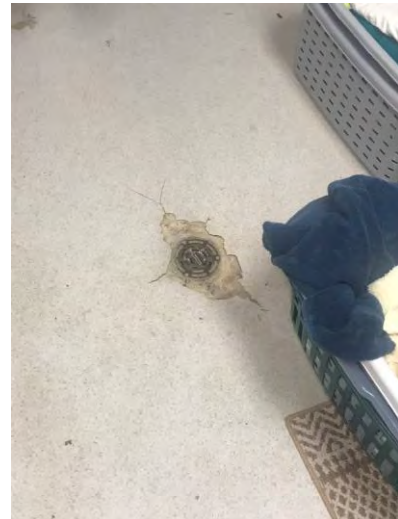
Year Installed / Industry Life / Remaining Useful Life: - / 40 / -  
Item No.: C2030.10.002  
Floor/Room: 1 / Laundry Room  
**Priority:** 1  
Quantity/Unit of Measure: 100/SF  
Total Deficiency Cost: \$4,830  
Deficiency Description: *Epoxy is approaching the end of its useful life.*

Description of Work: *Remove the existing epoxy and replace.*

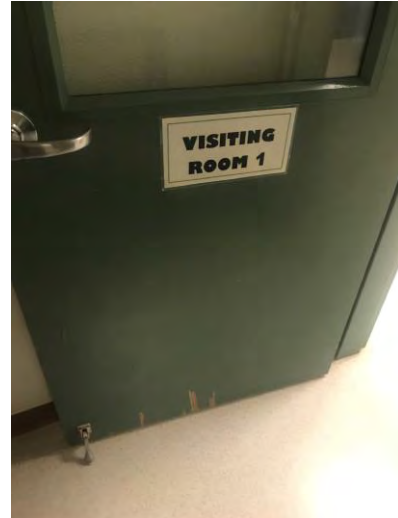
Year Installed / Industry Life / Remaining Useful Life: - / 30 / -  
Item No.: C1030.10.008  
Floor/Room: 1 / Visiting Room 1  
**Priority:** 5  
Quantity/Unit of Measure: 1/EA  
Total Deficiency Cost: \$1,180  
Deficiency Description: *Interior wood door is in visual need of refurbishment.*

Description of Work: *Refurbish and repaint the wood door.*

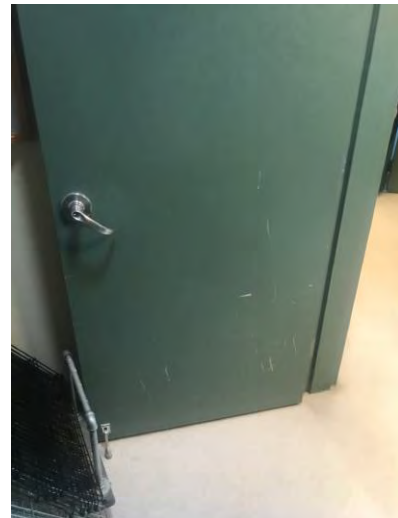
Year Installed / Industry Life / Remaining Useful Life: - / 30 / -  
Item No.: C1030.10.008  
Floor/Room: 1 / Visiting Room Area  
**Priority:** 5  
Quantity/Unit of Measure: 1/EA  
Total Deficiency Cost: \$1,180  
Deficiency Description: *Interior wood door is in visual need of refurbishment.*

Description of Work: *Refurbish and restain the wood door.*

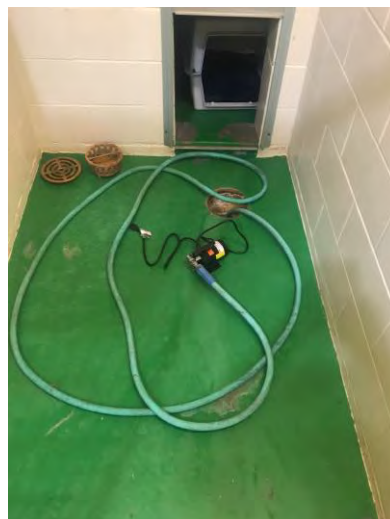
Comments: *Drainage issue in C1, D1, and D4. Plumbing contractor recommends jackhammering slab to access pipe, but underfloor heating prevents repairing sanitary sewer.*

Description of Work: *Provide equipment replacement and installation.*

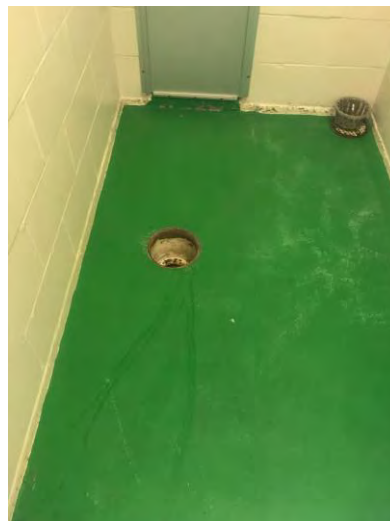
Comments: *Replace drain covers in kennel D1 and D5.*

Description of Work: *Provide new floor drain cover.*

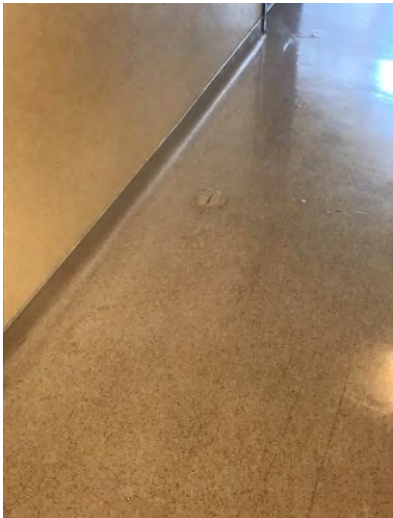
Year Installed / Industry Life / Remaining Useful Life: - / 60 / -  
Item No.: C2030.50.002  
Floor/Room: 1 / Throughout Building  
**Priority:** 5  
Quantity/Unit of Measure: 4,500/SF  
Total Deficiency Cost: \$216,580  
Deficiency Description: *Sheet vinyl is showing signs of age and wear.*

Description of Work: *Remove the existing sheet vinyl and replace.*

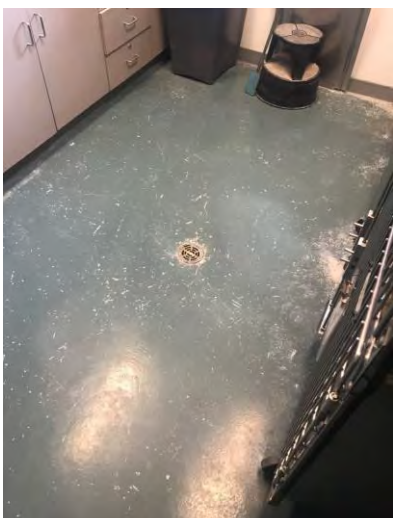
Year Installed / Industry Life / Remaining Useful Life: - / 50 / -  
Item No.: C2030.10.001  
Floor/Room: 1 / Cat Rooms/Surgery/Clinic/Euthanasia/Freezer  
**Priority:** 5  
Quantity/Unit of Measure: 960/SF  
Total Deficiency Cost: \$18,280  
Deficiency Description: *Concrete floor finish is approaching the end of its useful life.*

Description of Work: *Repair and refinish the concrete floor.*

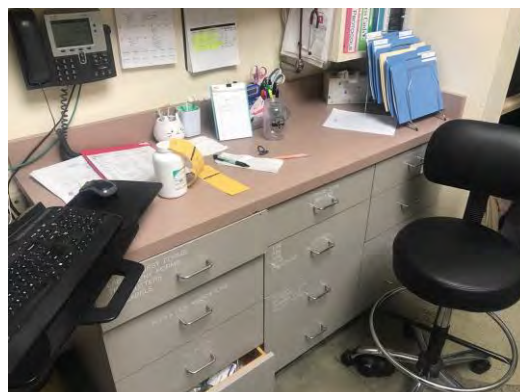
Record ID 789  
System E2010 - FIXED FURNISHINGS  
Year Installed / Industry Life / Remaining Useful Life - / 20 / -  
Item No. E2010.30.009  
Floor/Room: 1 / Throughout Building  
**Priority:** 1  
Quantity/Unit of Measure: 10/LF  
Total Deficiency Cost: \$21,590  
Deficiency Description: *Plastic laminate casework is at or will be approaching the end of its expected useful life.*

Description of Work: *Provide new plastic laminate casework (upper, lower, and countertop)*

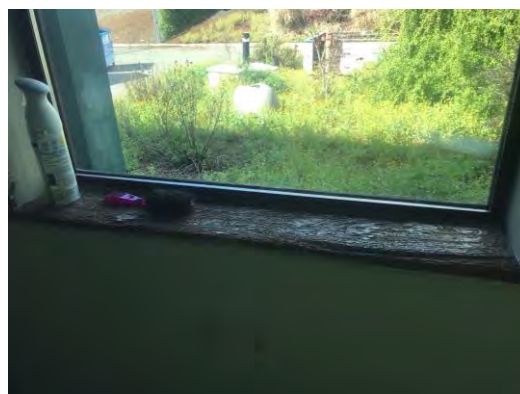
Year Installed / Industry Life / Remaining Useful Life - / 45 / -  
Item No. B2020.20.012  
Floor/Room: 1  
**Priority:** 2  
Quantity/Unit of Measure: 4/SF  
Total Deficiency Cost: \$1,360  
Deficiency Description: *Fixed window and rotted sill need restoration.*

Description of Work: *Remove window, restore and reinstall. Replace sill.*

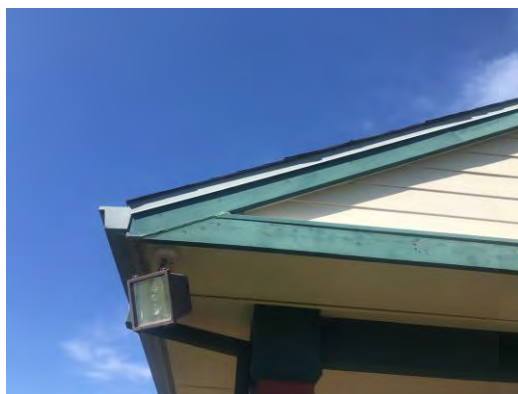
Comments: *Entire exterior.*

Description of Work: *Clean, prepare, and paint the plywood paneling.*

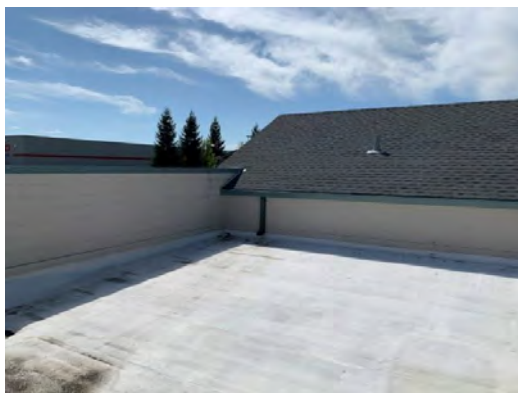
Record ID 1672  
System B3010 - ROOFING  
Year Installed / Industry Life / Remaining Useful Life - / 30 / -  
Item No. B3010.90.003  
Floor/Room: Roof / N/A  
**Priority:** 5  
Quantity/Unit of Measure: 1,050/SF  
Total Deficiency Cost: \$20,000  
Deficiency Description: *Roofing membrane needs a recoating.*

Description of Work: *Repair and recoat the roof membrane. Provide a white (light color) neoprene coating and replace the roof membrane as scheduled.*

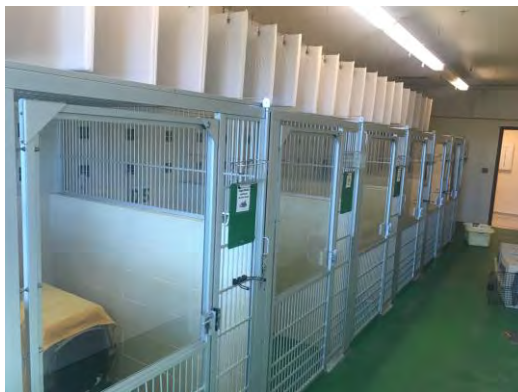
Record ID 1733  
System D5040 - LIGHTING  
Year Installed / Industry Life / Remaining Useful Life 1992 / 20 / -10  
Item No. D5040.50.411  
Floor/Room:  
**Priority:** 6  
Quantity/Unit of Measure: 11,805/SF  
Total Deficiency Cost: N/A - See Executive Summary  
Deficiency Description: *Interior lighting system is past its expected useful life.*

Description of Work: *Provide new interior lighting and control system throughout building per current CEC T24 code.*

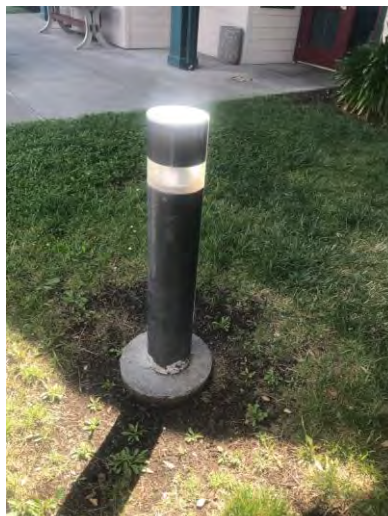
Record ID 1734  
System D5040 - LIGHTING  
Year Installed / Industry Life / Remaining Useful Life 1992 / 20 / -10  
Item No. D5040.50.302  
Floor/Room:  
**Priority:** 6  
Quantity/Unit of Measure: 7/EA  
Total Deficiency Cost: N/A - See Executive Summary  
Deficiency Description: *The exterior light fixture is past its expected useful life.*

Description of Work: *Replace the existing light fixture with an LED lighting fixture.*

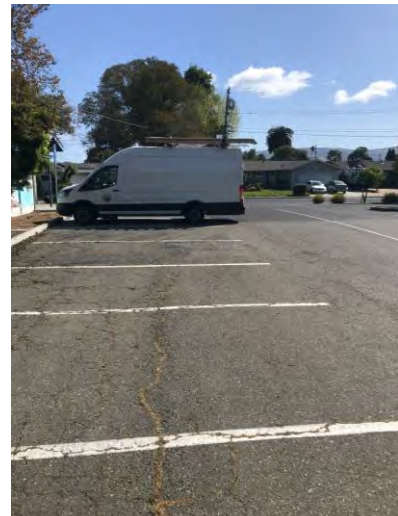
Record ID: 1642  
 System: G2020 - PARKING LOTS  
 Year Installed / Industry Life / Remaining Useful Life: - / - / -  
 Item No.: G2020.10.002  
 Floor/Room: Site / Parking  
**Priority:** 2  
 Quantity/Unit of Measure: 8,000/SF  
 Total Deficiency Cost: \$233,780  
 Deficiency Description: *AC paving shows signs of fatigue cracking.*

Description of Work: *Replace AC pavement section.*

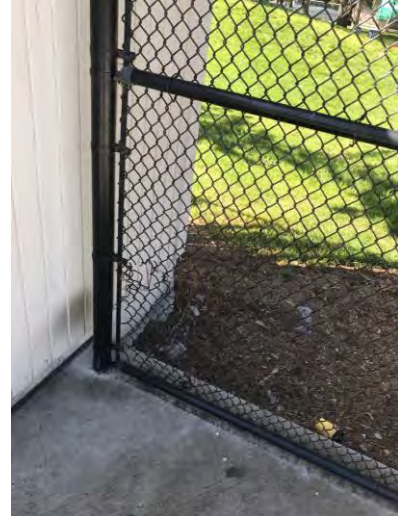
Record ID: 1643  
 System: G2060 - SITE DEVELOPMENT  
 Year Installed / Industry Life / Remaining Useful Life: - / - / -  
 Item No.: G2060.20.001  
 Floor/Room: Site / Fencing  
**Priority:** 2  
 Quantity/Unit of Measure: 10/SF  
 Total Deficiency Cost: \$210  
 Deficiency Description: *Chain link steel mesh is damaged or missing.*

Description of Work: *Replace chain link section.*

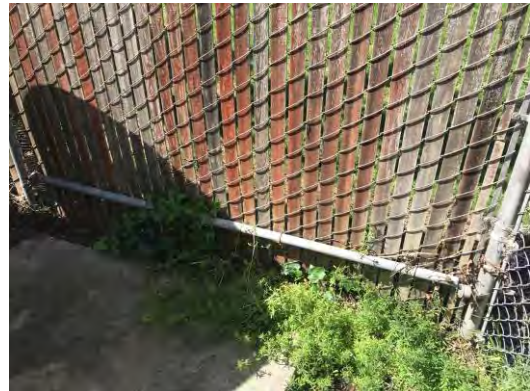
Record ID: 1644  
 System: G2060 - SITE DEVELOPMENT  
 Year Installed / Industry Life / Remaining Useful Life: - / - / -  
 Item No.: G2060.20.020  
 Floor/Room: Site / Fencing  
**Priority:** 5  
 Quantity/Unit of Measure: 300/LF  
 Total Deficiency Cost: \$10,280  
 Deficiency Description: *Chain link fencing shows heavy damage and requires full replacement.*

Comments: *Throughout site.*

Description of Work: *Replace entire fence, including mesh, posts, and concrete bases.*

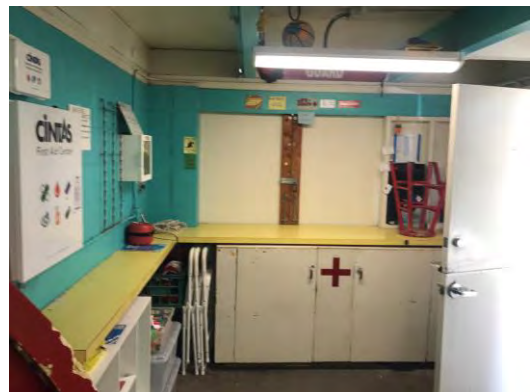
Record ID: 1735  
 System: D5040 - LIGHTING  
 Year Installed / Industry Life / Remaining Useful Life: - / 20 / -  
 Item No.: D5040.50.411  
 Floor/Room:  
**Priority:** 6  
 Quantity/Unit of Measure: 6,806/SF  
 Total Deficiency Cost: N/A - See Executive Summary  
 Deficiency Description: *Interior lighting system is past its expected useful life.*

Description of Work: *Provide new interior lighting and control system throughout building per current CEC T24 code.*

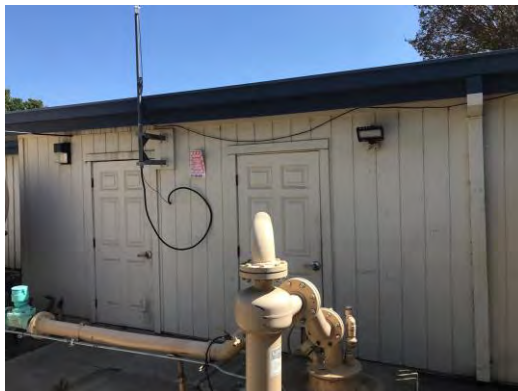
Year Installed / Industry Life / Remaining Useful Life - / 20 / -  
Item No. D5040.50.302  
Floor/Room:  
**Priority:** 6  
Quantity/Unit of Measure: 3/EA  
Total Deficiency Cost: N/A - See Executive Summary  
Deficiency Description: *The exterior light fixture is past its expected useful life.*

Description of Work: *Replace the existing light fixture with an LED lighting fixture.*

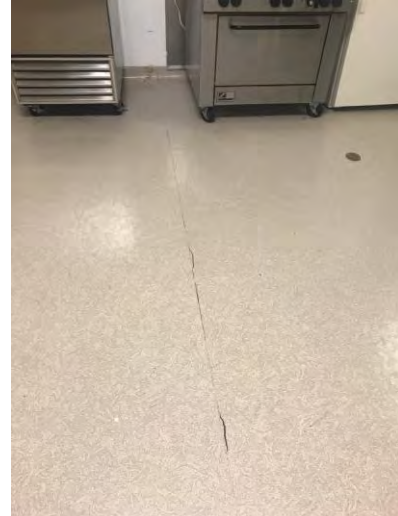
Year Installed / Industry Life / Remaining Useful Life: - / 60 / -  
Item No.: C2030.50.002  
Floor/Room: 1 / Kitchen  
**Priority:** 3  
Quantity/Unit of Measure: 800/SF  
Total Deficiency Cost: \$35,520  
Deficiency Description: *Sheet vinyl is approaching the end of its useful life.*

Description of Work: *Remove the existing sheet vinyl and replace.*

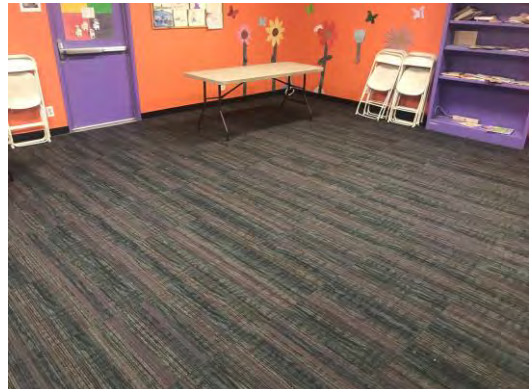
Record ID: 3  
System: C2030 - FLOORING

Year Installed / Industry Life / Remaining Useful Life: - / 20 / -  
Item No.: C2030.75.001  
Floor/Room: 1 / Throughout  
**Priority:** 5  
Quantity/Unit of Measure: 2,000/SF  
Total Deficiency Cost: \$60,880  
Deficiency Description: *Carpet tile is missing or damaged.*

Description of Work: *Replace carpet tile.*

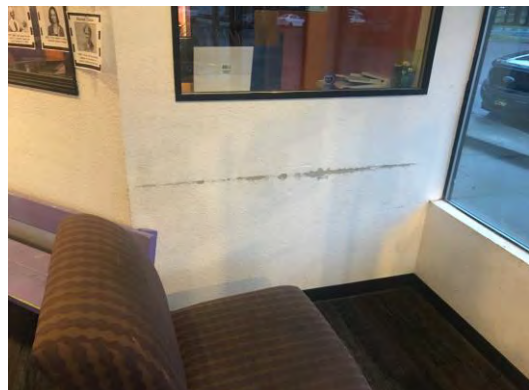
Record ID: 4  
System: C2010 - WALL FINISHES

Year Installed / Industry Life / Remaining Useful Life: - / 30 / -  
Item No.: C2010.70.001  
Floor/Room: 1 / Throughout  
**Priority:** 5  
Quantity/Unit of Measure: 4,000/SF  
Total Deficiency Cost: \$95,150  
Deficiency Description: *Painted gypsum wallboard is showing signs of wear.*

Description of Work: *Patch and paint the gypsum wallboard.*

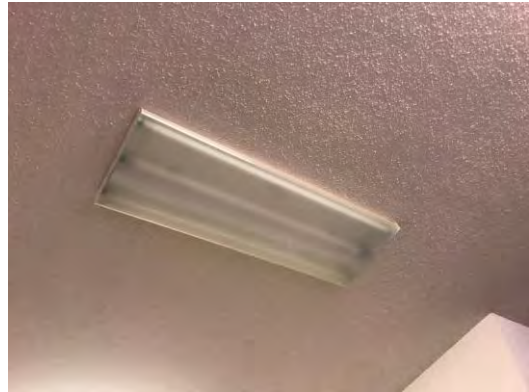
Year Installed / Industry Life / Remaining Useful Life - / 20 / -  
Item No. D5040.50.411  
Floor/Room:  
**Priority: 1**  
Quantity/Unit of Measure: 4,600/SF  
Total Deficiency Cost: \$263,220  
Deficiency Description: *Interior lighting system is approaching its expected useful life.*

Description of Work: *Provide new interior lighting and control system throughout building per current CEC T24 code.*

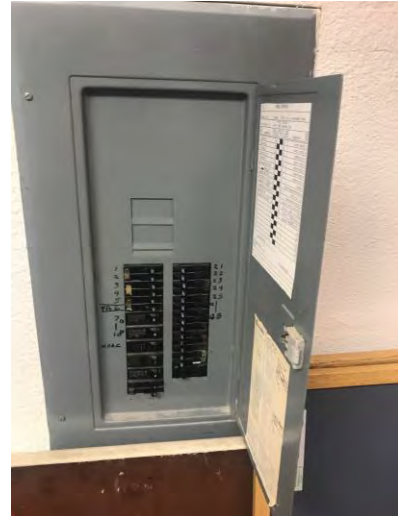
Record ID 8  
System D5020 - ELECTRICAL SERVICE AND DISTRIBUTION

Year Installed / Industry Life / Remaining Useful Life 1989 / 30 / -3  
Item No. D5020.30.4003  
Floor/Room:  
**Priority: 1**  
Quantity/Unit of Measure: 1/EA  
Total Deficiency Cost: \$8,700  
Deficiency Description: *The 200A load center is approaching the end of its expected useful life.*

Description of Work: *Replace the existing load center with a new load center.*

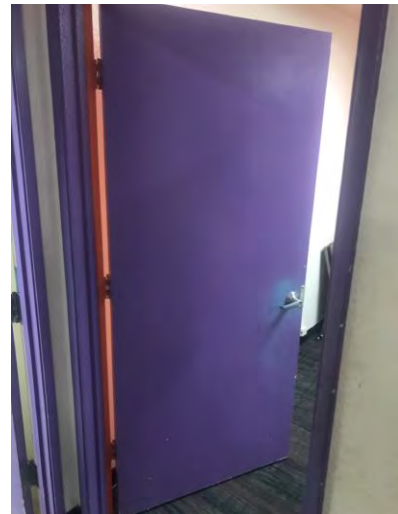
Record ID 9  
System C1030 - INTERIOR DOORS

Year Installed / Industry Life / Remaining Useful Life - / 60 / -  
Item No. C1030.90.003  
Floor/Room: 1 / Throughout  
**Priority: 3**  
Quantity/Unit of Measure: 13/EA  
Total Deficiency Cost: \$11,430  
Deficiency Description: *Metal door and frames are in fair to poor condition.*

Description of Work: *Repair and refinish the metal door and frames.*

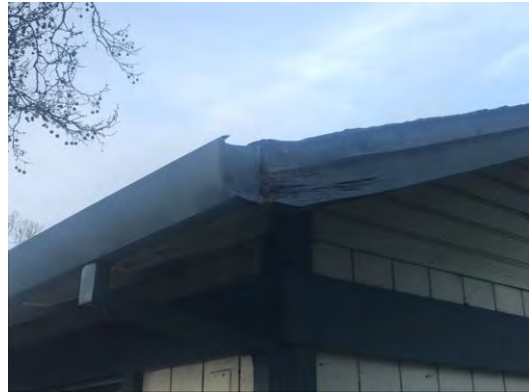
Deficiency Description: *The fascia appears to be deteriorated.*

Description of Work: *Selectively remove deteriorated fascia and replace with new material to match.*

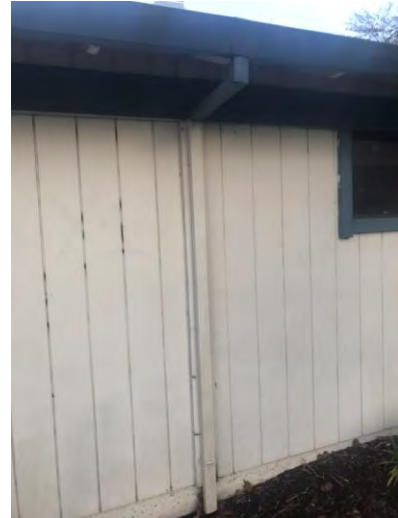
Record ID 17  
System B2010 - EXTERIOR WALLS

Deficiency Description: *Plywood siding is approaching the end of its useful life.*

Description of Work: *Remove and replace the existing plywood siding with new plywood siding. Prime and paint.*

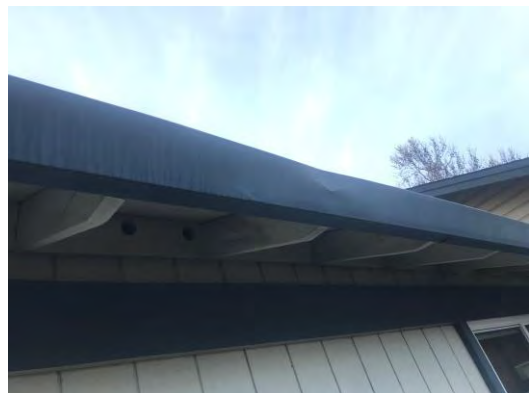
Record ID 18  
System B3020 - ROOF APPURTENANCES

Deficiency Description: *Rain leaders/gutters are damaged.*

Description of Work: *Repair, replace rain leaders/gutters.*

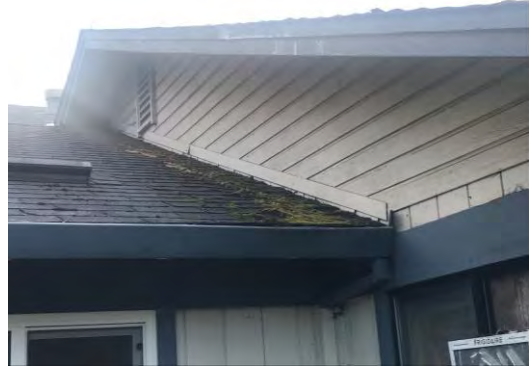
Item No.: B3010.10.001  
Floor/Room: Roof / Roof  
**Priority:** 5  
Quantity/Unit of Measure: 6,000/SF  
Total Deficiency Cost: \$342,400  
Deficiency Description: *Asphalt composition roof is in fair to poor condition with evidence of ponding, blisters & leaks.*

Description of Work: *Remove and replace asphalt composition shingle roofing.*

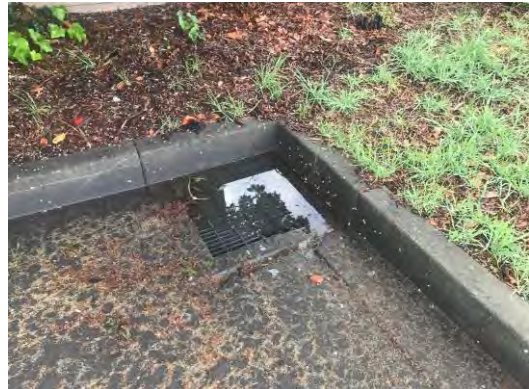
Record ID: 21  
System: G3030 - STORM DRAINAGE UTILITIES

Item No.: G3030.40.013  
Floor/Room: Site / Concrete Walkway  
**Priority:** 1  
Quantity/Unit of Measure: 1/EA  
Total Deficiency Cost: \$1,000  
Deficiency Description: *Drainage grate is clogged.*

Description of Work: *Provide repairs as necessary to drain grate.*

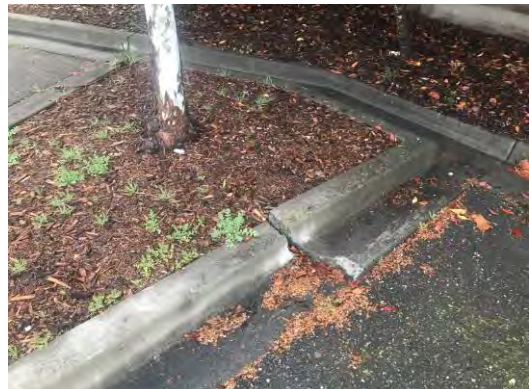
Record ID: 22  
System: G2030 - PEDESTRIAN PLAZAS AND WALKWAYS

Item No.: G2030.10.005  
Floor/Room: Site / Pavement  
**Priority:** 2  
Quantity/Unit of Measure: 25/SF  
Total Deficiency Cost: \$920  
Deficiency Description: *Concrete pavement has major damage / structural failure.*

Description of Work: *Replace concrete and base to match existing.*

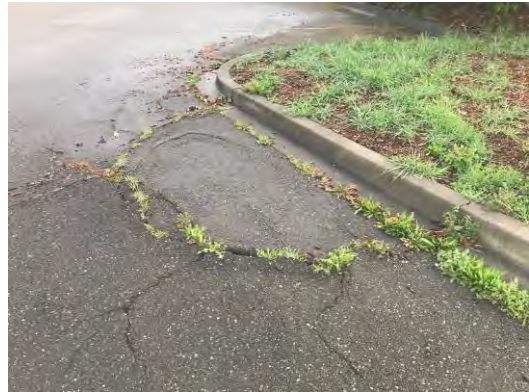
Record ID: 23  
System: G2020 - PARKING LOTS  
Year Installed / Industry Life / Remaining Useful Life: - / - / -  
Item No.: G2020.10.002  
Floor/Room: Site / AC Paving  
**Priority:** 3  
Quantity/Unit of Measure: 1,000/SF  
Total Deficiency Cost: \$30,520  
Deficiency Description: *AC paving shows evidence of potholing.*

Description of Work: *Replace AC pavement section.*

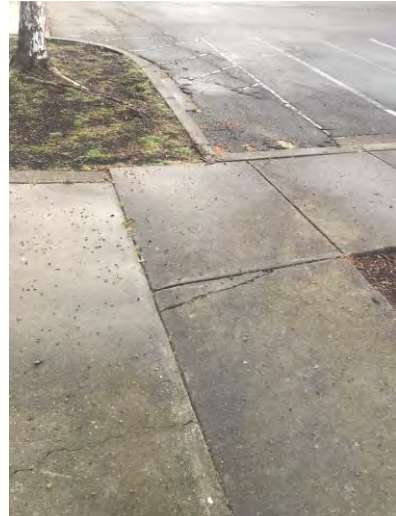
Record ID: 24  
System: G2030 - PEDESTRIAN PLAZAS AND WALKWAYS  
Year Installed / Industry Life / Remaining Useful Life: - / 30 / -  
Item No.: G2030.10.005  
Floor/Room: Site / Concrete Walkway  
**Priority:** 3  
Quantity/Unit of Measure: 400/SF  
Total Deficiency Cost: \$15,170  
Deficiency Description: *Concrete pavement has major damage / structural failure.*

Description of Work: *Replace concrete and base to match existing.*

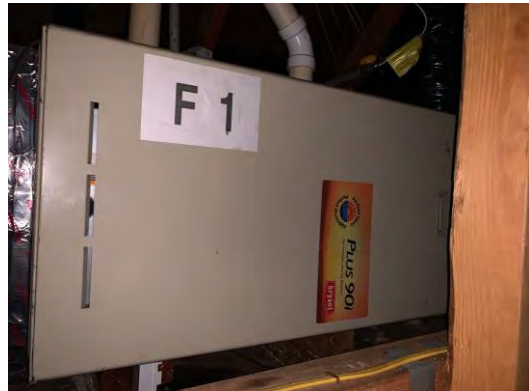
Record ID: 253  
System: D3020 - HEATING SYSTEMS  
Year Installed / Industry Life / Remaining Useful Life: - / 15 / -  
Item No.: D3020.10.007  
Floor/Room: Ceiling  
**Priority:** 7  
Quantity/Unit of Measure: 1/EA  
Total Deficiency Cost: \$20,990  
Deficiency Description: *Gas-fired furnace is approaching the end of its expected useful life.*

Description of Work: *Provide equipment replacement and installation.*

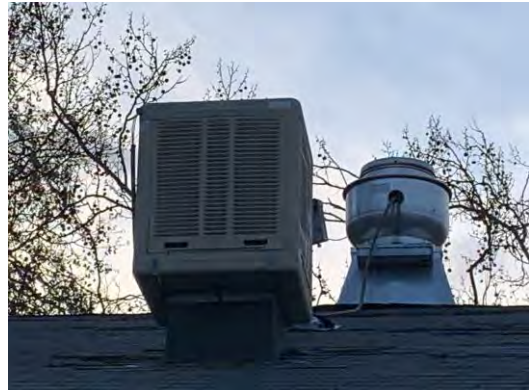
Year Installed / Industry Life / Remaining Useful Life - / 15 / -  
Item No. D3030.70.026  
Floor/Room:  
**Priority:** 3  
Quantity/Unit of Measure: 1/EA  
Total Deficiency Cost: \$22,810  
Deficiency Description: *Evaporative cooler is approaching the end of its expected useful life.*

Description of Work: *Provide equipment replacement and installation.*

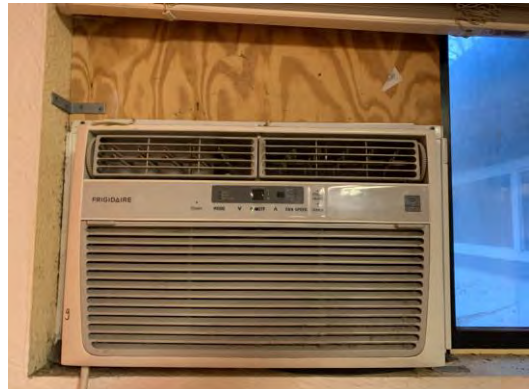
Record ID 258  
System D3030 - COOLING SYSTEMS

Year Installed / Industry Life / Remaining Useful Life 2011 / 10 / -1  
Item No. D3030.70.032  
Floor/Room: / Teens  
**Priority:** 4  
Quantity/Unit of Measure: 1/EA  
Total Deficiency Cost: \$7,320  
Deficiency Description: *Window mounted AC unit is approaching the end of its expected useful life.*

Description of Work: *Provide equipment replacement and installation.*

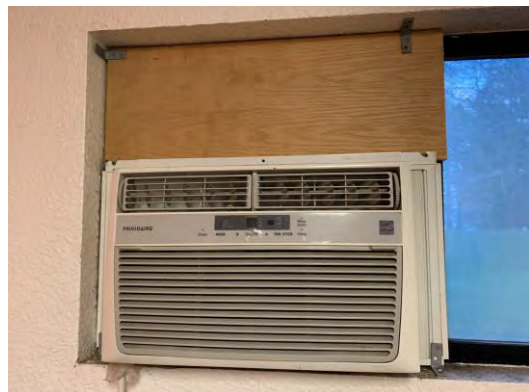
Record ID 259  
System D3030 - COOLING SYSTEMS

Year Installed / Industry Life / Remaining Useful Life 2013 / 10 / 1  
Item No. D3030.70.032  
Floor/Room: / Program Room  
**Priority:** 5  
Quantity/Unit of Measure: 1/EA  
Total Deficiency Cost: \$7,620  
Deficiency Description: *Window mounted AC unit is approaching the end of its expected useful life.*

Description of Work: *Provide equipment replacement and installation.*

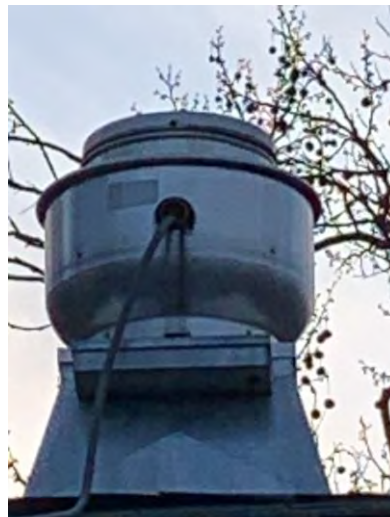
Deficiency Description: *Roof exhaust fan is approaching the end of its expected useful life.*

Comments: *Exhaust fan serves kitchen hood with ANSUL system.*

Description of Work: *Provide equipment replacement and installation.*

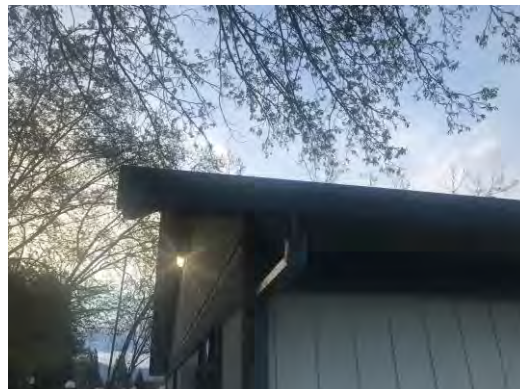
Record ID: 1739  
System: D5040 - LIGHTING

Deficiency Description: *Replace the existing light fixture with an LED lighting fixture.*

Description of Work: *Replace the existing light fixture with an LED lighting fixture.*

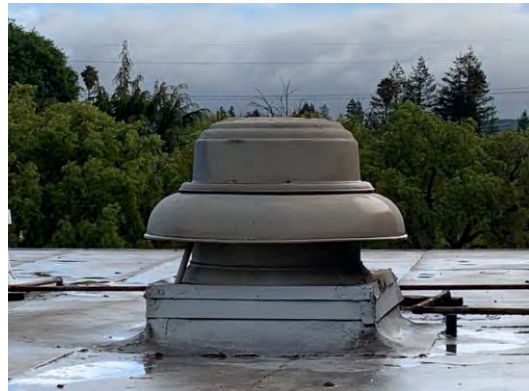
Record ID 1265  
System D3060 - VENTILATION

Comments: *Exhaust fan shown in photo serve the kitchen.*

Description of Work: *Provide equipment replacement and installation.*

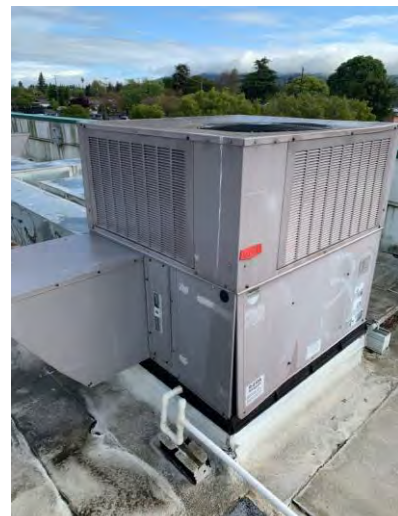
Record ID 1267  
System D3030 - COOLING SYSTEMS

Comments: *Condensate lines crushed and disconnected and unsupported on roof.*

Description of Work: *Provide equipment replacement and installation.*

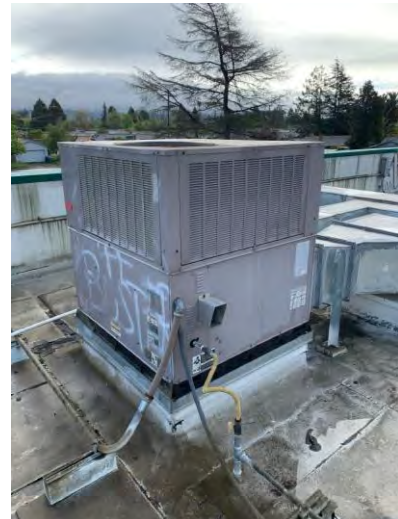
Comments: *Condensate lines crushed and disconnected and unsupported on roof.*

Description of Work: *Provide equipment replacement and installation.*

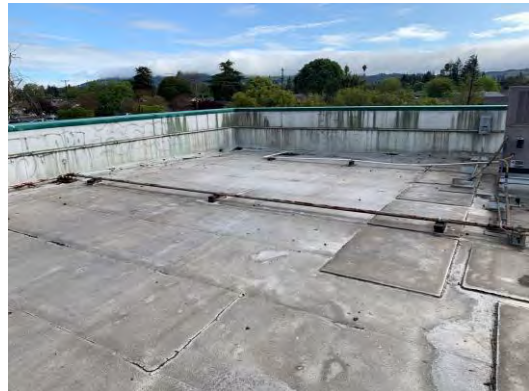
Record ID: 1269  
 System: B3010 - ROOFING

Year Installed / Industry Life / Remaining Useful Life: 2004 / 10 / -8

Description of Work: *Replace modified bitumen roofing.*

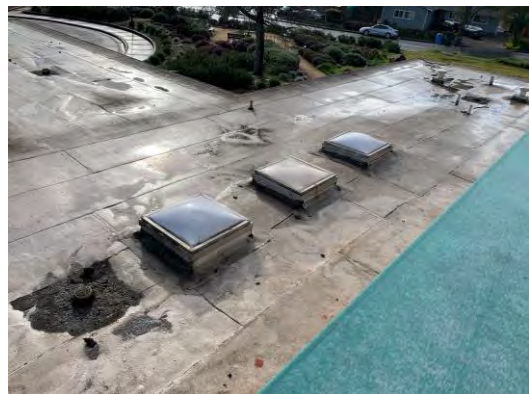
Record ID: 1270  
 System: B3060 - HORIZONTAL OPENINGS

Comments: *Skylights show signs of age and discoloring.*

Description of Work: *Remove the existing skylight and replace it with a new skylight.*

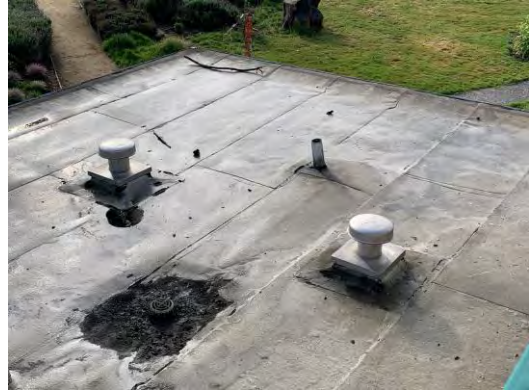
Comments: *Exhaust fans shown in photo serve restroom spaces.*

Description of Work: *Provide equipment replacement and installation.*

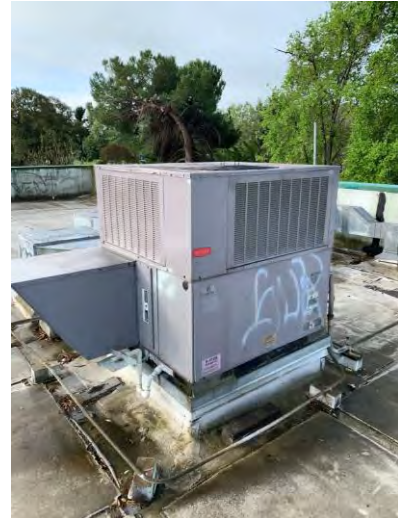
Record ID 1273  
System D3030 - COOLING SYSTEMS

Comments: *Condensate lines crushed and disconnected and unsupported on roof.*

Description of Work: *Provide equipment replacement and installation.*

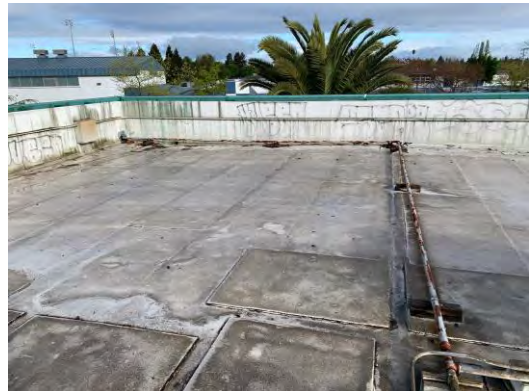
Record ID 1274  
System D2060 - PROCESS SUPPORT PLUMBING SYSTEMS

Comments: *Main gas line on roof should be investigated for overall integrity before repainting. Recommend replacement to service if units are being replaced.*

Description of Work: *Repaint gas line on roof to prevent further deterioration.*

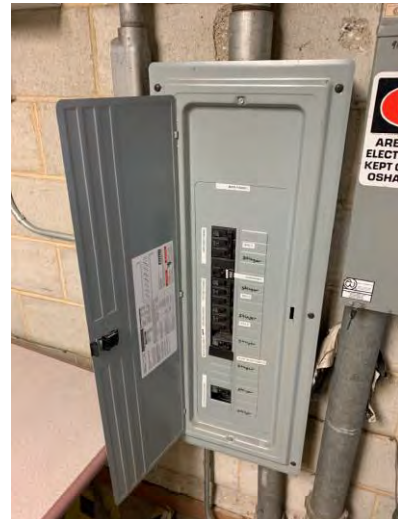
Record ID: 1275  
 System: D5020 - ELECTRICAL SERVICE AND DISTRIBUTION  
 Year Installed / Industry Life / Remaining Useful Life: 2005 / 30 / 13  
 Item No.: D5020.30.4002  
 Floor/Room: 1st / Storage  
**Priority:** 1  
 Quantity/Unit of Measure: 1/EA  
 Total Deficiency Cost: \$6,110  
 Deficiency Description: *The 200A (24 ckts, indoor, 1P) load center is approaching the end of its expected useful life.*  
 Description of Work: *Replace the existing load center with a new load center.*  
 Comments: *Age estimated. Equipment is not original.*

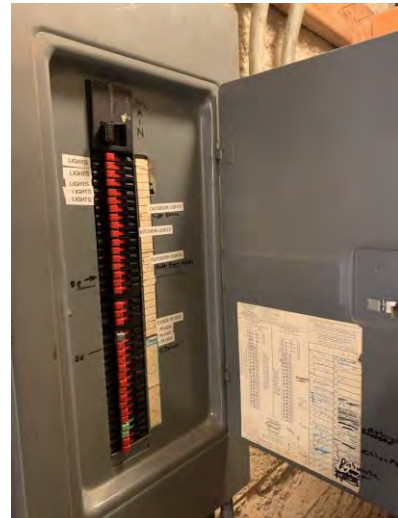
Record ID: 1279  
 System: D5020 - ELECTRICAL SERVICE AND DISTRIBUTION  
 Year Installed / Industry Life / Remaining Useful Life: 1968 / - / -  
 Item No.: D5020.30.1021  
 Floor/Room: 1 / Storage  
**Priority:** 1  
 Quantity/Unit of Measure: 1/EA  
 Total Deficiency Cost: \$24,660  
 Deficiency Description: *The 225A (40 ckts, 120/240, 1P) panelboard is past the end of its expected useful life.*  
 Description of Work: *Replace the existing panelboard with a new panelboard.*  
 Comments:

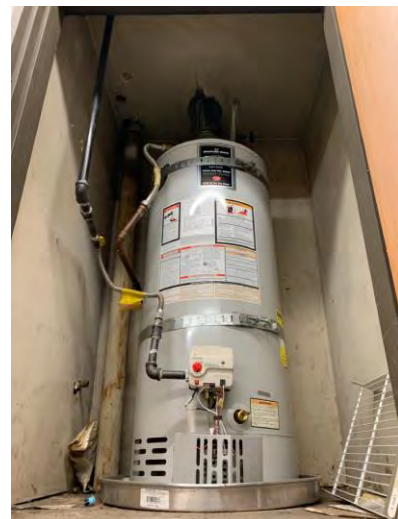
Record ID: 1280  
 System: D2010 - DOMESTIC WATER DISTRIBUTION  
 Year Installed / Industry Life / Remaining Useful Life: - / 15 / -  
 Item No.: D2010.20.002  
 Floor/Room: 1 / Kitchen  
**Priority:** 5  
 Quantity/Unit of Measure: 1/EA  
 Total Deficiency Cost: \$15,700  
 Deficiency Description: *Gas fired water heater is approaching the end of its expected useful life.*  
 Description of Work: *Provide equipment replacement and installation.*  
 Comments: *40 gallons*

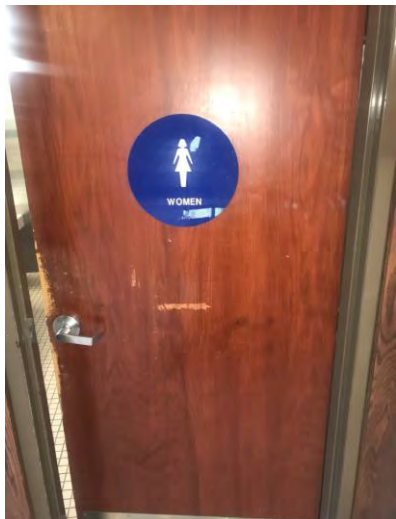
Deficiency Description: *Interior wood door is at or approaching the end of its useful life.*

Description of Work: *Replace with new wood door.*

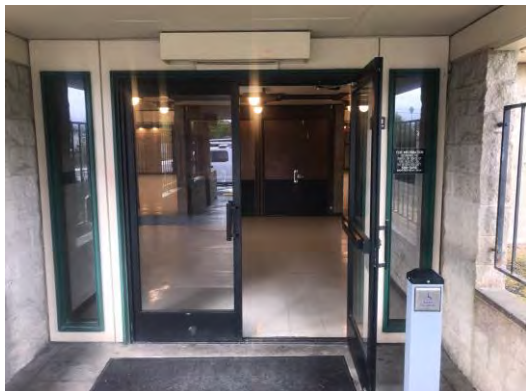
Deficiency Description: *Exterior aluminum (storefront) entrance door is approaching the end of its useful life.*

Comments: *Front door in need of replacement*

Description of Work: *Replace aluminum door (storefront).*

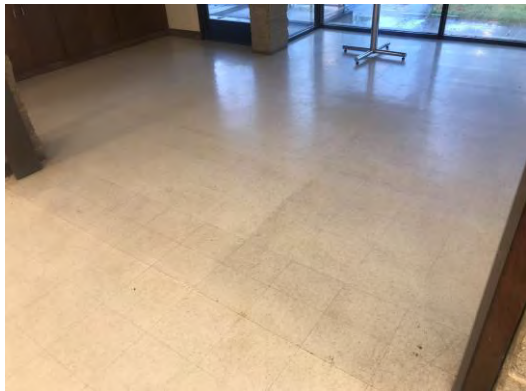
Deficiency Description: *Vinyl composition tile is approaching the end of its useful life.*

Description of Work: *Remove the existing vinyl composition tile and replace.*

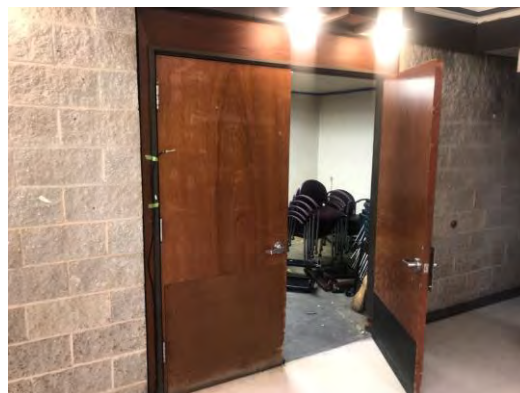
Deficiency Description: *Interior wood door is at or approaching the end of its useful life.*

Comments: *Wood swing doors are showing signs of age and are past their useful life.*

Description of Work: *Replace with new wood door.*

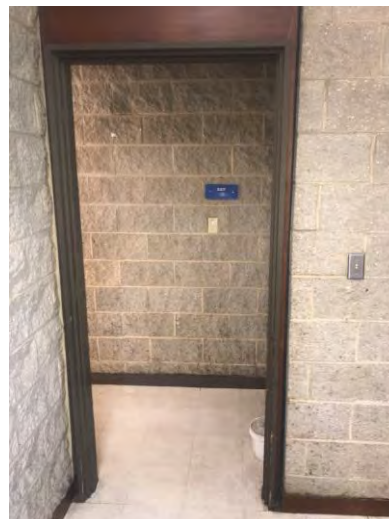
Deficiency Description: *Kitchen door missing.*

Description of Work: *Replace interior wood door, frame and hardware.*

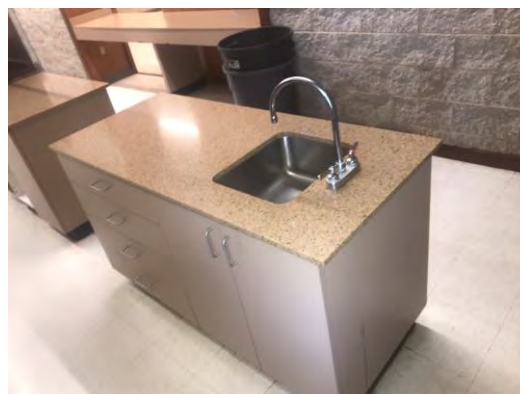
Deficiency Description: *The existing casework is at or is approaching the end of its useful life.*

Comments: *Kitchen casework is showing signs of age and wear.*

Description of Work: *Replace original wood cabinets and countertops.*

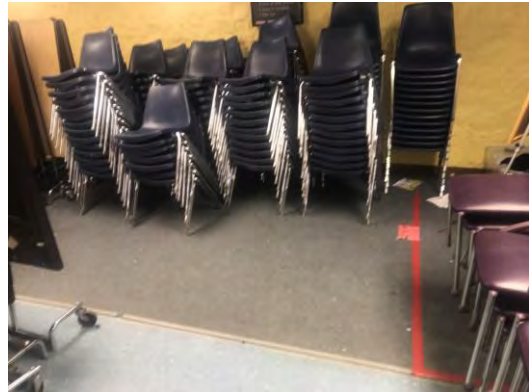
Deficiency Description: *Rolled carpeting is approaching the end of its useful life.*

Description of Work: *Remove existing rolled carpeting and replace it with new carpet flooring.*

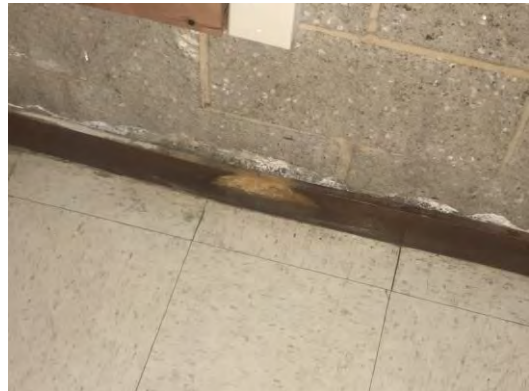
Deficiency Description: *Evidence of water infiltration in CMU wall along floor.*

Description of Work: *Monitor and verify if infiltration is active.*

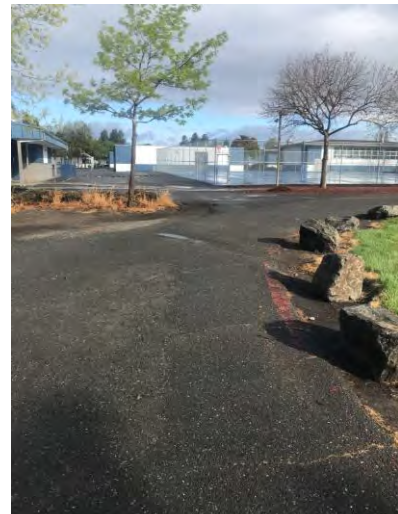
Deficiency Description: *AC paving shows evidence of potholing.*

Comments: *Rear access drive way.*

Description of Work: *Replace AC pavement section.*

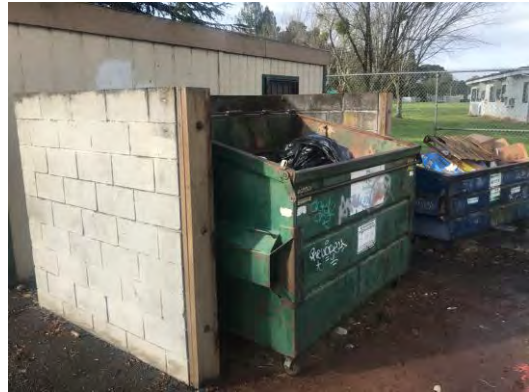
Record ID: 1446  
 System: G2060 - SITE DEVELOPMENT  
 Year Installed / Industry Life / Remaining Useful Life: - / - / -  
 Item No.: G2060.60.011  
 Floor/Room: Site / Trash Enclosure  
**Priority:** 5  
 Quantity/Unit of Measure: 260/SF  
 Total Deficiency Cost: \$2,090  
 Deficiency Description: *CMU trash enclosure walls are showing signs of age and wear.*

Description of Work: *Repaint walls.*

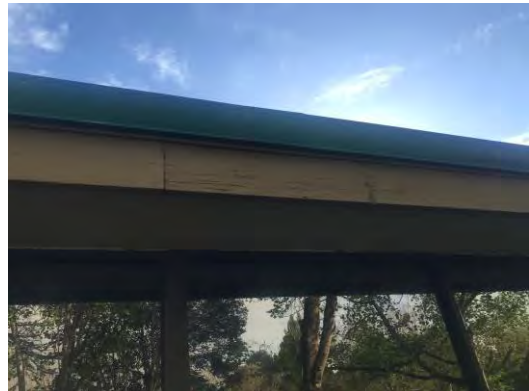
Record ID: 1453  
 System: B3020 - ROOF APPURTENANCES  
 Year Installed / Industry Life / Remaining Useful Life: - / 30 / -  
 Item No.: B3020.70.001  
 Floor/Room: Roof / Gutter  
**Priority:** 1  
 Quantity/Unit of Measure: 400/LF  
 Total Deficiency Cost: \$19,270  
 Deficiency Description: *Rain leaders/gutters are damaged and leak.*

Comments: *Rain gutters are in need of repair and/or replacement.*

Description of Work: *Repair, replace rain leaders/gutters.*

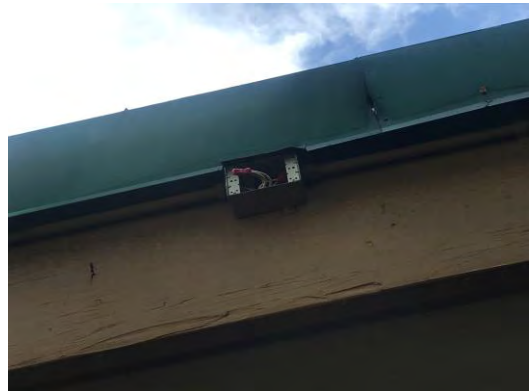
Record ID: 1454  
 System: G4010 - SITE ELECTRIC DISTRIBUTION SYSTEMS  
 Year Installed / Industry Life / Remaining Useful Life: - / - / -  
 Item No.: G4010.10.001  
 Floor/Room: Roof  
**Priority:** 1  
 Quantity/Unit of Measure: 1/EA  
 Total Deficiency Cost: \$380  
 Deficiency Description: *The wiring device (outlet box, junction box, receptacle, etc.) needs to be replaced.*

Description of Work: *Supply and install a new junction box and cover.*

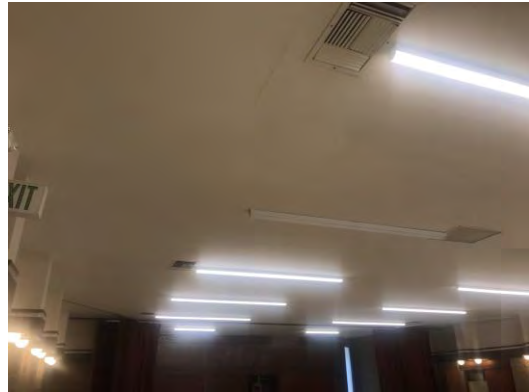
Deficiency Description: *Painted gypsum wallboard ceiling is approaching the end of its useful life.*

Description of Work: *Remove the existing gypsum board ceiling and replace. Tape and paint.*

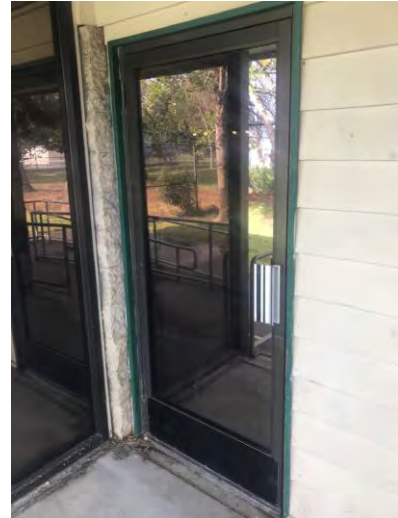
Deficiency Description: *Exterior glass entrance door is approaching the end of its useful life.*

Description of Work: *Replace glass entrance door.*

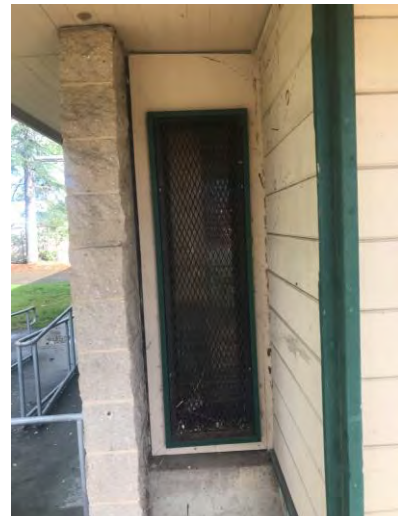
Deficiency Description: *Wood window is approaching the end of its useful life.*

Comments: *Single pane window.*

Description of Work: *Replace wood window.*

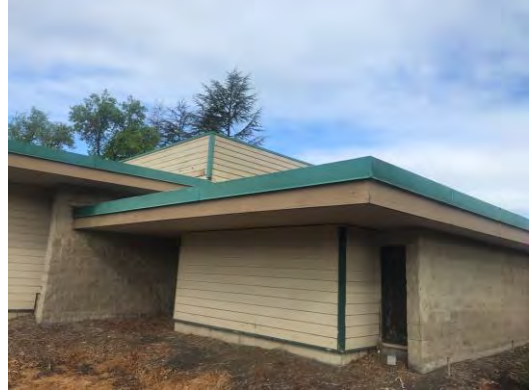
Deficiency Description: *Wood board siding is approaching the end of its useful life.*

Description of Work: *Replace or repair the existing wood siding. Place a new siding over building paper and plywood sheathing.*

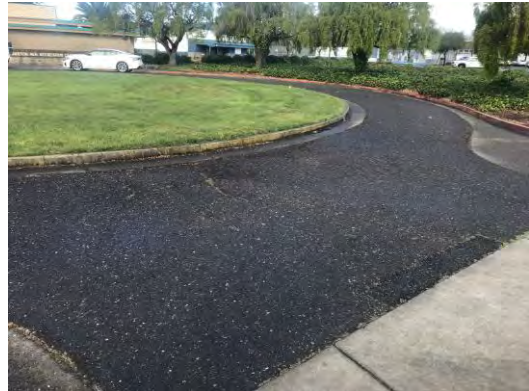
Deficiency Description: *AC paving has faded or has minor weathering.*

Comments: *Driveway pavement is showing signs of wear and age.*

Description of Work: *Provide chip seal.*

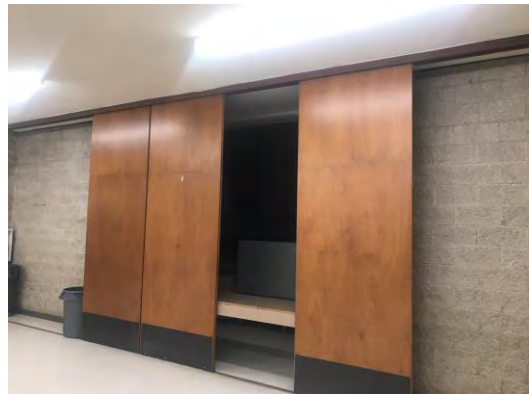
Deficiency Description: *Interior wood sliding door is at or approaching the end of its useful life.*

Comments: *Kitchen wood sliding doors are difficult to open and very heavy. Recommend replacement.*

Description of Work: *Replace with new wood door.*

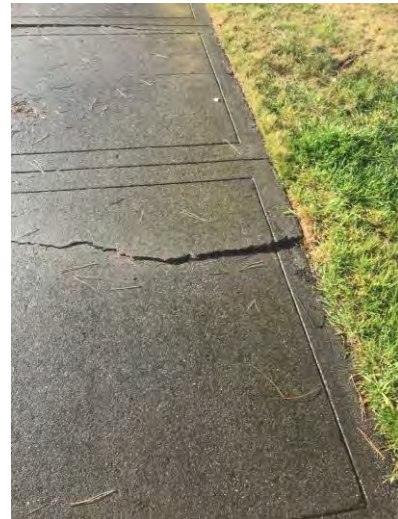
Record ID: 1662  
 System: G2030 - PEDESTRIAN PLAZAS AND WALKWAYS  
 Year Installed / Industry Life / Remaining Useful Life: - / - / -  
 Item No.: G2030.10.107  
 Floor/Room: Site  
**Priority:** 1  
 Quantity/Unit of Measure: 40/SF  
 Total Deficiency Cost: \$1,420  
 Deficiency Description: *Concrete paving is cracking.*

Comments: *Concrete pedestrian pavement is cracking at several locations along the path at the southern end of site.*

Description of Work: *Replace concrete paving.*

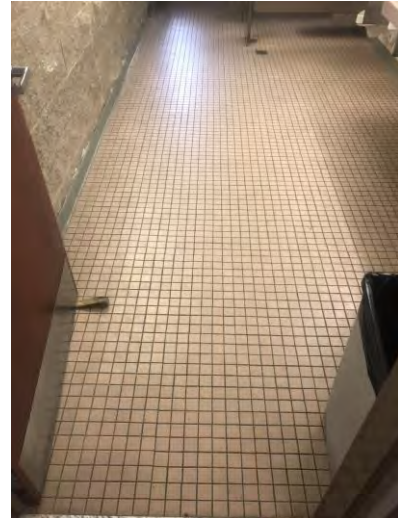
Record ID: 1664  
 System: C2030 - FLOORING  
 Year Installed / Industry Life / Remaining Useful Life: - / 60 / -  
 Item No.: C2030.20.001  
 Floor/Room: 1 / Restroom  
**Priority:** 1  
 Quantity/Unit of Measure: 1,000/SF  
 Total Deficiency Cost: \$63,570  
 Deficiency Description: *Ceramic tile floor is approaching the end of its useful life.*

Comments: *Tile flooring in men and women restrooms is showing signs of age.*

Description of Work: *Remove the existing ceramic tile flooring and replace.*

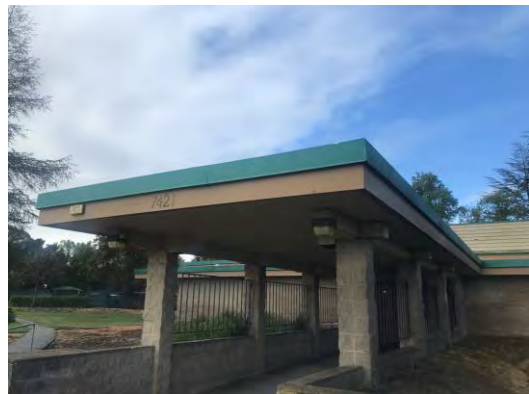
Record ID: 1670  
 System: D5040 - LIGHTING  
 Year Installed / Industry Life / Remaining Useful Life: 1968 / 20 / -34  
 Item No.: D5040.50.010  
 Floor/Room: 1 / Exterior  
**Priority:** 1  
 Quantity/Unit of Measure: 10/EA  
 Total Deficiency Cost: \$9,240  
 Deficiency Description: *The exterior ceiling mounted light fixture is damaged or approaching the end of its useful life and should be replaced.*

Comments: *Diffuser housing is discolored.*

Description of Work: *Replace the existing or damaged exterior light fixture with a new light fixture.*
