# City of Rohnert Park

## Facility Condition Assessment

Final Report

October 17, 2022

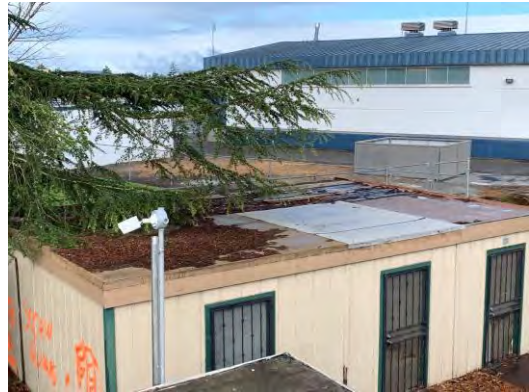
Year Installed / Industry Life / Remaining Useful Life: - / 30 / -  
Item No.: B3010.50.001  
Floor/Room: Roof  
**Priority:** 2  
Quantity/Unit of Measure: 600/SF  
Total Deficiency Cost: \$30,270  
Deficiency Description: *Asphalt roofing is in poor condition.*

Description of Work: *Replace asphalt roofing.*

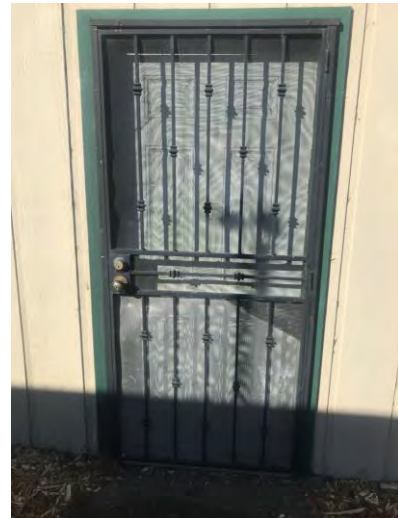
Year Installed / Industry Life / Remaining Useful Life: - / - / -  
Item No.: B2050.70.001  
Floor/Room: 1st Floor / Exterior  
**Priority:** 2  
Quantity/Unit of Measure: 3/LS  
Total Deficiency Cost: \$15,140  
Deficiency Description: *Existing gate is at or approaching the end of its useful life.*

Comments: *(3) Security gates.*

Description of Work: *Install a new gate and associated gate hardware.*

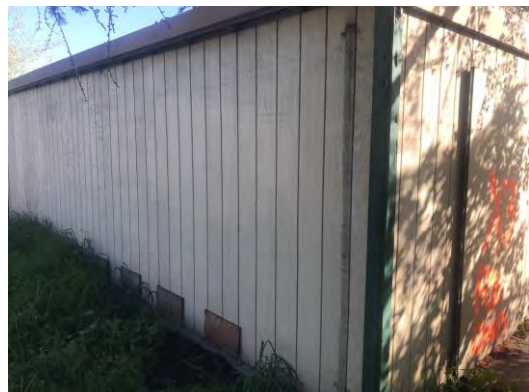
Year Installed / Industry Life / Remaining Useful Life: - / 30 / -  
Item No.: B2010.10.001  
Floor/Room: 1st Floor / Exterior  
**Priority:** 2  
Quantity/Unit of Measure: 900/SF  
Total Deficiency Cost: \$15,140  
Deficiency Description: *Plywood siding is approaching the end of its useful life.*

Description of Work: *Remove and replace the existing plywood siding with new plywood siding. Prime and paint.*

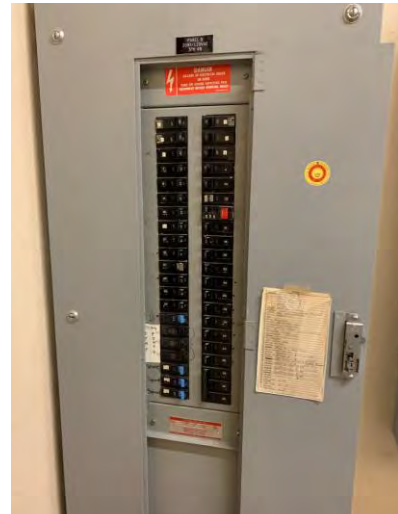
Year Installed / Industry Life / Remaining Useful Life: 1985 / 30 / -7

Description of Work: *Replace the existing panelboard with a new panelboard.*

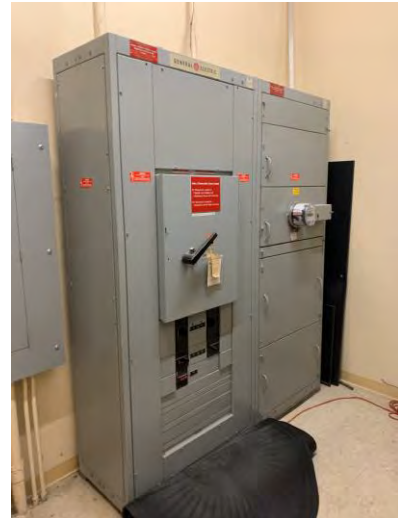
Record ID: 567  
System: D5020 - ELECTRICAL SERVICE AND DISTRIBUTION  
Year Installed / Industry Life / Remaining Useful Life: 1985 / 20 / -17  
Item No.: D5020.10.304  
Floor/Room: 1st / Electrical  
**Priority:** 1  
Quantity/Unit of Measure: 1/EA  
Total Deficiency Cost: \$21,340  
Deficiency Description: *The 800A metered main switchboard (3P, 120/208 ) is past its expected useful life.*

Description of Work: *Replace the existing metered main switchboard with a new metered main switchboard.*

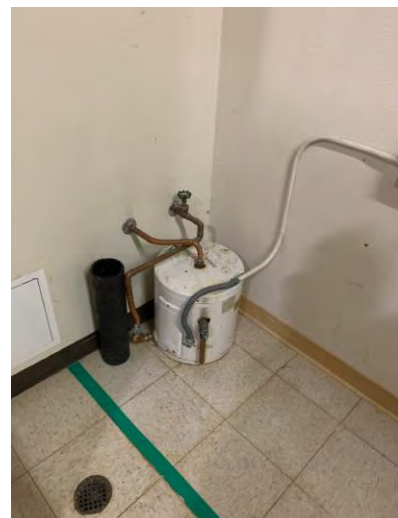
Record ID: 568  
System: D2010 - DOMESTIC WATER DISTRIBUTION  
Year Installed / Industry Life / Remaining Useful Life: - / 15 / -  
Item No.: D2010.20.020  
Floor/Room:  
**Priority:** 3  
Quantity/Unit of Measure: 1/EA  
Total Deficiency Cost: \$3,650  
Deficiency Description: *Electric water heater is approaching the end of its expected useful life.*

Description of Work: *Provide equipment replacement and installation.*

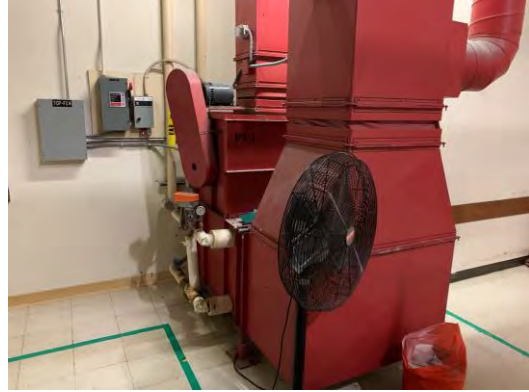
Comments: *Although operational with electronic controls. It is recommended to plan for replacement for energy efficiency.*

Description of Work: *Provide equipment replacement and installation.*

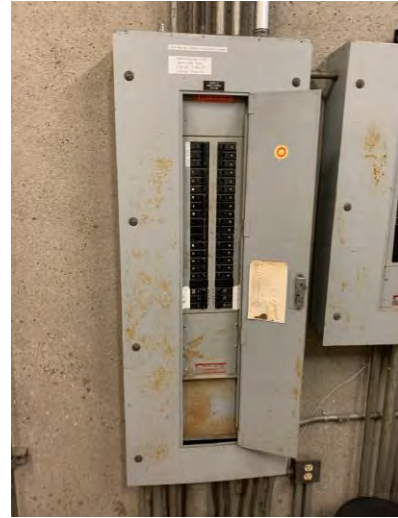
Comments: *Rust observed.*

Description of Work: *Replace the existing panelboard with a new panelboard.*

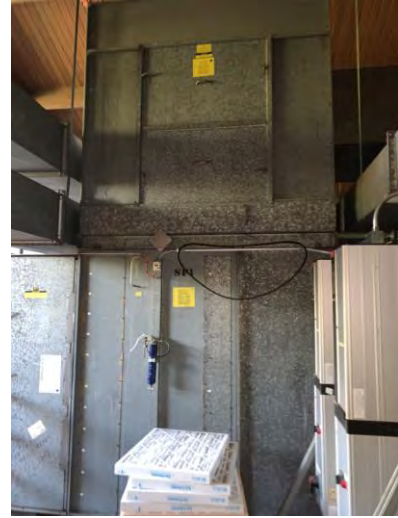
Comments: *Although operational with VFD and electronic controls. It is recommended to plan for replacement for energy efficiency.*

Description of Work: *Provide equipment replacement and installation.*

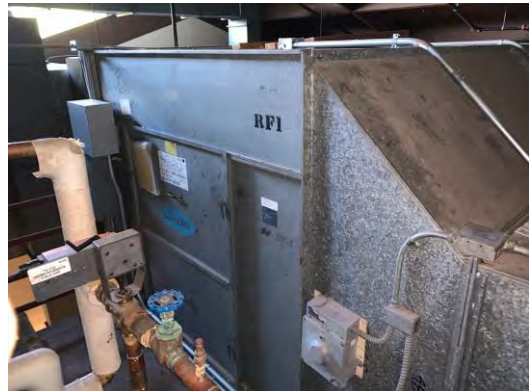
Record ID 580  
System D3050 - FACILITY HVAC DISTRIBUTION SYSTEMS  
Year Installed / Industry Life / Remaining Useful Life 1988 / 15 / -19  
Item No. D3050.50.014  
Floor/Room:  
**Priority: 7**  
Quantity/Unit of Measure: 1/EA  
Total Deficiency Cost: \$39,550  
Deficiency Description: *Air handler return fan is approaching the end of its expected useful life.*

Comments: *Although operational with VFD and electronic controls. It is recommended to plan for replacement for energy efficiency.*

Description of Work: *Provide equipment replacement and installation.*

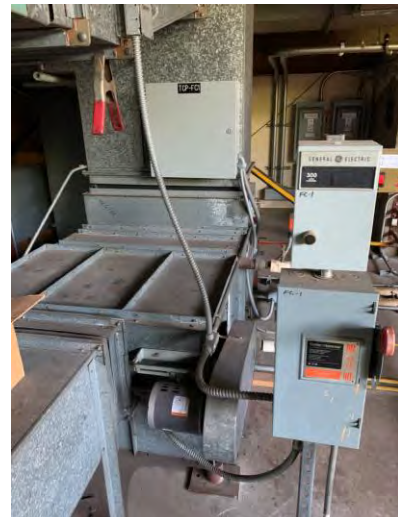
Record ID 581  
System D3030 - COOLING SYSTEMS  
Year Installed / Industry Life / Remaining Useful Life 1988 / 15 / -19  
Item No. D3030.70.012  
Floor/Room:  
**Priority: 7**  
Quantity/Unit of Measure: 1/EA  
Total Deficiency Cost: \$20,580  
Deficiency Description: *Fan coil unit is approaching the end of its expected useful life.*

Comments: *Although operational with electronic controls. It is recommended to plan for replacement for energy efficiency.*

Description of Work: *Provide equipment replacement and installation.*

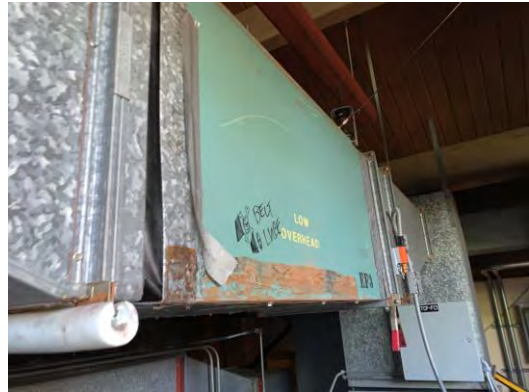
Deficiency Description: *In-Line building exhaust fan is approaching the end of its expected useful life.*

Description of Work: *Provide equipment replacement and installation.*

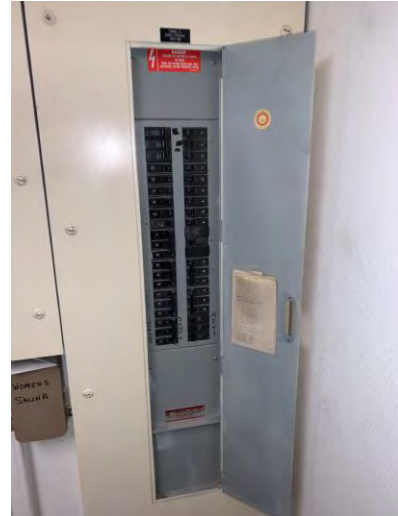
Record ID: 583  
 System: D5020 - ELECTRICAL SERVICE AND DISTRIBUTION

Deficiency Description: *The 400A (120/208, 3P) panelboard is past its expected useful life.*

Description of Work: *Replace the existing panelboard with a new panelboard.*

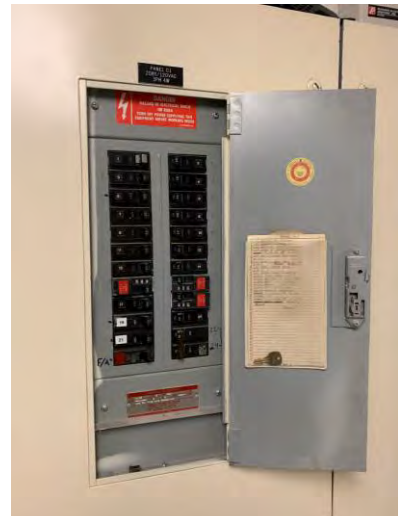
Record ID: 584  
 System: D5020 - ELECTRICAL SERVICE AND DISTRIBUTION

Deficiency Description: *The 100A (120/208, 3P) panelboard is past its expected useful life.*

Description of Work: *Replace the existing panelboard with a new panelboard.*

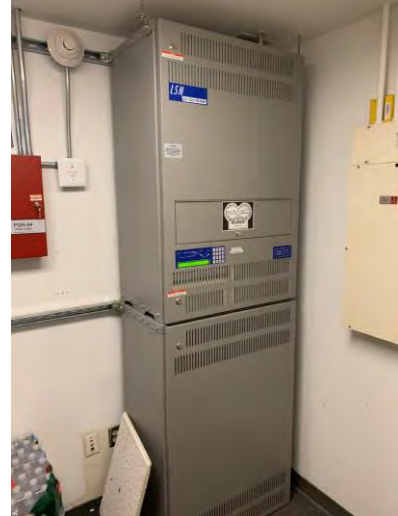
Record ID: 585  
 System: D8010 - INTEGRATED AUTOMATION FACILITY CONTROLS  
 Year Installed / Industry Life / Remaining Useful Life: 1985 / 15 / -22  
 Item No.: D8010.60.001  
 Floor/Room: 1st / Electrical  
**Priority:** 1  
 Quantity/Unit of Measure: 1/EA  
 Total Deficiency Cost: \$42,110  
 Deficiency Description: *The 5kVA lighting battery back-up system is past the end of its expected useful life.*

Description of Work: *Replace the existing integrated lighting back-up system with new.*

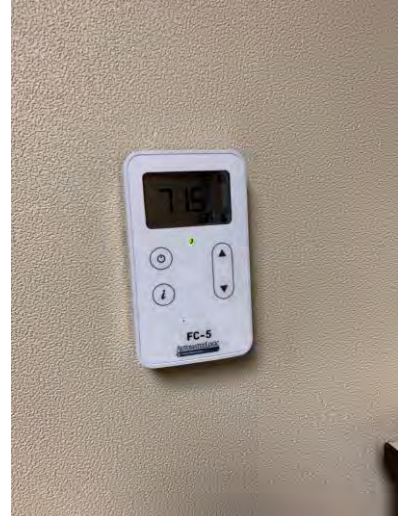
Record ID: 586  
 System: D3030 - COOLING SYSTEMS  
 Year Installed / Industry Life / Remaining Useful Life: 1988 / 15 / -19  
 Item No.: D3030.70.011  
 Floor/Room:  
**Priority:** 5  
 Quantity/Unit of Measure: 1/EA  
 Total Deficiency Cost: \$13,340  
 Deficiency Description: *Fan coil unit is approaching the end of its expected useful life.*

Comments: *Although operational with electronic controls. It is recommended to plan for replacement for energy efficiency.*

Description of Work: *Provide equipment replacement and installation.*

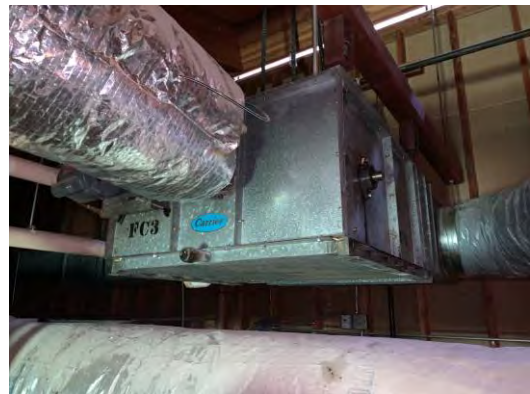
Record ID: 587  
 System: D3030 - COOLING SYSTEMS  
 Year Installed / Industry Life / Remaining Useful Life: 1988 / 15 / -19  
 Item No.: D3030.70.011  
 Floor/Room:  
**Priority:** 3  
 Quantity/Unit of Measure: 1/EA  
 Total Deficiency Cost: \$12,300  
 Deficiency Description: *Fan coil unit is approaching the end of its expected useful life.*

Comments: *Although operational with electronic controls. It is recommended to plan for replacement for energy efficiency.*

Description of Work: *Provide equipment replacement and installation.*

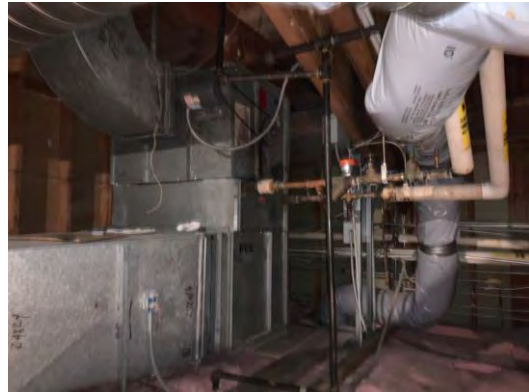
Deficiency Description: *Fan coil unit is approaching the end of its expected useful life.*

Comments: *Although operational with electronic controls. It is recommended to plan for replacement for energy efficiency.*

Description of Work: *Provide equipment replacement and installation.*

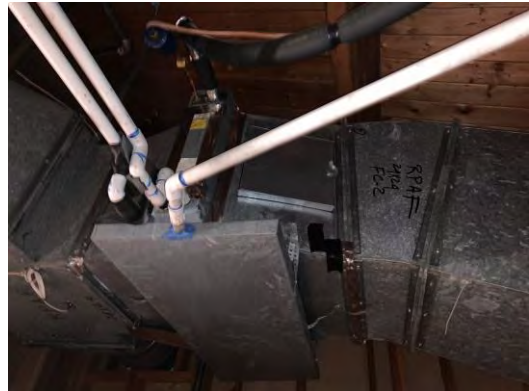
Record ID: 590  
 System: D3030 - COOLING SYSTEMS

Deficiency Description: *Fan coil unit is approaching the end of its expected useful life.*

Comments: *Although operational with electronic controls. It is recommended to plan for replacement for energy efficiency.*

Description of Work: *Provide equipment replacement and installation.*

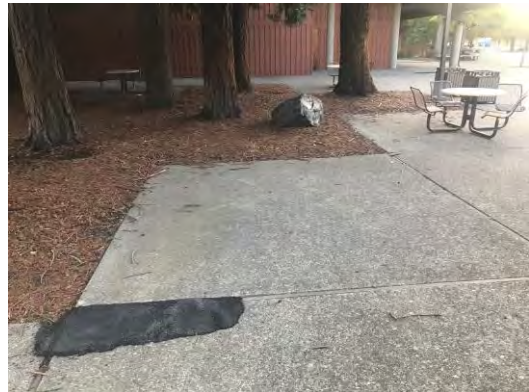
Record ID: 917  
 System: G2030 - PEDESTRIAN PLAZAS AND WALKWAYS

Deficiency Description: *Concrete pavement has major damage / structural failure.*

Description of Work: *Replace concrete and base to match existing.*

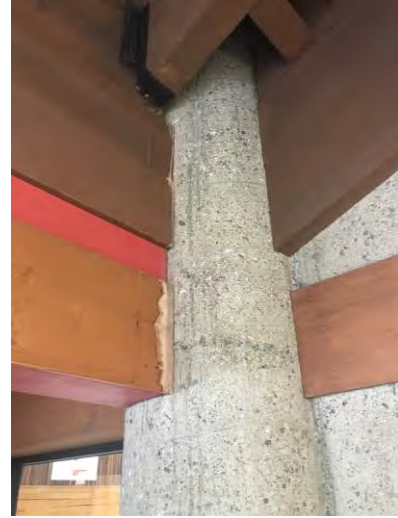
Priority: 1  
Quantity/Unit of Measure: 1/EA  
Total Deficiency Cost: \$340  
Deficiency Description: *Wood beam shows signs of wear.*

Comments: *Potential water intrusion. Further investigation is recommended to determine the source of water damage.*

Description of Work: *Clean, repair, seal, and refinish wood beam.*

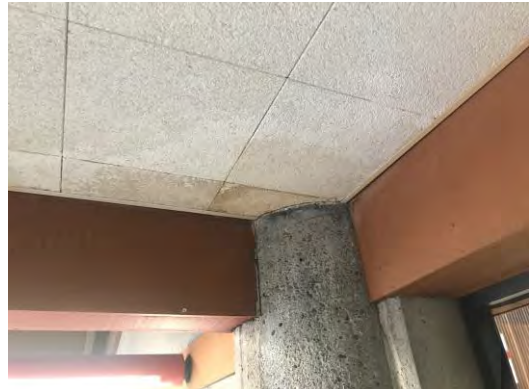
Record ID 920  
System C2050 - CEILING FINISHES

Priority: 1  
Quantity/Unit of Measure: 25/SF  
Total Deficiency Cost: \$720  
Deficiency Description: *Glue-On Acoustical Ceiling Tile is in poor condition.*

Comments: *Further investigation is recommended to determine the source of water damage.*

Description of Work: *Remove existing Glue-On Acoustical and replace with new Glue-On Acoustical Tiles.*

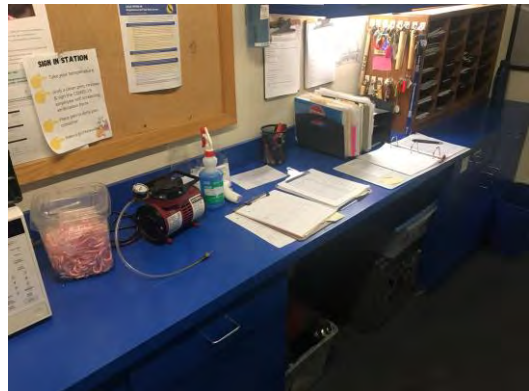
Record ID 921  
System E2010 - FIXED FURNISHINGS

Priority: 4  
Quantity/Unit of Measure: 10/LF  
Total Deficiency Cost: \$24,590  
Deficiency Description: *Plastic Laminate Casework is at or will be approaching the end of its expected useful life.*

Description of Work: *Provide new plastic laminate casework (upper, lower, and countertop)*

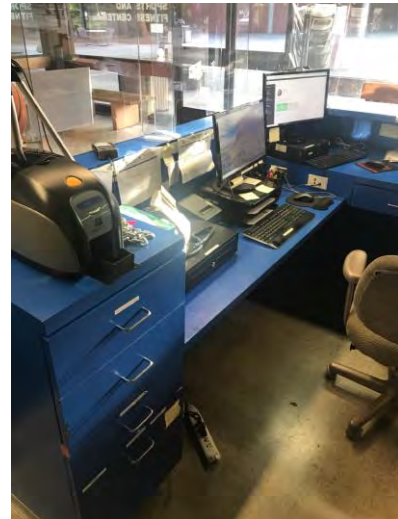
Deficiency Description: *Plastic laminate countertops are at or are approaching the end of their useful life.*

Description of Work: *Repair or replace plastic laminate countertops.*

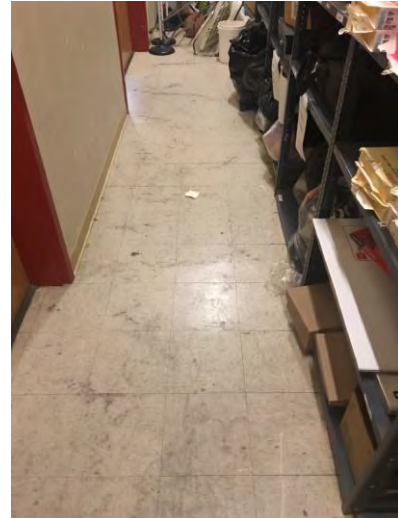
Record ID 923  
System C2030 - FLOORING

Deficiency Description: *Vinyl composition tile is approaching the end of its useful life.*

Description of Work: *Remove the existing vinyl composition tile and replace.*

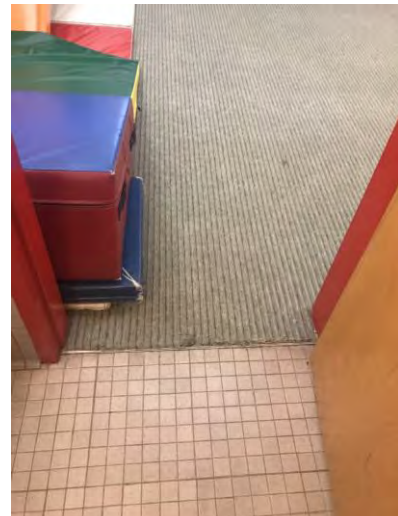
Record ID 924  
System C2030 - FLOORING

Deficiency Description: *Carpeting is approaching the end of its useful life.*

Description of Work: *Remove existing carpeting and replace it with new.*

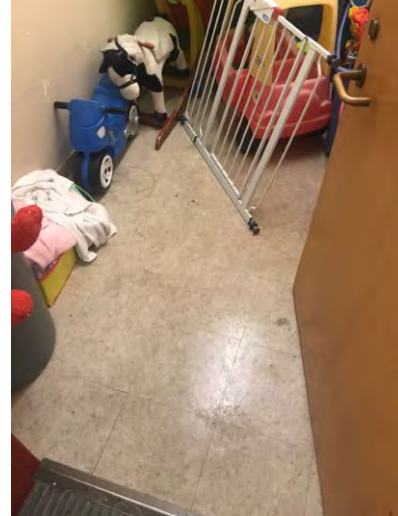
Deficiency Description: *Vinyl composition tile is approaching the end of its useful life.*

Description of Work: *Remove the existing vinyl composition tile and replace.*

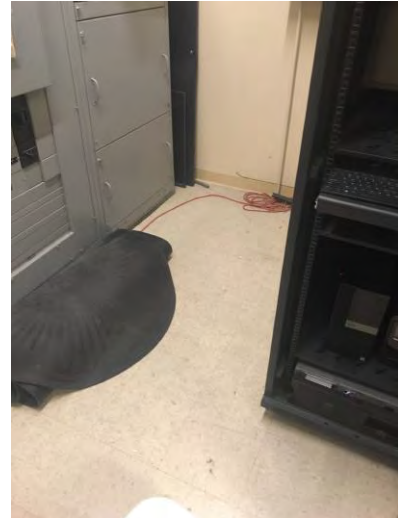
Record ID 926  
System C2030 - FLOORING

Deficiency Description: *Vinyl composition tile is approaching the end of its useful life.*

Description of Work: *Remove the existing vinyl composition tile and replace.*

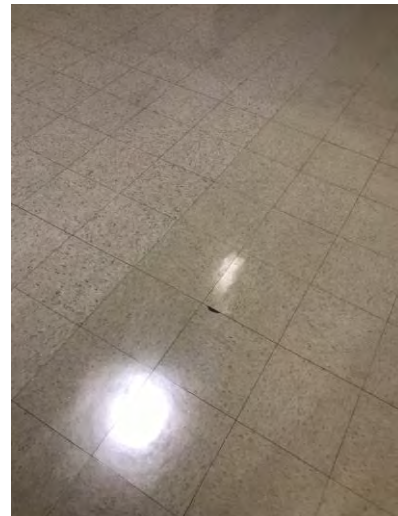
Record ID 928  
System C2030 - FLOORING

Deficiency Description: *Vinyl composition tile is approaching the end of its useful life.*

Description of Work: *Remove the existing vinyl composition tile and replace.*

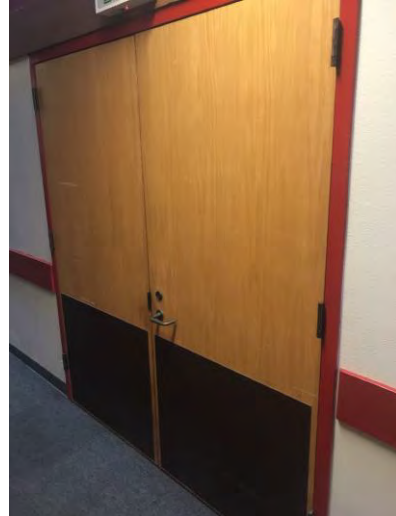
Deficiency Description: *Paint finish at wood doors and frames is in poor condition.*

Description of Work: *Refinish doors and frames.*

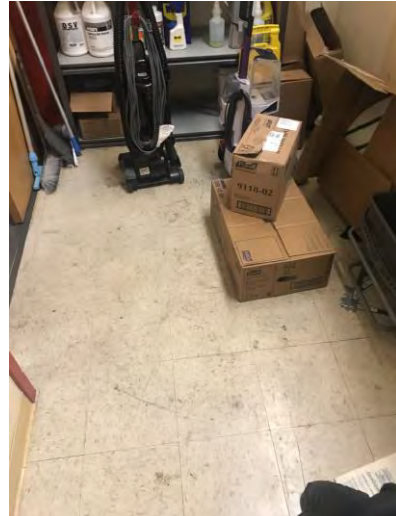
Record ID 931  
System C2030 - FLOORING

Deficiency Description: *Vinyl composition tile is approaching the end of its useful life.*

Description of Work: *Remove the existing vinyl composition tile and replace.*

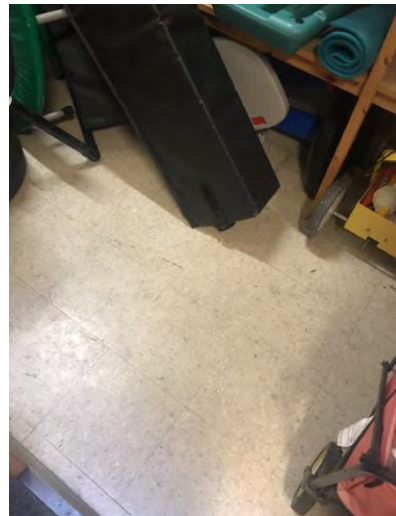
Record ID 932  
System C2030 - FLOORING

Deficiency Description: *Vinyl composition tile is approaching the end of its useful life.*

Description of Work: *Remove the existing vinyl composition tile and replace.*

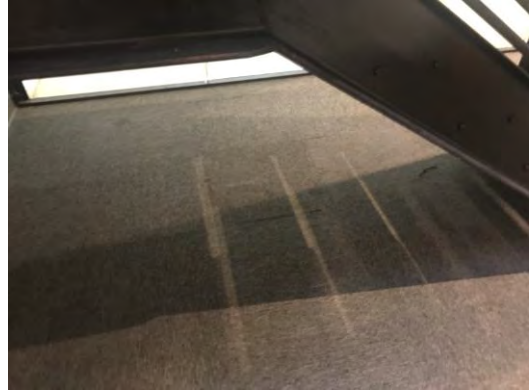
Record ID: 933  
System: C2030 - FLOORING  
Year Installed / Industry Life / Remaining Useful Life: - / 20 / -  
Item No.: C2030.75.001  
Floor/Room: 1st Floor / Corridor  
**Priority:** 3  
Quantity/Unit of Measure: 1,000/SF  
Total Deficiency Cost: \$28,070  
Deficiency Description: *Carpet tile is missing or damaged.*

Description of Work: *Replace carpet tile.*

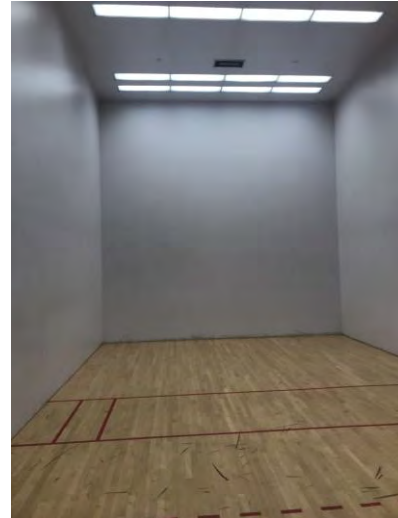
Record ID: 934  
System: C2010 - WALL FINISHES  
Year Installed / Industry Life / Remaining Useful Life: - / 30 / -  
Item No.: C2010.70.001  
Floor/Room: 1st Floor / Racquetball Court  
**Priority:** 3  
Quantity/Unit of Measure: 2,500/SF  
Total Deficiency Cost: \$54,820  
Deficiency Description: *Painted gypsum wallboard is showing signs of wear.*

Description of Work: *Patch and paint the gypsum wallboard.*

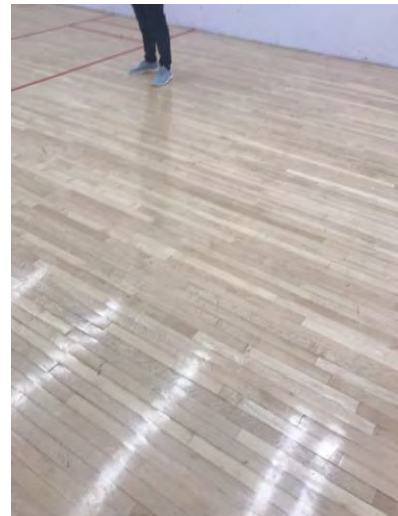
Record ID: 935  
System: C2030 - FLOORING  
Year Installed / Industry Life / Remaining Useful Life: - / 40 / -  
Item No.: C2030.80.001  
Floor/Room: 1st Floor / Racquetball Court  
**Priority:** 3  
Quantity/Unit of Measure: 800/SF  
Total Deficiency Cost: \$44,920  
Deficiency Description: *Gymnasium floor is approaching the end of its useful life.*

Comments: *Floor is uneven down court.*

Description of Work: *Replace the existing flooring with a new wood gym floor.*

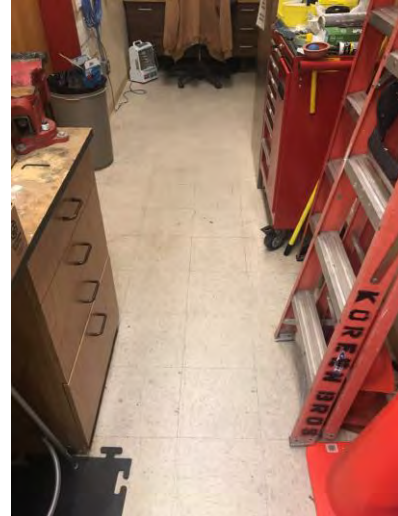
Quantity/Unit of Measure: 200/SF  
Total Deficiency Cost: \$5,730  
Deficiency Description: *Vinyl composition tile is approaching the end of its useful life.*

Description of Work: *Remove the existing vinyl composition tile and replace.*

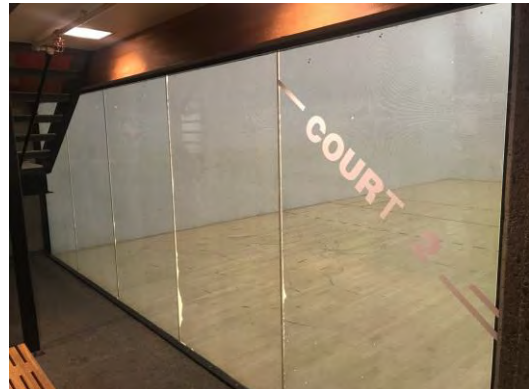
Record ID: 938  
System: E2010 - FIXED FURNISHINGS

Quantity/Unit of Measure: 250/SF  
Total Deficiency Cost: \$4,230  
Deficiency Description: *Film/tint on window is deteriorating.*

Description of Work: *Remove and reinstall film coating.*

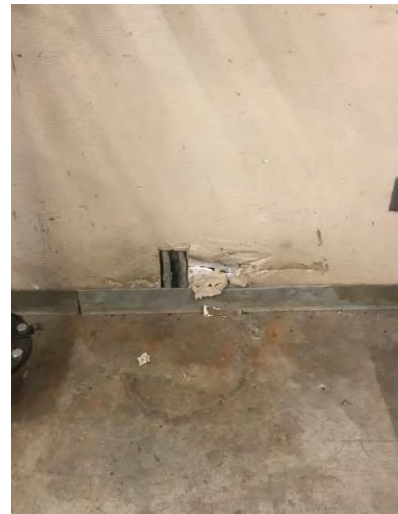
Record ID: 941  
System: C1010 - INTERIOR PARTITIONS

Quantity/Unit of Measure: 100/SF  
Total Deficiency Cost: \$690  
Deficiency Description: *Painted gypsum wallboard is in poor condition with several cracks.*

Description of Work: *Remove and replace existing gypsum board with a new gypsum board and expansion joints. Tape and paint.*

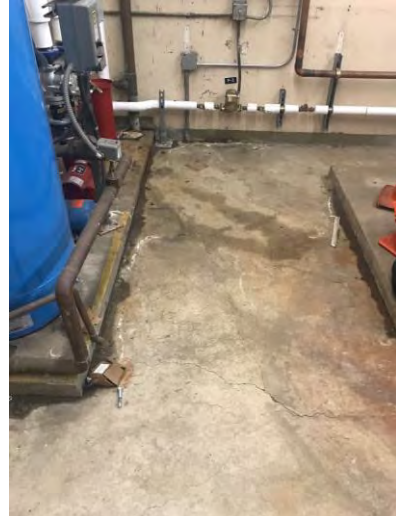
Year Installed / Industry Life / Remaining Useful Life: - / 50 / -  
Item No.: C2030.10.001  
Floor/Room: 1st Floor / Mechanical Room  
**Priority:** 5  
Quantity/Unit of Measure: 1,000/SF  
Total Deficiency Cost: \$19,060  
Deficiency Description: *Concrete flooring is showing signs of cracking and wear.*

Description of Work: *Repair and refinish the concrete floor.*

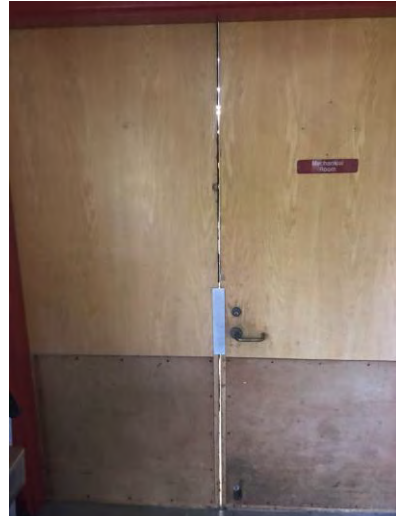
Record ID: 944  
System: C1030 - INTERIOR DOORS

Year Installed / Industry Life / Remaining Useful Life: - / 50 / -  
Item No.: C1030.10.001  
Floor/Room: 1st Floor / Mechanical Room  
**Priority:** 3  
Quantity/Unit of Measure: 2/EA  
Total Deficiency Cost: \$15,450  
Deficiency Description: *Interior wood door is at or approaching the end of its useful life.*

Description of Work: *Replace with new wood door.*

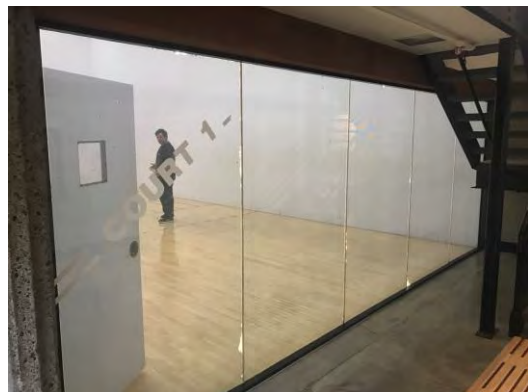
Record ID: 945  
System: E2010 - FIXED FURNISHINGS

Year Installed / Industry Life / Remaining Useful Life: - / - / -  
Item No.: E2010.20.003  
Floor/Room: 1 / Court 1  
**Priority:** 2  
Quantity/Unit of Measure: 250/SF  
Total Deficiency Cost: \$4,230  
Deficiency Description: *Film/tint on window is deteriorating.*

Description of Work: *Remove and reinstall film coating.*

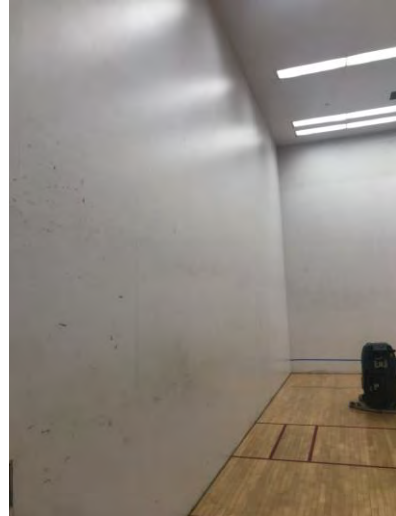
Year Installed / Industry Life / Remaining Useful Life: - / 30 / -  
Item No.: C2010.70.001  
Floor/Room: 1st Floor / Racquetball Ball 2  
**Priority:** 3  
Quantity/Unit of Measure: 2,500/SF  
Total Deficiency Cost: \$54,820  
Deficiency Description: *Painted gypsum wallboard is showing signs of wear.*

Description of Work: *Patch and paint the gypsum wallboard.*

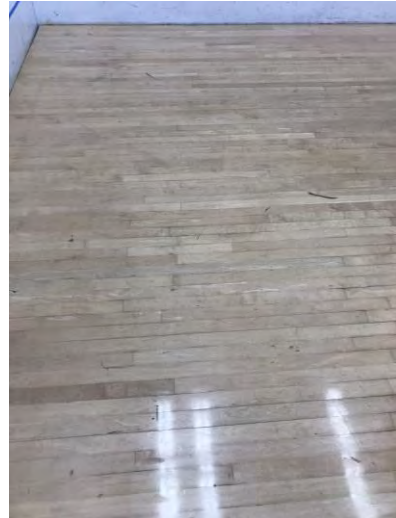
Record ID: 947  
System: C2030 - FLOORING

Year Installed / Industry Life / Remaining Useful Life: - / 40 / -  
Item No.: C2030.80.001  
Floor/Room: 1st Floor / Racquetball Ball 2  
**Priority:** 3  
Quantity/Unit of Measure: 1,000/SF  
Total Deficiency Cost: \$56,130  
Deficiency Description: *Gymnasium floor is approaching the end of its useful life.*

Description of Work: *Replace the existing flooring with a new wood gym floor.*

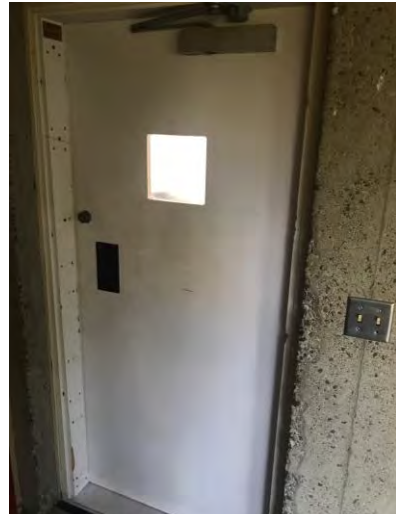
Record ID: 948  
System: C1030 - INTERIOR DOORS

Year Installed / Industry Life / Remaining Useful Life: - / 60 / -  
Item No.: C1030.90.003  
Floor/Room: 1 / Racquetball Ball 2  
**Priority:** 3  
Quantity/Unit of Measure: 1/EA  
Total Deficiency Cost: \$900  
Deficiency Description: *Metal door and frame are in fair to poor condition.*

Description of Work: *Repair and refinish the metal door and frame.*

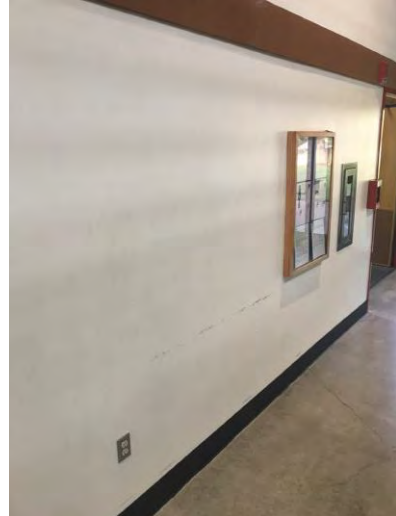
Year Installed / Industry Life / Remaining Useful Life: - / 30 / -  
Item No.: C2010.70.001  
Floor/Room: 1 / Corridor  
**Priority:** 3  
Quantity/Unit of Measure: 200/SF  
Total Deficiency Cost: \$4,420  
Deficiency Description: *Painted gypsum wallboard is showing signs of wear.*

Description of Work: *Patch and paint the gypsum wallboard.*

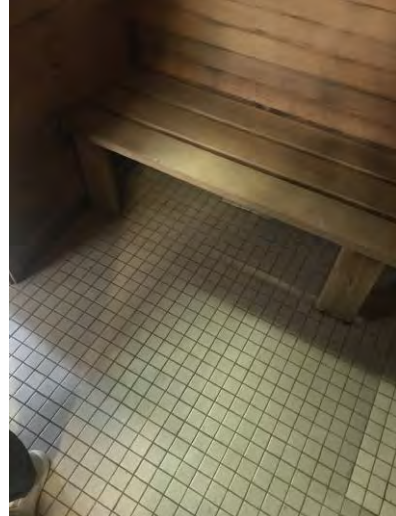
Record ID: 952  
System: C2030 - FLOORING

Year Installed / Industry Life / Remaining Useful Life: - / 60 / -  
Item No.: C2030.20.001  
Floor/Room: 1 / Men's Sauna  
**Priority:** 3  
Quantity/Unit of Measure: 100/SF  
Total Deficiency Cost: \$6,980  
Deficiency Description: *Ceramic tile floor is approaching the end of its useful life.*

Description of Work: *Remove the existing ceramic tile flooring and replace.*

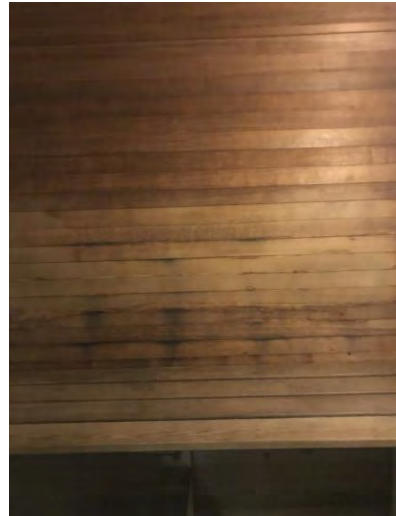
Record ID: 953  
System: C2010 - WALL FINISHES

Year Installed / Industry Life / Remaining Useful Life: - / 30 / -  
Item No.: C2010.20.002  
Floor/Room: 1 / Men's Sauna  
**Priority:** 3  
Quantity/Unit of Measure: 250/SF  
Total Deficiency Cost: \$2,210  
Deficiency Description: *The existing veneer plywood is damaged or worn.*

Description of Work: *Clean, prepare, and paint the plywood paneling.*

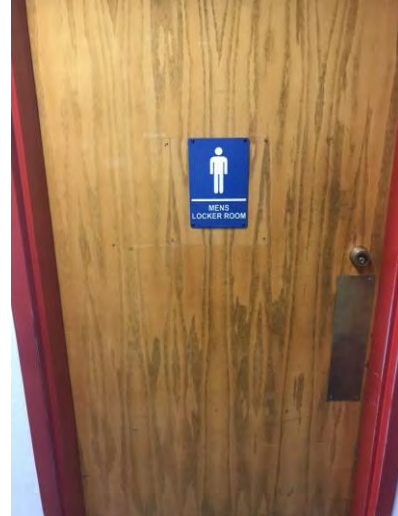
Deficiency Description: *Interior wood door is in visual need of refurbishment.*

Description of Work: *Refurbish and restrain the wood door.*

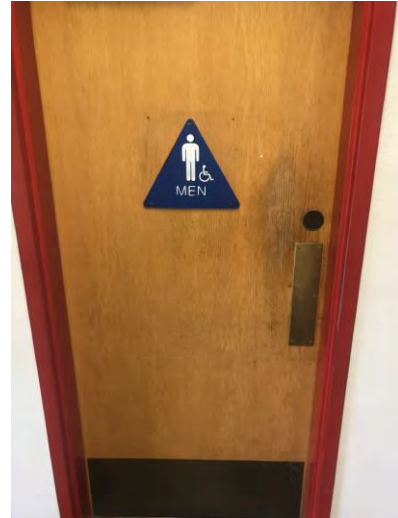
Record ID 955  
System C1030 - INTERIOR DOORS

Deficiency Description: *Interior wood door is in visual need of refurbishment.*

Description of Work: *Refurbish and restrain the wood door.*

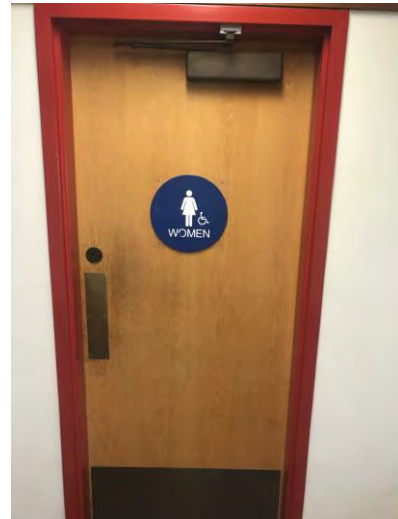
Deficiency Description: *Interior wood door is in visual need of refurbishment.*

Description of Work: *Refurbish and restain the wood door.*

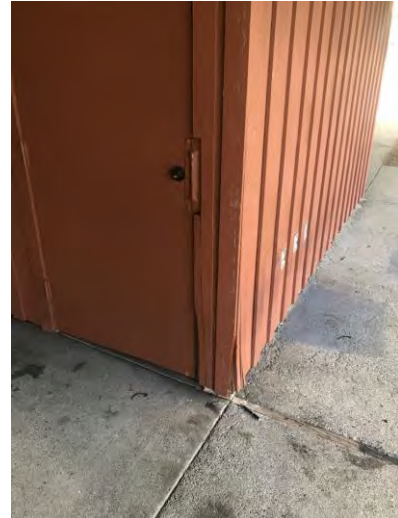
Record ID 958  
System B2010 - EXTERIOR WALLS

Deficiency Description: *Wood board siding is approaching the end of its useful life.*

Description of Work: *Replace or repair the existing wood siding. Place a new siding over building paper and plywood sheathing.*

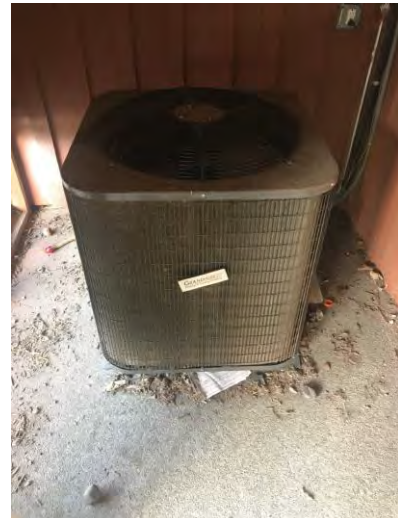
Record ID 959  
System D3030 - COOLING SYSTEMS

Deficiency Description: *Split system with fan coil and outdoor condensing unit is approaching the end of its expected useful life.*

Description of Work: *Provide equipment replacement and installation.*

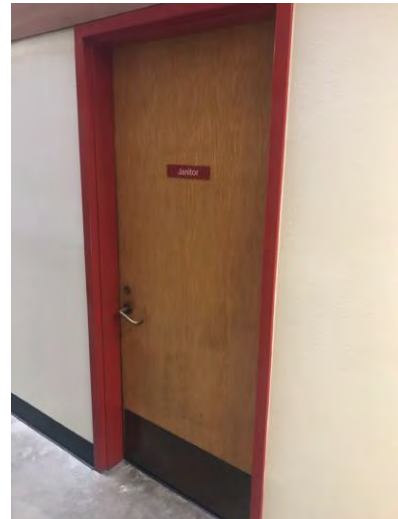
Deficiency Description: *Paint finish at wood doors and frames is in poor condition.*

Description of Work: *Refinish doors and frames.*

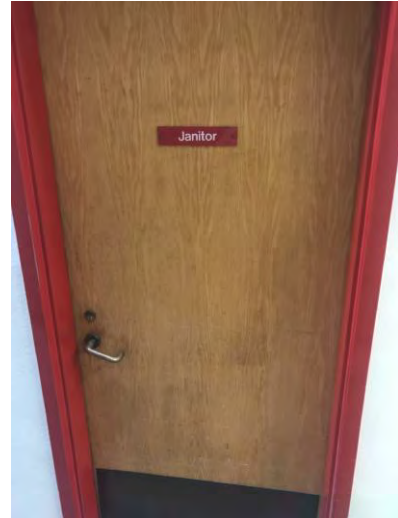
Record ID: 962  
 System: C1030 - INTERIOR DOORS

Deficiency Description: *Interior door hardware is at or approaching the end of its useful life.*

Description of Work: *Replace interior door hardware.*

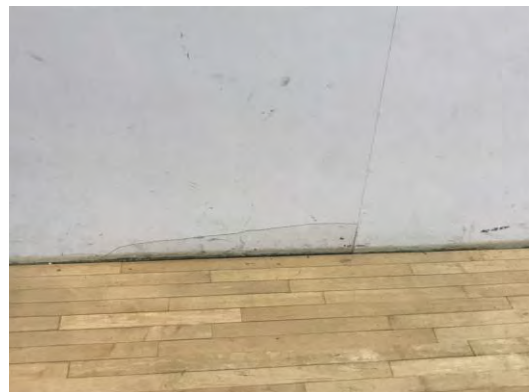
Record ID: 966  
 System: C1010 - INTERIOR PARTITIONS

Deficiency Description: *Painted gypsum wallboard is in poor condition with several cracks.*

Description of Work: *Remove and replace existing gypsum board with a new gypsum board and expansion joints. Tape and paint.*

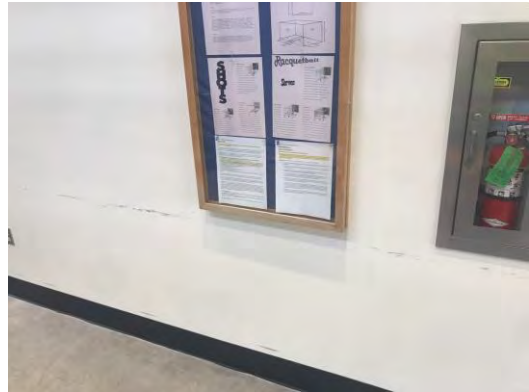
Year Installed / Industry Life / Remaining Useful Life: - / 30 / -  
Item No.: C2010.70.001  
Floor/Room: 1 / Corridor  
**Priority:** 3  
Quantity/Unit of Measure: 200/SF  
Total Deficiency Cost: \$4,420  
Deficiency Description: *Painted gypsum wallboard is showing signs of wear.*

Description of Work: *Patch and paint the gypsum wallboard.*

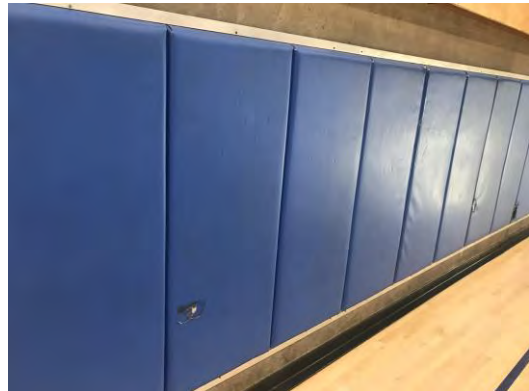
Record ID: 968  
System: G2050 - ATHLETIC, RECREATIONAL, AND PLAYFIELD AREAS

Year Installed / Industry Life / Remaining Useful Life: - / - / -  
Item No.: G2050.10.028  
Floor/Room: 1 / Basketball Court  
**Priority:** 3  
Quantity/Unit of Measure: 600/SF  
Total Deficiency Cost: \$50,520  
Deficiency Description: *Basketball court wall padding is damaged.*

Description of Work: *Replace basketball court wall padding.*

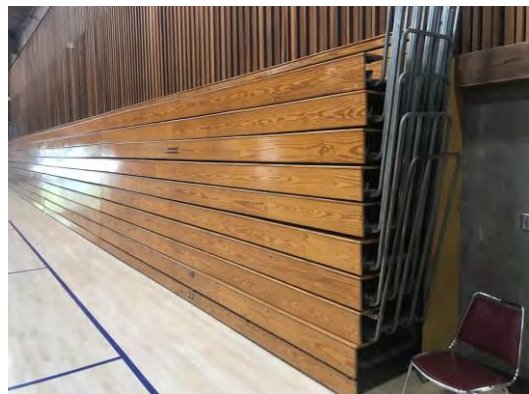
Record ID: 969  
System: E2010 - FIXED FURNISHINGS

Year Installed / Industry Life / Remaining Useful Life: - / - / -  
Item No.: E2010.70.001  
Floor/Room: 1 / Basketball Court  
**Priority:** 3  
Quantity/Unit of Measure: 100/LF  
Total Deficiency Cost: \$21,060  
Deficiency Description: *Bleachers are in need of refurbishment.*

Description of Work: *Repair, refurbish, and refinish the bleachers accordingly.*

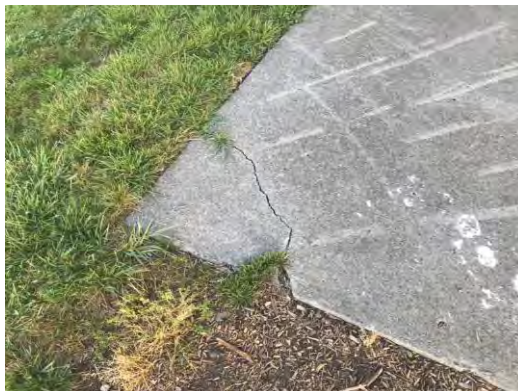
Record ID: 971  
System: G2030 - PEDESTRIAN PLAZAS AND WALKWAYS  
Year Installed / Industry Life / Remaining Useful Life: - / 30 / -  
Item No.: G2030.10.005  
Floor/Room: Site / Pavement  
**Priority:** 2  
Quantity/Unit of Measure: 25/SF  
Total Deficiency Cost: \$920  
Deficiency Description: *Concrete pavement has major damage / structural failure.*

Description of Work: *Replace concrete and base to match existing.*

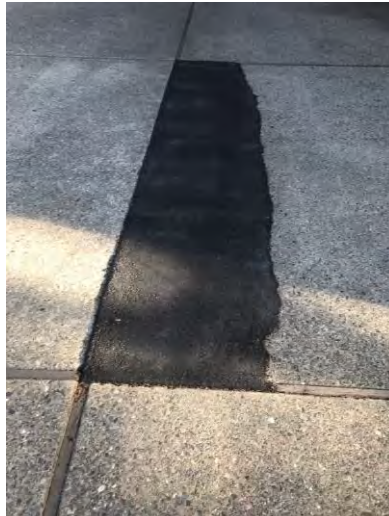
Record ID: 975  
System: G2030 - PEDESTRIAN PLAZAS AND WALKWAYS  
Year Installed / Industry Life / Remaining Useful Life: - / 30 / -  
Item No.: G2030.10.005  
Floor/Room: Site / Pavement  
**Priority:** 3  
Quantity/Unit of Measure: 50/SF  
Total Deficiency Cost: \$1,900  
Deficiency Description: *Concrete pavement has major damage / structural failure.*

Description of Work: *Replace concrete and base to match existing.*

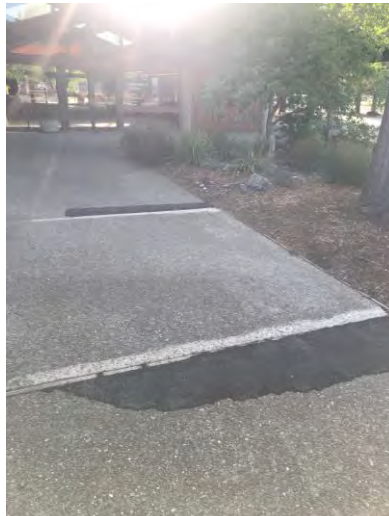
Record ID: 976  
System: G2030 - PEDESTRIAN PLAZAS AND WALKWAYS  
Year Installed / Industry Life / Remaining Useful Life: - / 30 / -  
Item No.: G2030.10.005  
Floor/Room: Site / Pavement  
**Priority:** 3  
Quantity/Unit of Measure: 300/SF  
Total Deficiency Cost: \$11,380  
Deficiency Description: *Concrete pavement has major damage / structural failure.*

Description of Work: *Replace concrete and base to match existing.*

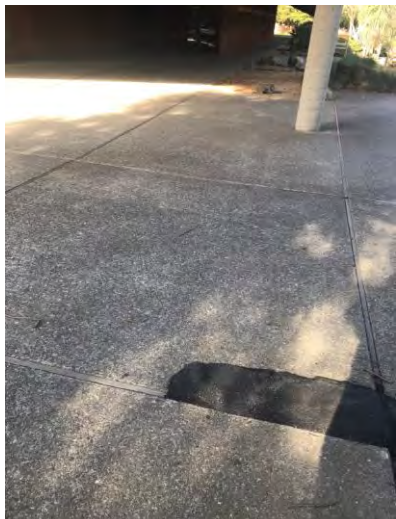
Record ID: 977  
System: G2030 - PEDESTRIAN PLAZAS AND WALKWAYS  
Year Installed / Industry Life / Remaining Useful Life: - / 30 / -  
Item No.: G2030.10.005  
Floor/Room: Site / Pavement  
**Priority:** 3  
Quantity/Unit of Measure: 50/SF  
Total Deficiency Cost: \$1,900  
Deficiency Description: *Concrete pavement has major damage / structural failure.*

Description of Work: *Replace concrete and base to match existing.*

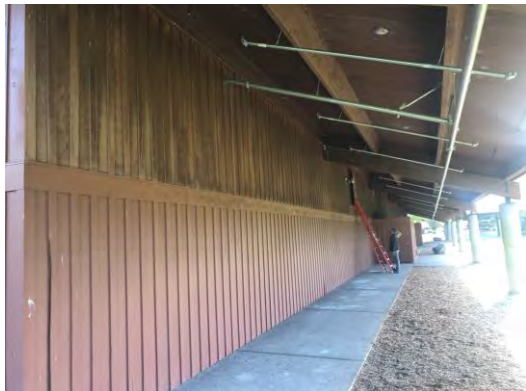
Record ID: 1740  
System: D5040 - LIGHTING  
Year Installed / Industry Life / Remaining Useful Life: 1985 / 20 / -17  
Item No.: D5040.50.302  
Floor/Room:  
**Priority:** 1  
Quantity/Unit of Measure: 54/EA  
Total Deficiency Cost: \$122,620  
Deficiency Description: *The exterior light fixture is past its expected useful life.*

Description of Work: *Replace the existing light fixture with an LED lighting fixture.*

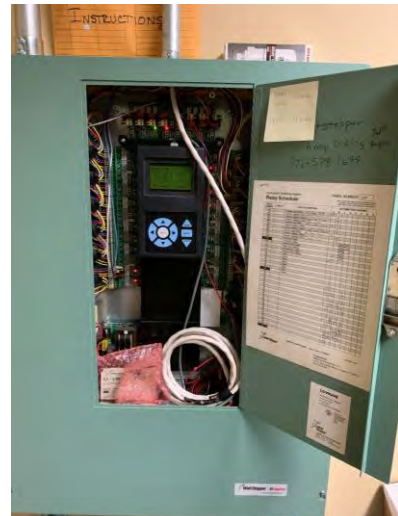
Record ID: 637  
 System: D5040 - LIGHTING

Comments: *Broken and obsolete needs replacement*

Description of Work: *Replace the existing switches and provide a new lighting control system.*

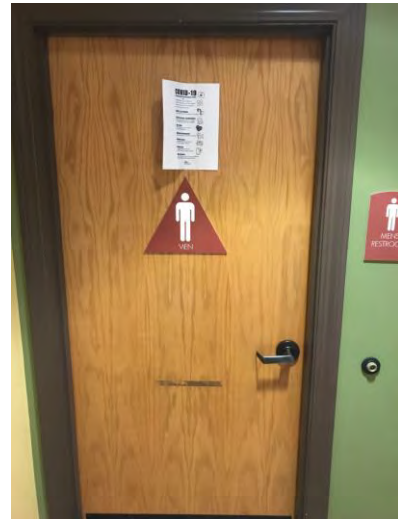
Quantity/Unit of Measure: 1/EA  
Total Deficiency Cost: \$1,090  
Deficiency Description: *Interior wood door is in visual need of refurbishment.*

Description of Work: *Refurbish and restrain the wood door.*

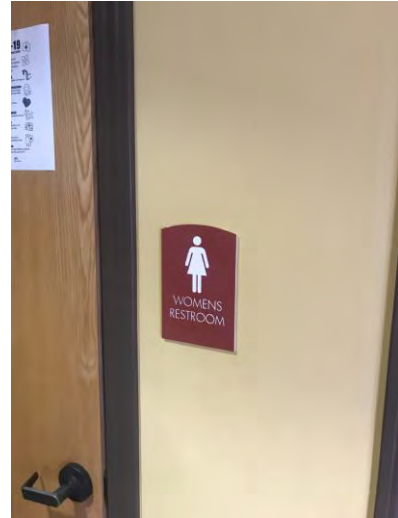
Record ID: 1022  
System: C1030 - INTERIOR DOORS

Quantity/Unit of Measure: 1/EA  
Total Deficiency Cost: \$1,090  
Deficiency Description: *Interior wood door is in visual need of refurbishment.*

Description of Work: *Refurbish and restrain the wood door.*

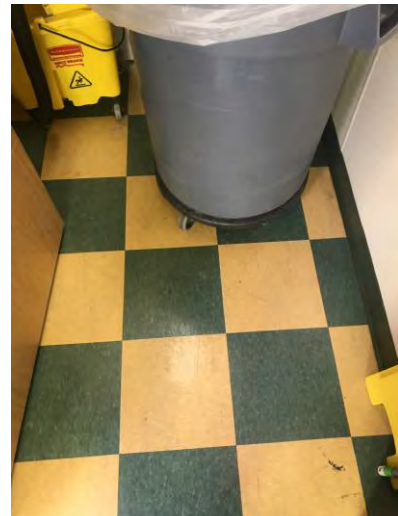
Record ID: 1024  
System: C2030 - FLOORING

Quantity/Unit of Measure: 50/SF  
Total Deficiency Cost: \$1,450  
Deficiency Description: *Vinyl composition tile is approaching the end of its useful life.*

Description of Work: *Remove the existing vinyl composition tile and replace.*

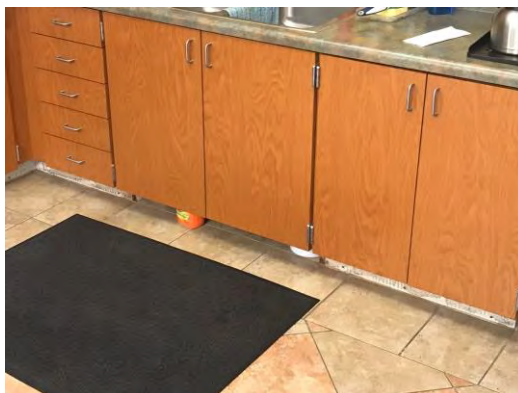
Deficiency Description: *Vinyl wall base is approaching the end of its useful life.*

Description of Work: *Replace the vinyl wall base.*

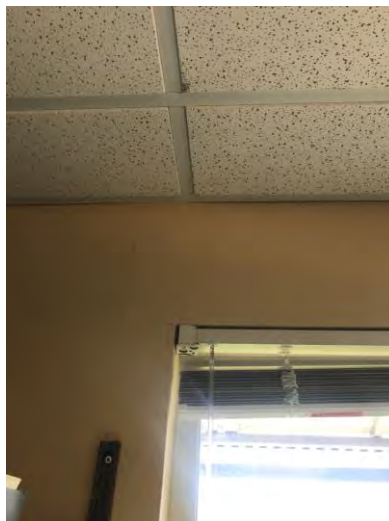
Record ID: 1027  
 System: C2010 - WALL FINISHES

Deficiency Description: *Painted gypsum wallboard is showing signs of wear.*

Description of Work: *Patch and paint the gypsum wallboard.*

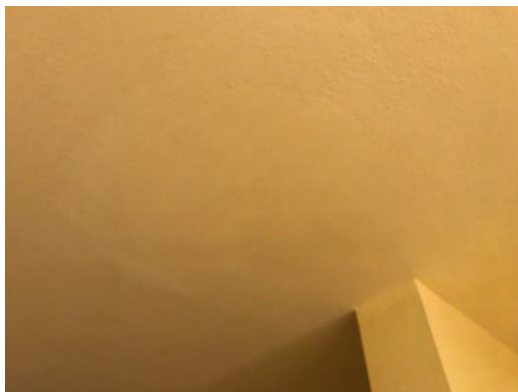
Record ID: 1028  
 System: C2050 - CEILING FINISHES

Deficiency Description: *Paint is approaching the end of its useful life.*

Comments: *Further investigation is recommended to determine source of water damage.*

Description of Work: *Paint the ceiling and/or walls (prime + 2 finish coats).*

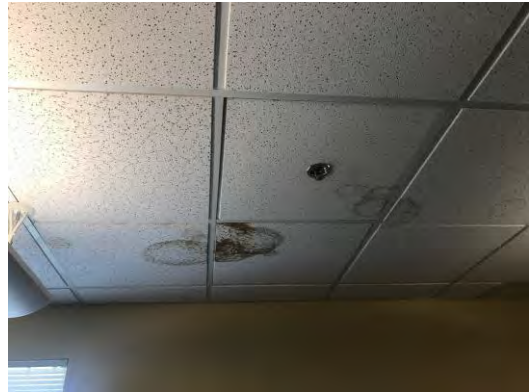
Deficiency Description: *Lay-in Acoustical Tile is in poor condition.*

Description of Work: *Remove existing lay-in Acoustical Tiles and replace with new lay-in Acoustical Tiles.*

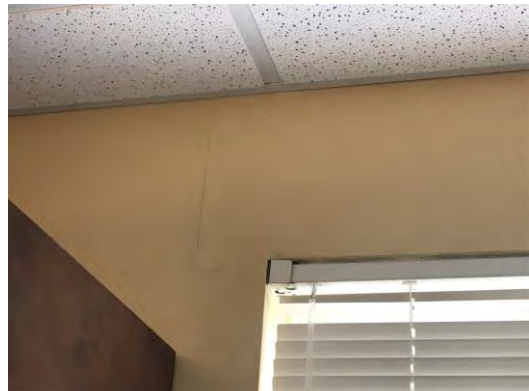
Deficiency Description: *Painted gypsum wallboard is in poor condition with several cracks.*

Description of Work: *Remove and replace existing gypsum board with a new gypsum board and expansion joints. Tape and paint.*

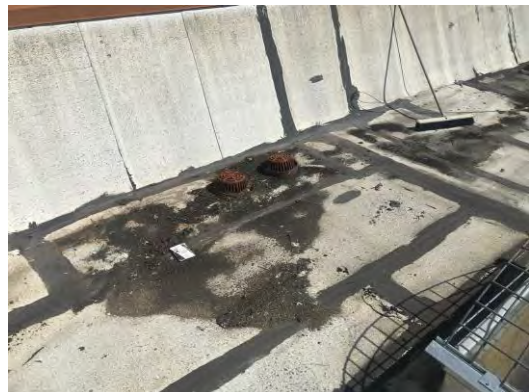
Deficiency Description: *Single-ply (modified bitumen) roofing is at or approaching the end of its useful life.*

Comments: *Signs of ponding and deterioration throughout.*

Description of Work: *Replace single-ply (modified bitumen) roofing.*

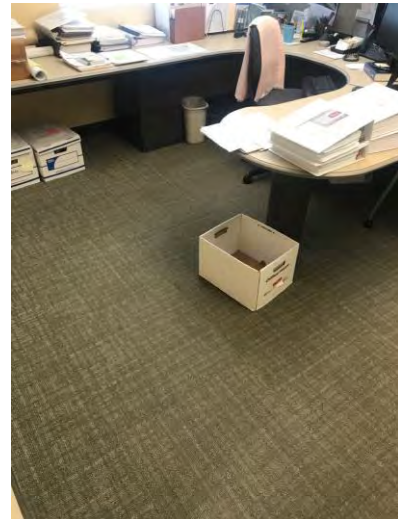
Record ID: 1033  
System: C2030 - FLOORING  
Year Installed / Industry Life / Remaining Useful Life: - / 20 / -  
Item No.: C2030.75.001  
Floor/Room: 1 / Throughout  
**Priority:** 3  
Quantity/Unit of Measure: 10,000/SF  
Total Deficiency Cost: \$280,590  
Deficiency Description: *Carpet tile is missing or damaged.*

Comments: *Through first and second floor carpet.*

Description of Work: *Replace carpet tile.*

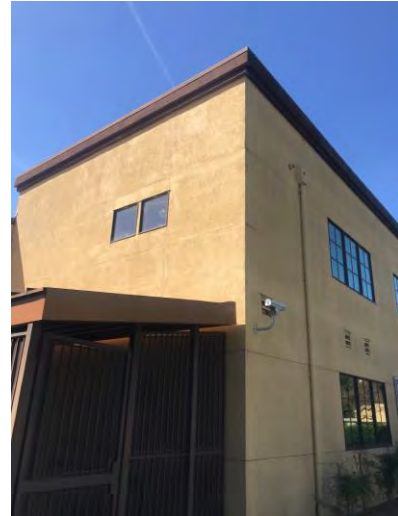
Record ID: 1035  
System: B2010 - EXTERIOR WALLS  
Year Installed / Industry Life / Remaining Useful Life: - / 10 / -  
Item No.: B2010.10.016  
Floor/Room: 1 / Exterior  
**Priority:** 3  
Quantity/Unit of Measure: 5,000/SF  
Total Deficiency Cost: \$131,540  
Deficiency Description: *Painted stucco wall is showing signs of wear and cracking.*

Comments: *Entire stucco wall.*

Description of Work: *Clean, patch, and paint existing stucco walls.*

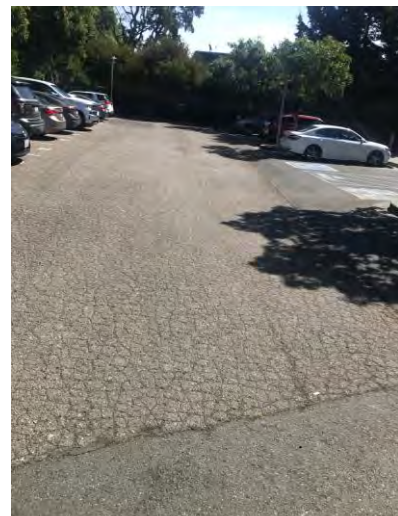
Record ID: 1036  
System: G2020 - PARKING LOTS  
Year Installed / Industry Life / Remaining Useful Life: - / - / -  
Item No.: G2020.10.002  
Floor/Room: Site / North Parking Lot  
**Priority:** 4  
Quantity/Unit of Measure: 7,500/SF  
Total Deficiency Cost: \$238,560  
Deficiency Description: *AC paving shows evidence of potholing.*

Description of Work: *Replace AC pavement section.*

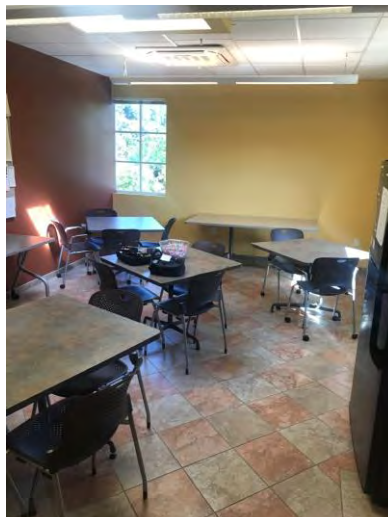
Deficiency Description: *Interior lighting system is approaching the end its expected useful life.*

Description of Work: *Provide new interior lighting and control system throughout building per current CEC T24 code.*
