# City of Rohnert Park

## Facility Condition Assessment

Final Report

October 17, 2022

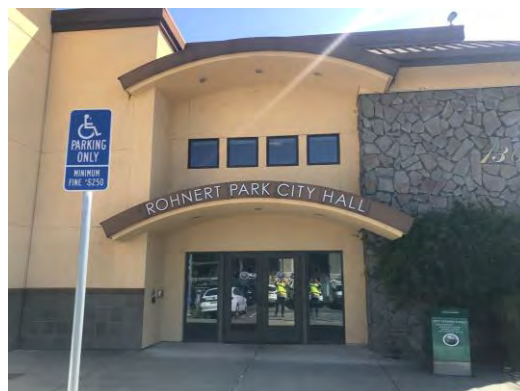
Record ID 1742  
System D5040 - LIGHTING

Deficiency Description: *The exterior light fixture is past its expected useful life.*

Description of Work: *Replace the existing light fixture with an LED lighting fixture.*

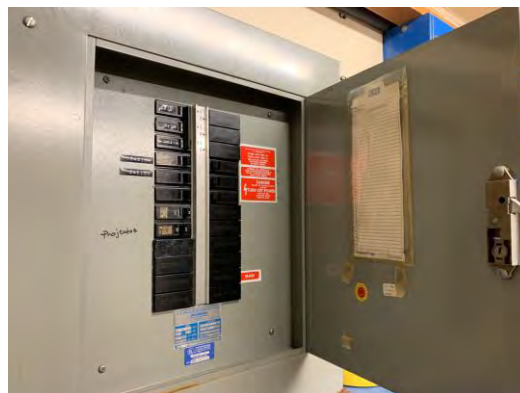
Record ID: 593  
System: D5020 - ELECTRICAL SERVICE AND DISTRIBUTION  
Year Installed / Industry Life / Remaining Useful Life: 1978 / 30 / -14  
Item No.: D5020.30.4001  
Floor/Room:  
**Priority:** 1  
Quantity/Unit of Measure: 1/EA  
Total Deficiency Cost: \$4,910  
Deficiency Description: *The load center is past its expected useful life.*  
Description of Work: *Replace the existing load center with a new load center.*  
Comments:

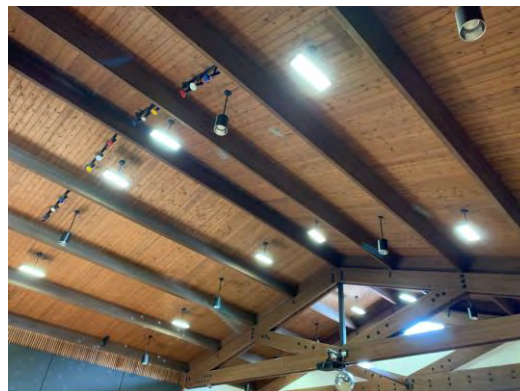
Record ID: 595  
System: D5040 - LIGHTING  
Year Installed / Industry Life / Remaining Useful Life: - / 20 / -  
Item No.: D5040.50.411  
Floor/Room: 1st Floor  
**Priority:** 1  
Quantity/Unit of Measure: 20,792/SF  
Total Deficiency Cost: \$1,189,670  
Deficiency Description: *Interior lighting system is functional but past its expected useful life.*  
Description of Work: *Provide new interior lighting and control system throughout building per current CEC T24 code.*  
Comments:

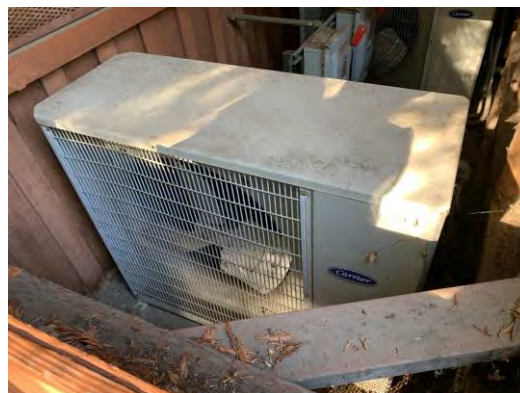
Record ID: 599  
System: D3030 - COOLING SYSTEMS  
Year Installed / Industry Life / Remaining Useful Life: 2005 / 15 / -2  
Item No.: D3030.70.002  
Floor/Room:  
**Priority:** 2  
Quantity/Unit of Measure: 1/EA  
Total Deficiency Cost: \$17,250  
Deficiency Description: *Outdoor condensing unit is approaching the end of its expected useful life.*  
Description of Work: *Provide equipment replacement and installation.*  
Comments:

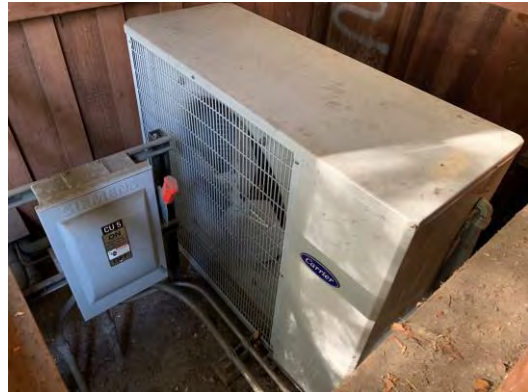
Deficiency Description: *Outdoor condensing unit is approaching the end of its expected useful life.*

Description of Work: *Provide equipment replacement and installation.*

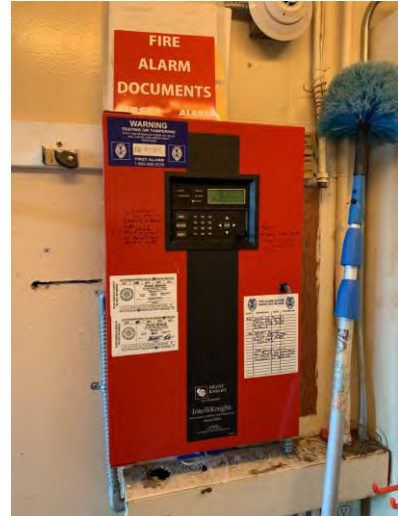
Record ID: 601  
 System: D7050 - DETECTION AND ALARM

Comments: *Estimated 2012 Installation (latest annual inspection)*

Description of Work: *Replace with a new fire alarm system with associated initiating and signaling devices.*

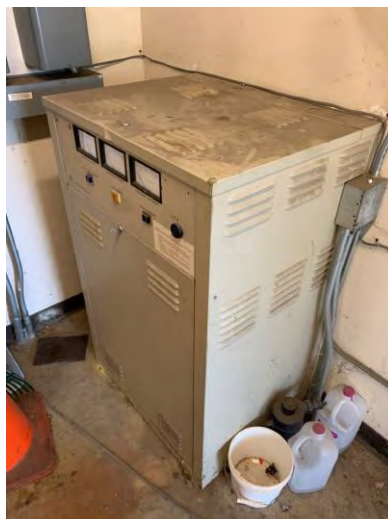
Record ID: 604  
System: D5010 - FACILITY POWER GENERATION  
Year Installed / Industry Life / Remaining Useful Life: 1978 / 10 / -34  
Item No.: D5010.10.601  
Floor/Room: 1  
**Priority:** 1  
Quantity/Unit of Measure: 2/KW  
Total Deficiency Cost: \$11,100  
Deficiency Description: *The Vehicle Charger Power Source are at or are approaching the end of their useful lives.*

Description of Work: *Replace the charger.*

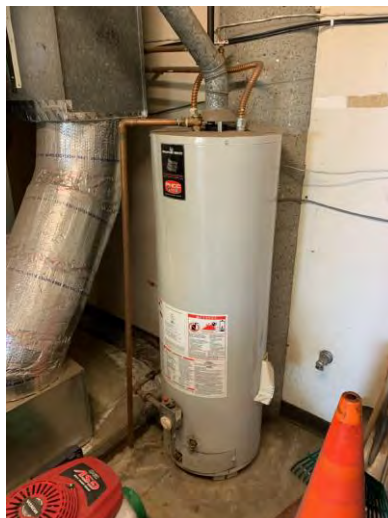
Record ID: 605  
System: D2010 - DOMESTIC WATER DISTRIBUTION  
Year Installed / Industry Life / Remaining Useful Life: 2015 / 15 / 8  
Item No.: D2010.20.002  
Floor/Room:  
**Priority:** 7  
Quantity/Unit of Measure: 1/EA  
Total Deficiency Cost: \$16,310  
Deficiency Description: *Gas fired water heater is approaching the end of its expected useful life.*

Description of Work: *Provide equipment replacement and installation.*

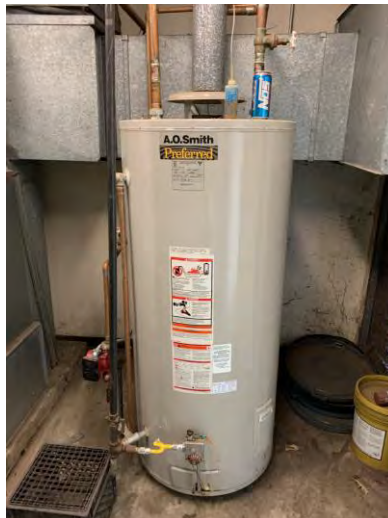
Record ID: 610  
 System: D2010 - DOMESTIC WATER DISTRIBUTION  
 Year Installed / Industry Life / Remaining Useful Life: 2008 / 15 / 1  
 Item No.: D2010.20.003  
 Floor/Room:  
**Priority:** 3  
 Quantity/Unit of Measure: 1/EA  
 Total Deficiency Cost: \$27,120  
 Deficiency Description: *Gas fired water heater is approaching the end of its expected useful life.*

Description of Work: *Provide equipment replacement and installation.*

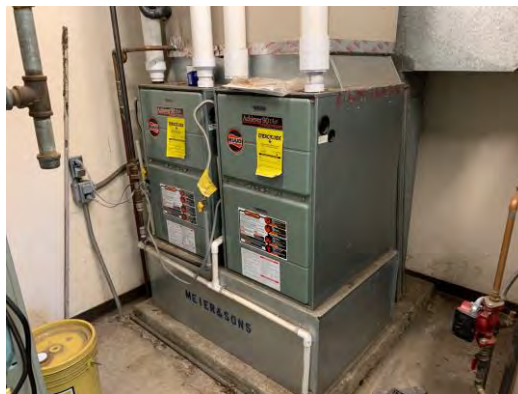
Record ID: 611  
 System: D3020 - HEATING SYSTEMS  
 Year Installed / Industry Life / Remaining Useful Life: - / 15 / -  
 Item No.: D3020.10.007  
 Floor/Room:  
**Priority:** 7  
 Quantity/Unit of Measure: 2/EA  
 Total Deficiency Cost: \$41,940  
 Deficiency Description: *Furnace is approaching the end of its expected useful life.*

Description of Work: *Provide equipment replacement and installation.*

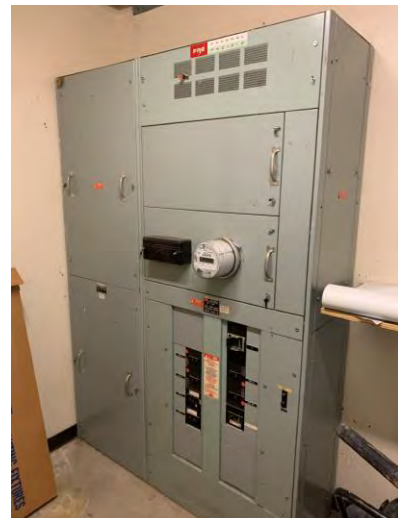
Quantity/Unit of Measure: 1/EA  
 Total Deficiency Cost: \$21,340  
 Deficiency Description: *The 800A metered main switchboard (3P, 120/208 ) is past its expected useful life.*

Description of Work: *Replace the existing metered main switchboard with a new metered main switchboard.*

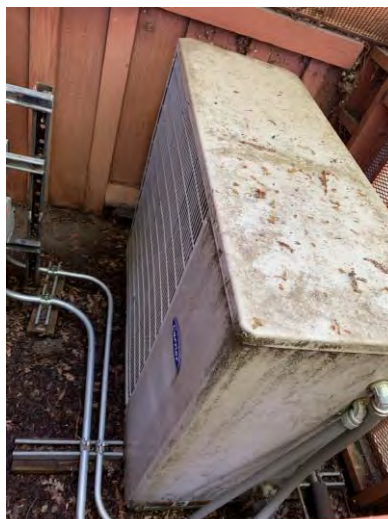
Deficiency Description: *Outdoor condensing unit is approaching the end of its expected useful life.*

Description of Work: *Provide equipment replacement and installation.*

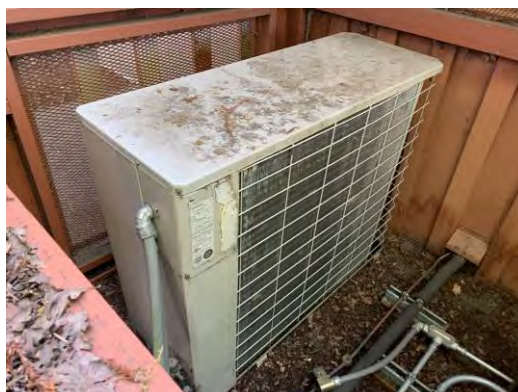
Deficiency Description: *Outdoor condensing unit is approaching the end of its expected useful life.*

Description of Work: *Provide equipment replacement and installation.*

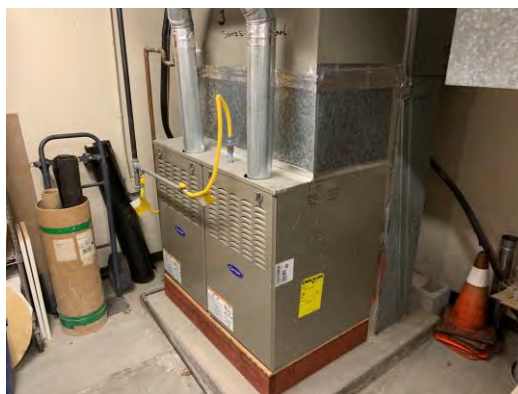
Deficiency Description: *Furnace is approaching the end of its expected useful life.*

Description of Work: *Provide equipment replacement and installation.*

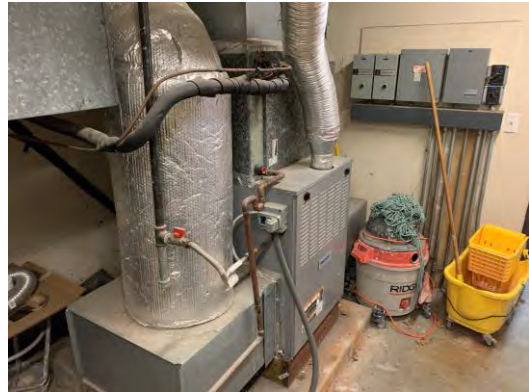
Quantity/Unit of Measure: 1/EA  
Total Deficiency Cost: \$20,990  
Deficiency Description: *Furnace is approaching the end of its expected useful life.*

Description of Work: *Provide equipment replacement and installation.*

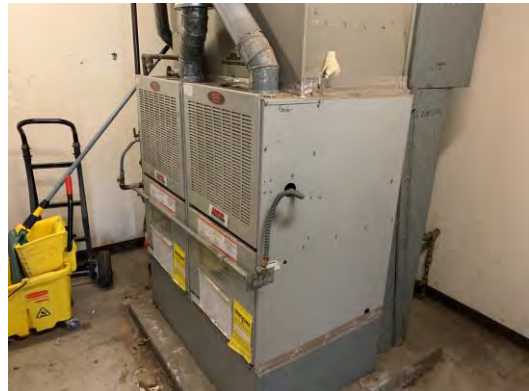
Quantity/Unit of Measure: 1/EA  
Total Deficiency Cost: \$20,990  
Deficiency Description: *Furnace is approaching the end of its expected useful life.*

Description of Work: *Provide equipment replacement and installation.*

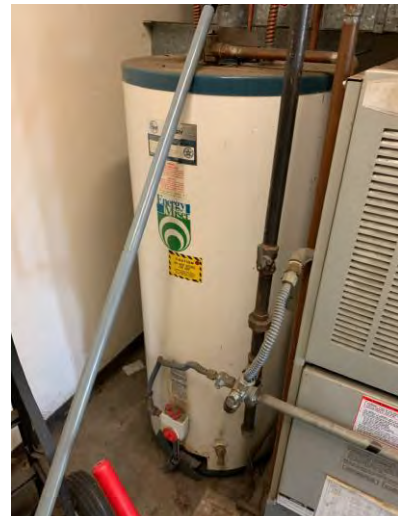
Quantity/Unit of Measure: 1/EA  
Total Deficiency Cost: \$13,250  
Deficiency Description: *Gas fired water heater is approaching the end of its expected useful life.*

Description of Work: *Provide equipment replacement and installation.*

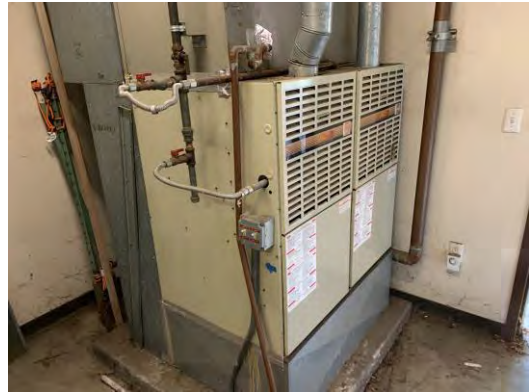
Year Installed / Industry Life / Remaining Useful Life - / 15 / -  
Item No. D3020.10.007  
Floor/Room:  
**Priority:** 1  
Quantity/Unit of Measure: 2/EA  
Total Deficiency Cost: \$34,060  
Deficiency Description: *Furnace is approaching the end of its expected useful life.*

Description of Work: *Provide equipment replacement and installation.*

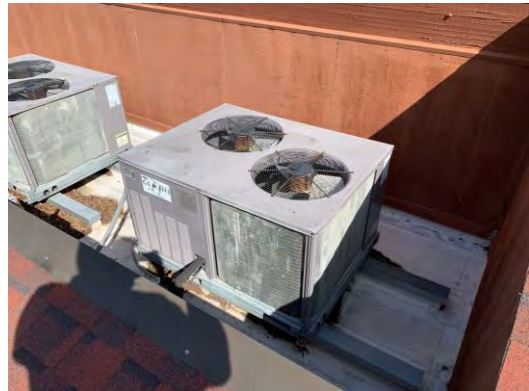
Year Installed / Industry Life / Remaining Useful Life - / 15 / -  
Item No. D3030.10.018  
Floor/Room:  
**Priority:** 3  
Quantity/Unit of Measure: 1/EA  
Total Deficiency Cost: \$52,640  
Deficiency Description: *Packaged AC unit is approaching the end of its expected useful life.*

Description of Work: *Provide equipment replacement and installation.*

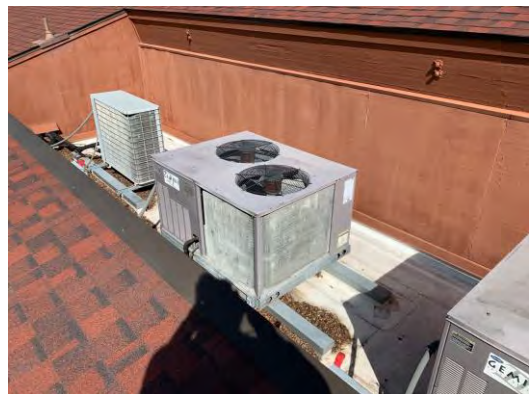
Year Installed / Industry Life / Remaining Useful Life - / 15 / -  
Item No. D3030.10.018  
Floor/Room: Roof  
**Priority:** 3  
Quantity/Unit of Measure: 1/EA  
Total Deficiency Cost: \$52,640  
Deficiency Description: *Packaged AC unit is approaching the end of its expected useful life.*

Description of Work: *Provide equipment replacement and installation.*

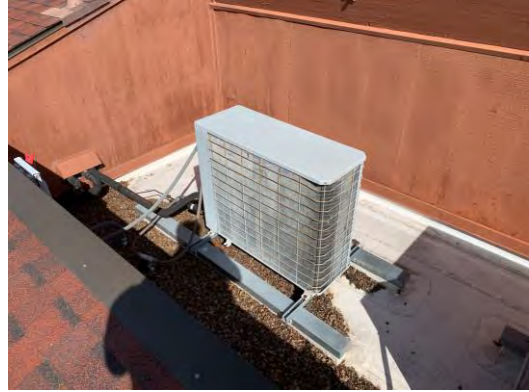
Deficiency Description: *Outdoor condensing unit is approaching the end of its expected useful life.*

Description of Work: *Provide equipment replacement and installation.*

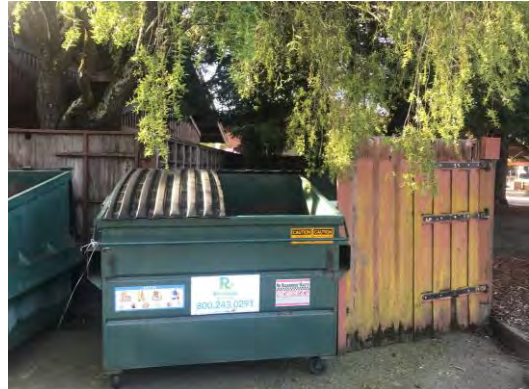
Deficiency Description: *Wood fence is deteriorated or at end-of-life.*

Description of Work: *Replace wood fencing, including slats and posts.*

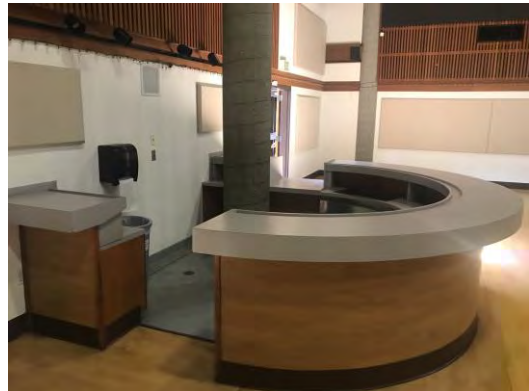
Deficiency Description: *Plastic laminate base cabinet (with countertop) is in poor condition.*

Description of Work: *Remove and replace with new plastic laminate base cabinet and countertop.*

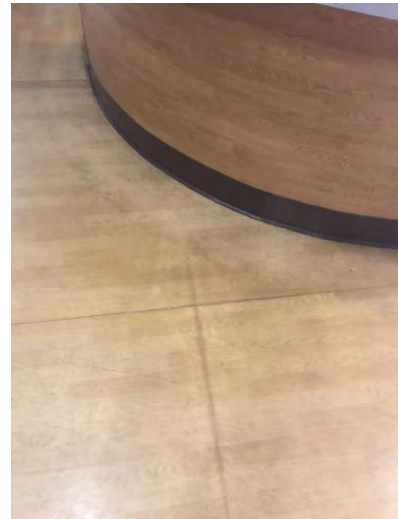
Item No. C2030.50.002  
Floor/Room: 1 / Gymnasium  
**Priority:** 2  
Quantity/Unit of Measure: 500/SF  
Total Deficiency Cost: \$21,260  
Deficiency Description: *Sheet vinyl is approaching the end of its useful life.*

Description of Work: *Remove the existing sheet vinyl and replace.*

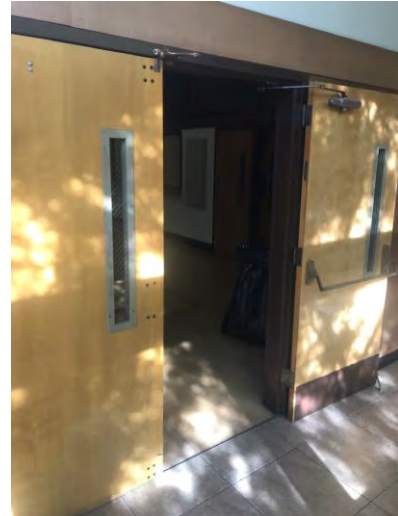
Item No. B2050.10.007  
Floor/Room: 1 / Exterior  
**Priority:** 3  
Quantity/Unit of Measure: 3/EA  
Total Deficiency Cost: \$16,500  
Deficiency Description: *Exterior wood door is damaged or deteriorating.*

Description of Work: *Refurbish/repair wood door.*

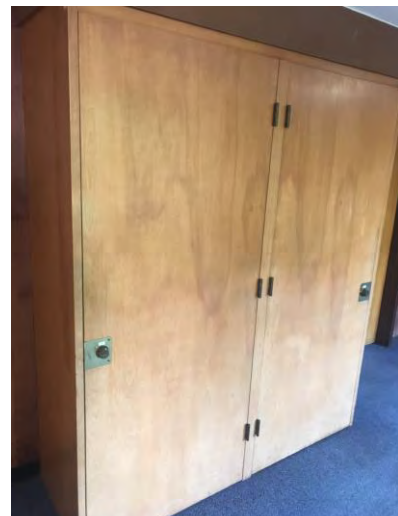
Item No. E2010.30.005  
Floor/Room: 1 / Storage  
**Priority:** 3  
Quantity/Unit of Measure: 5/LF  
Total Deficiency Cost: \$3,540  
Deficiency Description: *The existing casework is in need of refurbishment.*

Description of Work: *Repair, refurbish, and refinish the existing wood casework and counters.*

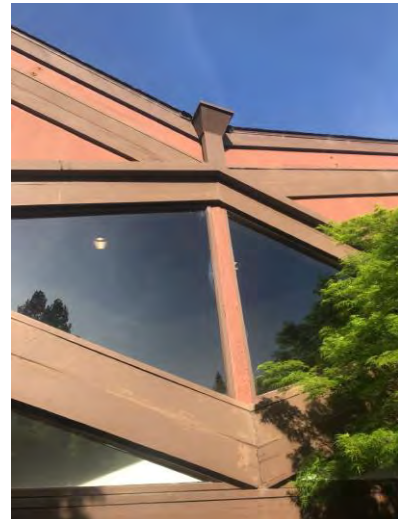
Deficiency Description: *Wood veneer is showing signs of wear.*

Description of Work: *Clean and repaint exterior wood veneer.*

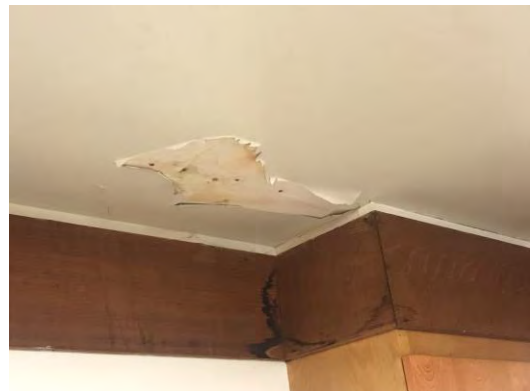
Deficiency Description: *Painted gypsum wallboard ceiling is approaching the end of its useful life.*

Description of Work: *Remove the existing gypsum board ceiling and replace. Tape and paint.*

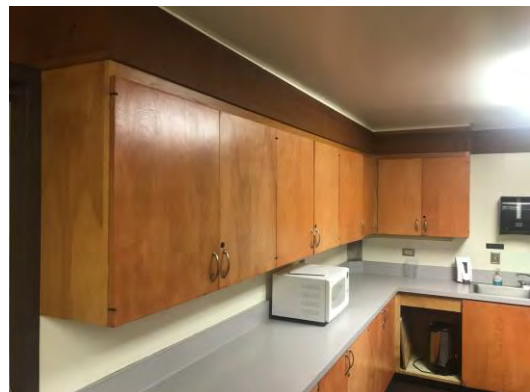
Deficiency Description: *The existing casework is in need of refurbishment.*

Description of Work: *Repair, refurbish, and refinish the existing wood casework and counters.*

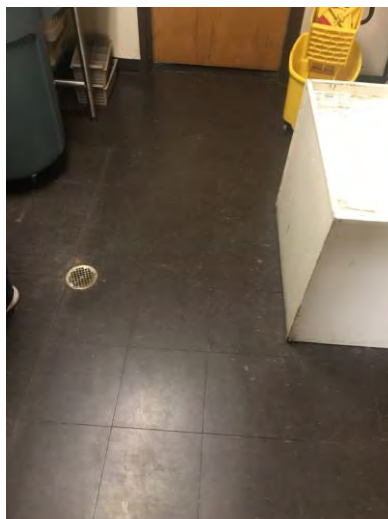
Deficiency Description: *Vinyl composition tile is approaching the end of its useful life.*

Description of Work: *Remove the existing vinyl composition tile and replace.*

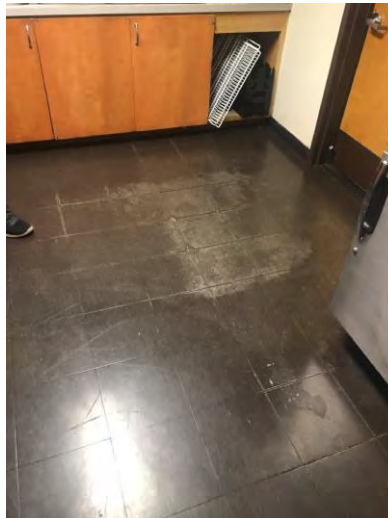
Deficiency Description: *Vinyl composition tile is approaching the end of its useful life.*

Description of Work: *Remove the existing vinyl composition tile and replace.*

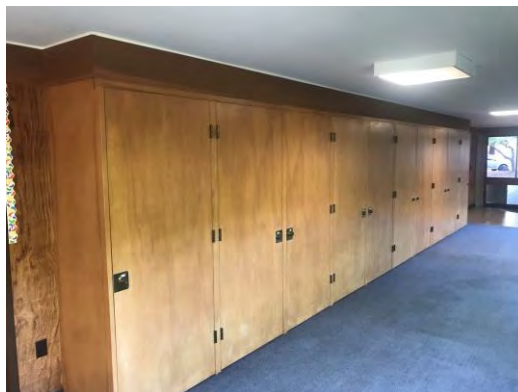
Deficiency Description: *The existing casework is in need of refurbishment.*

Description of Work: *Repair, refurbish, and refinish the existing wood casework.*

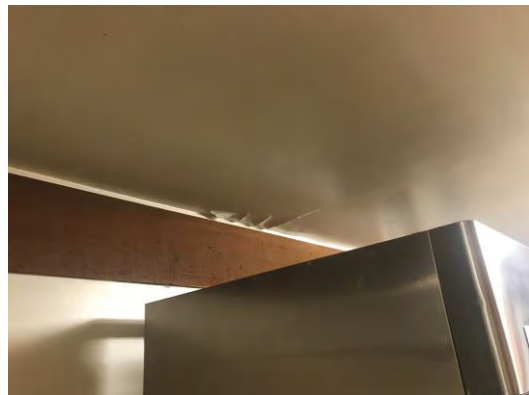
Deficiency Description: *Painted gypsum wallboard ceiling is approaching the end of its useful life.*

Description of Work: *Remove the existing gypsum board ceiling and replace. Tape and paint.*

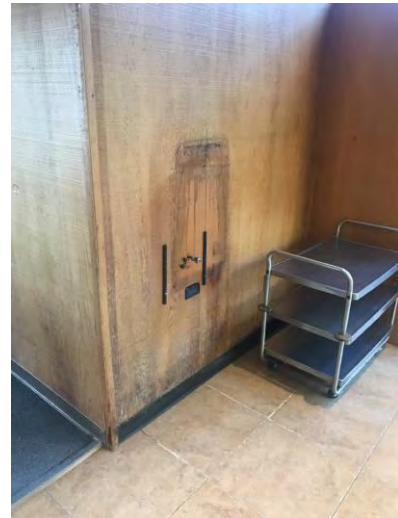
Deficiency Description: *Paneling is not in serviceable condition.*

Description of Work: *Remove and replace existing wood wall panels.*

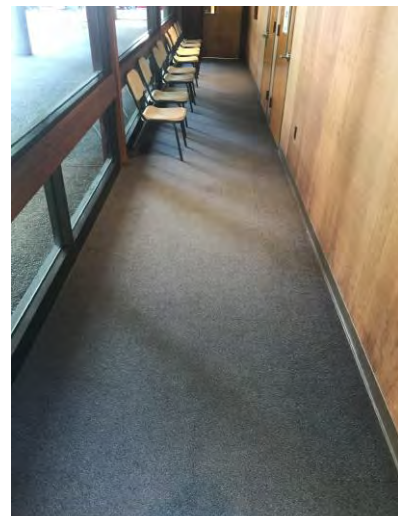
Deficiency Description: *Carpet tile is missing or damaged.*

Description of Work: *Replace carpet tile.*

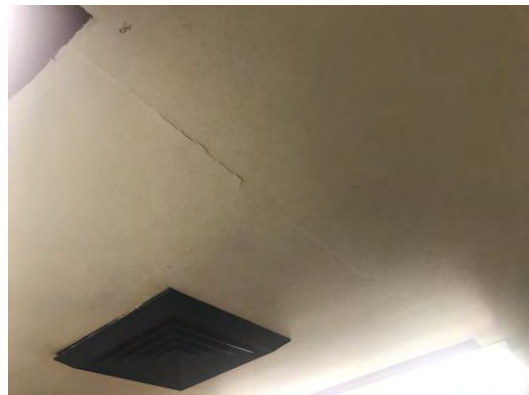
Deficiency Description: *Painted gypsum wallboard ceiling is approaching the end of its useful life.*

Description of Work: *Remove the existing gypsum board ceiling and replace. Tape and paint.*

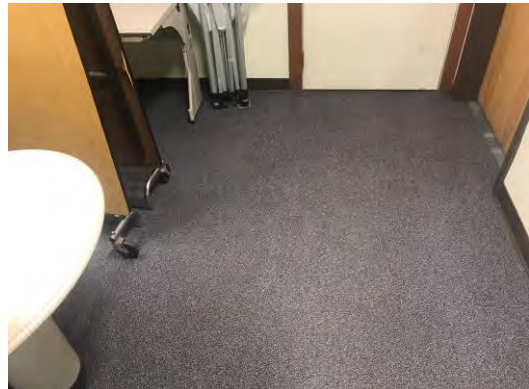
Deficiency Description: *Carpet tile is missing or damaged.*

Description of Work: *Replace carpet tile.*

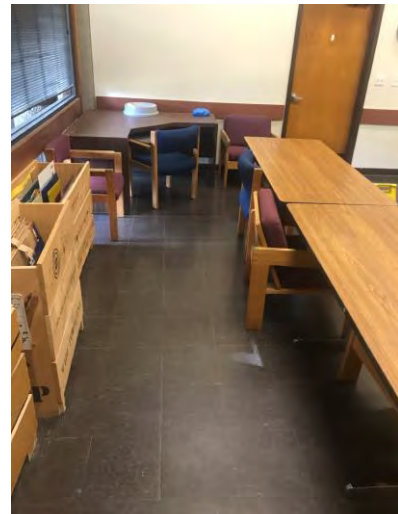
Deficiency Description: *Ceramic tile floor is approaching the end of its useful life.*

Description of Work: *Remove the existing ceramic tile flooring and replace.*

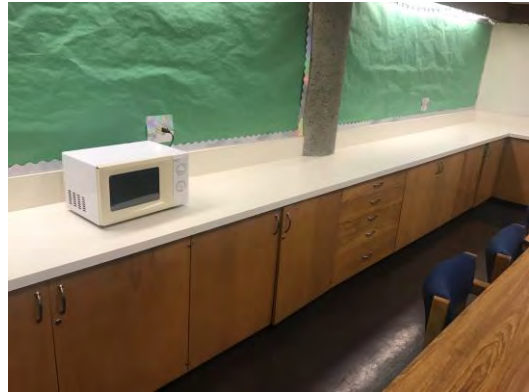
Year Installed / Industry Life / Remaining Useful Life - / - / -  
Item No. E2010.30.005  
Floor/Room: 1 / Crafts  
**Priority:** 5  
Quantity/Unit of Measure: 25/LF  
Total Deficiency Cost: \$19,060  
Deficiency Description: *The existing casework is in need of refurbishment.*

Description of Work: *Repair, refurbish, and refinish the existing casework and counters.*

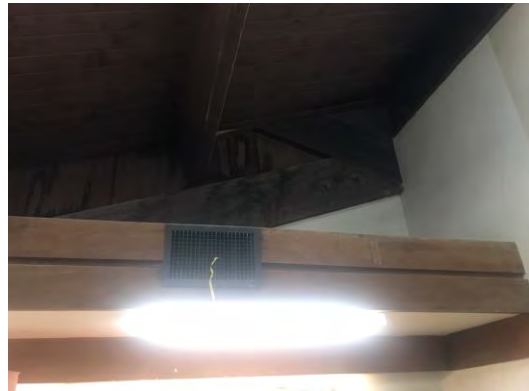
Year Installed / Industry Life / Remaining Useful Life - / 50 / -  
Item No. B1020.10.003  
Floor/Room: 1 / Pottery  
**Priority:** 3  
Quantity/Unit of Measure: 1/EA  
Total Deficiency Cost: \$370  
Deficiency Description: *Wood roof beam is in need of refinishing.*

Description of Work: *Clean, repair, seal, and refinish wood beam.*

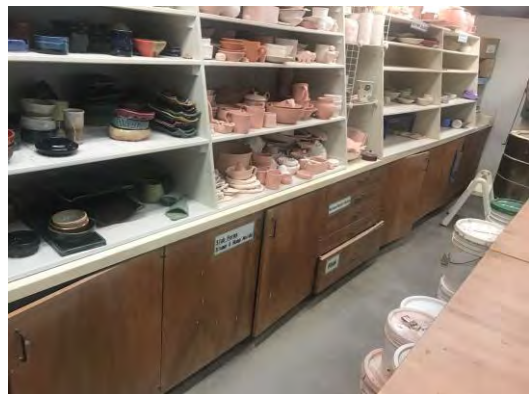
Year Installed / Industry Life / Remaining Useful Life - / - / -  
Item No. E2010.30.004  
Floor/Room: 1 / Pottery  
**Priority:** 3  
Quantity/Unit of Measure: 50/LF  
Total Deficiency Cost: \$78,940  
Deficiency Description: *The existing casework is at or is approaching the end of its useful life.*

Description of Work: *Replace original wood cabinets*

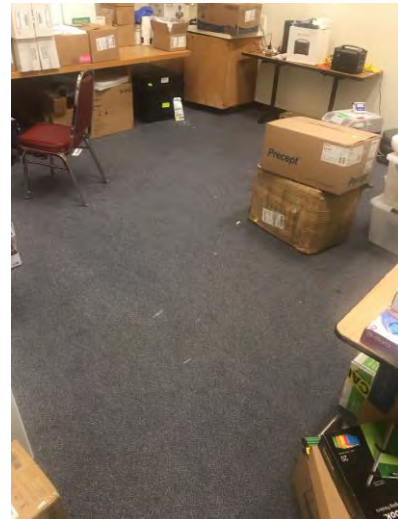
Record ID: 1001  
 System: C2030 - FLOORING  
 Year Installed / Industry Life / Remaining Useful Life: - / 20 / -  
 Item No.: C2030.75.001  
 Floor/Room: 1 / Conference  
**Priority:** 3  
 Quantity/Unit of Measure: 400/SF  
 Total Deficiency Cost: \$11,250  
 Deficiency Description: *Carpet tile is showing signs of wear.*

Description of Work: *Replace carpet tile.*

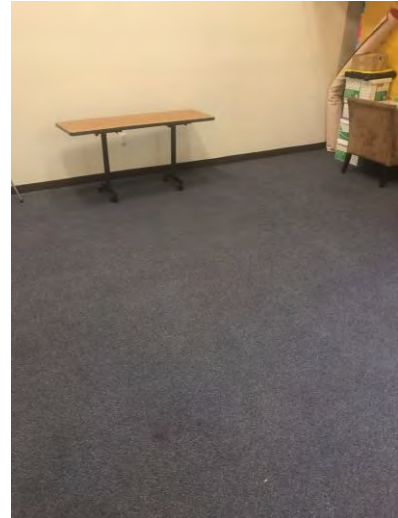
Record ID: 1002  
 System: C2030 - FLOORING  
 Year Installed / Industry Life / Remaining Useful Life: - / 20 / -  
 Item No.: C2030.75.001  
 Floor/Room: 1 / Meeting 1  
**Priority:** 3  
 Quantity/Unit of Measure: 400/SF  
 Total Deficiency Cost: \$11,250  
 Deficiency Description: *Carpet tile is showing signs of wear.*

Description of Work: *Replace carpet tile.*

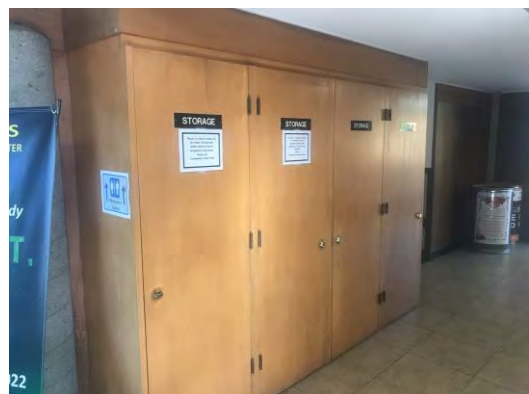
Record ID: 1004  
 System: E2010 - FIXED FURNISHINGS  
 Year Installed / Industry Life / Remaining Useful Life: - / - / -  
 Item No.: E2010.30.005  
 Floor/Room: 1  
**Priority:** 3  
 Quantity/Unit of Measure: 15/LF  
 Total Deficiency Cost: \$10,550  
 Deficiency Description: *The existing casework is in need of refurbishment.*

Description of Work: *Repair, refurbish, and refinish the existing wood casework.*

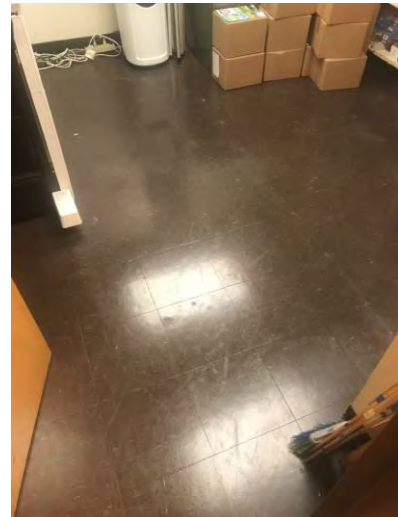
Deficiency Description: *Vinyl composition tile is approaching the end of its useful life.*

Description of Work: *Remove the existing vinyl composition tile and replace.*

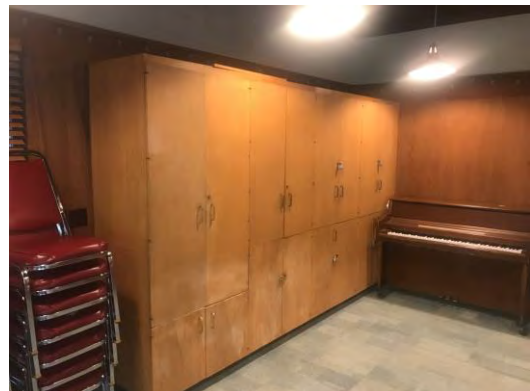
Deficiency Description: *The existing casework is in need of refurbishment.*

Description of Work: *Repair, refurbish, and refinish the existing wood casework and counters.*

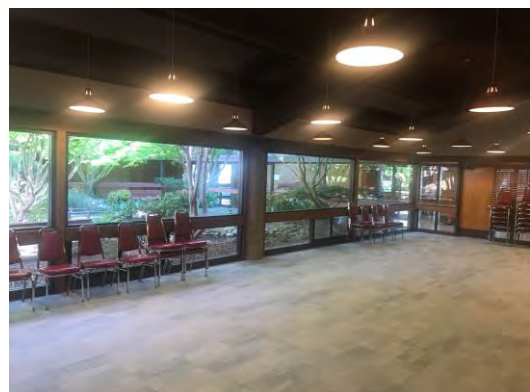
Deficiency Description: *Carpet tile is showing signs of wear.*

Description of Work: *Replace carpet tile.*

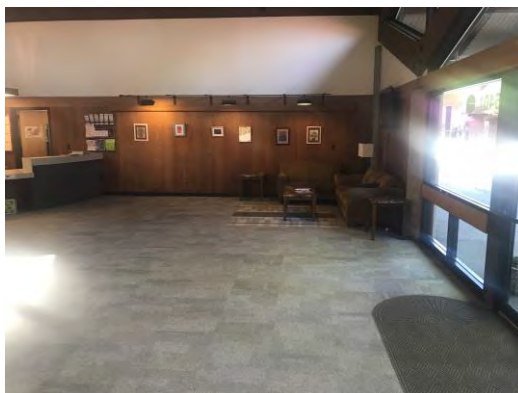
Record ID 1011  
System C2030 - FLOORING  
Year Installed / Industry Life / Remaining Useful Life - / 20 / -  
Item No. C2030.75.001  
Floor/Room: 1 / Lobby  
**Priority:** 3  
Quantity/Unit of Measure: 2,000/SF  
Total Deficiency Cost: \$56,130  
Deficiency Description: *Carpet tile is showing signs of wear.*

Description of Work: *Replace carpet tile.*

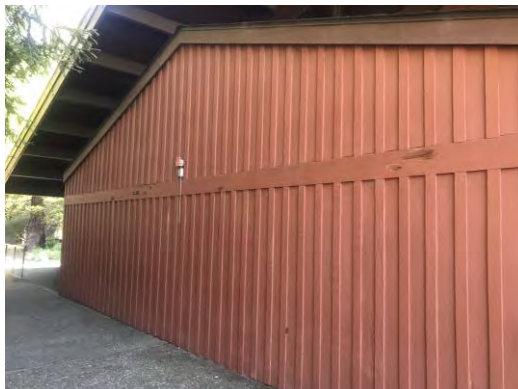
Record ID 1012  
System B2010 - EXTERIOR WALLS  
Year Installed / Industry Life / Remaining Useful Life - / 30 / -  
Item No. B2010.10.003  
Floor/Room: 1 / Exterior  
**Priority:** 5  
Quantity/Unit of Measure: 1,200/SF  
Total Deficiency Cost: \$36,550  
Deficiency Description: *Wood board siding is showing signs of wear.*

Comments: *Throughout exterior.*

Description of Work: *Replace or repair the existing wood siding. Place a new siding over building paper and plywood sheathing.*

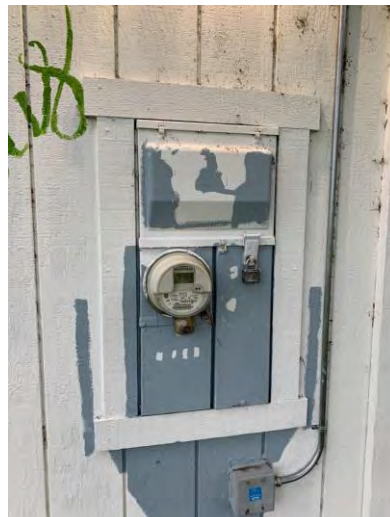
Record ID 1253  
System D5020 - ELECTRICAL SERVICE AND DISTRIBUTION  
Year Installed / Industry Life / Remaining Useful Life 1992 / 30 / 0  
Item No. D5020.10.001  
Floor/Room: Site  
**Priority: 1**  
Quantity/Unit of Measure: 1/EA  
Total Deficiency Cost: \$8,230  
Deficiency Description: *The 100A (120/240V, 1P) all-in-one combination service entrance device is past its expected useful life.*  
Description of Work: *Replace the existing all-in-one combination service entrance device with a new all-in-one combination service entrance device.*  
Comments:

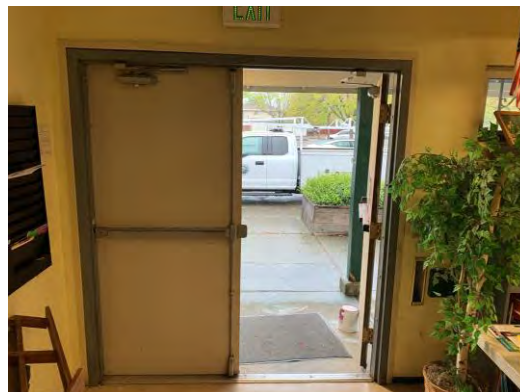
Record ID 1254  
System B2050 - EXTERIOR DOORS AND GRILLES  
Year Installed / Industry Life / Remaining Useful Life - / 75 / -  
Item No. B2050.10.001  
Floor/Room: 1 / Entrance  
**Priority: 1**  
Quantity/Unit of Measure: 2/EA  
Total Deficiency Cost: \$16,090  
Deficiency Description: *Exterior entrance door is approaching the end of its useful life.*  
Description of Work: *Replace entry doors.*  
Comments: *Front door is at end of life and unable to secure.*

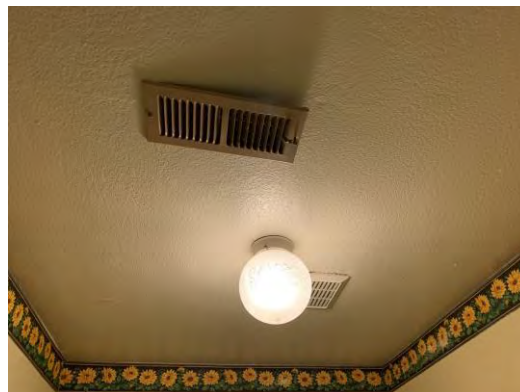
Record ID 1255  
System D3050 - FACILITY HVAC DISTRIBUTION SYSTEMS  
Year Installed / Industry Life / Remaining Useful Life - / 30 / -  
Item No. D3050.50.004  
Floor/Room:  
**Priority: 1**  
Quantity/Unit of Measure: 1/EA  
Total Deficiency Cost: \$340  
Deficiency Description: *Diffusers is hanging from ceiling and not secure.*  
Description of Work: *Secure diffuser.*  
Comments: *Diffuser hanging*

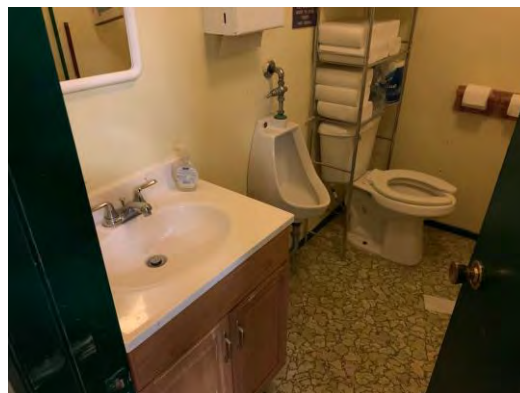
Deficiency Description: *Restroom piping and plumbing fixtures are at or approaching the end of its expected useful service life.*

Description of Work: *Provide equipment replacement and installation.*

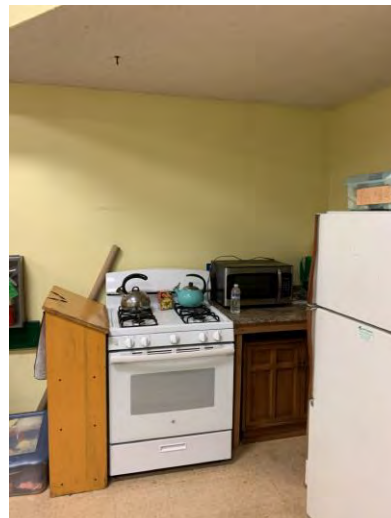
Record ID: 1258  
 System: E1060 - RESIDENTIAL EQUIPMENT

Deficiency Description: *Residential type kitchen exhaust hood recommended.*

Description of Work: *Provide new residential type kitchen exhaust hood with ductwork and electrical.*

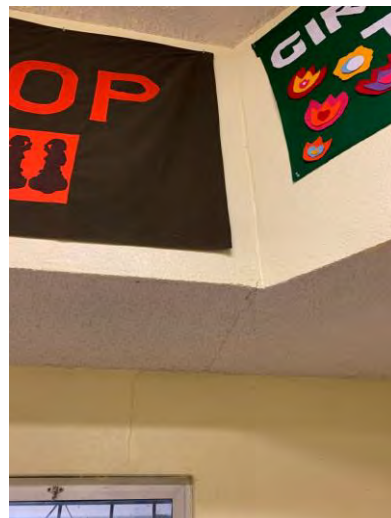
Record ID: 1259  
 System: C1010 - INTERIOR PARTITIONS

Deficiency Description: *Painted gypsum wallboard is in poor condition with several cracks.*

Comments: *Significant cracking was observed along transition beam. Further investigation by a structural engineer is recommended.*

Description of Work: *Remove and replace existing gypsum board with a new gypsum board and expansion joints. Tape and paint.*

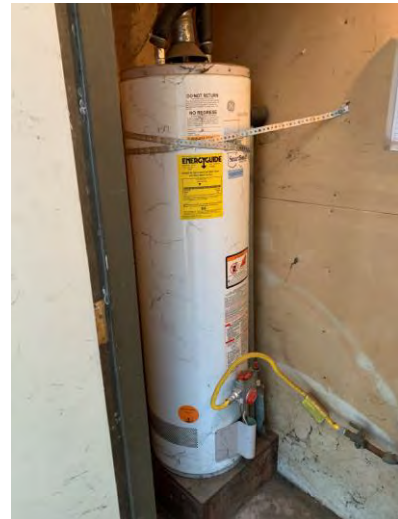
Deficiency Description: *Gas fired water heater is approaching the end of its expected useful life.*

Description of Work: *Provide equipment replacement and installation.*

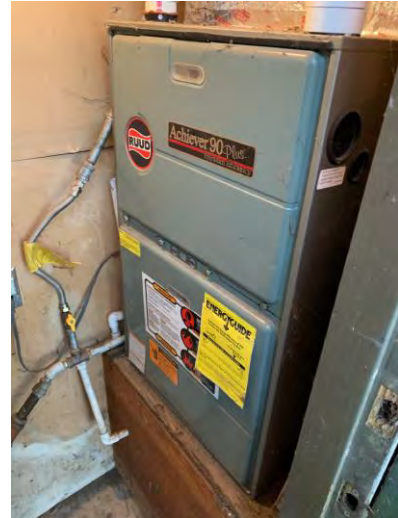
Record ID: 1261  
 System: D3020 - HEATING SYSTEMS

Deficiency Description: *Furnace is approaching the end of its expected useful life.*

Description of Work: *Provide equipment replacement and installation.*

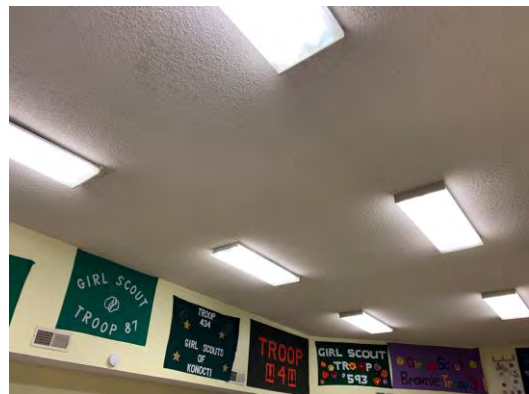
Record ID: 1262  
 System: D5040 - LIGHTING

Deficiency Description: *Interior lighting system is functional but past its expected useful life.*

Description of Work: *Provide new interior lighting and control system throughout building per current CEC T24 code.*

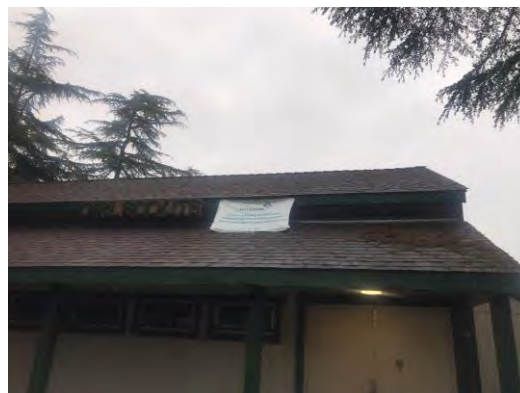
Year Installed / Industry Life / Remaining Useful Life: - / 30 / -  
Item No.: B3010.10.001  
Floor/Room: -  
Priority: 7  
Quantity/Unit of Measure: 1,600/SF  
Total Deficiency Cost: \$94,890  
Deficiency Description: *Asphalt composition roof is in fair to poor condition with evidence of ponding, blisters & leaks.*

Description of Work: *Remove and replace asphalt composition shingle roofing.*

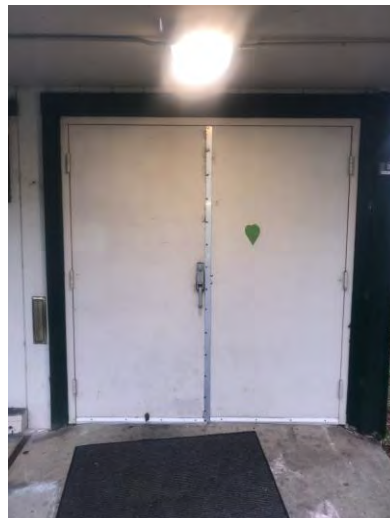
Record ID: 1411  
System: B2050 - EXTERIOR DOORS AND GRILLES

Year Installed / Industry Life / Remaining Useful Life: - / 30 / -  
Item No.: B2050.20.002  
Floor/Room: 1 / Exterior  
Priority: 2  
Quantity/Unit of Measure: 2/EA  
Total Deficiency Cost: \$8,070  
Deficiency Description: *Door is damaged or deteriorated.*

Description of Work: *Repair door and repaint.*

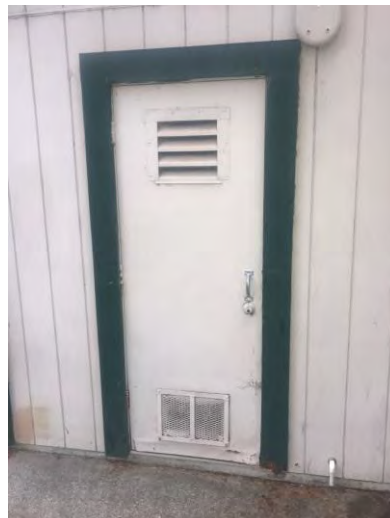
Record ID: 1412  
System: B2050 - EXTERIOR DOORS AND GRILLES

Year Installed / Industry Life / Remaining Useful Life: - / - / -  
Item No.: B2050.10.007  
Floor/Room: 1 / Exterior  
Priority: 2  
Quantity/Unit of Measure: 1/EA  
Total Deficiency Cost: \$5,280  
Deficiency Description: *Exterior wood door is damaged or deteriorating.*

Description of Work: *Refurbish/repair wood door.*

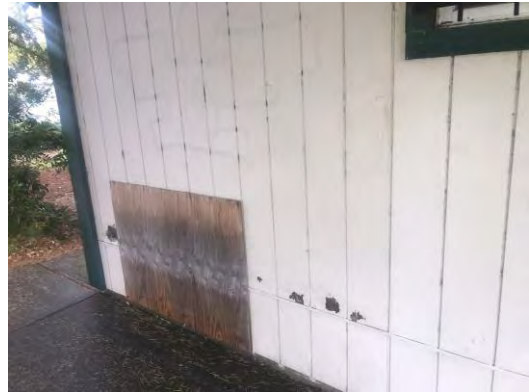
Item No.: B2010.10.003  
Floor/Room: 1 / Exterior  
**Priority:** 3  
Quantity/Unit of Measure: 1,000/SF  
Total Deficiency Cost: \$28,070  
Deficiency Description: *Wood board siding is approaching the end of its useful life.*

Description of Work: *Replace or repair the existing wood siding. Place a new siding over building paper and plywood sheathing.*

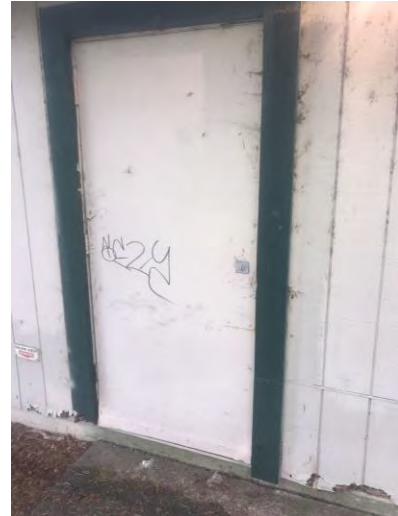
Record ID: 1414  
System: B2050 - EXTERIOR DOORS AND GRILLES

Item No.: B2050.10.001  
Floor/Room: 1 / Exterior  
**Priority:** 1  
Quantity/Unit of Measure: 1/EA  
Total Deficiency Cost: \$8,050  
Deficiency Description: *Exterior wood entrance door is approaching the end of its useful life.*

Description of Work: *Replace wood door.*

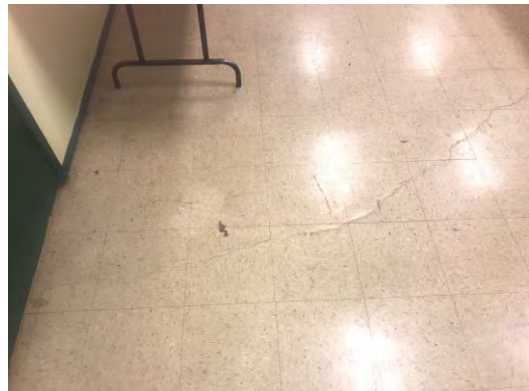
Record ID: 1416  
System: C2030 - FLOORING

Item No.: C2030.50.001  
Floor/Room: 1 / Main Room  
**Priority:** 2  
Quantity/Unit of Measure: 800/SF  
Total Deficiency Cost: \$20,160  
Deficiency Description: *Vinyl composition tile is approaching the end of its useful life.*

Description of Work: *Remove the existing vinyl composition tile and replace.*

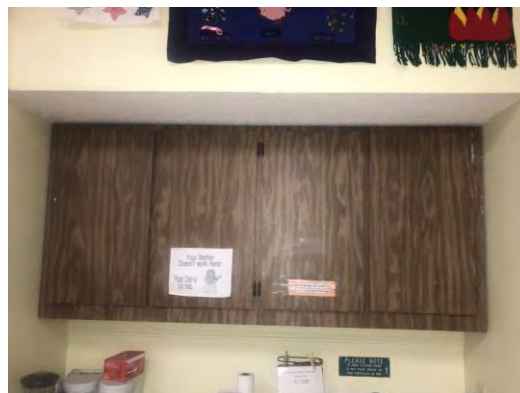
Deficiency Description: *Plastic laminate casework is at or will be approaching the end of its expected useful life.*

Description of Work: *Provide new plastic laminate casework (upper, lower, and countertop)*

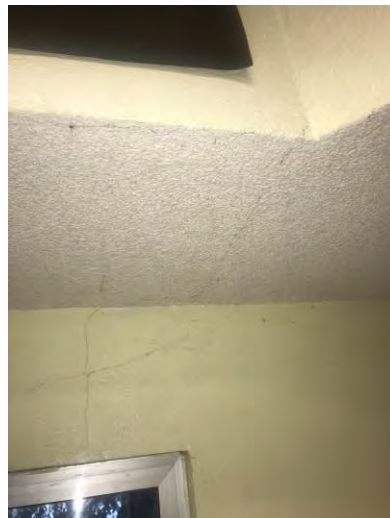
Record ID: 1420  
System: C2010 - WALL FINISHES

Deficiency Description: *Painted gypsum wallboard is showing signs of wear.*

Description of Work: *Patch and paint the gypsum wallboard.*

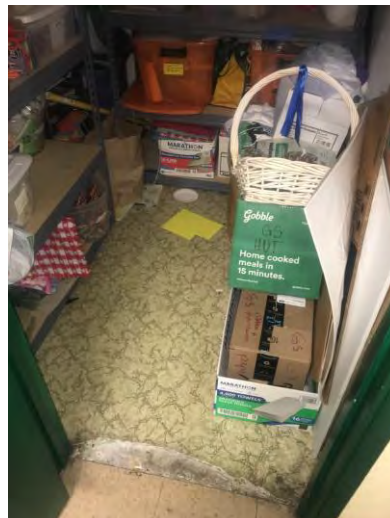
Record ID: 1421  
System: C2030 - FLOORING

Deficiency Description: *Sheet vinyl is approaching the end of its useful life.*

Description of Work: *Remove the existing sheet vinyl and replace.*

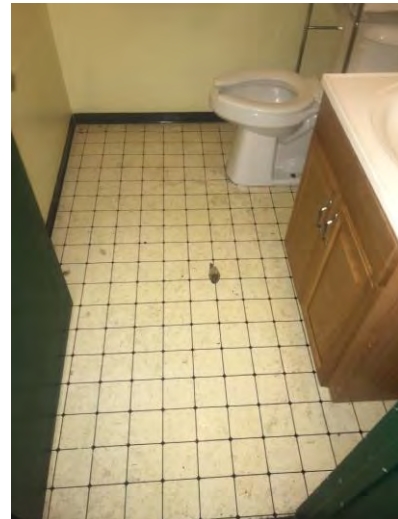
Record ID: 1422  
 System: C2030 - FLOORING  
 Year Installed / Industry Life / Remaining Useful Life: - / 60 / -  
 Item No.: C2030.20.001  
 Floor/Room: 1 / Restroom  
**Priority:** 3  
 Quantity/Unit of Measure: 50/SF  
 Total Deficiency Cost: \$3,500  
 Deficiency Description: *Ceramic tile floor is approaching the end of its useful life.*  
 Description of Work: *Remove the existing ceramic tile flooring and replace.*  
 Comments:

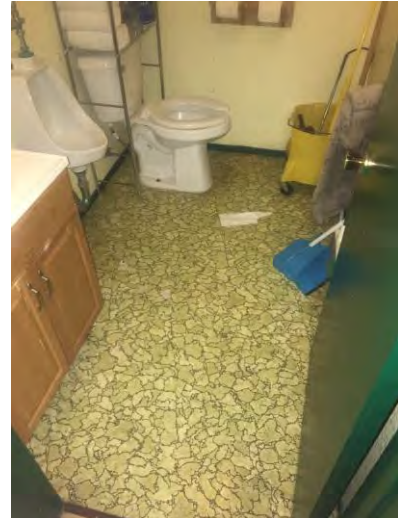
Record ID: 1425  
 System: C2030 - FLOORING  
 Year Installed / Industry Life / Remaining Useful Life: - / 60 / -  
 Item No.: C2030.50.002  
 Floor/Room: 1 / Restroom  
**Priority:** 3  
 Quantity/Unit of Measure: 50/SF  
 Total Deficiency Cost: \$2,240  
 Deficiency Description: *Sheet vinyl is approaching the end of its useful life.*  
 Description of Work: *Remove the existing sheet vinyl and replace.*  
 Comments:

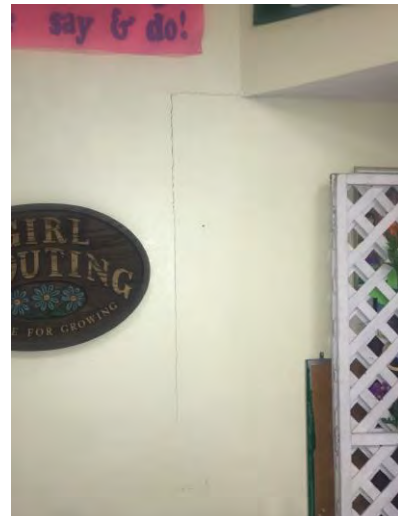
Record ID: 1427  
 System: C2010 - WALL FINISHES  
 Year Installed / Industry Life / Remaining Useful Life: - / 30 / -  
 Item No.: C2010.70.001  
 Floor/Room: 1 / Main Room  
**Priority:** 3  
 Quantity/Unit of Measure: 100/SF  
 Total Deficiency Cost: \$2,210  
 Deficiency Description: *Painted gypsum wallboard is showing signs of wear.*  
 Description of Work: *Patch and paint the gypsum wallboard.*  
 Comments:

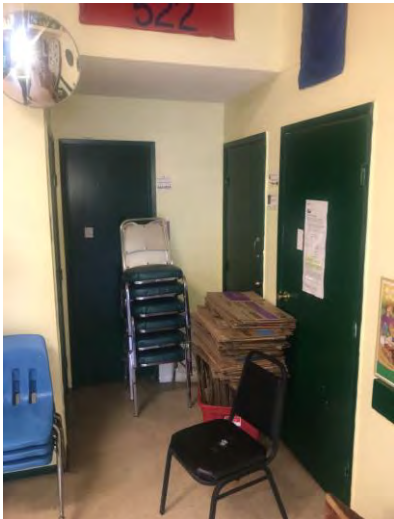
Record ID: 1428  
 System: C1030 - INTERIOR DOORS  
 Year Installed / Industry Life / Remaining Useful Life: - / 30 / -  
 Item No.: C1030.10.008  
 Floor/Room: 1 / Main Room  
**Priority:** 3  
 Quantity/Unit of Measure: 9/EA  
 Total Deficiency Cost: \$9,480  
 Deficiency Description: *Interior wood door is in visual need of refurbishment.*

Description of Work: *Refurbish and restain the wood door.*

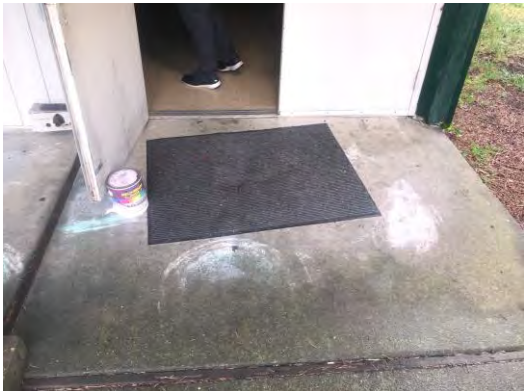
Record ID: 1430  
 System: G2030 - PEDESTRIAN PLAZAS AND WALKWAYS  
 Year Installed / Industry Life / Remaining Useful Life: - / - / -  
 Item No.: G2030.10.004  
 Floor/Room: Site / Entry  
**Priority:** 3  
 Quantity/Unit of Measure: 150/SF  
 Total Deficiency Cost: \$5,080  
 Deficiency Description: *Concrete pavement is damaged.*

Description of Work: *Replace concrete paving (base to remain).*

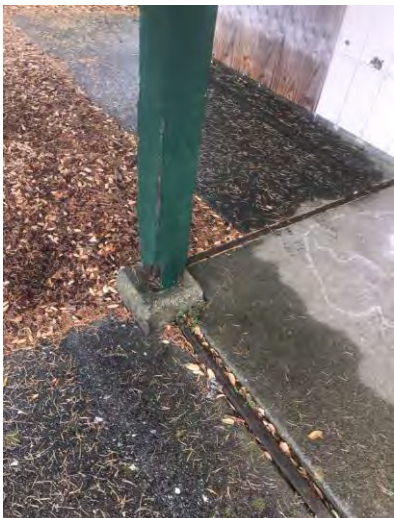
Record ID: 1431  
 System: B1020 - ROOF CONSTRUCTION  
 Year Installed / Industry Life / Remaining Useful Life: - / 50 / -  
 Item No.: B1020.10.003  
 Floor/Room: Site / Exterior  
**Priority:** 3  
 Quantity/Unit of Measure: 5/EA  
 Total Deficiency Cost: \$1,780  
 Deficiency Description: *Wood columns are in need of refinishing.*

Description of Work: *Refinish wood columns.*

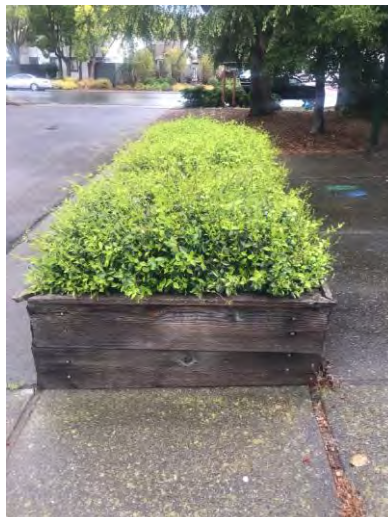
Record ID: 1432  
System: G2080 - LANDSCAPING  
Year Installed / Industry Life / Remaining Useful Life: - / - / -  
Item No.: G2080.50.001  
Floor/Room: Site / Exterior  
**Priority:** 3  
Quantity/Unit of Measure: 40/SF  
Total Deficiency Cost: \$3,390  
Deficiency Description: *Above-ground planter walls show evidence of damage.*

Description of Work: *Replace wooden planter.*

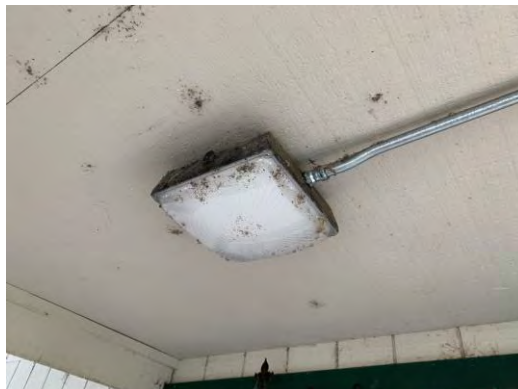
Record ID: 1744  
System: D5040 - LIGHTING  
Year Installed / Industry Life / Remaining Useful Life: 1992 / 20 / -10  
Item No.: D5040.50.302  
Floor/Room: 1 / Site  
**Priority:** 1  
Quantity/Unit of Measure: 6/EA  
Total Deficiency Cost: \$13,650  
Deficiency Description: *The exterior light fixture is functional but past its expected useful life.*

Description of Work: *Replace the existing light fixture with an LED lighting fixture.*

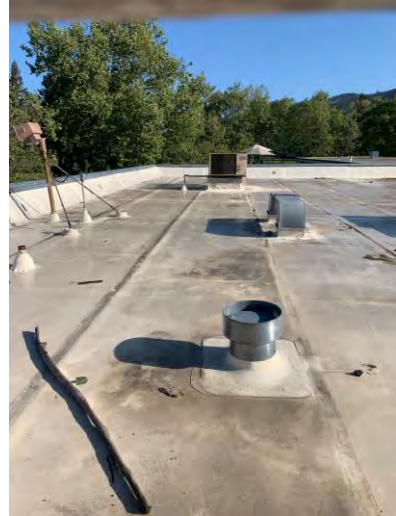
Comments: *Mechanical unit, roof access limited*

Description of Work: *Provide equipment replacement and installation.*

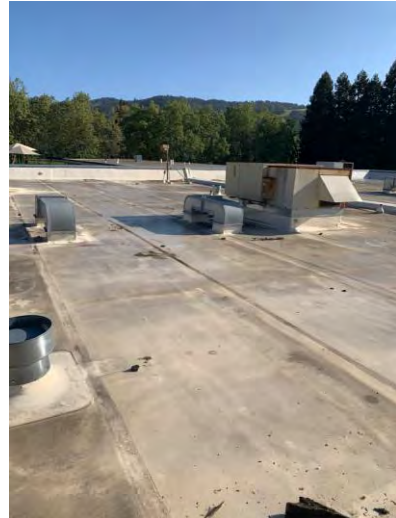
Record ID 1343  
System D3030 - COOLING SYSTEMS

Comments: *Mechanical unit, roof access limited*

Description of Work: *Provide equipment replacement and installation.*

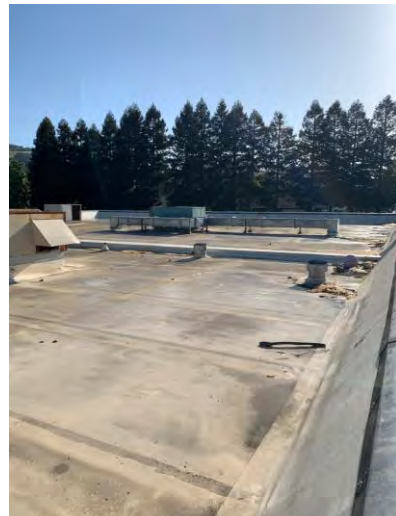
Record ID 1344  
System D3030 - COOLING SYSTEMS

Comments: *Mechanical unit, roof access limited*

Description of Work: *Provide equipment replacement and installation.*

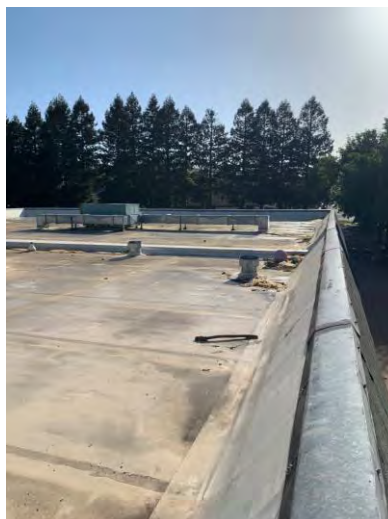
Comments: *Mechanical unit, roof access limited*

Description of Work: *Provide equipment replacement and installation.*
