# City of Rohnert Park

## Facility Condition Assessment

Final Report

October 17, 2022

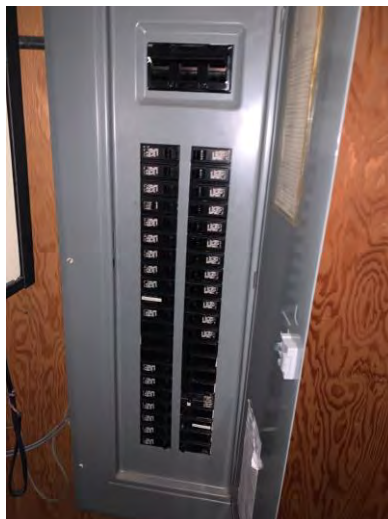
Record ID: 1347  
 System: D5020 - ELECTRICAL SERVICE AND DISTRIBUTION

Year Installed / Industry Life / Remaining Useful Life: 1975 / 30 / -17

Description of Work: *Replace the existing load center with a new load center.*

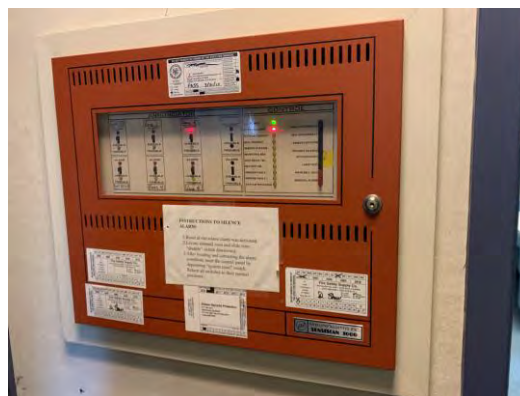
Record ID: 1348  
 System: D7050 - DETECTION AND ALARM

Comments: *No longer monitored because no data/phone. Annunciation for all buildings.*

Description of Work: *Provide a fully addressable fire alarm control panel with associated initiating and signaling devices.*

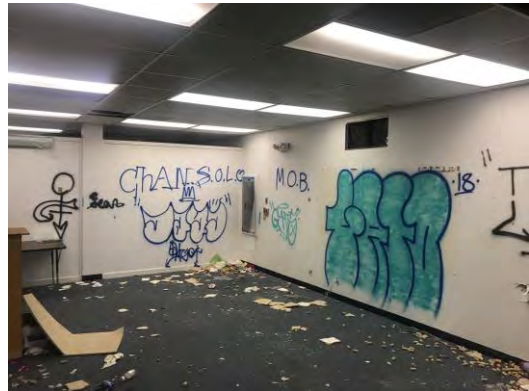
Record ID 1605  
System C1010 - INTERIOR PARTITIONS

Comments: *Interior walls have been vandalized.*

Description of Work: *Remove and replace existing gypsum board with a new gypsum board and expansion joints. Tape and paint.*

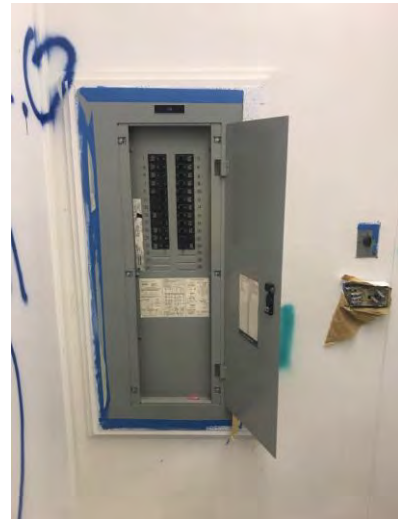
Record ID 1607  
System D5020 - ELECTRICAL SERVICE AND DISTRIBUTION  
Year Installed / Industry Life / Remaining Useful Life 1975 / 30 / -17  
Item No. D5020.30.1008  
Floor/Room: 1  
**Priority: 1**  
Quantity/Unit of Measure: 1/EA  
Total Deficiency Cost: \$18,570  
Deficiency Description: *The 225A (120/208, 3P) panelboard is past its expected useful life.*

Description of Work: *Replace the existing panelboard with a new panelboard.*

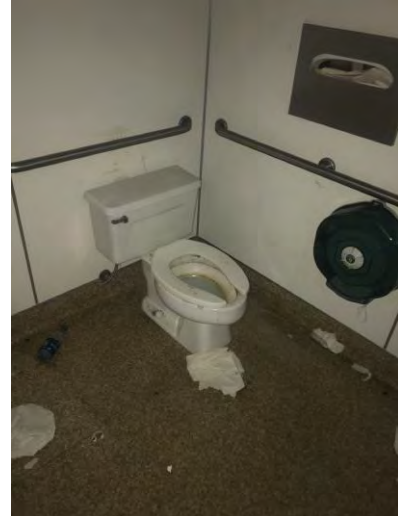
Record ID 1610  
System D2010 - DOMESTIC WATER DISTRIBUTION  
Year Installed / Industry Life / Remaining Useful Life - / 30 / -  
Item No. D2010.60.047  
Floor/Room: 1 / Restroom  
**Priority: 1**  
Quantity/Unit of Measure: 1/EA  
Total Deficiency Cost: \$19,270  
Deficiency Description: *Restroom piping and plumbing fixtures are at or approaching the end of its expected useful service life.*

Description of Work: *Provide equipment replacement and installation.*

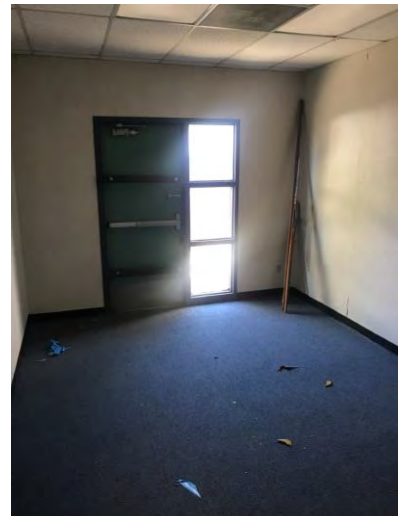
Record ID 1611  
System C2030 - FLOORING  
Year Installed / Industry Life / Remaining Useful Life - / 20 / -  
Item No. C2030.75.002  
Floor/Room: 1 / Throughout  
**Priority: 1**  
Quantity/Unit of Measure: 4,000/SF  
Total Deficiency Cost: \$102,720  
Deficiency Description: *Carpet flooring is worn.*

Description of Work: *Remove and replace carpet flooring.*

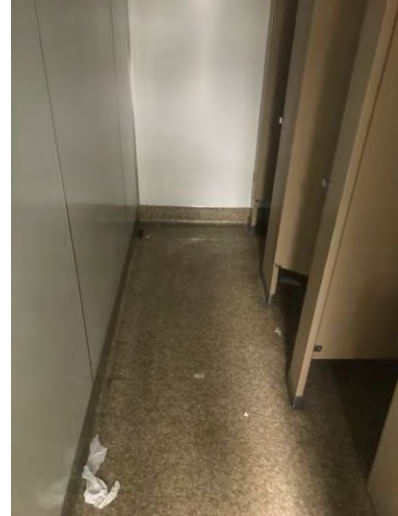
Deficiency Description: *Restrooms are in poor condition and not accessible.*

Description of Work: *Renovate restroom with accessible features.*

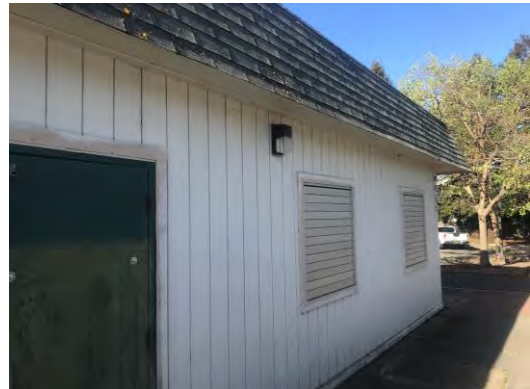
Deficiency Description: *The exterior light fixture is past its expected useful life.*

Description of Work: *Replace the existing light fixture with an LED lighting fixture.*

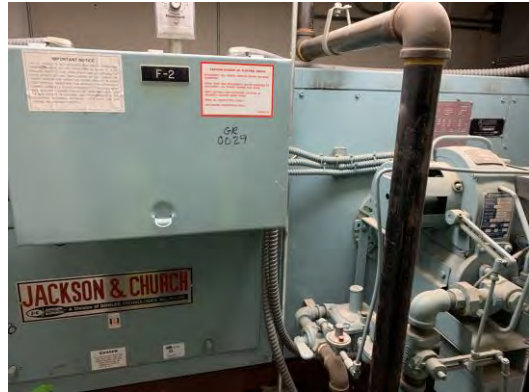
Quantity/Unit of Measure: 1/EA  
 Total Deficiency Cost: \$29,750  
 Deficiency Description: *Furnace is approaching the end of its expected useful life.*

Description of Work: *Provide equipment replacement and installation.*

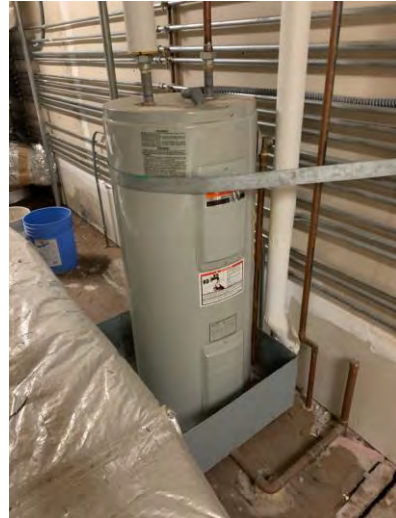
Quantity/Unit of Measure: 1/EA  
 Total Deficiency Cost: \$14,470  
 Deficiency Description: *Electric water heater is approaching the end of its expected useful life.*

Description of Work: *Provide equipment replacement and installation.*

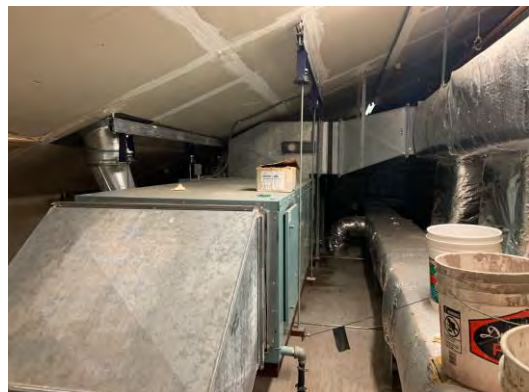
Quantity/Unit of Measure: 1/EA  
 Total Deficiency Cost: \$29,750  
 Deficiency Description: *Furnace is approaching the end of its expected useful life.*

Description of Work: *Provide equipment replacement and installation.*

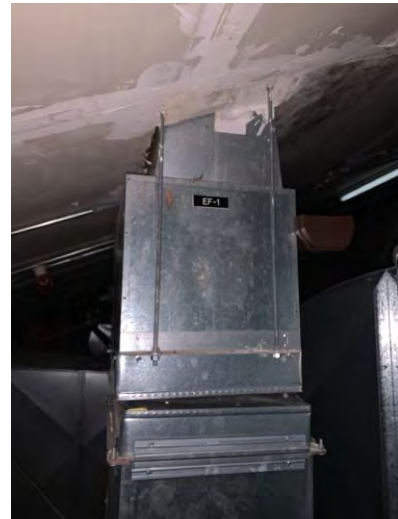
Deficiency Description: *Exhaust fan is approaching the end of its expected useful life.*

Comments: *Exhaust serves kitchen hood*

Description of Work: *Provide equipment replacement and installation.*

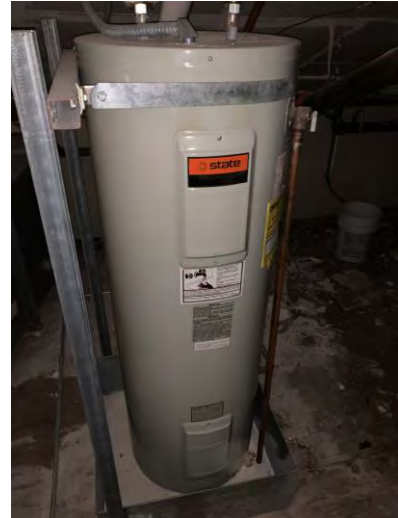
Deficiency Description: *Gas fired water heater is approaching the end of its expected useful life.*

Description of Work: *Provide equipment replacement and installation.*

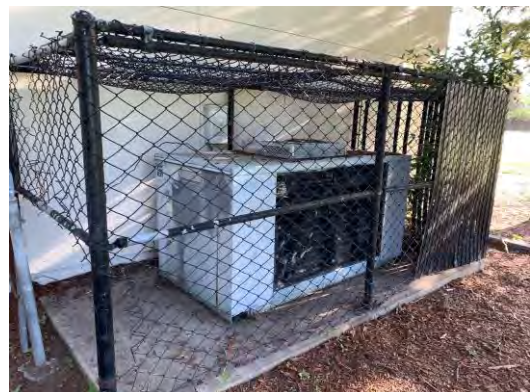
Deficiency Description: *Packaged AC unit is approaching the end of its expected useful life.*

Description of Work: *Provide equipment replacement and installation.*

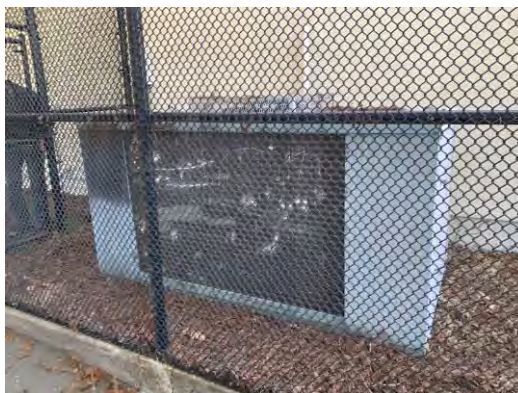
Quantity/Unit of Measure: 1/EA  
Total Deficiency Cost: \$52,640  
Deficiency Description: *Packaged AC unit is approaching the end of its expected useful life.*

Description of Work: *Provide equipment replacement and installation.*

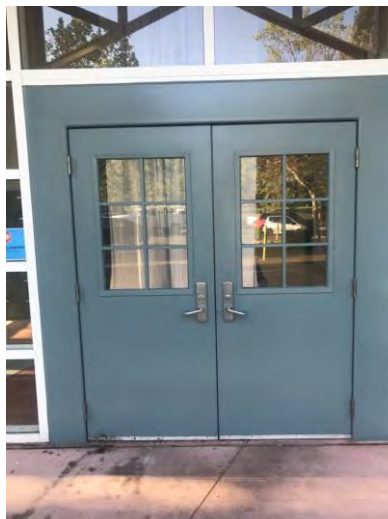
Quantity/Unit of Measure: 2/EA  
Total Deficiency Cost: \$8,430  
Deficiency Description: *Metal door is damaged or deteriorated.*

Description of Work: *Repair door and repaint.*

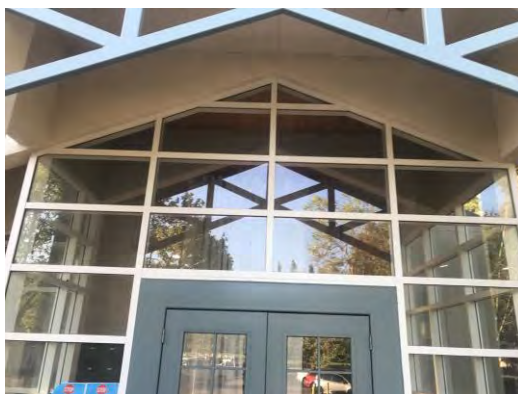
Quantity/Unit of Measure: 40/SF  
Total Deficiency Cost: \$6,430  
Deficiency Description: *Glazing is damaged.*

Comments: *5 panes damaged.*

Description of Work: *Re-glaze single glazing window.*

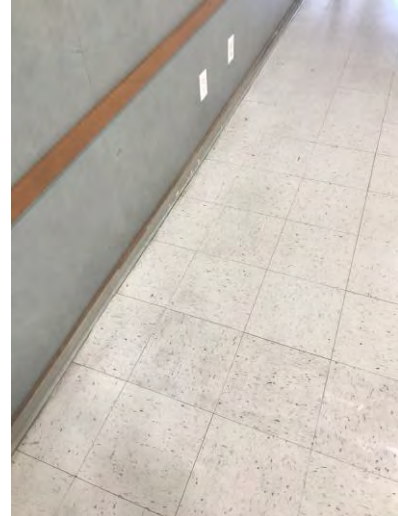
Deficiency Description: *Vinyl composition tile is approaching the end of its useful life.*

Description of Work: *Remove the existing vinyl composition tile and replace.*

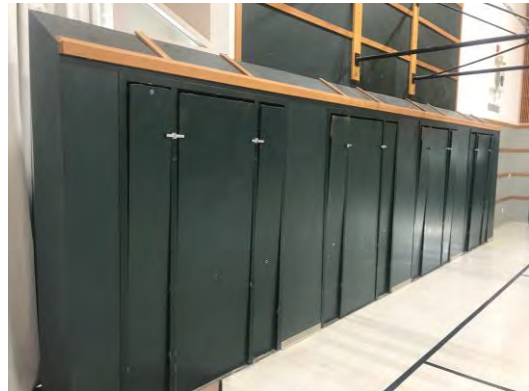
Deficiency Description: *The existing casework is at or is approaching the end of its useful life.*

Description of Work: *Replace original wood cabinets.*

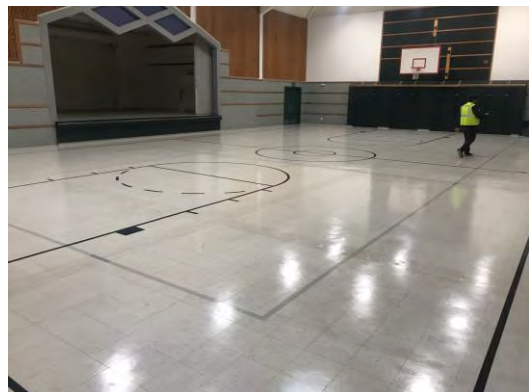
Deficiency Description: *Vinyl composition tile is approaching the end of its useful life.*

Description of Work: *Remove the existing vinyl composition tile and replace.*

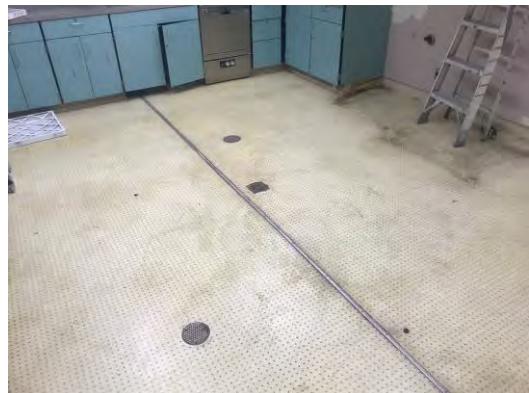
Year Installed / Industry Life / Remaining Useful Life - / 60 / -  
Item No. C2030.50.002  
Floor/Room: 1 / Kitchen  
**Priority: 2**  
Quantity/Unit of Measure: 600/SF  
Total Deficiency Cost: \$25,510  
Deficiency Description: *Sheet vinyl is approaching the end of its useful life.*

Description of Work: *Remove the existing sheet vinyl and replace.*

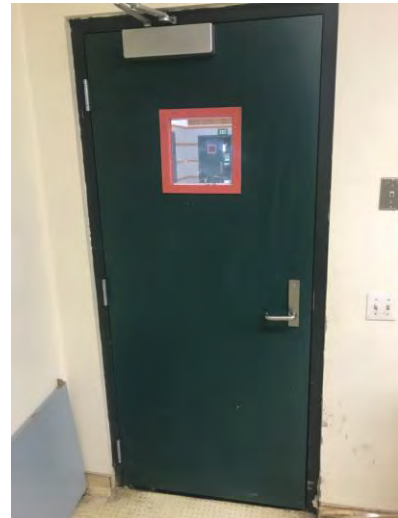
Year Installed / Industry Life / Remaining Useful Life - / - / -  
Item No. C1030.10.009  
Floor/Room: 1 / Kitchen  
**Priority: 3**  
Quantity/Unit of Measure: 1/EA  
Total Deficiency Cost: \$11,930  
Deficiency Description: *Interior hollow metal door is in visual need of refurbishment.*

Description of Work: *Refurbish/repair interior hollow metal door.*

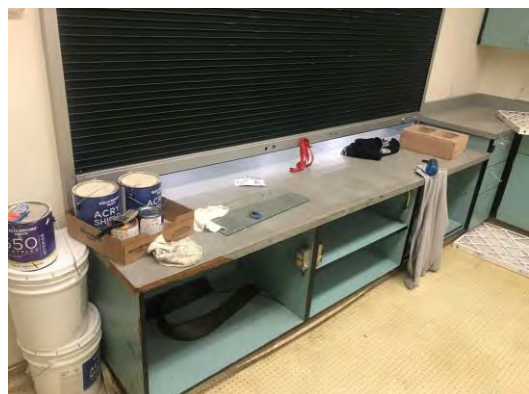
Year Installed / Industry Life / Remaining Useful Life - / - / -  
Item No. E2010.30.008  
Floor/Room: 1 / Kitchen  
**Priority: 2**  
Quantity/Unit of Measure: 40/LF  
Total Deficiency Cost: \$53,750  
Deficiency Description: *Plastic laminate base cabinet (with countertop) is in poor condition.*

Description of Work: *Remove and replace with new plastic laminate base cabinet and countertop.*

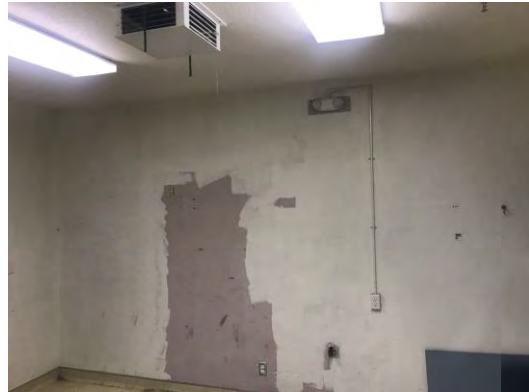
Year Installed / Industry Life / Remaining Useful Life: - / 30 / -  
Item No.: C2010.70.001  
Floor/Room: 1 / Kitchen  
**Priority:** 2  
Quantity/Unit of Measure: 400/SF  
Total Deficiency Cost: \$8,420  
Deficiency Description: *Painted gypsum wallboard is showing signs of wear.*

Description of Work: *Patch and paint the gypsum wallboard.*

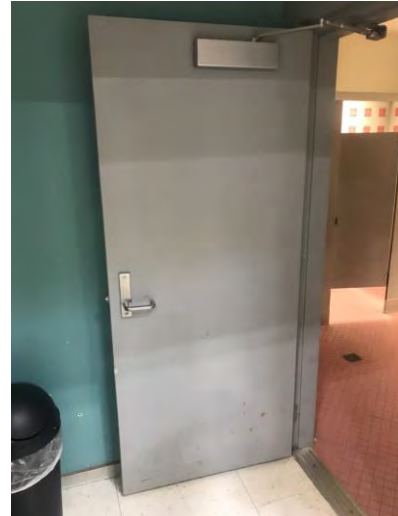
Year Installed / Industry Life / Remaining Useful Life: - / 60 / -  
Item No.: C1030.90.003  
Floor/Room: 1 / Women's Restroom  
**Priority:** 3  
Quantity/Unit of Measure: 1/EA  
Total Deficiency Cost: \$900  
Deficiency Description: *Metal door and frame are in fair to poor condition.*

Description of Work: *Repair and refinish the metal door and frame.*

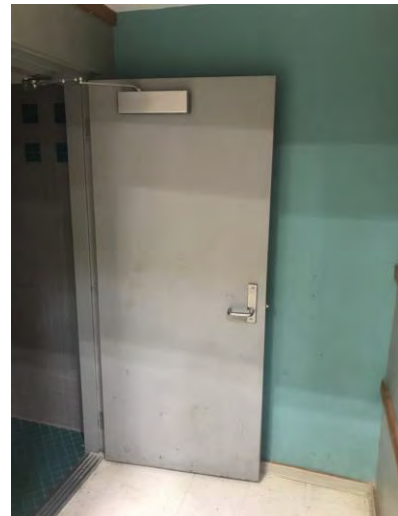
Year Installed / Industry Life / Remaining Useful Life: - / 60 / -  
Item No.: C1030.90.003  
Floor/Room: 1 / Men's Restroom  
**Priority:** 3  
Quantity/Unit of Measure: 1/EA  
Total Deficiency Cost: \$900  
Deficiency Description: *Metal door and frame are in fair to poor condition.*

Description of Work: *Repair and refinish the metal door and frame.*

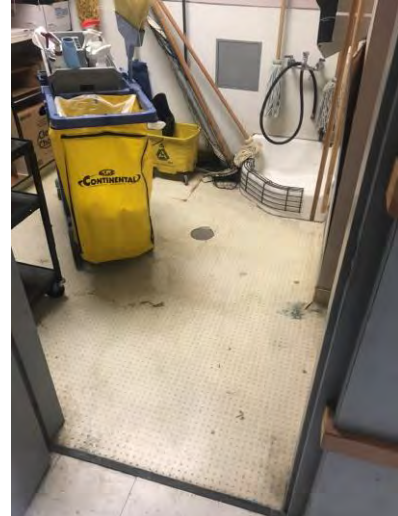
Year Installed / Industry Life / Remaining Useful Life - / 60 / -  
Item No. C2030.50.002  
Floor/Room: 1 / Janitor's Closet  
**Priority: 2**  
Quantity/Unit of Measure: 100/SF  
Total Deficiency Cost: \$4,280  
Deficiency Description: *Sheet vinyl is approaching the end of its useful life.*

Description of Work: *Remove the existing sheet vinyl and replace.*

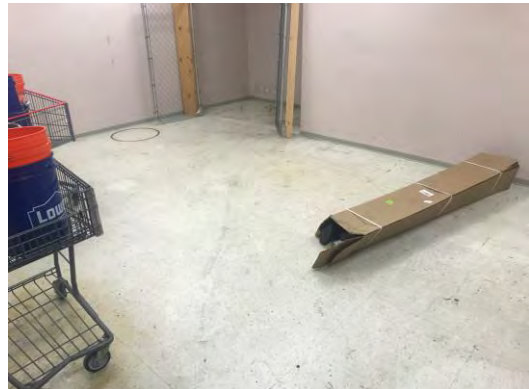
Year Installed / Industry Life / Remaining Useful Life - / 60 / -  
Item No. C2030.50.001  
Floor/Room: 1 / Storage  
**Priority: 2**  
Quantity/Unit of Measure: 200/SF  
Total Deficiency Cost: \$5,060  
Deficiency Description: *Vinyl composition tile is approaching the end of its useful life.*

Description of Work: *Remove the existing vinyl composition tile and replace.*

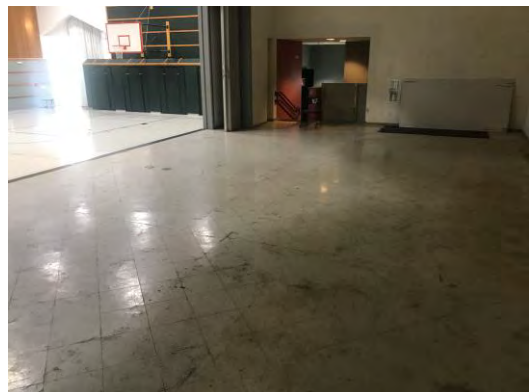
Year Installed / Industry Life / Remaining Useful Life - / 60 / -  
Item No. C2030.50.001  
Floor/Room: 1 / Stage  
**Priority: 2**  
Quantity/Unit of Measure: 400/SF  
Total Deficiency Cost: \$10,110  
Deficiency Description: *Vinyl composition tile is approaching the end of its useful life.*

Description of Work: *Remove the existing vinyl composition tile and replace.*

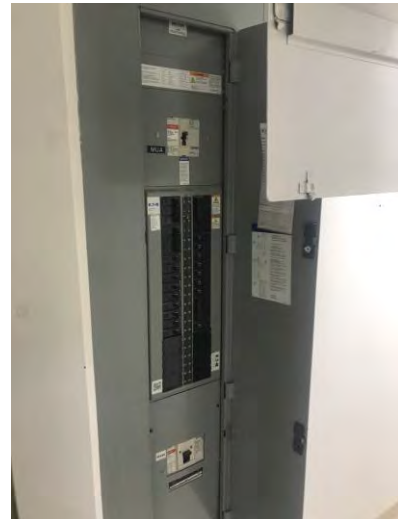
Record ID: 1586  
 System: D5020 - ELECTRICAL SERVICE AND DISTRIBUTION  
 Year Installed / Industry Life / Remaining Useful Life: 2020 / 30 / 28  
 Item No.: D5020.30.1009  
 Floor/Room: 6  
**Priority:** 6  
 Quantity/Unit of Measure: 1/EA  
 Total Deficiency Cost: N/A - See Executive Summary  
 Deficiency Description: *The 400A (42 ckts, 120/208, 3P) panelboard useful life is beyond the priority timeline of FCA(Informational).*  
 Description of Work: *None.*  
 Comments:

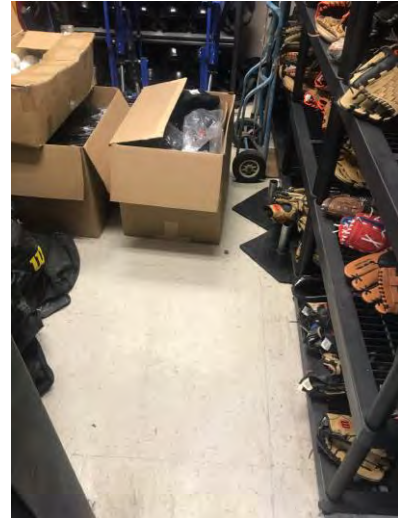
Record ID: 1588  
 System: C2030 - FLOORING  
 Year Installed / Industry Life / Remaining Useful Life: - / 60 / -  
 Item No.: C2030.50.001  
 Floor/Room: 1 / Storage  
**Priority:** 3  
 Quantity/Unit of Measure: 100/SF  
 Total Deficiency Cost: \$2,650  
 Deficiency Description: *Vinyl composition tile is approaching the end of its useful life.*  
 Description of Work: *Remove the existing vinyl composition tile and replace.*  
 Comments:

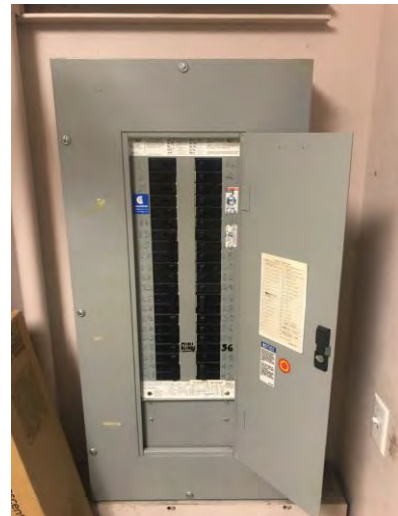
Electrical power is routed to main panel 400A, 120/208V, 3-phase panel "MU". This subfeeds a second 225A, panel "MUA". Panel "MUA" is original to the building at end the end of its expected life. Panel "MU" was installed recently in 2020 and appears to be in very good condition.

Record ID: 1589  
 System: D5020 - ELECTRICAL SERVICE AND DISTRIBUTION  
 Year Installed / Industry Life / Remaining Useful Life: 1992 / 30 / 0  
 Item No.: D5020.30.1008  
 Floor/Room: 1  
**Priority:** 1  
 Quantity/Unit of Measure: 1/EA  
 Total Deficiency Cost: \$18,570  
 Deficiency Description: *The 225A (120/208, 3P) panelboard is past its expected useful life.*  
 Description of Work: *Replace the existing panelboard with a new panelboard.*  
 Comments:

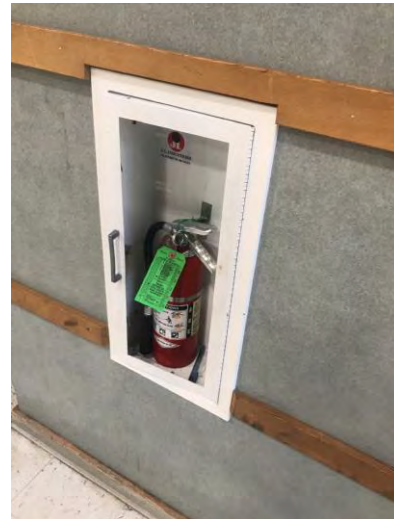
Deficiency Description: *Fire extinguisher cabinet is damaged.*

Description of Work: *Replace fire extinguisher cabinet.*

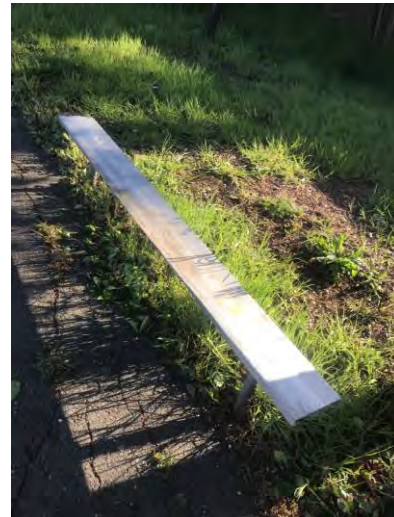
Quantity/Unit of Measure: 1/EA  
 Total Deficiency Cost: \$3,390  
 Deficiency Description: *Bench is at or approaching the end of its useful life.*

Description of Work: *Replace bench.*

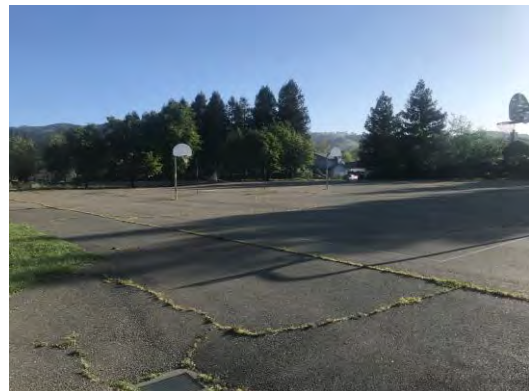
Quantity/Unit of Measure: 40,000/SF  
 Total Deficiency Cost: \$547,120  
 Deficiency Description: *Asphalt courts: AC paving has faded or has minor weathering.*

Description of Work: *Reseal AC paving.*

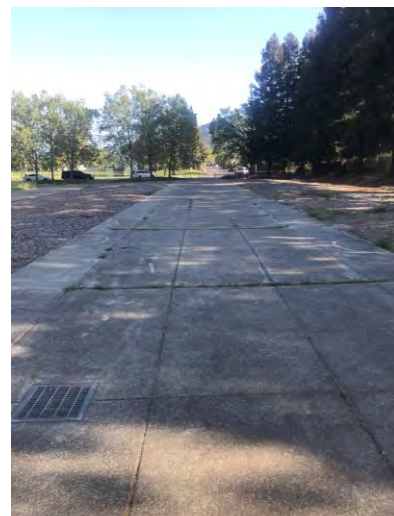
Quantity/Unit of Measure: 2,000/SF  
 Total Deficiency Cost: \$67,360  
 Deficiency Description: *Concrete pavement has major damage / structural failure.*

Description of Work: *Replace concrete paving (base to remain).*

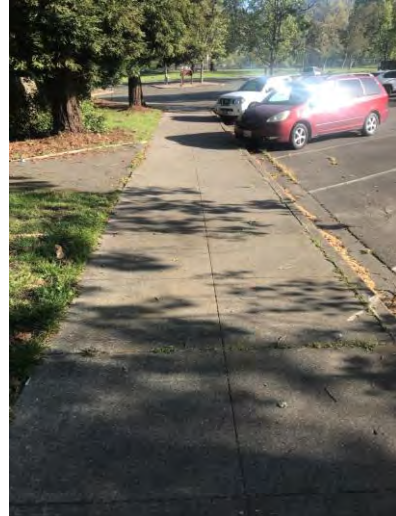
Record ID: 1599  
 System: G2030 - PEDESTRIAN PLAZAS AND WALKWAYS  
 Year Installed / Industry Life / Remaining Useful Life: - / - / -  
 Item No.: G2030.10.004  
 Floor/Room: Site / Parking Lot Sidewalk  
**Priority:** 3  
 Quantity/Unit of Measure: 200/SF  
 Total Deficiency Cost: \$6,770  
 Deficiency Description: *Concrete pavement has major damage / structural failure.*

Description of Work: *Replace concrete paving (base to remain).*

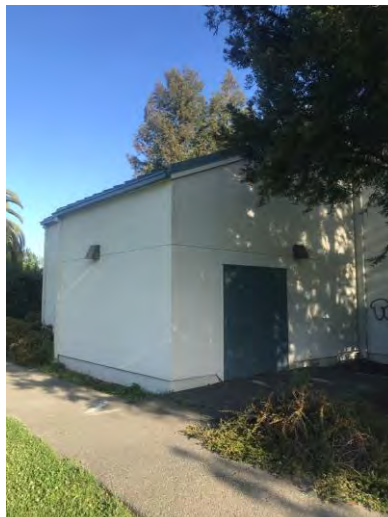
Deficiency Description: *The exterior light fixture is past its expected useful life.*

Description of Work: *Replace the existing light fixture with an LED lighting fixture.*

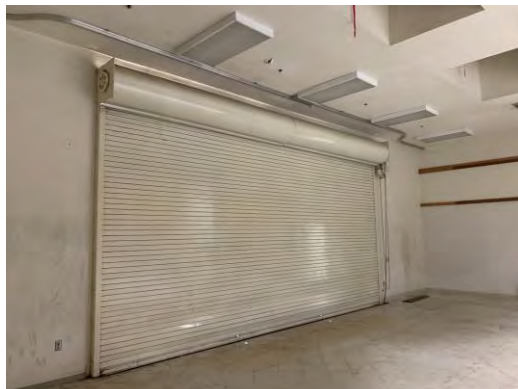
Record ID 1747  
System D5040 - LIGHTING

Deficiency Description: *Interior lighting system is past its expected useful life.*

Description of Work: *Provide new interior lighting and control system throughout building per current CEC T24 code.*

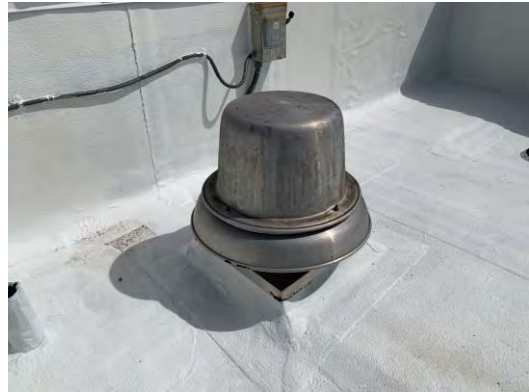
Deficiency Description: *Roof exhaust fan is approaching the end of its expected useful life.*

Comments: *Replacement recommended in 10 years based on industry standard useful life.*

Description of Work: *Provide equipment replacement and installation.*

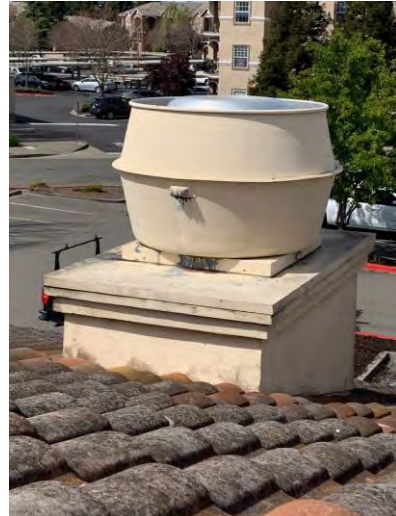
Record ID: 531  
System: D3060 - VENTILATION

Deficiency Description: *Large roof exhaust fan is approaching the end of its expected useful life.*

Comments: *Replacement recommended in 10 years based on industry standard useful life.*

Description of Work: *Provide equipment replacement and installation.*

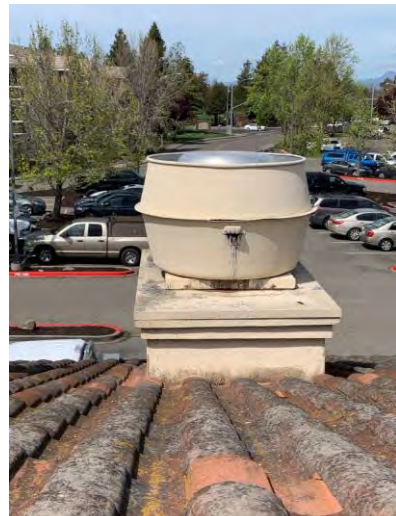
Record ID: 532  
System: D3060 - VENTILATION

Deficiency Description: *Large roof exhaust fan is approaching the end of its expected useful life.*

Comments: *Replacement recommended in 10 years based on industry standard useful life.*

Description of Work: *Provide equipment replacement and installation.*

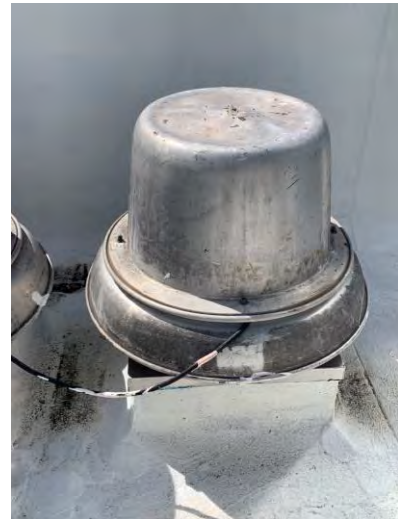
Quantity/Unit of Measure: 1/EA  
 Total Deficiency Cost: \$5,950  
 Deficiency Description: *Roof exhaust fan is approaching the end of its expected useful life.*

Comments: *Replacement recommended in 10 years based on industry standard useful life.*

Description of Work: *Provide equipment replacement and installation.*

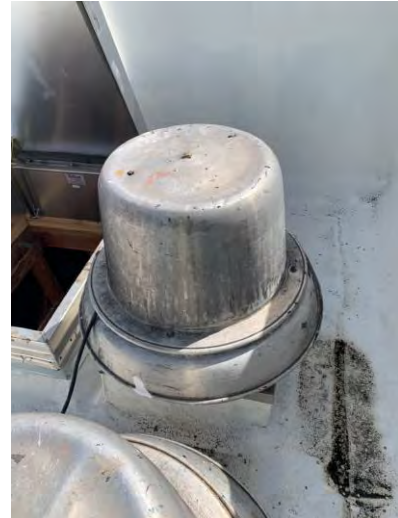
Record ID: 534  
 System: D3060 - VENTILATION

Quantity/Unit of Measure: 1/EA  
 Total Deficiency Cost: \$5,950  
 Deficiency Description: *Roof exhaust fan is approaching the end of its expected useful life.*

Comments: *Replacement recommended in 10 years based on industry standard useful life.*

Description of Work: *Provide equipment replacement and installation.*

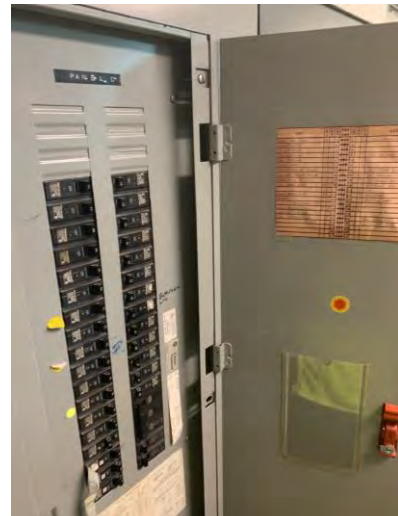
Record ID: 556  
 System: D5020 - ELECTRICAL SERVICE AND DISTRIBUTION

Quantity/Unit of Measure: 1/EA  
 Total Deficiency Cost: \$18,570  
 Deficiency Description: *The 225A (120/208, 3P) panelboard is past its expected useful life.*

Description of Work: *Replace the existing panelboard with a new panelboard.*

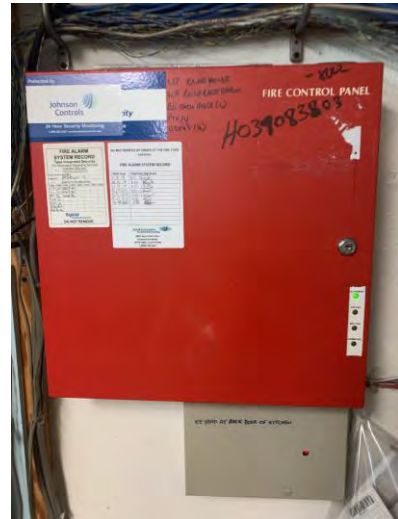
Deficiency Description: *The existing fire alarm system is at the end of its industry rated useful life.*

Description of Work: *Provide a fully addressable fire alarm control panel with associated initiating and signaling devices.*

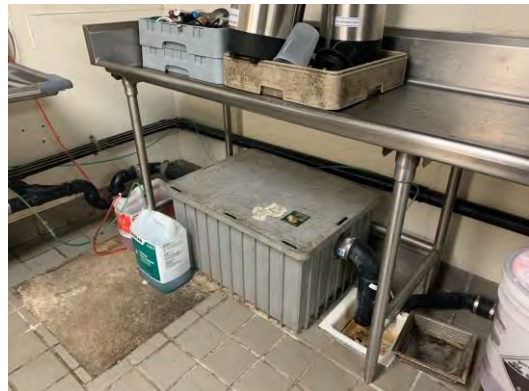
Deficiency Description: *Grease interceptor is at or approaching end of its expected useful service life.*

Comments: *Replacement recommended in 10 years based on industry standard useful life.*

Description of Work: *Provide equipment replacement and installation.*

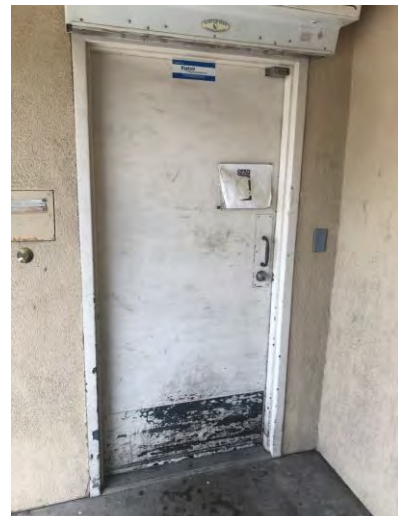
Deficiency Description: *Metal entrance door is damaged or deteriorating.*

Description of Work: *Refurbish/repair metal entrance door.*

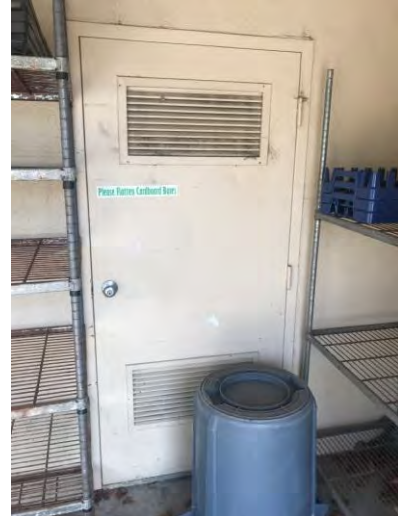
Deficiency Description: *Metal entrance door is damaged or deteriorating.*

Description of Work: *Refurbish/repair metal entrance door.*

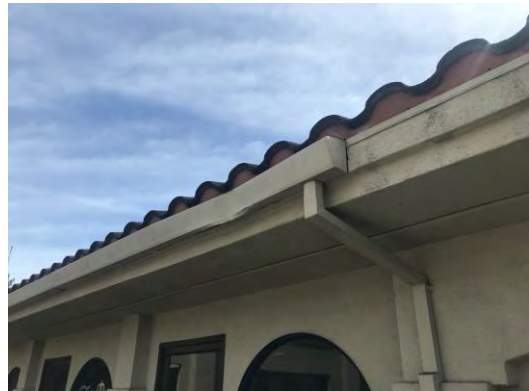
Record ID: 874  
System: B3020 - ROOF APPURTENANCES

Deficiency Description: *Rain leaders/gutters are damaged and leak.*

Description of Work: *Repair, replace rain leaders/gutters.*

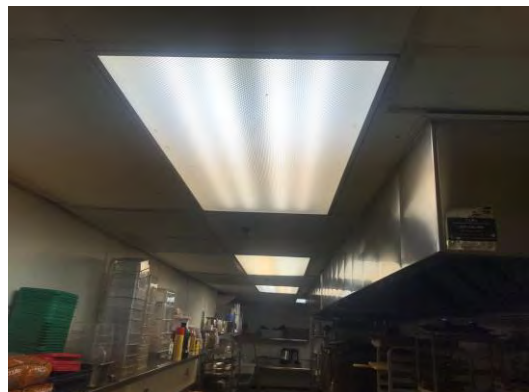
Record ID: 883  
System: D5040 - LIGHTING

Deficiency Description: *Interior lighting system is at or is approaching end of its expected useful life.*

Description of Work: *Provide new interior lighting and control system throughout building per current CEC T24 code.*

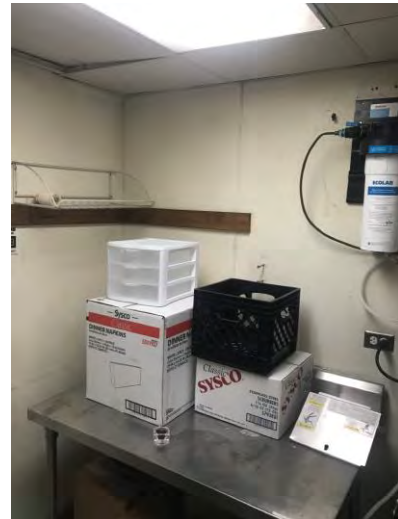
Deficiency Description: *Fiberglass reinforced paneling is at or approaching the end of its useful life.*

Description of Work: *Install and replace the fiberglass reinforced paneling.*

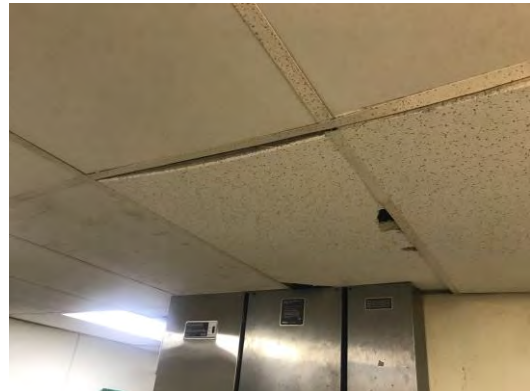
Record ID: 885  
 System: C2050 - CEILING FINISHES

Deficiency Description: *Lay-in Acoustical Tile is in poor condition.*

Description of Work: *Remove existing lay-in Acoustical Tiles and replace with new lay-in Acoustical Tiles.*

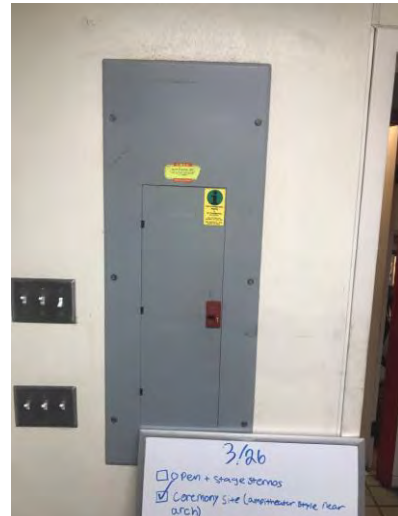
Record ID: 887  
 System: D5020 - ELECTRICAL SERVICE AND DISTRIBUTION

Deficiency Description: *The 225A (120/208, 3P) panelboard is past its expected useful life.*

Description of Work: *Replace the existing panelboard with a new panelboard.*

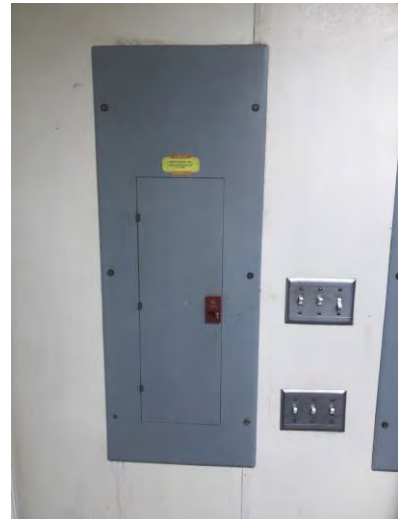
Record ID: 888  
 System: D5020 - ELECTRICAL SERVICE AND DISTRIBUTION  
 Year Installed / Industry Life / Remaining Useful Life: 1989 / 30 / -3  
 Item No.: D5020.30.1008  
 Floor/Room: 1st Floor / Panel B  
**Priority:** 1  
 Quantity/Unit of Measure: 1/EA  
 Total Deficiency Cost: \$18,570  
 Deficiency Description: *The 225A (120/208, 3P) panelboard is past its expected useful life.*

Description of Work: *Replace the existing panelboard with a new panelboard.*

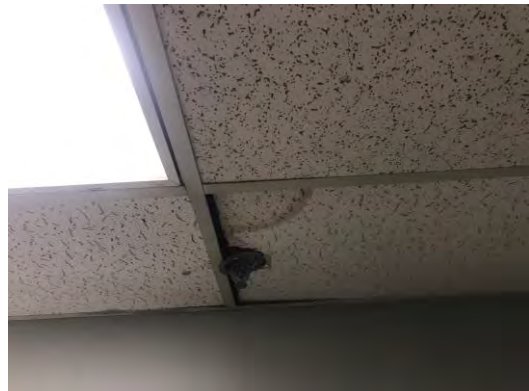
Record ID: 895  
 System: C2050 - CEILING FINISHES  
 Year Installed / Industry Life / Remaining Useful Life: - / 50 / -  
 Item No.: C2050.80.001  
 Floor/Room: 1st Floor / Bridal Suite  
**Priority:** 1  
 Quantity/Unit of Measure: 8/SF  
 Total Deficiency Cost: \$160  
 Deficiency Description: *Lay-in Acoustical Tile is in poor condition.*

Comments: *Investigate source of water stain.*

Description of Work: *Remove existing lay-in Acoustical Tiles and replace with new lay-in Acoustical Tiles.*

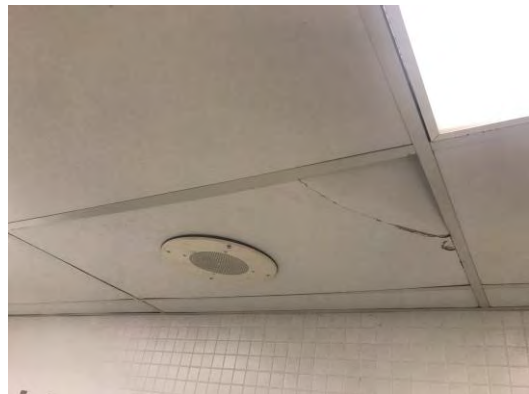
Record ID: 897  
 System: C2050 - CEILING FINISHES  
 Year Installed / Industry Life / Remaining Useful Life: - / 50 / -  
 Item No.: C2050.80.001  
 Floor/Room: 1st Floor / Men's Restroom  
**Priority:** 1  
 Quantity/Unit of Measure: 8/SF  
 Total Deficiency Cost: \$160  
 Deficiency Description: *Lay-in Acoustical Tile is in poor condition.*

Description of Work: *Remove existing lay-in Acoustical Tiles and replace with new lay-in Acoustical Tiles.*

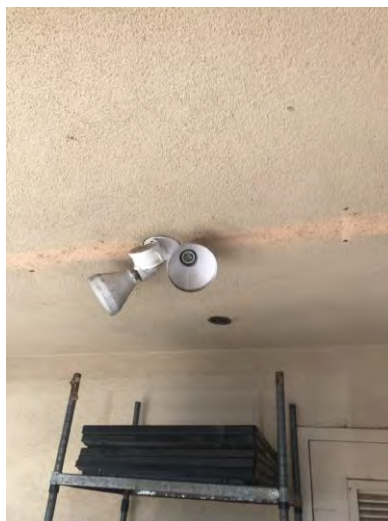
Deficiency Description: *The exterior wall mounted fixture is past its expected useful life.*

Description of Work: *Replace the existing wall mounted lighting fixture with an LED lighting fixture.*

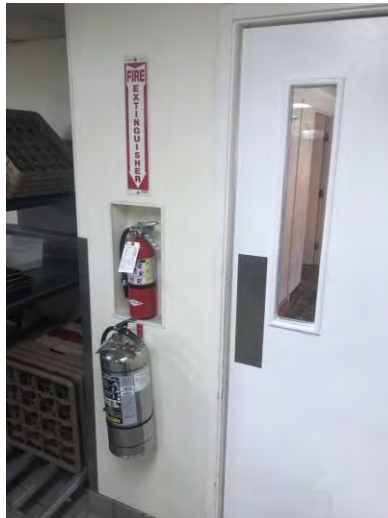
Record ID 1683  
System C2010 - WALL FINISHES

Deficiency Description: *Painted gypsum wallboard is showing signs of wear.*

Description of Work: *Patch and paint the gypsum wallboard.*

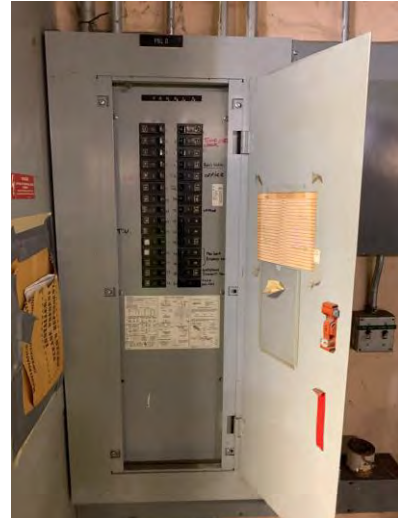
Record ID 537  
System D5020 - ELECTRICAL SERVICE AND DISTRIBUTION  
Year Installed / Industry Life / Remaining Useful Life 1989 / 30 / -3  
Item No. D5020.30.1007  
Floor/Room: 1st Floor / Cart Barn  
**Priority:** 1  
Quantity/Unit of Measure: 1/EA  
Total Deficiency Cost: \$11,460  
Deficiency Description: *The 100A (120/208, 3P) panelboard is past its expected useful life.*

Description of Work: *Replace the existing panelboard with a new panelboard.*

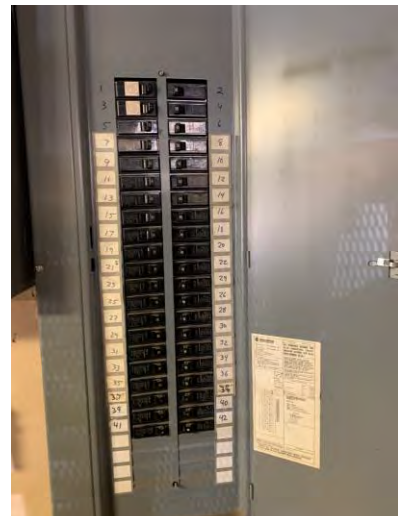
Record ID 538  
System D5020 - ELECTRICAL SERVICE AND DISTRIBUTION  
Year Installed / Industry Life / Remaining Useful Life 1989 / 30 / -3  
Item No. D5020.30.1008  
Floor/Room: 1st Floor / Cart Barn  
**Priority:** 1  
Quantity/Unit of Measure: 1/EA  
Total Deficiency Cost: \$18,570  
Deficiency Description: *The 225A (120/208, 3P) panelboard is past its expected useful life.*

Description of Work: *Replace the existing panelboard with a new panelboard.*

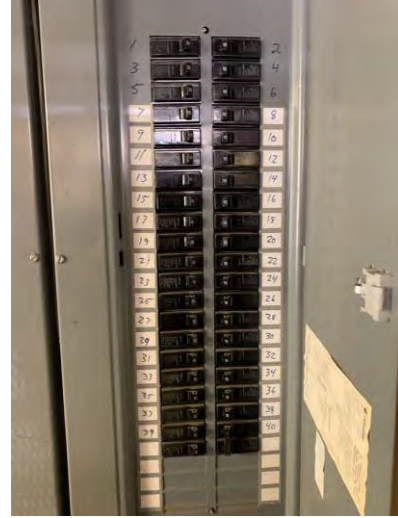
Record ID 540  
 System D5020 - ELECTRICAL SERVICE AND DISTRIBUTION  
 Year Installed / Industry Life / Remaining Useful Life 1989 / 30 / -3  
 Item No. D5020.30.1008  
 Floor/Room: 1st Floor / Cart Barn  
**Priority: 1**  
 Quantity/Unit of Measure: 1/EA  
 Total Deficiency Cost: \$18,570  
 Deficiency Description: *The 225A (120/208, 3P) panelboard is past its expected useful life.*

Description of Work: *Replace the existing panelboard with a new panelboard.*

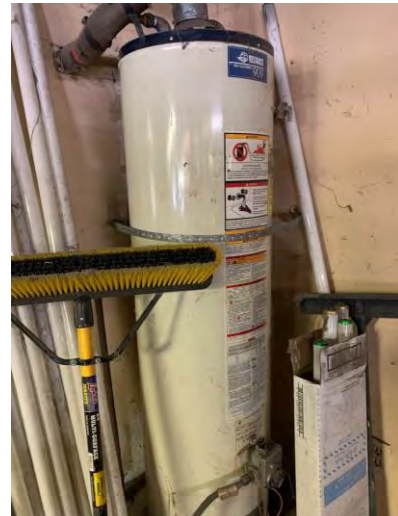
Record ID 541  
 System D2010 - DOMESTIC WATER DISTRIBUTION  
 Year Installed / Industry Life / Remaining Useful Life 2011 / 15 / 4  
 Item No. D2010.20.002  
 Floor/Room: Cart Barn  
**Priority: 1**  
 Quantity/Unit of Measure: 1/EA  
 Total Deficiency Cost: \$13,250  
 Deficiency Description: *Gas fired water heater is approaching the end of its expected useful life.*

Comments: *30 gallon water heater*

Description of Work: *Provide equipment replacement and installation.*

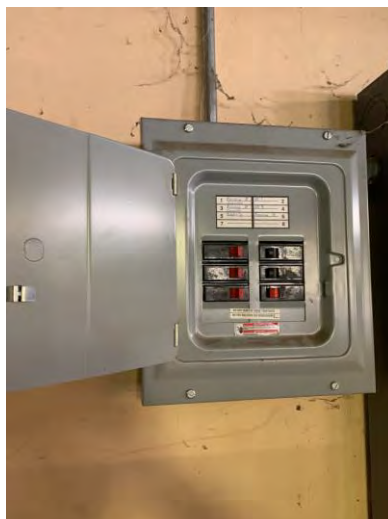
Record ID: 542  
System: D5020 - ELECTRICAL SERVICE AND DISTRIBUTION  
Year Installed / Industry Life / Remaining Useful Life: 1989 / 30 / -3  
Item No.: D5020.30.4002  
Floor/Room: 1st Floor / Cart Barn  
**Priority:** 1  
Quantity/Unit of Measure: 1/EA  
Total Deficiency Cost: \$6,110  
Deficiency Description: *The load center past its expected useful life.*  
Description of Work: *Replace the existing load center with a new load center.*  
Comments:

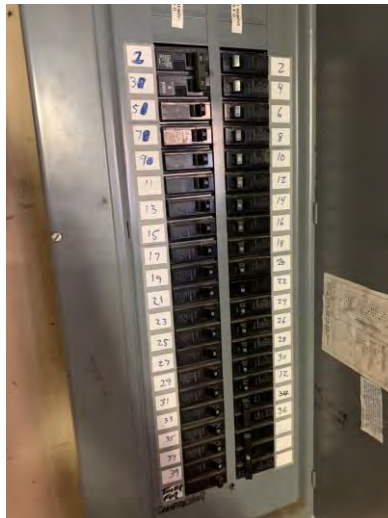
Record ID: 543  
System: D5020 - ELECTRICAL SERVICE AND DISTRIBUTION  
Year Installed / Industry Life / Remaining Useful Life: 1989 / 30 / -3  
Item No.: D5020.30.1002  
Floor/Room: 1st / Cart Barn  
**Priority:** 1  
Quantity/Unit of Measure: 1/EA  
Total Deficiency Cost: \$18,290  
Deficiency Description: *The 225A (42 ckts, 120/240V, 3P) panelboard is past its expected useful life.*  
Description of Work: *Replace the existing panelboard with a new panelboard.*  
Comments:

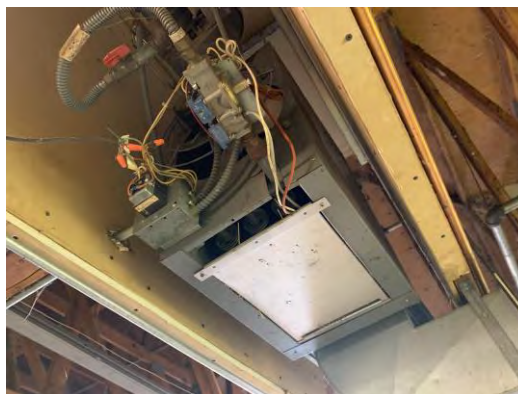
Record ID: 544  
System: D3020 - HEATING SYSTEMS  
Year Installed / Industry Life / Remaining Useful Life: 1989 / 30 / -3  
Item No.: D3020.70.003  
Floor/Room: Cart Barn  
**Priority:** 1  
Quantity/Unit of Measure: 1/EA  
Total Deficiency Cost: \$11,920  
Deficiency Description: *Gas fired unit heater is approaching the end of its expected useful life.*  
Description of Work: *Provide equipment replacement and installation.*  
Comments: *Inoperable during inspection.*

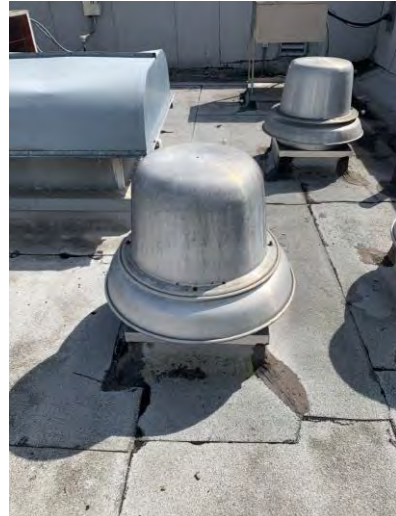
Record ID: 547  
System: D3060 - VENTILATION

Comments: *Rattling observed on site indicating an unbalanced motor. Repair recommended in mean time. Unit appears newer than 1989 construction, but should be replaced in coming years.*

Description of Work: *Provide equipment replacement and installation.*

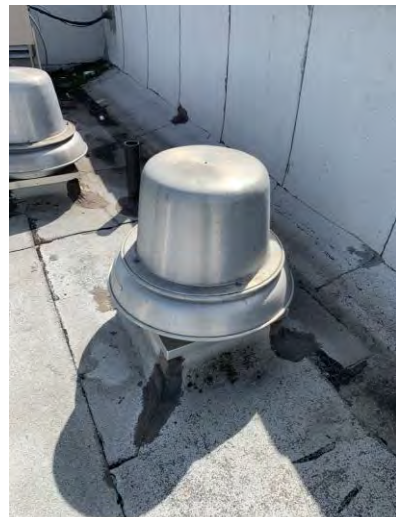
Record ID: 548  
System: D3060 - VENTILATION

Comments: *Unit appears newer than 1989 construction, but should be replaced in coming years.*

Description of Work: *Provide equipment replacement and installation.*

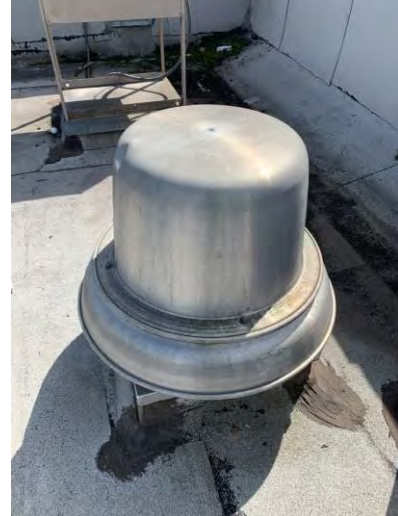
Comments: *Unit appears newer than 1989 construction, but should be replaced in coming years.*

Description of Work: *Provide equipment replacement and installation.*

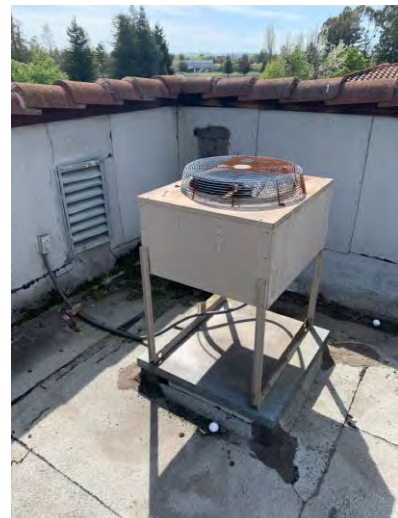
Record ID: 551  
System: D3030 - COOLING SYSTEMS

Deficiency Description: *Evaporator unit for cold box system is approaching the end of its expected useful life.*

Description of Work: *Provide equipment replacement and installation.*

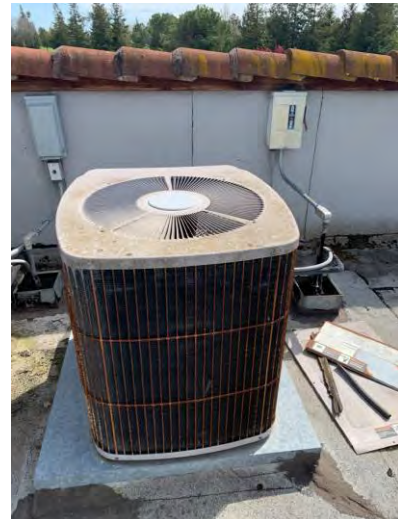
Deficiency Description: *Split system with fan coil and outdoor condensing unit is approaching the end of its expected useful life.*

Description of Work: *Provide equipment replacement and installation.*

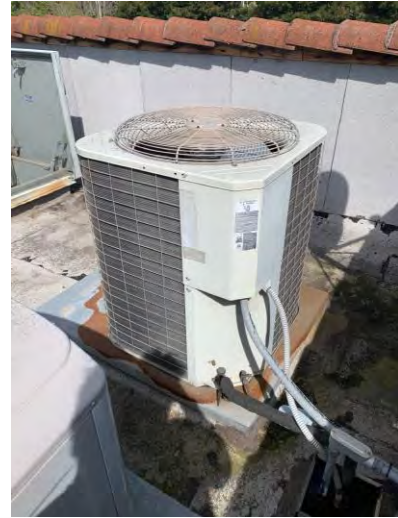
Record ID 554  
System D3030 - COOLING SYSTEMS

Deficiency Description: *Split system with fan coil and outdoor condensing unit is approaching the end of its expected useful life.*

Description of Work: *Provide equipment replacement and installation.*

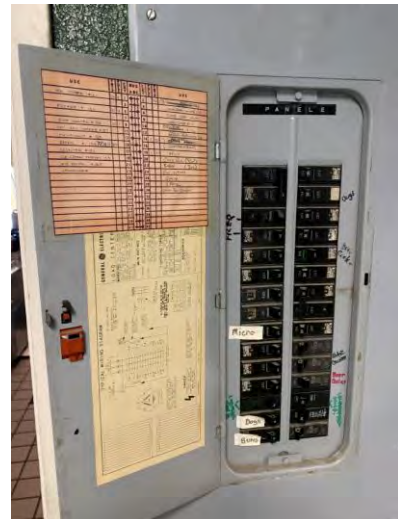
Record ID 555  
System D5020 - ELECTRICAL SERVICE AND DISTRIBUTION

Deficiency Description: *The load center is approaching the end of its expected useful life.*

Description of Work: *Replace the existing load center with a new load center.*

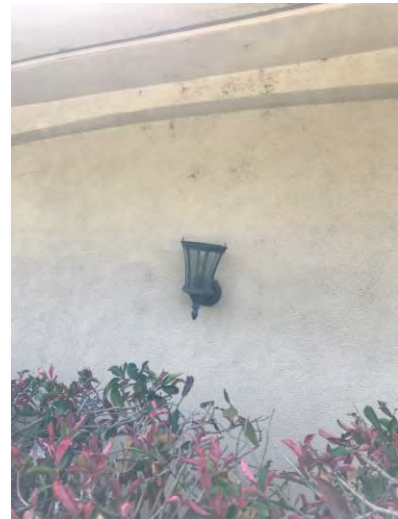
Deficiency Description: *The exterior light is damaged or approaching the end of its useful life and should be replaced.*

Description of Work: *Replace the existing or damaged exterior wallpack with a new wallpack.*

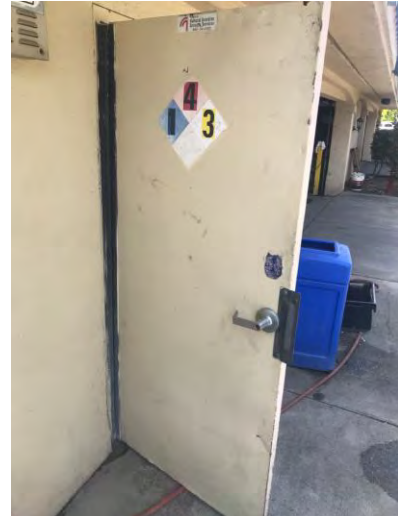
Record ID 858  
System B2050 - EXTERIOR DOORS AND GRILLES

Deficiency Description: *Metal entrance door is damaged or deteriorating.*

Description of Work: *Refurbish/repair metal entrance door.*

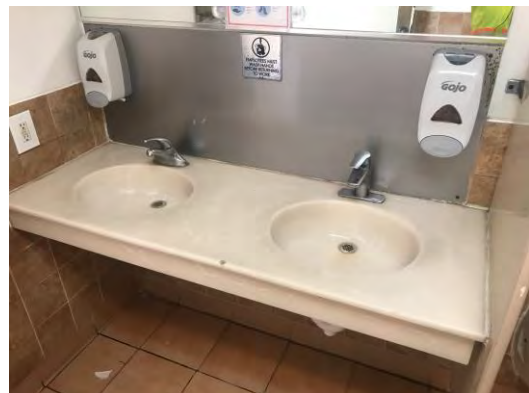
Record ID 862  
System D2010 - DOMESTIC WATER DISTRIBUTION

Deficiency Description: *Wall mounted hand sink and faucet are at or approaching the end of its expected useful service life.*

Description of Work: *Provide equipment replacement and installation.*

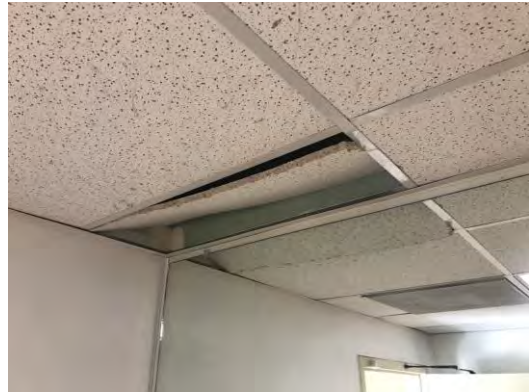
Year Installed / Industry Life / Remaining Useful Life - / 50 / -  
Item No. C2050.80.001  
Floor/Room: **1 / Men's Restroom**  
**Priority: 1**  
Quantity/Unit of Measure: 160/SF  
Total Deficiency Cost: \$2,420  
Deficiency Description: *Lay-in Acoustical Tile is in poor condition.*

Description of Work: *Remove existing lay-in Acoustical Tiles and replace with new lay-in Acoustical Tiles.*

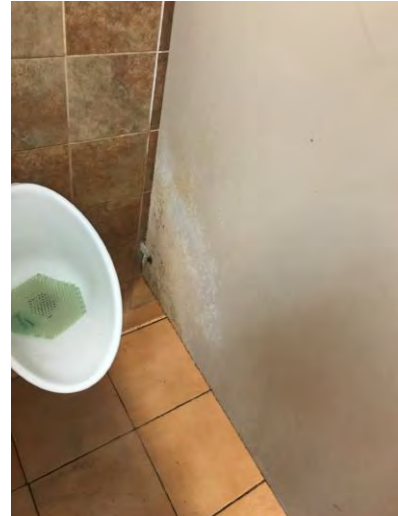
Year Installed / Industry Life / Remaining Useful Life - / 30 / -  
Item No. C1090.25.001  
Floor/Room: **1st Floor / Men's Restroom**  
**Priority: 1**  
Quantity/Unit of Measure: 4/EA  
Total Deficiency Cost: \$15,430  
Deficiency Description: *Toilet partitions have excessive amounts of rust.*

Description of Work: *Replace the toilet partitions*
