# City of Rohnert Park

## Facility Condition Assessment

Final Report

October 17, 2022

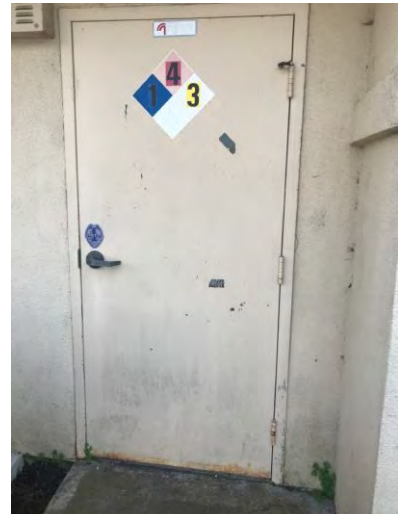
Year Installed / Industry Life / Remaining Useful Life - / 30 / -  
Item No. B2050.10.018  
Floor/Room: 1st Floor / N/A  
**Priority: 1**  
Quantity/Unit of Measure: 1/EA  
Total Deficiency Cost: \$640  
Deficiency Description: *Metal entrance door is damaged or deteriorating.*

Description of Work: *Refurbish/repair metal entrance door.*

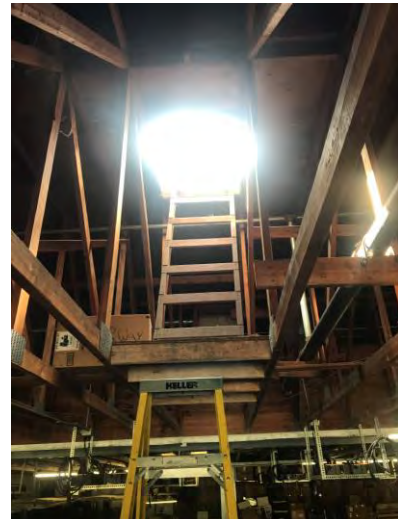
Record ID: 902  
 System: B3060 - HORIZONTAL OPENINGS  
 Year Installed / Industry Life / Remaining Useful Life: - / 30 / -  
 Item No.: B3060.50.004  
 Floor/Room: 1st Floor / N/A  
**Priority:** 1  
 Quantity/Unit of Measure: 1/EA  
 Total Deficiency Cost: \$16,090  
 Deficiency Description: *Roof access ladder is damaged or missing.*

Description of Work: *Provide roof access ladder.*

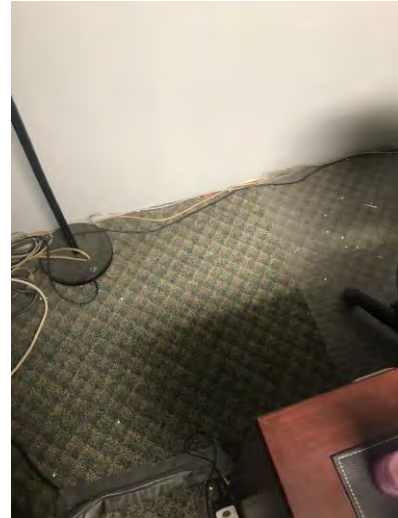
Record ID: 909  
 System: C2030 - FLOORING  
 Year Installed / Industry Life / Remaining Useful Life: - / 20 / -  
 Item No.: C2030.75.002  
 Floor/Room: 1st Floor / Office  
**Priority:** 3  
 Quantity/Unit of Measure: 100/SF  
 Total Deficiency Cost: \$2,830  
 Deficiency Description: *Rolled carpeting is approaching the end of its useful life.*

Description of Work: *Remove existing rolled carpeting and replace it with new 40 oz. nylon carpet.*

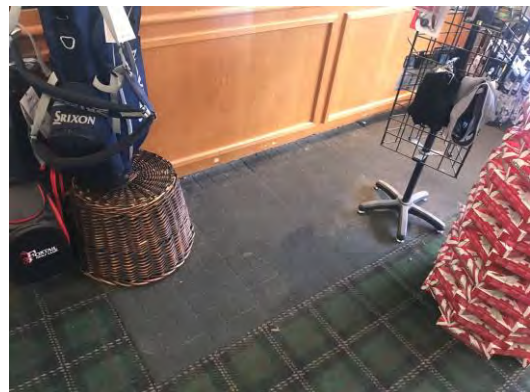
Record ID: 914  
 System: C2030 - FLOORING  
 Year Installed / Industry Life / Remaining Useful Life: - / 20 / -  
 Item No.: C2030.75.002  
 Floor/Room: 1st Floor / Pro Shop  
**Priority:** 5  
 Quantity/Unit of Measure: 1,400/SF  
 Total Deficiency Cost: \$42,640  
 Deficiency Description: *Rolled carpeting is approaching the end of its useful life.*

Description of Work: *Remove existing rolled carpeting and replace it with new 40 oz. nylon carpet.*

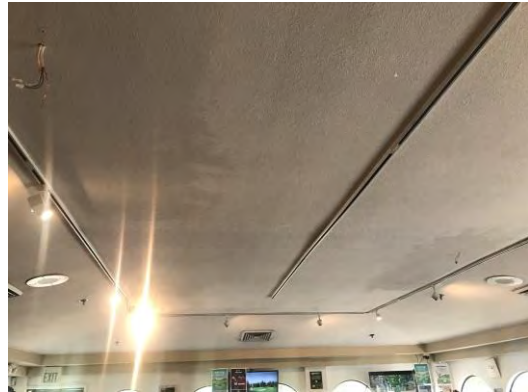
Year Installed / Industry Life / Remaining Useful Life 1989 / 20 / -13  
 Item No. D5040.50.411  
 Floor/Room: 1st Floor / All Rooms  
**Priority: 1**  
 Quantity/Unit of Measure: 9,800/SF  
 Total Deficiency Cost: \$560,740  
 Deficiency Description: *Interior lighting system is at or is approaching end of its expected useful life.*

Description of Work: *Provide new interior lighting and control system throughout building per current CEC T24 code.*

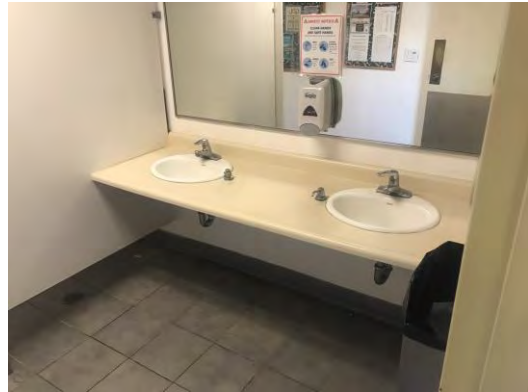
Year Installed / Industry Life / Remaining Useful Life - / 30 / -  
 Item No. D2010.60.031  
 Floor/Room: 1st Floor / Women's Restroom  
**Priority: 5**  
 Quantity/Unit of Measure: 2/EA  
 Total Deficiency Cost: \$15,220  
 Deficiency Description: *Wall mounted hand sink and faucet are at or approaching the end of its expected useful service life.*

Description of Work: *Provide equipment replacement and installation.*

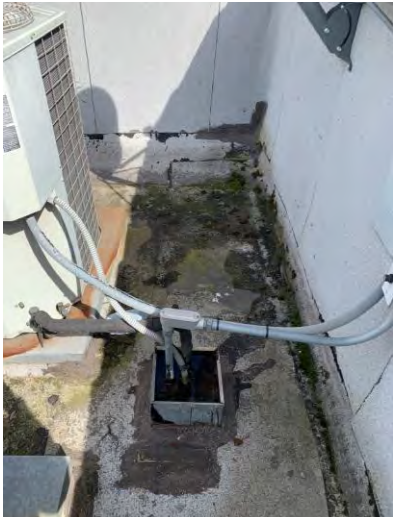
Year Installed / Industry Life / Remaining Useful Life - / 10 / -  
 Item No. B3010.50.004  
 Floor/Room: Roof / N/A  
**Priority: 1**  
 Quantity/Unit of Measure: 1,200/SF  
 Total Deficiency Cost: \$44,320  
 Deficiency Description: *Single-ply (modified bitumen) roofing is at or approaching the end of its useful life.*

Description of Work: *Replace single-ply (modified bitumen) roofing.*

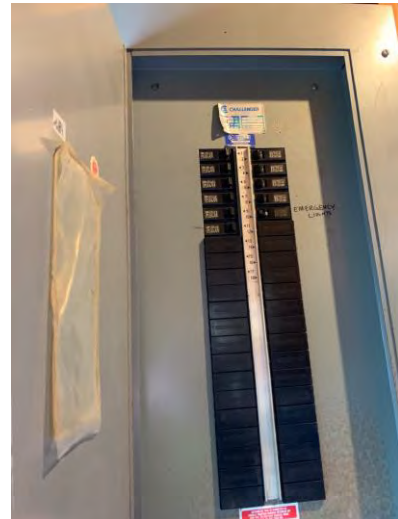
Record ID: 1351  
 System: D5020 - ELECTRICAL SERVICE AND DISTRIBUTION  
 Year Installed / Industry Life / Remaining Useful Life: 1986 / 30 / -6  
 Item No.: D5020.30.1002  
 Floor/Room: 1 / Closet  
**Priority:** 1  
 Quantity/Unit of Measure: 1/EA  
 Total Deficiency Cost: \$18,290  
 Deficiency Description: *The 225A (120/240V, 3P) panelboard is past its expected useful life.*

Description of Work: *Replace the existing panelboard with a new panelboard.*

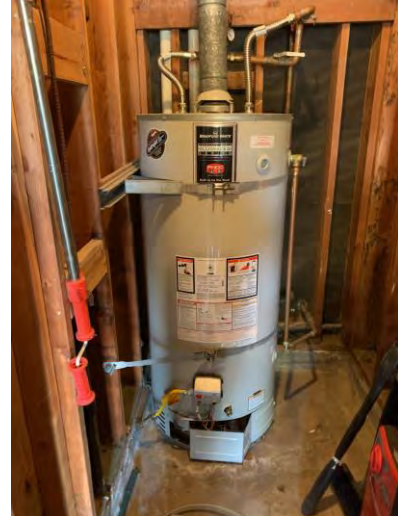
Record ID: 1352  
 System: D2010 - DOMESTIC WATER DISTRIBUTION  
 Year Installed / Industry Life / Remaining Useful Life: 2018 / 15 / 11  
 Item No.: D2010.20.002  
 Floor/Room:  
**Priority:** 7  
 Quantity/Unit of Measure: 1/EA  
 Total Deficiency Cost: \$16,310  
 Deficiency Description: *Gas fired water heater is approaching the end of its expected useful life.*

Description of Work: *Provide equipment replacement and installation.*

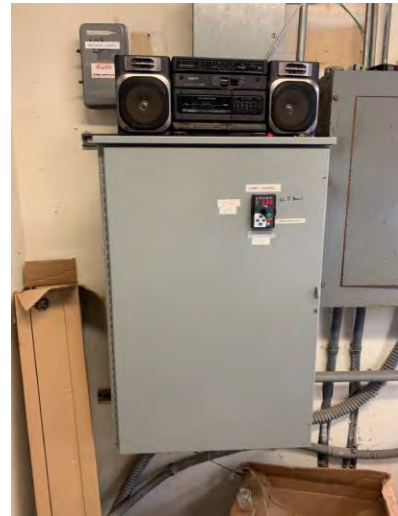
Although the plumbing systems appear to be in operable condition, there are key concerns with the year-round operation at Honeybee Pool. There are significant concerns with the flow issues on all return water primarily due to the pool leaks all over the system. Maintenance staff reported they use a significant amount of make-up water to keep the system operational year-round. Significant work and closure of the pool will be required to remedy the pool leaks.

Record ID: 1355  
 System: Z1090 - LIFE CYCLE ACTIVITIES  
 Year Installed / Industry Life / Remaining Useful Life: - / 30 / -  
 Item No.: Z1090.10.002  
 Floor/Room:  
**Priority:** 1  
 Quantity/Unit of Measure: 1/EA  
 Total Deficiency Cost: \$1,620  
 Deficiency Description: *Pool pump control system needs further investigation as there reported issues on the leaks and return water.*

Comments: *Pool flow issues noted on all return water in system mainly due to leaks.*

Description of Work: *Further investigation required to prescribe a solution.*

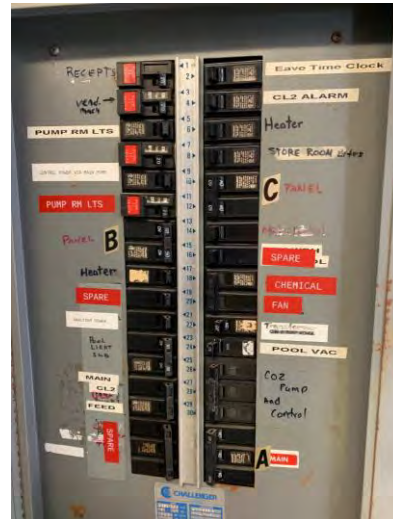
Record ID: 1356  
 System: D5020 - ELECTRICAL SERVICE AND DISTRIBUTION  
 Year Installed / Industry Life / Remaining Useful Life: 1986 / 30 / -6  
 Item No.: D5020.30.1001  
 Floor/Room: 1 / Equip  
**Priority:** 1  
 Quantity/Unit of Measure: 1/EA  
 Total Deficiency Cost: \$8,230  
 Deficiency Description: *The 100A (120/240V, 3P) panelboard is past its expected useful life.*

Description of Work: *Replace the existing panelboard with a new panelboard.*

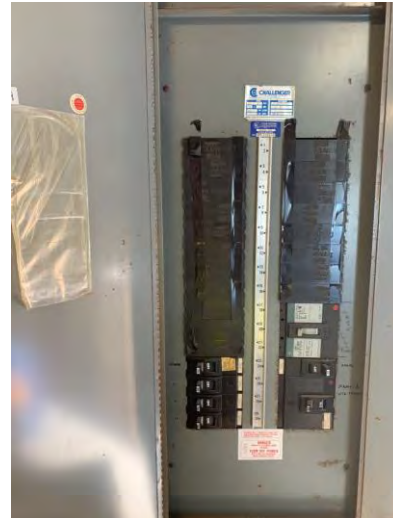
Record ID: 1358  
 System: D5020 - ELECTRICAL SERVICE AND DISTRIBUTION  
 Year Installed / Industry Life / Remaining Useful Life: 1986 / 30 / -6  
 Item No.: D5020.30.1002  
 Floor/Room: 1st / Equip  
**Priority:** 1  
 Quantity/Unit of Measure: 1/EA  
 Total Deficiency Cost: \$18,290  
 Deficiency Description: *The 225A (120/240V, 3P) panelboard is past its expected useful life.*

Description of Work: *Replace the existing panelboard with a new panelboard.*

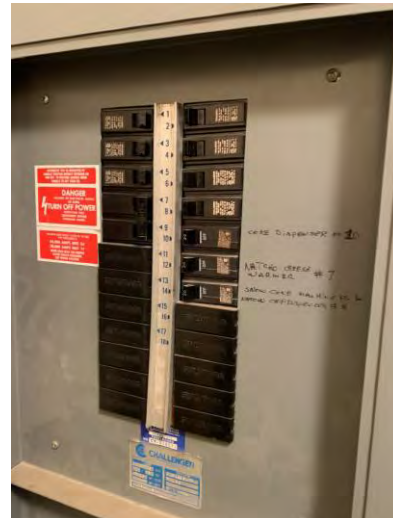
Record ID: 1363  
 System: D5020 - ELECTRICAL SERVICE AND DISTRIBUTION  
 Year Installed / Industry Life / Remaining Useful Life: 1986 / 30 / -6  
 Item No.: D5020.30.4001  
 Floor/Room: 1st / Corridor  
**Priority:** 1  
 Quantity/Unit of Measure: 1/EA  
 Total Deficiency Cost: \$4,910  
 Deficiency Description: *The load center is past its expected useful life.*

Description of Work: *Replace the existing load center with a new load center.*

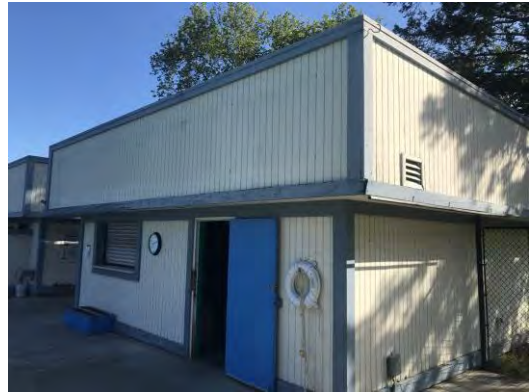
Record ID 1614  
System -  
Year Installed / Industry Life / Remaining Useful Life - / - / -  
Item No.  
Floor/Room: 1 / Exterior  
**Priority:** 5  
Quantity/Unit of Measure: 4,000/  
Total Deficiency Cost:  
Deficiency Description:

Comments: *Dry rot repairs/ fresh paint budgeted CIP Project 2019-31*

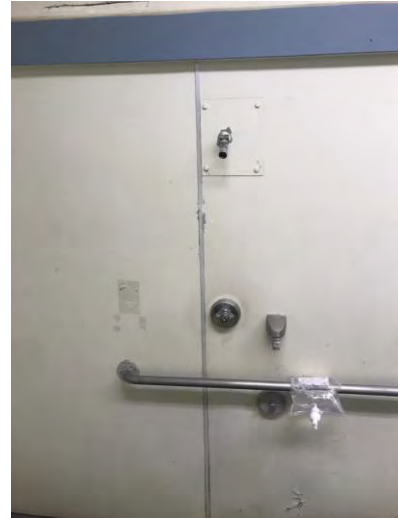
Record ID 1618  
System -  
Year Installed / Industry Life / Remaining Useful Life - / - / -  
Item No.  
Floor/Room: 1 / Men's Restroom  
**Priority:** 2  
Quantity/Unit of Measure: 1,000/  
Total Deficiency Cost:  
Deficiency Description:

Comments: *Budgeted, CIP Project No. 2019-31*

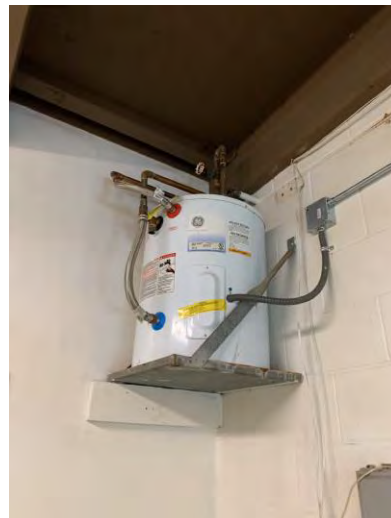
Record ID 1286  
System D2010 - DOMESTIC WATER DISTRIBUTION

Year Installed / Industry Life / Remaining Useful Life 2013 / 15 / 6  
Item No. D2010.20.021  
Floor/Room:  
**Priority: 7**  
Quantity/Unit of Measure: 1/EA  
Total Deficiency Cost: \$14,670  
Deficiency Description: *Electric water heater is approaching the end of its expected useful life.*

Description of Work: *Provide equipment replacement and installation.*

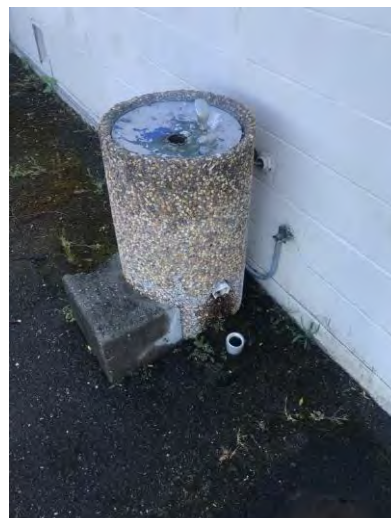
Record ID 1466  
System G3010 - WATER UTILITIES

Year Installed / Industry Life / Remaining Useful Life - / - / -  
Item No. G3010.10.006  
Floor/Room: Site / Exterior  
**Priority: 3**  
Quantity/Unit of Measure: 1/EA  
Total Deficiency Cost: \$23,180  
Deficiency Description: *Drinking fountains show evidence of heavy damage and requires replacement.*

Description of Work: *Replace stand-alone drinking fountain (ornamental or specialty fountain).*

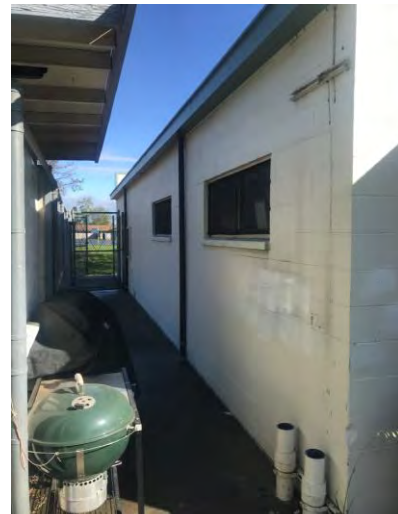
Record ID 1475  
System B2010 - EXTERIOR WALLS

The exterior finish materials consist of concrete masonry units and single-ply roofing. The exterior CMU wall finishes are beginning to show signs of wear and should be repainted. Overall, the exterior finish materials appear to be in fair condition.

Description of Work: *Clean and repaint CMU walls.*

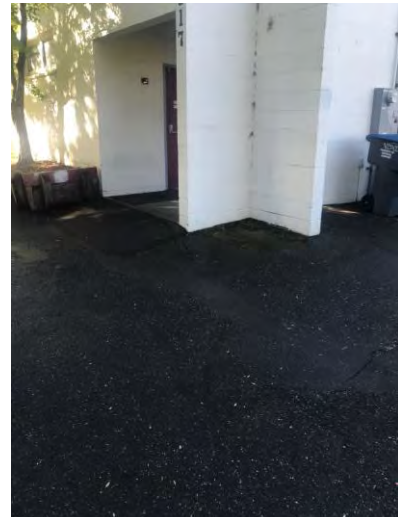
The site surfaces primarily consist of concrete-paved walkways and AC paving in the parking lot. The concrete walkways are generally in fair condition with no major deficiencies. The AC paving is showing signs of fatigue cracking throughout the entire parking lot and is recommended for replacement. Overall, the site surfaces appear to be in fair to poor condition.

Record ID: 1476  
 System: G2030 - PEDESTRIAN PLAZAS AND WALKWAYS  
 Year Installed / Industry Life / Remaining Useful Life: - / - / -  
 Item No.: G2030.10.002  
 Floor/Room: Site / AC Paving  
**Priority:** 5  
 Quantity/Unit of Measure: 3,000/SF  
 Total Deficiency Cost: \$99,310  
 Deficiency Description: *AC paving has major damage and/or structure failure.*

Description of Work: *Replace AC pavement section.*

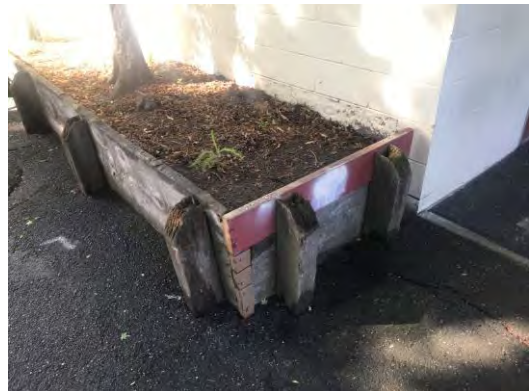
Record ID: 1477  
 System: G2080 - LANDSCAPING  
 Year Installed / Industry Life / Remaining Useful Life: - / - / -  
 Item No.: G2080.50.001  
 Floor/Room: Site / Planter  
**Priority:** 3  
 Quantity/Unit of Measure: 52/SF  
 Total Deficiency Cost: \$4,380  
 Deficiency Description: *Above-ground planter walls show evidence of damage.*

Description of Work: *Replace wood slats and posts.*

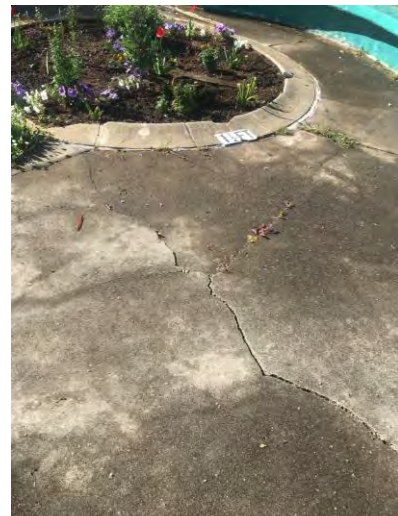
Record ID: 1478  
 System: G2030 - PEDESTRIAN PLAZAS AND WALKWAYS  
 Year Installed / Industry Life / Remaining Useful Life: - / 30 / -  
 Item No.: G2030.10.005  
 Floor/Room: Site / Concrete Pavement  
**Priority:** 3  
 Quantity/Unit of Measure: 1,500/SF  
 Total Deficiency Cost: \$56,850  
 Deficiency Description: *Concrete pavement has major damage / structural failure.*

Description of Work: *Replace concrete and base to match existing.*

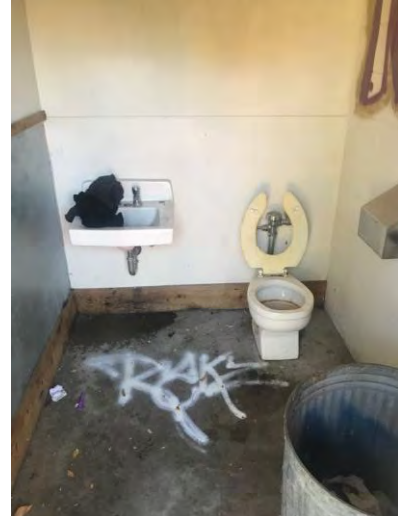
Deficiency Description: *Restroom is in poor condition and lacks accessible features.*

Description of Work: *Renovate restroom with accessible features.*

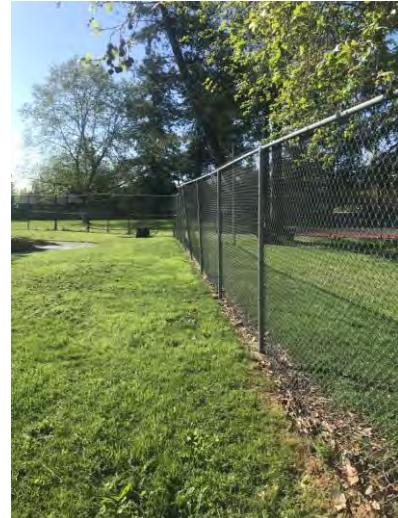
Record ID 1484  
System G2050 - ATHLETIC, RECREATIONAL, AND PLAYFIELD AREAS

Deficiency Description: *Chain link fencing is approaching the end of its useful life.*

Description of Work: *Replace chain link fencing.*

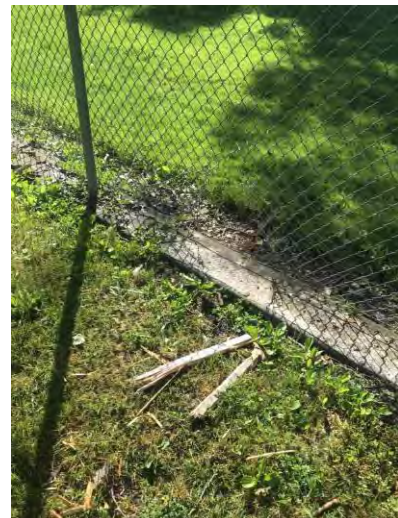
Record ID 1486  
System G2060 - SITE DEVELOPMENT

Deficiency Description: *Chain link steel mesh is damaged or missing.*

Description of Work: *Replace chain link section.*

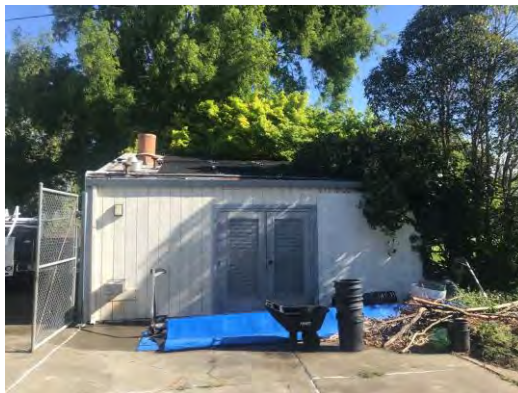
Deficiency Description: *The exterior light fixture is functional but past its expected useful life.*

Description of Work: *Replace the existing light fixture with an LED lighting fixture.*

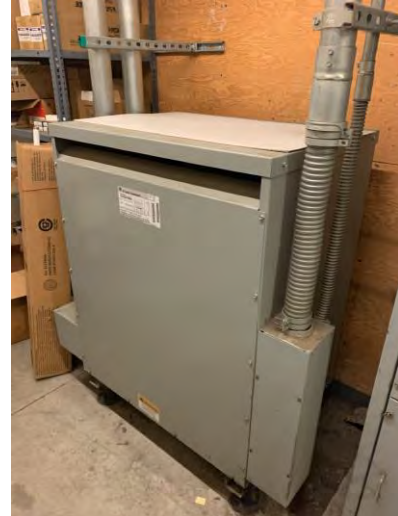
Record ID 1306  
System D5020 - ELECTRICAL SERVICE AND DISTRIBUTION  
Year Installed / Industry Life / Remaining Useful Life 2001 / 30 / 9  
Item No. D5020.10.219  
Floor/Room: 1st / Electrical  
**Priority:** 7  
Quantity/Unit of Measure: 1/EA  
Total Deficiency Cost: \$31,830  
Deficiency Description: *The 150kVA transformer (3P dry-type, 480-120/208V) is approaching the end of its expected useful life.*  
Description of Work: *Replace the existing transformer with a new transformer.*  
Comments:

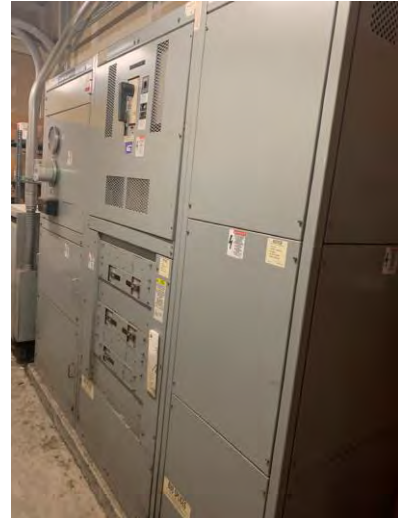
Record ID 1307  
System D5020 - ELECTRICAL SERVICE AND DISTRIBUTION  
Year Installed / Industry Life / Remaining Useful Life 2001 / 20 / -1  
Item No. D5020.10.313  
Floor/Room: 1st / Electrical  
**Priority:** 7  
Quantity/Unit of Measure: 1/EA  
Total Deficiency Cost: \$52,300  
Deficiency Description: *The 1200A metered main switchboard (3P, 277/480 ) is approaching the end of its expected useful life.*  
Description of Work: *Replace the existing metered main switchboard with a new metered main switchboard.*  
Comments:

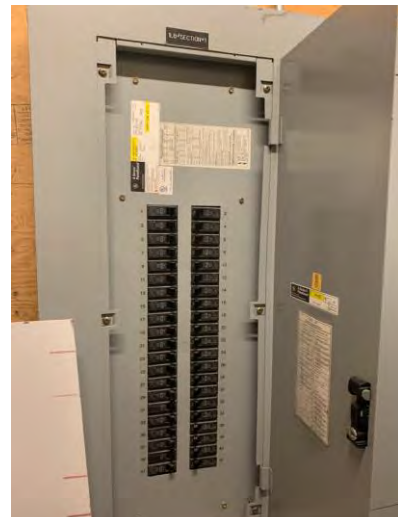
Record ID 1308  
System D5020 - ELECTRICAL SERVICE AND DISTRIBUTION  
Year Installed / Industry Life / Remaining Useful Life 2001 / 30 / 9  
Item No. D5020.30.1008  
Floor/Room: 1st / Electrical  
**Priority:** 7  
Quantity/Unit of Measure: 1/EA  
Total Deficiency Cost: \$22,870  
Deficiency Description: *The 225A (42 ccts, 120/208, 3P) panelboard is approaching the end of its expected useful life.*  
Description of Work: *Replace the existing panelboard with a new panelboard.*  
Comments:

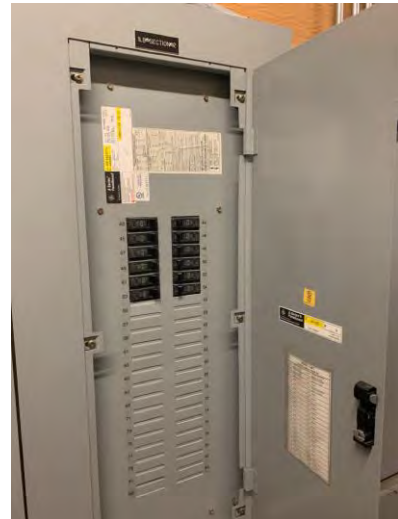
Record ID 1309  
System D5020 - ELECTRICAL SERVICE AND DISTRIBUTION  
Year Installed / Industry Life / Remaining Useful Life 2001 / 30 / 9  
Item No. D5020.30.1008  
Floor/Room: 1st / Electrical  
**Priority:** 7  
Quantity/Unit of Measure: 1/EA  
Total Deficiency Cost: \$22,870  
Deficiency Description: *The 225A (42 ckts, 120/208, 3P) panelboard is approaching the end of its expected useful life.*  
Description of Work: *Replace the existing panelboard with a new panelboard.*  
Comments:

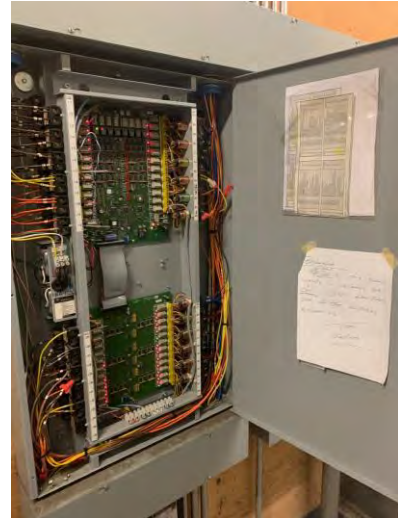
Record ID 1310  
System D5040 - LIGHTING  
Year Installed / Industry Life / Remaining Useful Life 2001 / 20 / -1  
Item No. D5040.10.003  
Floor/Room: 1st / Elec  
**Priority:** 1  
Quantity/Unit of Measure: 1/EA  
Total Deficiency Cost: \$1,140  
Deficiency Description: *The existing lighting low voltage relays and controls are at or are approaching end of their expected useful life.*  
Description of Work: *Replace the lighting control panel.*  
Comments: *Lighting controller has been faulty per onsite electrical.*

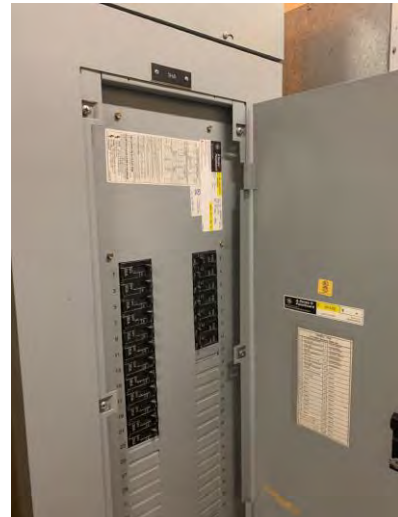
Record ID 1311  
System D5020 - ELECTRICAL SERVICE AND DISTRIBUTION  
Year Installed / Industry Life / Remaining Useful Life 2001 / 30 / 9  
Item No. D5020.30.1008  
Floor/Room: 1st / Electrical  
**Priority:** 7  
Quantity/Unit of Measure: 1/EA  
Total Deficiency Cost: \$22,870  
Deficiency Description: *The 225A (42 ckts, 120/208, 3P) panelboard is approaching the end of its expected useful life.*  
Description of Work: *Replace the existing panelboard with a new panelboard.*  
Comments:

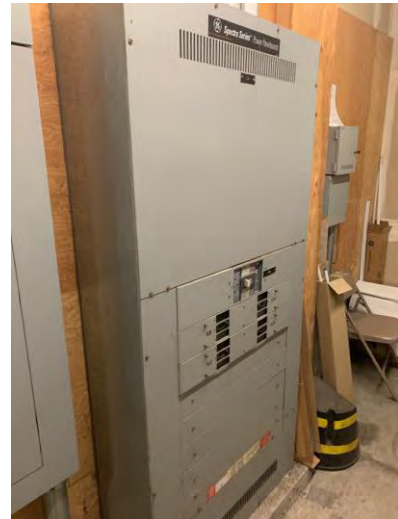
Record ID: 1312  
 System: D5020 - ELECTRICAL SERVICE AND DISTRIBUTION  
 Year Installed / Industry Life / Remaining Useful Life: 2001 / 40 / 19  
 Item No.: D5020.30.0010  
 Floor/Room: 1st / Electrical  
 Priority: 7  
 Quantity/Unit of Measure: 1/EA  
 Total Deficiency Cost: \$26,270  
 Deficiency Description: *The 600A switchboard is approaching the end of its expected useful life.*

Description of Work: *Replace the existing switchboard with a new switchboard.*

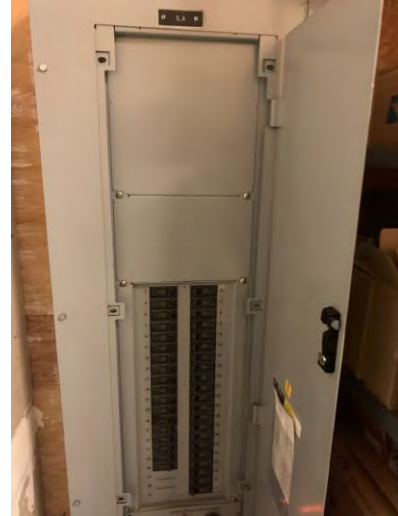
Record ID: 1314  
 System: D5020 - ELECTRICAL SERVICE AND DISTRIBUTION  
 Year Installed / Industry Life / Remaining Useful Life: 2001 / 30 / 9  
 Item No.: D5020.30.1008  
 Floor/Room: 1st / Electric  
 Priority: 7  
 Quantity/Unit of Measure: 1/EA  
 Total Deficiency Cost: \$22,870  
 Deficiency Description: *The 225A (42 ckts, 120/208, 3P) panelboard is approaching the end of its expected useful life.*

Description of Work: *Replace the existing panelboard with a new panelboard.*

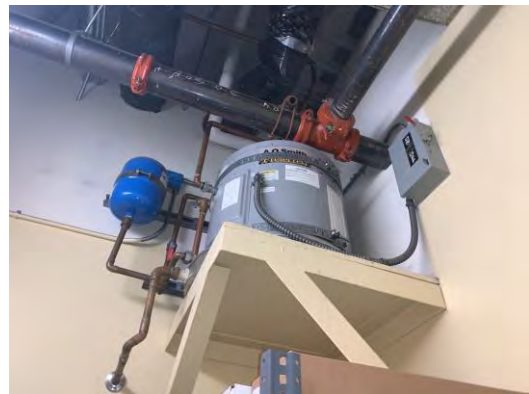
Record ID: 1315  
 System: D2010 - DOMESTIC WATER DISTRIBUTION  
 Year Installed / Industry Life / Remaining Useful Life: - / 15 / -  
 Item No.: D2010.20.021  
 Floor/Room:  
 Priority: 7  
 Quantity/Unit of Measure: 1/EA  
 Total Deficiency Cost: \$14,670  
 Deficiency Description: *Electric water heater is approaching the end of its expected useful life.*

Description of Work: *Provide equipment replacement and installation.*

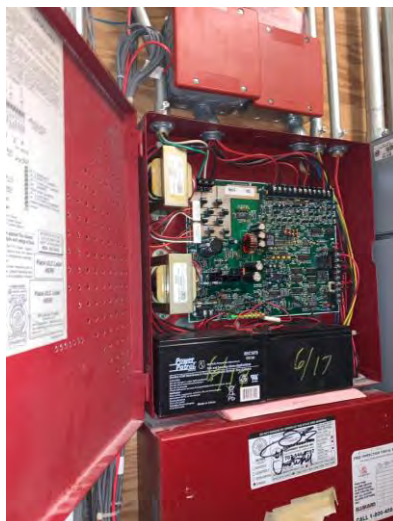
Deficiency Description: *The existing fire alarm system is past its expected useful life.*

Description of Work: *Provide a fully addressable fire alarm control panel with associated initiating and signaling devices.*

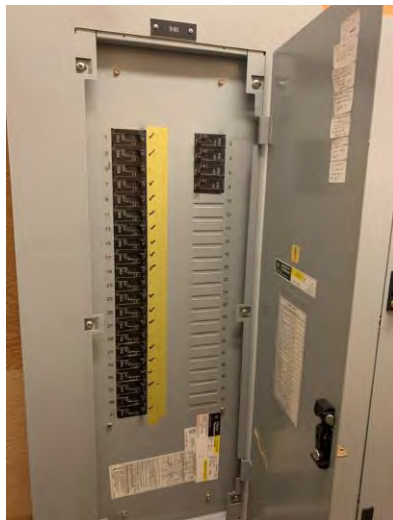
Record ID: 1318  
 System: D5020 - ELECTRICAL SERVICE AND DISTRIBUTION

Deficiency Description: *The 225A (42 ckts, 120/208, 3P) panelboard is approaching the end of its expected useful life.*

Description of Work: *Replace the existing panelboard with a new panelboard.*

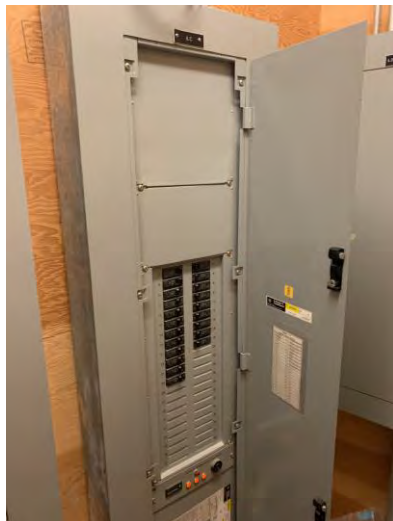
Record ID: 1319  
 System: D5020 - ELECTRICAL SERVICE AND DISTRIBUTION

Deficiency Description: *The 225A (42 ckts, 120/208, 3P) panelboard is approaching the end of its expected useful life.*

Description of Work: *Replace the existing panelboard with a new panelboard.*

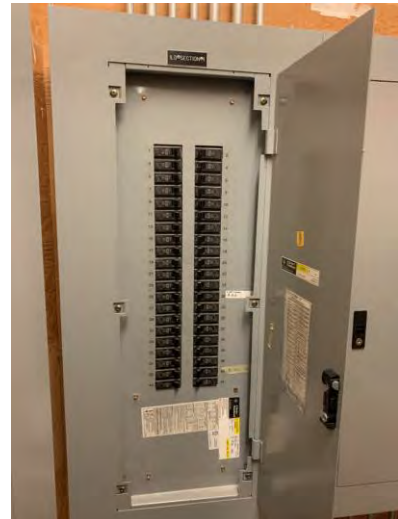
Record ID: 1320  
 System: D5020 - ELECTRICAL SERVICE AND DISTRIBUTION  
 Year Installed / Industry Life / Remaining Useful Life: 2001 / 30 / 9  
 Item No.: D5020.30.1008  
 Floor/Room: 1st / Electrical  
 Priority: 7  
 Quantity/Unit of Measure: 1/EA  
 Total Deficiency Cost: \$22,870  
 Deficiency Description: *The 225A (42 ckts, 120/208, 3P) panelboard is approaching the end of its expected useful life.*  
 Description of Work: *Replace the existing panelboard with a new panelboard.*  
 Comments:

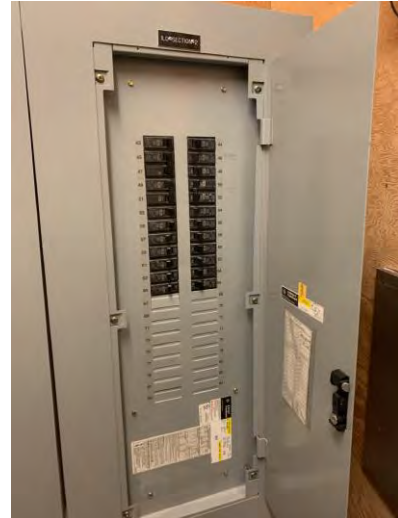
Record ID: 1321  
 System: D5020 - ELECTRICAL SERVICE AND DISTRIBUTION  
 Year Installed / Industry Life / Remaining Useful Life: 2001 / 30 / 9  
 Item No.: D5020.30.1008  
 Floor/Room: 1st / Electrical  
 Priority: 7  
 Quantity/Unit of Measure: 1/EA  
 Total Deficiency Cost: \$22,870  
 Deficiency Description: *The 225A (42 ckts, 120/208, 3P) panelboard is approaching the end of its expected useful life.*  
 Description of Work: *Replace the existing panelboard with a new panelboard.*  
 Comments: *Good condition.*

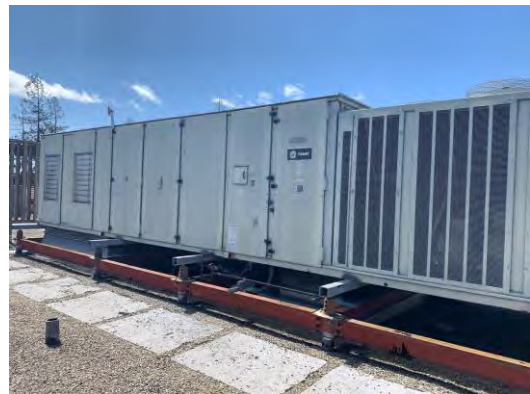
Overall, the key issues identified by Sonoma County Library maintenance is the air handling unit outside air sensor has not worked as intended and consistently registers too high for proper usage. The VAV's and VAV valves were also reported to begin failing as they are at the end of their expected useful life. Maintenance staff has been replacing them as they have failed, but complete replacement is recommended to get ahead of unscheduled maintenance.

Record ID: 1322  
 System: D3050 - FACILITY HVAC DISTRIBUTION SYSTEMS  
 Year Installed / Industry Life / Remaining Useful Life: - / 30 / -  
 Item No.: D3050.50.006  
 Floor/Room:  
 Priority: 7  
 Quantity/Unit of Measure: 1/EA  
 Total Deficiency Cost: \$88,970  
 Deficiency Description: *Air handler is approaching the end of its expected useful life.*  
 Description of Work: *Provide equipment replacement and installation.*  
 Comments: *R-22. OSA sensor not working and will need to be replaced to bring proper use of the system. Recommend to address replacement of sensor.*

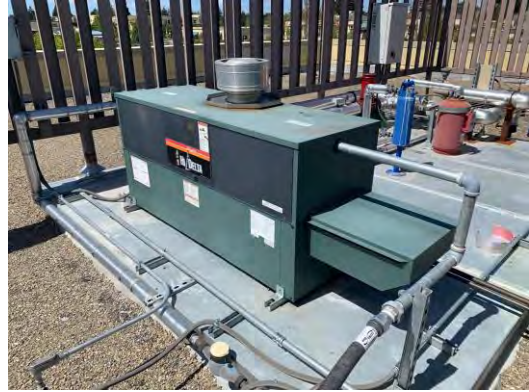
Deficiency Description: *Boiler is approaching the end of its expected useful life.*

Comments: *Error upon inspection.*

Description of Work: *Provide equipment replacement and installation.*

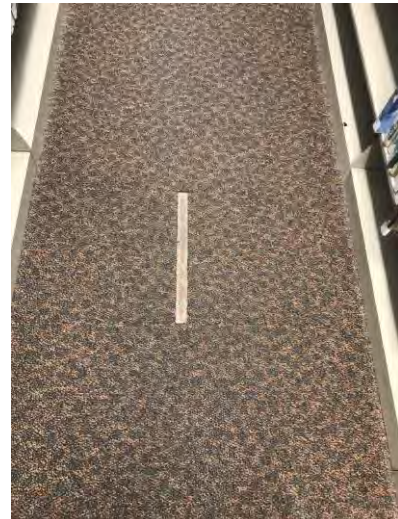
Record ID: 1544  
System: C2030 - FLOORING

Year Installed / Industry Life / Remaining Useful Life: - / 20 / -  
Item No.: C2030.75.001  
Floor/Room: 1 / Library  
**Priority:** 3  
Quantity/Unit of Measure: 5,000/SF  
Total Deficiency Cost: \$140,300  
Deficiency Description: *Carpet tile is showing signs of wear.*

Description of Work: *Replace carpet tile.*

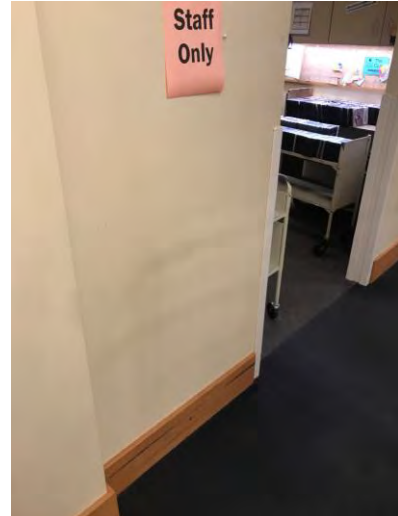
Record ID: 1545  
System: C2010 - WALL FINISHES

Year Installed / Industry Life / Remaining Useful Life: - / 30 / -  
Item No.: C2010.70.001  
Floor/Room: 1 / Library  
**Priority:** 3  
Quantity/Unit of Measure: 100/SF  
Total Deficiency Cost: \$2,210  
Deficiency Description: *Painted gypsum wallboard is showing signs of wear.*

Description of Work: *Patch and paint the gypsum wallboard.*

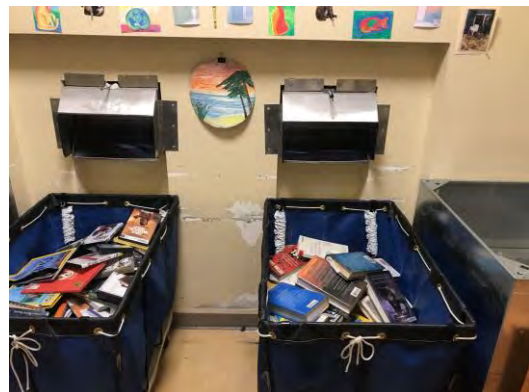
Record ID: 1546  
System: C2010 - WALL FINISHES

Year Installed / Industry Life / Remaining Useful Life: - / 30 / -  
Item No.: C2010.70.001  
Floor/Room: 1 / Book Room  
**Priority:** 3  
Quantity/Unit of Measure: 300/SF  
Total Deficiency Cost: \$6,590  
Deficiency Description: *Painted gypsum wallboard is showing signs of wear.*

Description of Work: *Patch and paint the gypsum wallboard.*

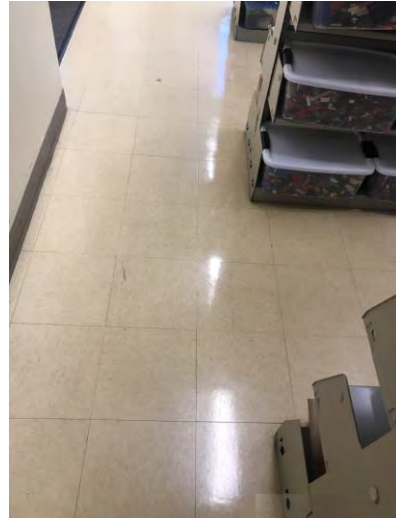
Record ID 1548  
System C2030 - FLOORING  
Year Installed / Industry Life / Remaining Useful Life - / 60 / -  
Item No. C2030.50.001  
Floor/Room: 1 / Work Storage  
**Priority:** 3  
Quantity/Unit of Measure: 300/SF  
Total Deficiency Cost: \$7,920  
Deficiency Description: *Vinyl composition tile is approaching the end of its useful life.*

Description of Work: *Remove the existing vinyl composition tile and replace.*

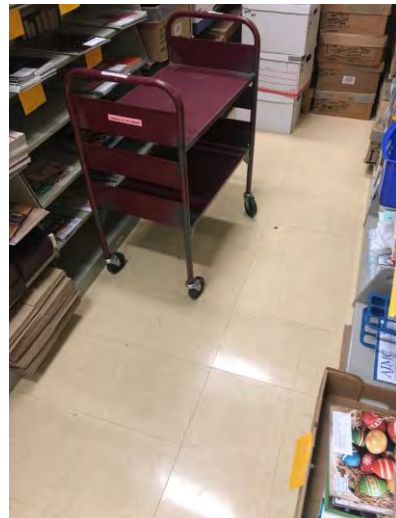
Record ID 1549  
System C2030 - FLOORING  
Year Installed / Industry Life / Remaining Useful Life - / 60 / -  
Item No. C2030.50.001  
Floor/Room: 1 / Work Storage  
**Priority:** 3  
Quantity/Unit of Measure: 1,000/SF  
Total Deficiency Cost: \$26,330  
Deficiency Description: *Vinyl composition tile is approaching the end of its useful life.*

Description of Work: *Remove the existing vinyl composition tile and replace.*

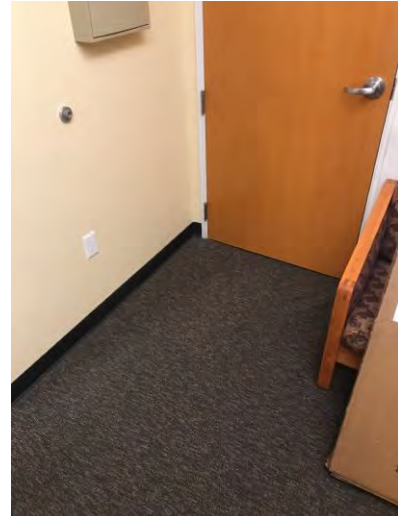
Record ID 1553  
System C2030 - FLOORING

Deficiency Description: *Carpet tile is showing signs of wear.*

Description of Work: *Replace carpet tile.*

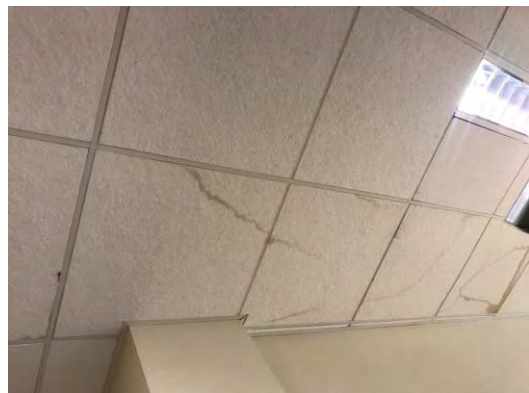
Record ID 1554  
System C2050 - CEILING FINISHES

Deficiency Description: *Lay-in Acoustical Tile is in poor condition.*

Description of Work: *Remove existing lay-in Acoustical Tiles and replace with new lay-in Acoustical Tiles.*

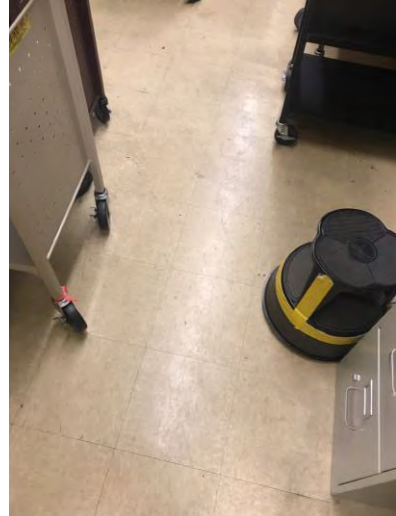
Deficiency Description: *Vinyl composition tile is approaching the end of its useful life.*

Description of Work: *Remove the existing vinyl composition tile and replace.*

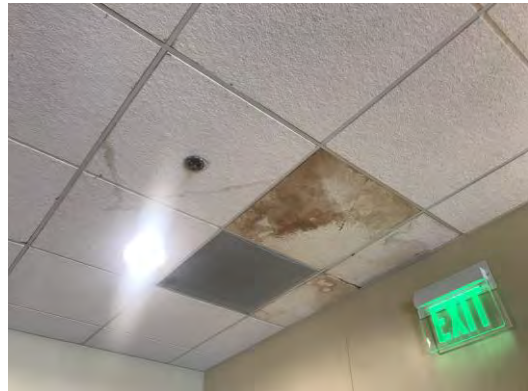
Record ID 1558  
System C2050 - CEILING FINISHES

Deficiency Description: *Lay-in Acoustical Tile is in poor condition.*

Description of Work: *Remove existing lay-in Acoustical Tiles and replace with new lay-in Acoustical Tiles.*

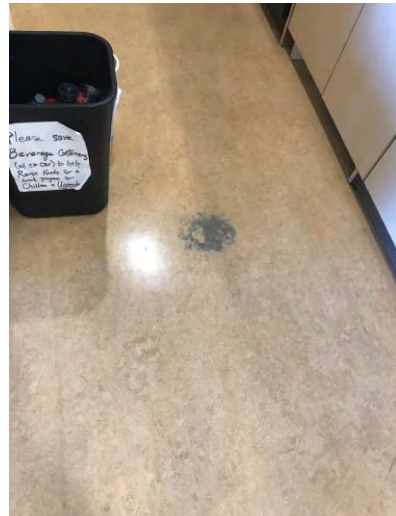
Record ID 1559  
System C2030 - FLOORING

Deficiency Description: *Sheet vinyl is approaching the end of its useful life.*

Description of Work: *Remove the existing sheet vinyl and replace.*

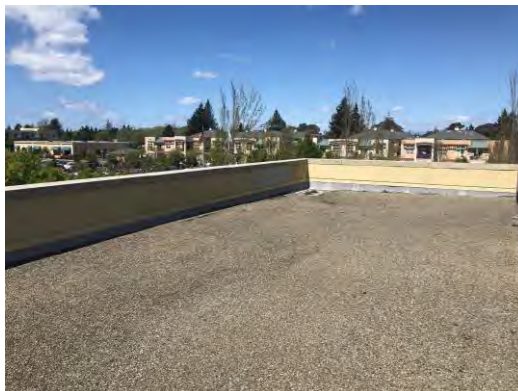
Item No.: B3010.50.001  
 Floor/Room: Roof  
**Priority:** 7

Quantity/Unit of Measure: 14,500/SF  
 Total Deficiency Cost: \$859,780  
 Deficiency Description: *Built-up roofing is beyond its expected useful service life and needs replacement.*

Description of Work: *Remove and replace built-up roofing.*

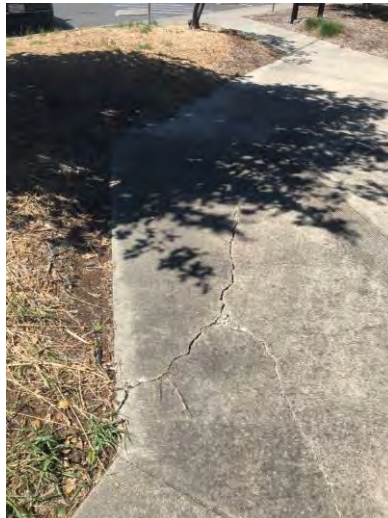
Item No.: G2030.10.005  
 Floor/Room: Site / Pavement  
**Priority:** 1

Quantity/Unit of Measure: 100/SF  
 Total Deficiency Cost: \$3,480  
 Deficiency Description: *Concrete pavement has major damage / structural failure.*

Description of Work: *Replace concrete and base to match existing.*

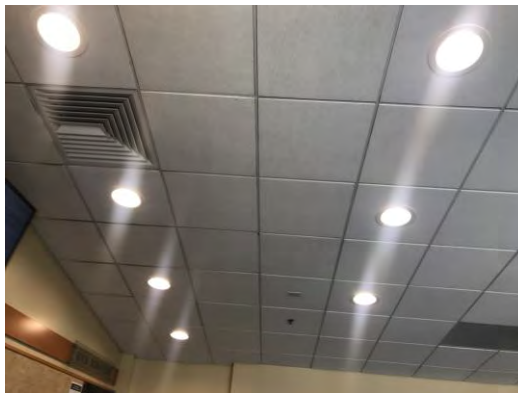
Deficiency Description: *Interior lighting system is operational but past its expected useful life.*

Comments: *Interior lighting in good condition.*

Description of Work: *Provide new interior lighting and control system throughout building per current CEC T24 code.*

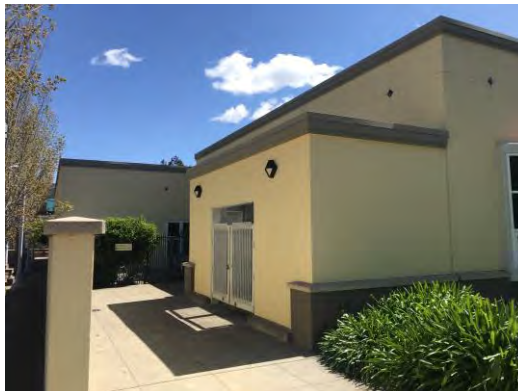
Record ID: 1756  
System: D5040 - LIGHTING

Deficiency Description: *The exterior light fixture is operational but past its expected useful life.*

Comments: *Exterior lighting in good condition.*

Description of Work: *Replace the existing light fixture with an LED lighting fixture.*

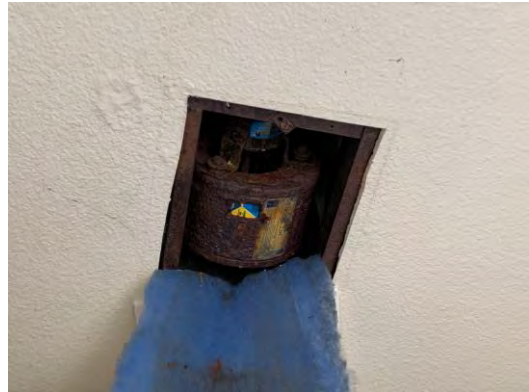
Quantity/Unit of Measure: 1/EA  
Total Deficiency Cost: \$2,260  
Deficiency Description: *Ceiling exhaust fan is approaching the end of its expected useful life.*

Comments: *Corroded due to addition of acid into room not designed for acid.*

Description of Work: *Provide equipment replacement and installation.*

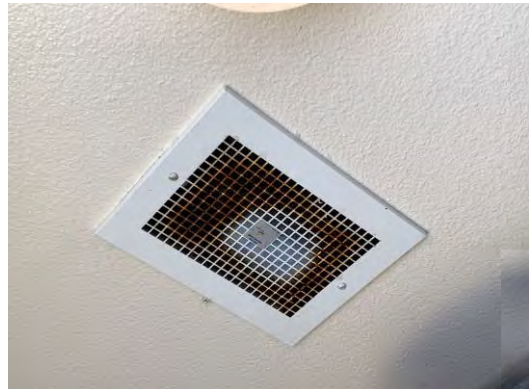
Record ID 1368  
System D3060 - VENTILATION

Quantity/Unit of Measure: 1/EA  
Total Deficiency Cost: \$2,260  
Deficiency Description: *Exhaust fan is damaged due to condition of room.*

Description of Work: *Provide appropriate replacement resistant to conditions within the space.*

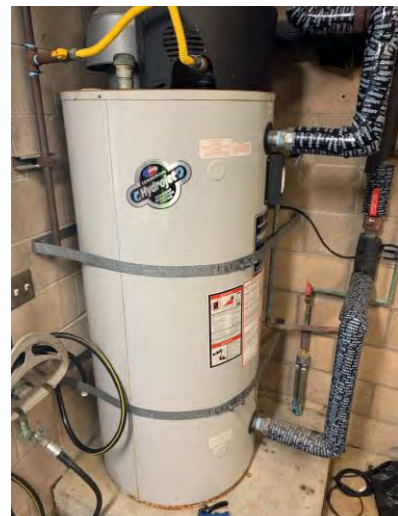
Record ID 1369  
System D2010 - DOMESTIC WATER DISTRIBUTION

Quantity/Unit of Measure: 1/EA  
Total Deficiency Cost: \$30,570  
Deficiency Description: *Gas fired water heater is approaching the end of its expected useful life.*

Description of Work: *Provide equipment replacement and installation.*

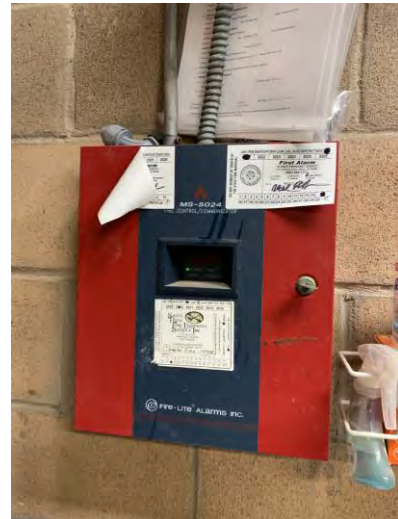
Deficiency Description: *The existing fire alarm system is at the end of its industry rated useful life.*

Description of Work: *Provide a new fully addressable fire alarm control panel with associated initiating and signaling devices.*

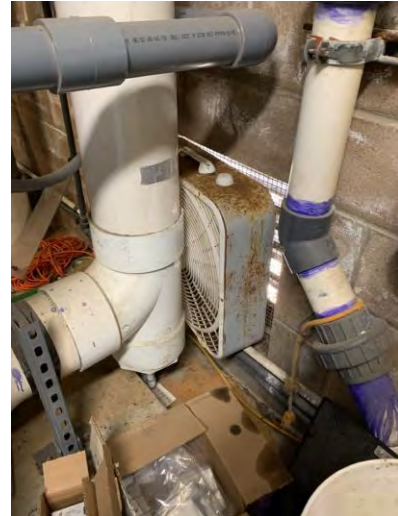
Record ID: 1373  
 System: D3060 - VENTILATION

Deficiency Description: *Sidewall propeller fan is approaching the end of its expected useful life.*

Comments: *Ventilation issues evident. Need to add active ventilation. Box fan is inadequate for operation and is deteriorating due to significant moisture.*

Description of Work: *Provide equipment replacement and installation.*

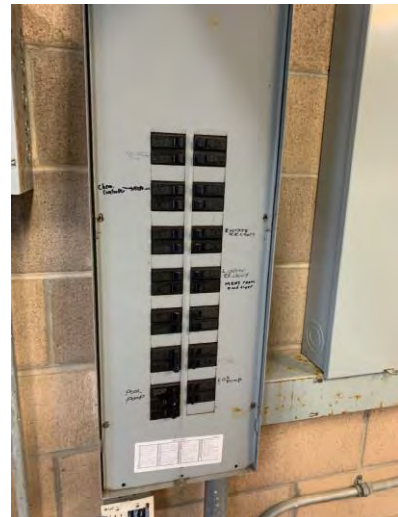
Record ID: 1377  
 System: D5020 - ELECTRICAL SERVICE AND DISTRIBUTION

Deficiency Description: *The 200A (24 ckts, indoor, 1P) load center is approaching the end of its expected useful life.*

Description of Work: *Replace the existing load center with a new load center.*

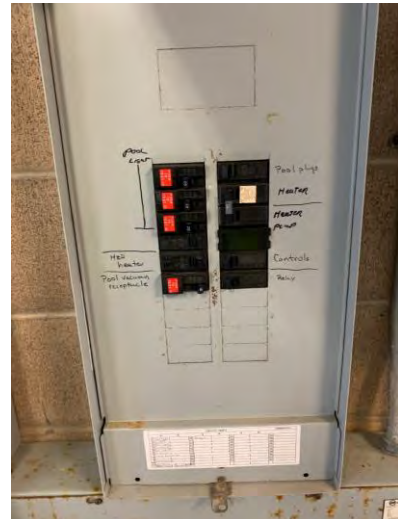
Record ID: 1378  
 System: D5020 - ELECTRICAL SERVICE AND DISTRIBUTION  
 Year Installed / Industry Life / Remaining Useful Life: 2001 / 30 / 9  
 Item No.: D5020.30.4002  
 Floor/Room: 1st  
**Priority:** 7  
 Quantity/Unit of Measure: 1/EA  
 Total Deficiency Cost: \$7,520  
 Deficiency Description: *The 200A (24 ckts, indoor, 1P) load center is approaching the end of its expected useful life.*  
 Description of Work: *Replace the existing load center with a new load center.*  
 Comments:

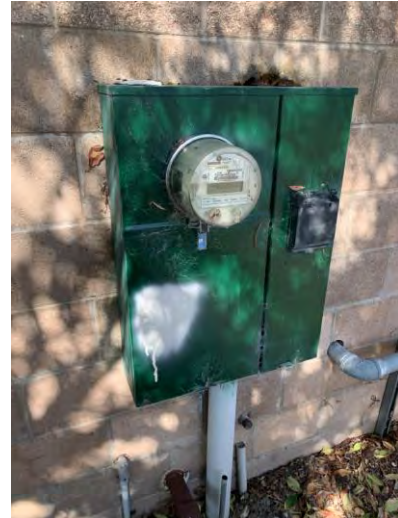
Record ID: 1380  
 System: D5020 - ELECTRICAL SERVICE AND DISTRIBUTION  
 Year Installed / Industry Life / Remaining Useful Life: 2001 / 30 / 9  
 Item No.: D5020.10.002  
 Floor/Room: 1st / Site  
**Priority:** 7  
 Quantity/Unit of Measure: 1/EA  
 Total Deficiency Cost: \$34,120  
 Deficiency Description: *The 200A (120/240V, 1P) all-in-one combination service entrance device is approaching the end of its expected useful life.*  
 Description of Work: *Replace the existing all-in-one combination service entrance device with a new all-in-one combination service entrance device.*  
 Comments:

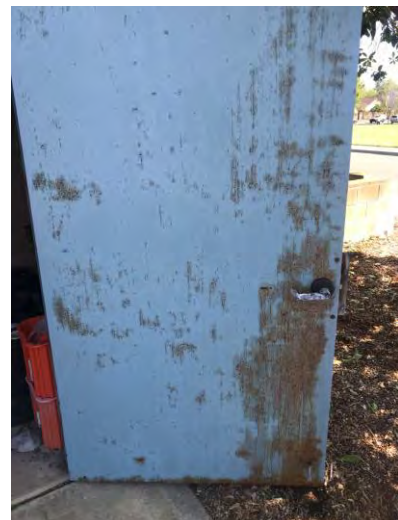
Record ID: 1622  
 System: B2050 - EXTERIOR DOORS AND GRILLES  
 Year Installed / Industry Life / Remaining Useful Life: - / 15 / -  
 Item No.: B2050.20.001  
 Floor/Room: 1  
**Priority:** 2  
 Quantity/Unit of Measure: 1/EA  
 Total Deficiency Cost: \$11,780  
 Deficiency Description: *The exterior door is approaching the end of its useful life.*  
 Description of Work: *Replace the door.*  
 Comments:

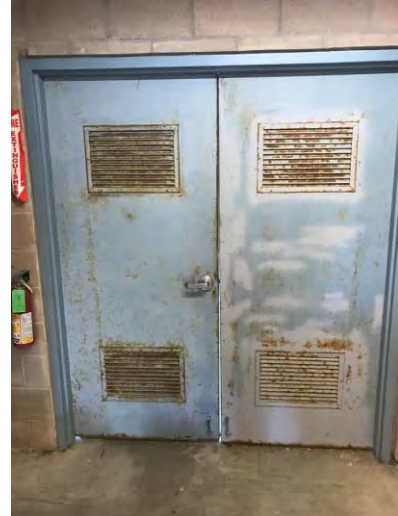
Deficiency Description: *The exterior door is approaching the end of its useful life.*

Description of Work: *Replace the door.*

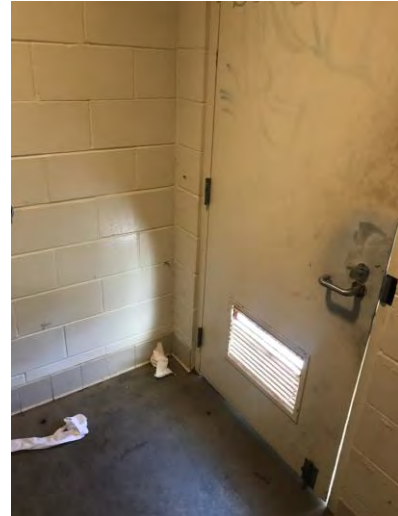
Record ID 1624  
System B2050 - EXTERIOR DOORS AND GRILLES

Deficiency Description: *The exterior door is approaching the end of its useful life.*

Description of Work: *Replace the door.*

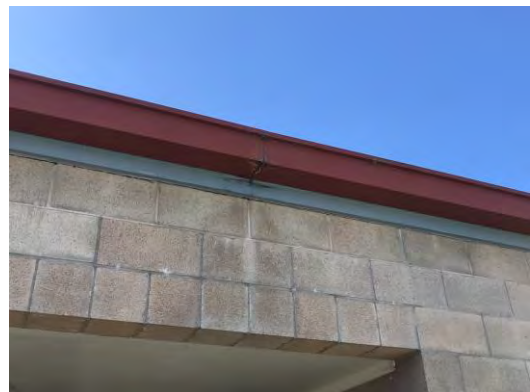
Record ID 1625  
System B2010 - EXTERIOR WALLS

The exterior concrete masonry unit (CMU) walls show signs of efflorescence likely due to moisture intrusion. It is recommended the exterior CMU surfaces are cleaned. Further investigation is recommended to determine the source of efflorescence.

Deficiency Description: *CMU walls are showing signs of water penetration.*

Comments: *CMU walls show signs of water penetration and efflorescence.*

Description of Work: *Clean CMU walls.*

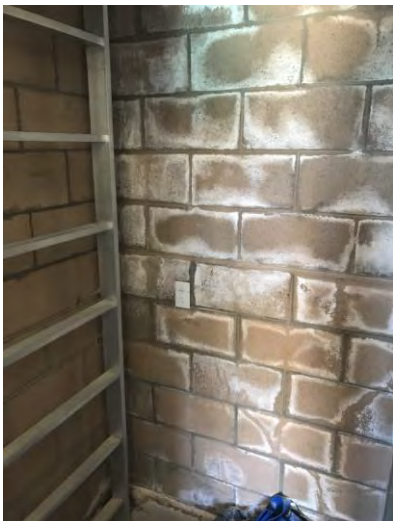
Record ID: 1626  
System: B2010 - EXTERIOR WALLS

Year Installed / Industry Life / Remaining Useful Life: - / 50 / -  
Item No.: B2010.20.005  
Floor/Room: / Office  
**Priority:** 2  
Quantity/Unit of Measure: 800/SF  
Total Deficiency Cost: \$6,730  
Deficiency Description: *CMU walls are showing signs of water penetration.*

Comments: *CMU walls show signs of water penetration and efflorescence.*

Description of Work: *Clean CMU walls.*

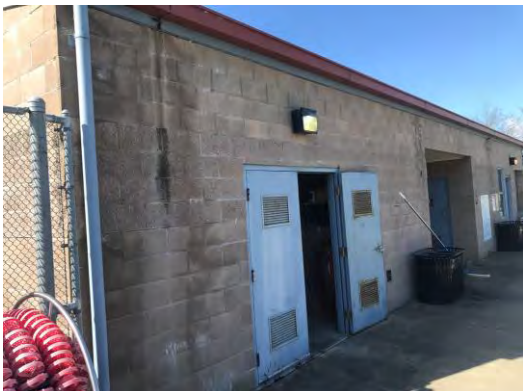
Record ID: 1757  
System: D5040 - LIGHTING

Year Installed / Industry Life / Remaining Useful Life: 2001 / 20 / -1  
Item No.: D5040.50.302  
Floor/Room:  
**Priority:** 1  
Quantity/Unit of Measure: 8/EA  
Total Deficiency Cost: \$18,190  
Deficiency Description: *The exterior light fixture is past its expected useful life.*

Comments: *Exterior lighting on during day.*

Description of Work: *Replace the existing light fixture with an LED lighting fixture.*

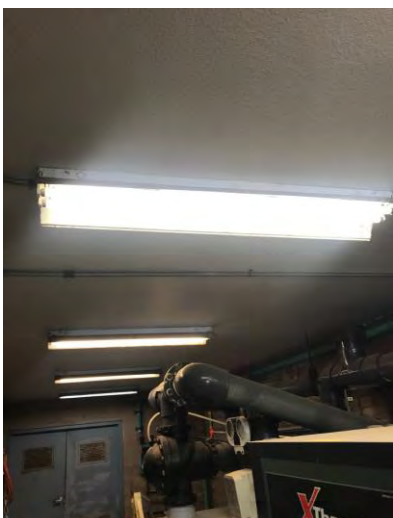
Record ID: 1758  
System: D5040 - LIGHTING

Year Installed / Industry Life / Remaining Useful Life: 2001 / 20 / -1  
Item No.: D5040.50.411  
Floor/Room:  
**Priority:** 1  
Quantity/Unit of Measure: 2,551/SF  
Total Deficiency Cost: \$145,980  
Deficiency Description: *Interior lighting system is past its expected useful life.*

Description of Work: *Provide new interior lighting and control system throughout building per current CEC T24 code.*

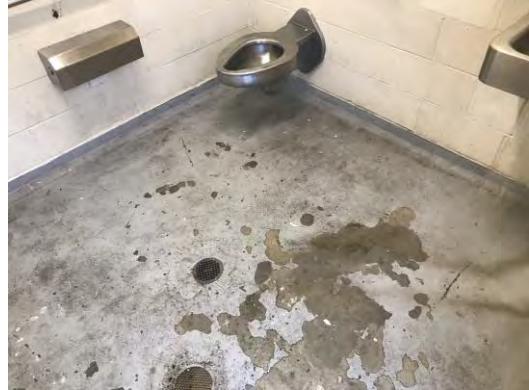
Year Installed / Industry Life / Remaining Useful Life - / 40 / -  
Item No. C2030.10.002  
Floor/Room: 1 / Restroom  
**Priority: 2**  
Quantity/Unit of Measure: 100/SF  
Total Deficiency Cost: \$5,060  
Deficiency Description: *Epoxy is approaching the end of its useful life.*

Description of Work: *Remove the existing epoxy and replace.*
