# City of Rohnert Park

## Facility Condition Assessment

Final Report

October 17, 2022

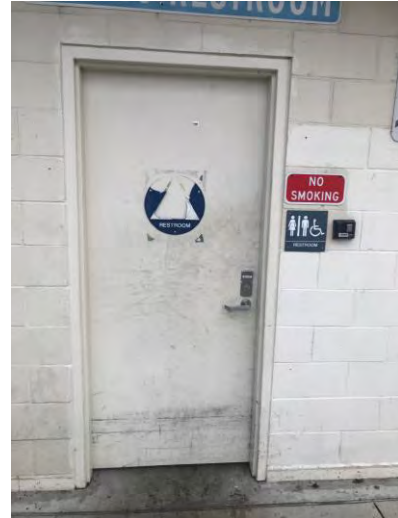
Record ID 190  
System C1030 - INTERIOR DOORS

Year Installed / Industry Life / Remaining Useful Life - / 60 / -  
Item No. C1030.90.003  
Floor/Room: 1 / Exterior  
**Priority: 3**  
Quantity/Unit of Measure: 2/EA  
Total Deficiency Cost: \$1,780  
Deficiency Description: *Metal door and frame are in fair to poor condition.*

Description of Work: *Repair and refinish the metal door and frame.*

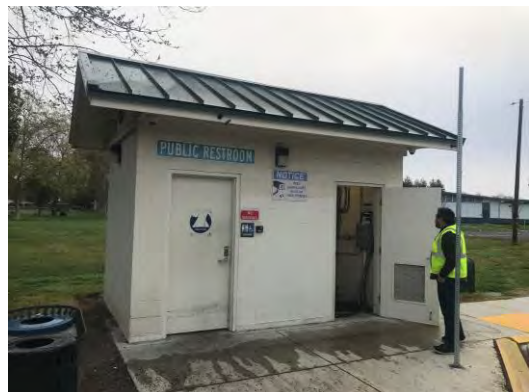
Record ID 192  
System B2010 - EXTERIOR WALLS

Year Installed / Industry Life / Remaining Useful Life - / 50 / -  
Item No. B2010.20.005  
Floor/Room: 1 / Exterior  
**Priority: 3**  
Quantity/Unit of Measure: 800/SF  
Total Deficiency Cost: \$7,030  
Deficiency Description: *CMU walls are showing signs of wear.*

Description of Work: *Clean and repaint CMU walls.*

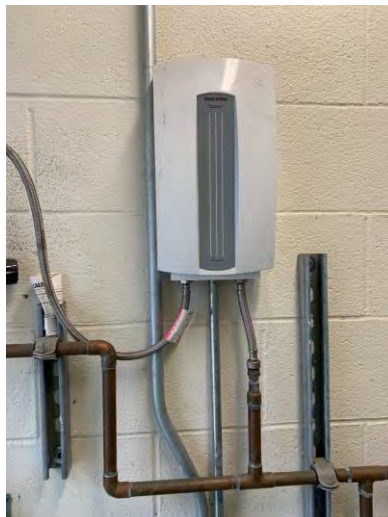
Deficiency Description: *Electric water heater is approaching the end of its expected useful life.*

Description of Work: *Provide equipment replacement and installation.*

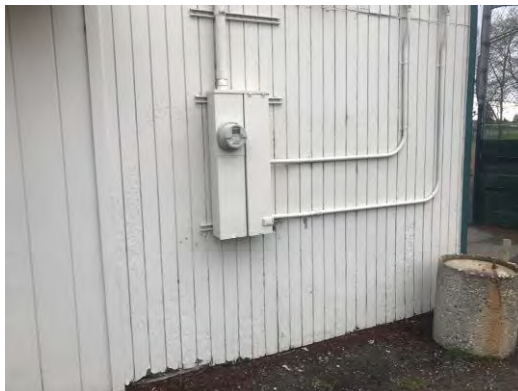
Record ID 197  
System D5020 - ELECTRICAL SERVICE AND DISTRIBUTION  
Year Installed / Industry Life / Remaining Useful Life 1992 / 30 / 0  
Item No. D5020.10.001  
Floor/Room: 1 / Exterior  
**Priority: 1**  
Quantity/Unit of Measure: 1/EA  
Total Deficiency Cost: \$8,230  
Deficiency Description: *The all-in-one combination service entrance device is past its expected useful life.*  
Description of Work: *Replace the existing all-in-one combination service entrance device with a new all-in-one combination service entrance device.*  
Comments:

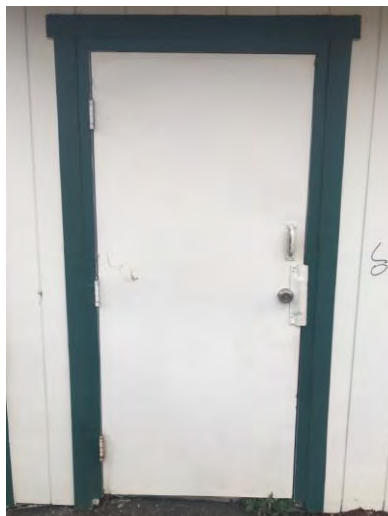
Record ID 200  
System B2050 - EXTERIOR DOORS AND GRILLES  
Year Installed / Industry Life / Remaining Useful Life - / 75 / -  
Item No. B2050.10.001  
Floor/Room: 1 / Exterior  
**Priority: 2**  
Quantity/Unit of Measure: 1/EA  
Total Deficiency Cost: \$8,420  
Deficiency Description: *Exterior entrance door is approaching the end of its useful life.*  
Description of Work: *Replace exterior door.*  
Comments:

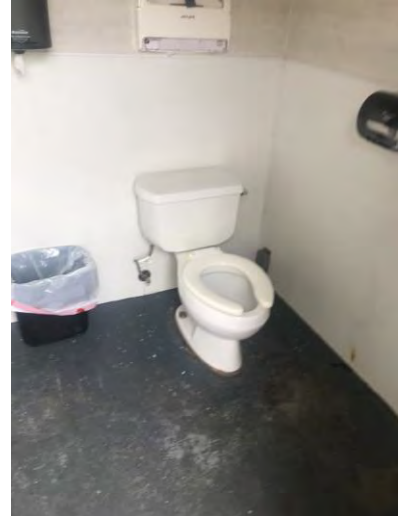
Record ID: 1659  
 System: C2030 - FLOORING  
 Year Installed / Industry Life / Remaining Useful Life: - / 40 / -  
 Item No.: C2030.10.002  
 Floor/Room: 1 / Restroom  
**Priority: 3**  
 Quantity/Unit of Measure: 100/SF  
 Total Deficiency Cost: \$5,280  
 Deficiency Description: *Epoxy is approaching the end of its useful life.*

Description of Work: *Remove the existing epoxy and replace.*

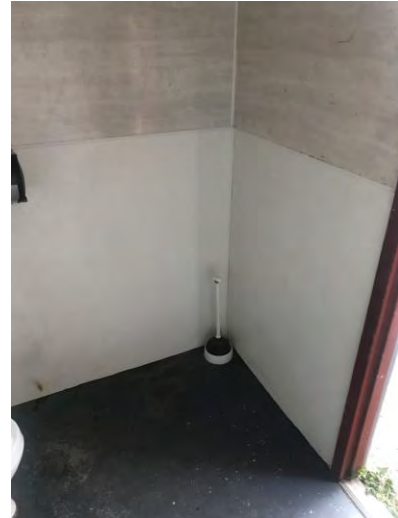
Record ID: 1732  
 System: C2010 - WALL FINISHES  
 Year Installed / Industry Life / Remaining Useful Life: - / 20 / -  
 Item No.: C2010.20.003  
 Floor/Room: 1 / Restroom  
**Priority: 1**  
 Quantity/Unit of Measure: 100/SF  
 Total Deficiency Cost: \$1,960  
 Deficiency Description: *Fiberglass reinforced paneling is at or approaching the end of its useful life.*

Description of Work: *Install and replace the fiberglass reinforced paneling.*

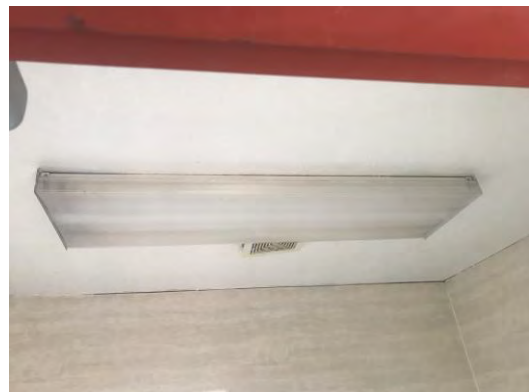
Record ID: 1759  
 System: D5040 - LIGHTING  
 Year Installed / Industry Life / Remaining Useful Life: 1992 / 20 / -10  
 Item No.: D5040.50.411  
 Floor/Room: 1 / Interior  
**Priority: 1**  
 Quantity/Unit of Measure: 272/SF  
 Total Deficiency Cost: \$15,590  
 Deficiency Description: *Interior lighting system is past its expected useful life.*

Description of Work: *Provide new interior lighting and control system throughout building per current CEC T24 code.*

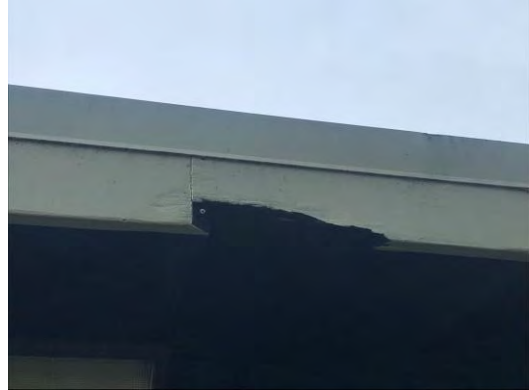
Record ID: 202  
System: B3010 - ROOFING  
Year Installed / Industry Life / Remaining Useful Life: - / 20 / -  
Item No.: B3010.90.010  
Floor/Room: 1 / Exterior  
**Priority:** 2  
Quantity/Unit of Measure: 10/LF  
Total Deficiency Cost: \$360  
Deficiency Description: *The 2' fascia is appears deteriorated.*

Description of Work: *Selectively remove deteriorated fascia and replace with new material to match.*

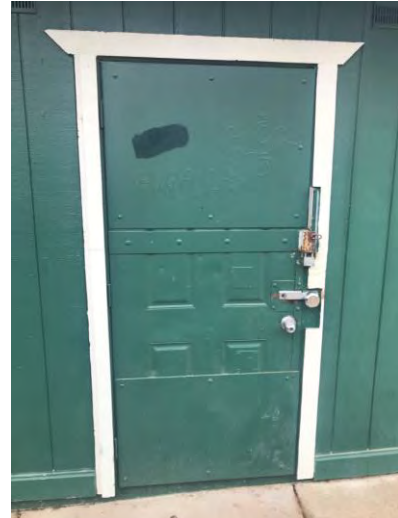
Record ID: 203  
System: B2050 - EXTERIOR DOORS AND GRILLES  
Year Installed / Industry Life / Remaining Useful Life: - / 15 / -  
Item No.: B2050.20.003  
Floor/Room: 1 / Exterior  
**Priority:** 3  
Quantity/Unit of Measure: 1/EA  
Total Deficiency Cost: \$12,300  
Deficiency Description: *Exterior doors, frames and hardware are approaching the end of their useful life.*

Description of Work: *Replace the exterior doors, frames and hardware.*

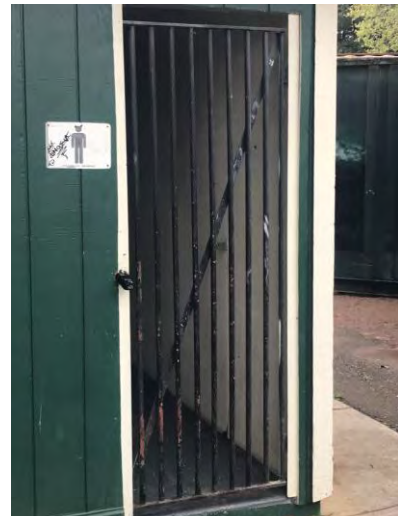
Record ID: 204  
System: B2050 - EXTERIOR DOORS AND GRILLES  
Year Installed / Industry Life / Remaining Useful Life: - / - / -  
Item No.: B2050.70.001  
Floor/Room: 1 / Exterior  
**Priority:** 3  
Quantity/Unit of Measure: 2/LS  
Total Deficiency Cost: \$10,550  
Deficiency Description: *Existing gate is at or approaching the end of its useful life.*

Description of Work: *Install a new gate and associated gate hardware.*

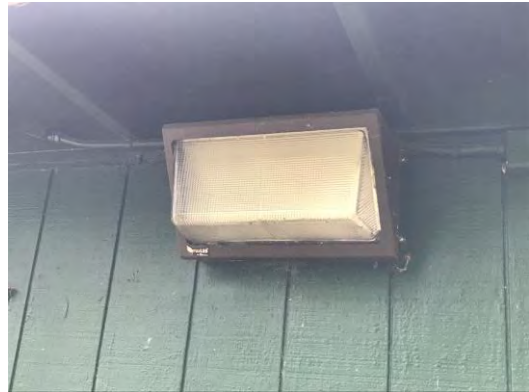
Year Installed / Industry Life / Remaining Useful Life: 2010 / 20 / 8  
Item No.: D5040.50.302  
Floor/Room: 1 / Exterior  
**Priority:** 1  
Quantity/Unit of Measure: 3/EA  
Total Deficiency Cost: \$6,830  
Deficiency Description: *The exterior light fixture is LED type.*

Comments: *Appears to be retrofit.*

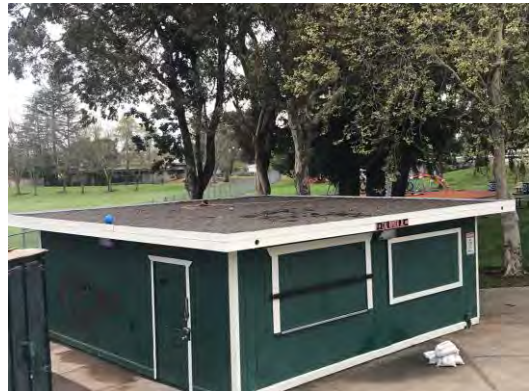
Year Installed / Industry Life / Remaining Useful Life: - / 30 / -  
Item No.: B3010.50.001  
Floor/Room: Roof / Exterior  
**Priority:** 5  
Quantity/Unit of Measure: 600/SF  
Total Deficiency Cost: \$34,280  
Deficiency Description: *Built-up roofing is beyond its expected useful service life and needs replacement.*

Description of Work: *Remove and replace built-up roofing.*

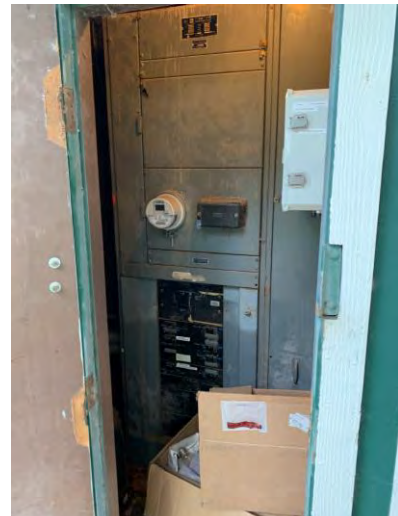
Year Installed / Industry Life / Remaining Useful Life: 1977 / 20 / -25  
Item No.: D5020.10.303  
Floor/Room: 1 / Exterior  
**Priority:** 1  
Quantity/Unit of Measure: 1/EA  
Total Deficiency Cost: \$17,750  
Deficiency Description: *The 600A metered main switchboard is past its expected useful life.*

Comments: *Signs of Rust on equipment.*

Description of Work: *Replace the existing metered main switchboard with a new metered main switchboard.*

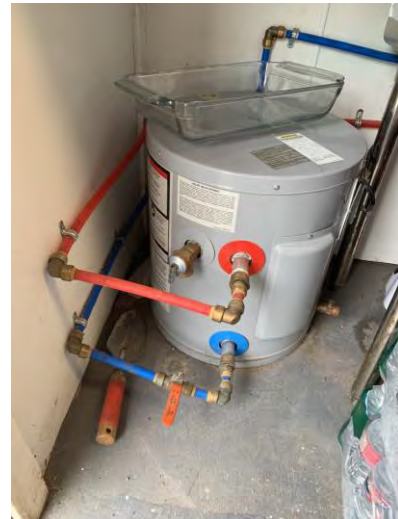
Deficiency Description: *Electric water heater is approaching the end of its expected useful life.*

Comments: *Heavy sulfur smell from water heater*

Description of Work: *Provide equipment replacement and installation.*

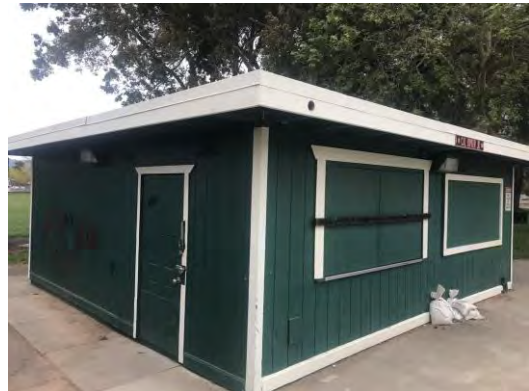
Deficiency Description: *Plywood siding is approaching the end of its useful life.*

Description of Work: *Remove and replace the existing plywood siding with new plywood siding. Prime and paint.*

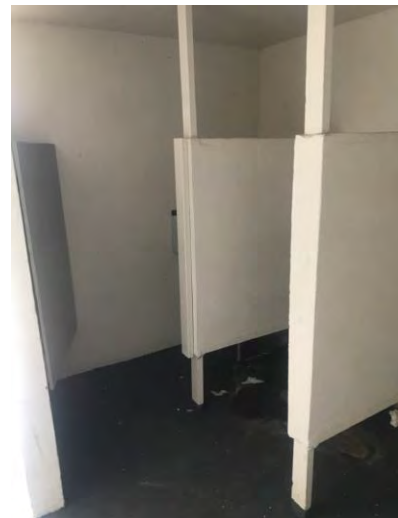
Deficiency Description: *Restrooms are not accessible and in old condition.*

Description of Work: *Renovate restroom with accessible features.*

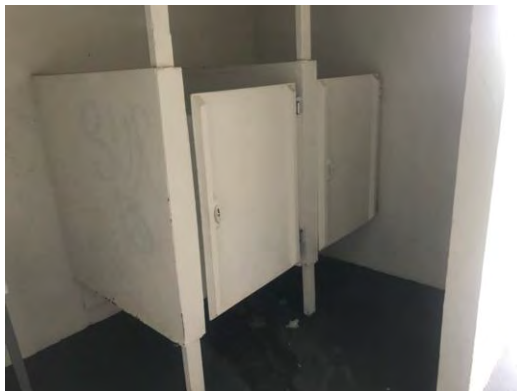
Deficiency Description: *Restrooms are not accessible and in old condition.*

Description of Work: *Renovate restroom with accessible features.*

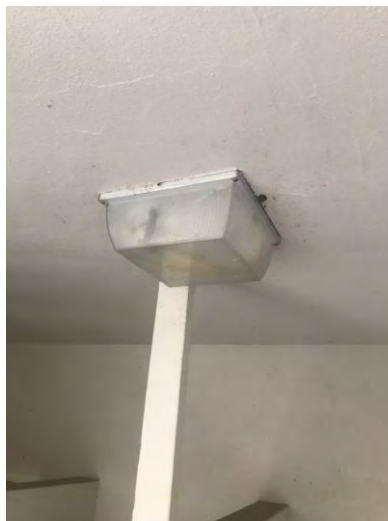
Deficiency Description: *Interior lighting system is past its expected useful life.*

Comments: *Diffuser stained.*

Description of Work: *Provide new interior lighting and control system throughout building per current CEC T24 code.*

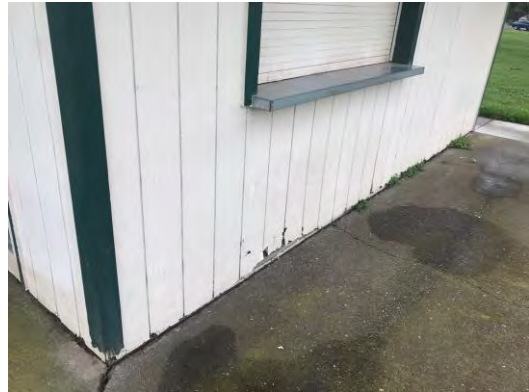
Year Installed / Industry Life / Remaining Useful Life - / 30 / -  
Item No. B2010.10.001  
Floor/Room: 1 / Exterior  
**Priority: 3**  
Quantity/Unit of Measure: 500/SF  
Total Deficiency Cost: \$8,800  
Deficiency Description: *Plywood siding is approaching the end of its useful life.*

Description of Work: *Remove and replace the existing plywood siding with new plywood siding. Prime and paint.*

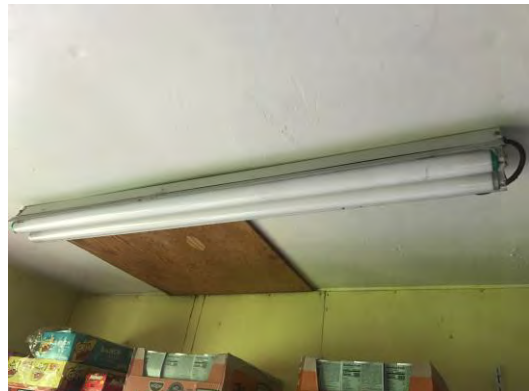
Year Installed / Industry Life / Remaining Useful Life - / 30 / -  
Item No. C2050.10.001  
Floor/Room: 1 / Snack Bar  
**Priority: 1**  
Quantity/Unit of Measure: 100/SF  
Total Deficiency Cost: \$2,020  
Deficiency Description: *Painted gypsum wallboard ceiling is approaching the end of its useful life.*

Description of Work: *Remove the existing gypsum board ceiling and replace. Tape and paint.*

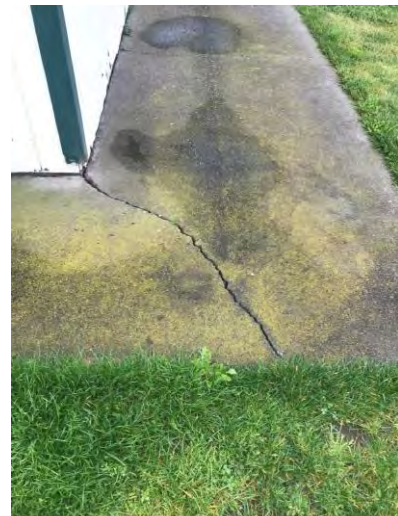
Year Installed / Industry Life / Remaining Useful Life - / 30 / -  
Item No. G2030.10.005  
Floor/Room: Site / Pavement  
**Priority: 3**  
Quantity/Unit of Measure: 100/SF  
Total Deficiency Cost: \$3,800  
Deficiency Description: *Concrete pavement has major damage / structural failure.*

Description of Work: *Replace concrete and base to match existing.*

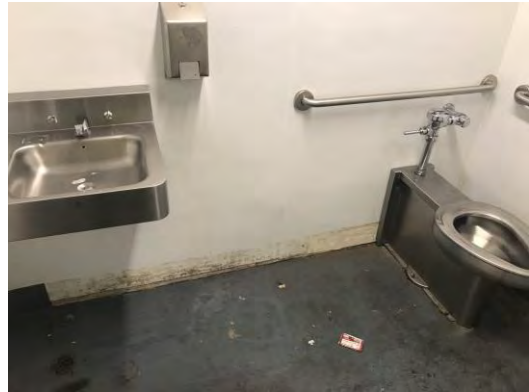
Year Installed / Industry Life / Remaining Useful Life - / - / -  
Item No. C2030.90.001  
Floor/Room: 1 / Restroom  
**Priority: 1**  
Quantity/Unit of Measure: 30/LF  
Total Deficiency Cost: \$480  
Deficiency Description: *Vinyl wall base is approaching the end of its useful life.*

Description of Work: *Replace the vinyl wall base.*

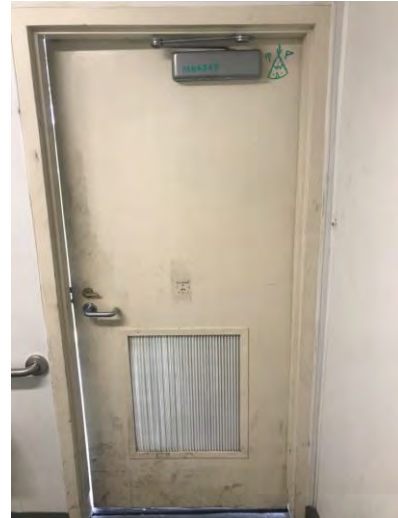
Year Installed / Industry Life / Remaining Useful Life - / 15 / -  
Item No. B2050.20.003  
Floor/Room: 1 / Restroom  
**Priority: 3**  
Quantity/Unit of Measure: 1/EA  
Total Deficiency Cost: \$12,300  
Deficiency Description: *Exterior doors, frames and hardware are approaching the end of their useful life.*

Description of Work: *Replace the exterior doors, frames and hardware.*

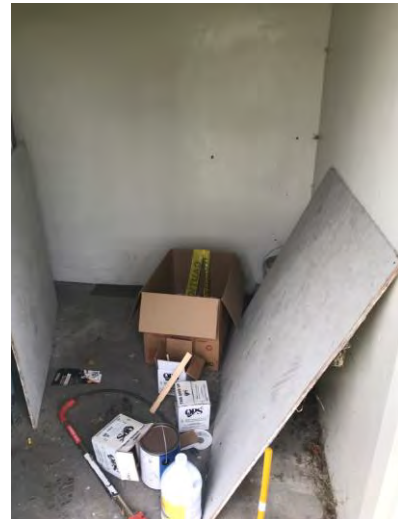
Record ID: 216  
 System: F1050 - SPECIAL FACILITY COMPONENTS  
 Year Installed / Industry Life / Remaining Useful Life: - / - / -  
 Item No.: F1050.80.011  
 Floor/Room: 1 / Restroom  
**Priority:** 1  
 Quantity/Unit of Measure: 56/SF  
 Total Deficiency Cost: \$22,500  
 Deficiency Description: *Restroom is in poor condition.*

Description of Work: *Renovate restrooms with accessible features.*

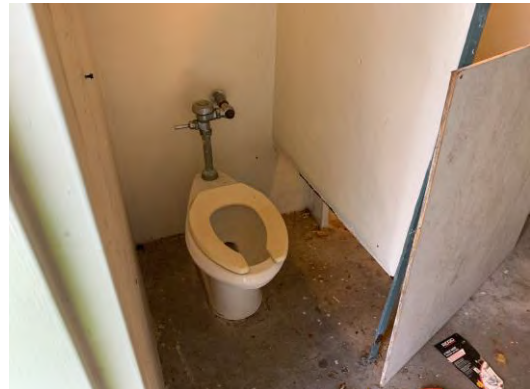
Record ID: 429  
 System: D2010 - DOMESTIC WATER DISTRIBUTION  
 Year Installed / Industry Life / Remaining Useful Life: - / 30 / -  
 Item No.: D2010.60.047  
 Floor/Room:  
**Priority:** 3  
 Quantity/Unit of Measure: 2/EA  
 Total Deficiency Cost: \$42,100  
 Deficiency Description: *Restroom piping and plumbing fixtures are at or approaching the end of its expected useful service life.*

Description of Work: *Provide equipment replacement and installation.*

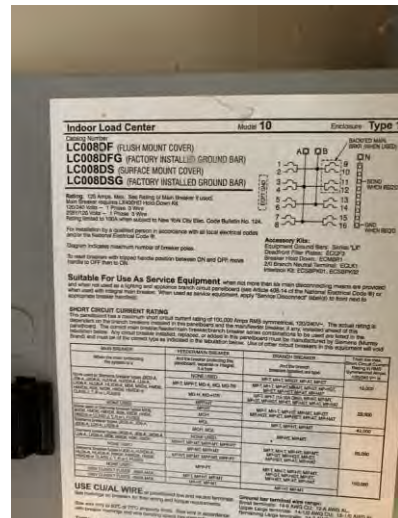
Record ID: 432  
 System: D5020 - ELECTRICAL SERVICE AND DISTRIBUTION  
 Year Installed / Industry Life / Remaining Useful Life: 2010 / 30 / 18  
 Item No.: D5020.30.4001  
 Floor/Room:  
**Priority:** 6  
 Quantity/Unit of Measure: 1/EA  
 Total Deficiency Cost: N/A - See Executive Summary  
 Deficiency Description: *The 100A (18 ckt, 20A plug-in breakers, 1P) load center useful life is beyond priority timeline of FCA(informational).*

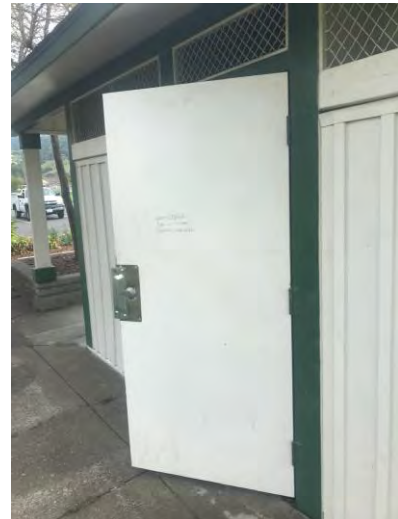
Quantity/Unit of Measure: 1/EA  
 Total Deficiency Cost: \$90  
 Deficiency Description: *Exterior aluminum door is damaged or deteriorating.*

Description of Work: *Refurbish/repair aluminum door.*

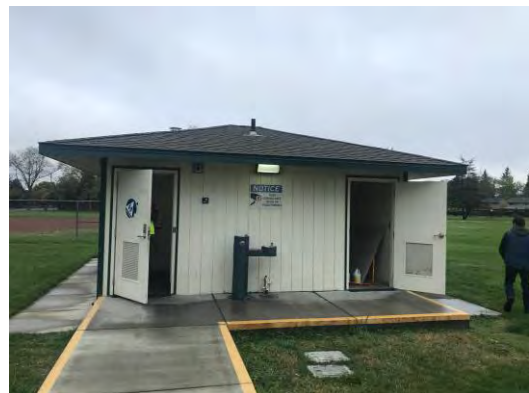
Comments: *Appears to be retrofit.*

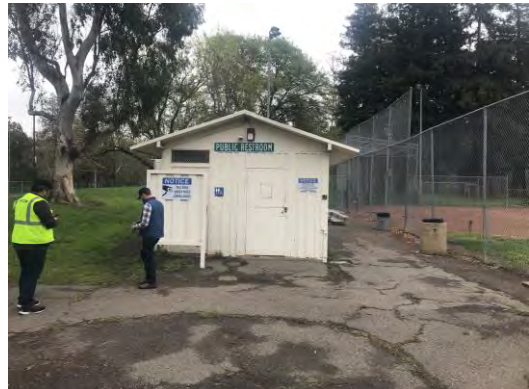
Record ID: 250  
 System: G2020 - PARKING LOTS  
 Year Installed / Industry Life / Remaining Useful Life: - / - / -  
 Item No.: G2020.10.002  
 Floor/Room: Site / AC Paving  
**Priority:** 2  
 Quantity/Unit of Measure: 1,500/SF  
 Total Deficiency Cost: \$43,840  
 Deficiency Description: *AC paving shows evidence of potholing.*

Description of Work: *Replace AC pavement section.*

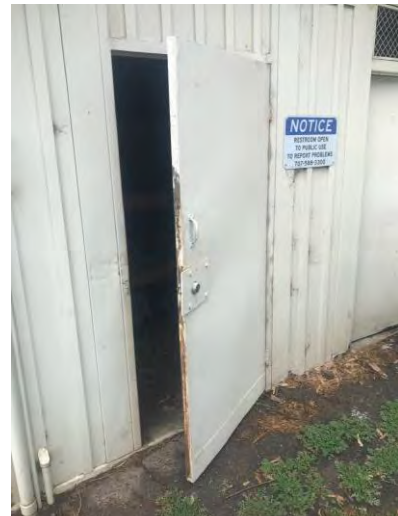
Record ID: 251  
 System: B2050 - EXTERIOR DOORS AND GRILLES  
 Year Installed / Industry Life / Remaining Useful Life: - / 15 / -  
 Item No.: B2050.20.003  
 Floor/Room: 1 / Exterior  
**Priority:** 3  
 Quantity/Unit of Measure: 1/EA  
 Total Deficiency Cost: \$12,300  
 Deficiency Description: *Exterior doors, frames and hardware are approaching the end of their useful life.*

Description of Work: *Replace the exterior doors, frames and hardware.*

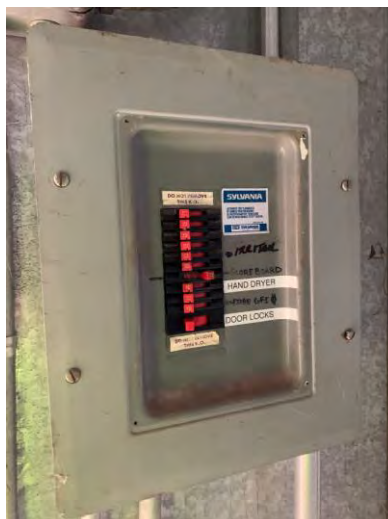
Record ID: 447  
 System: D5020 - ELECTRICAL SERVICE AND DISTRIBUTION  
 Year Installed / Industry Life / Remaining Useful Life: 1975 / 30 / -17  
 Item No.: D5020.30.4001  
 Floor/Room: 1 / Electrical  
**Priority:** 1  
 Quantity/Unit of Measure: 1/EA  
 Total Deficiency Cost: \$4,910  
 Deficiency Description: *The load center is past its expected useful life.*

Description of Work: *Replace the existing load center with a new load center.*

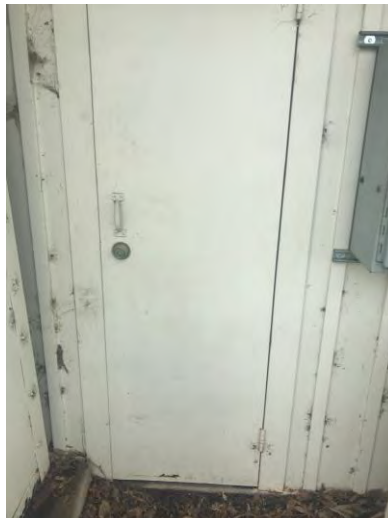
Record ID: 687  
 System: B2050 - EXTERIOR DOORS AND GRILLES  
 Year Installed / Industry Life / Remaining Useful Life: - / 15 / -  
 Item No.: B2050.20.003  
 Floor/Room: 1 / Exterior  
**Priority:** 3  
 Quantity/Unit of Measure: 1/EA  
 Total Deficiency Cost: \$12,300  
 Deficiency Description: *Exterior doors, frames and hardware are approaching the end of their useful life.*

Description of Work: *Replace the exterior doors, frames and hardware.*

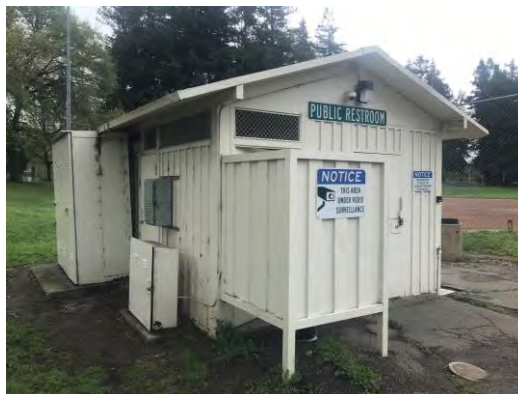
Record ID: 1763  
 System: -  
 Year Installed / Industry Life / Remaining Useful Life: 2010 / - / -  
 Item No.:  
 Floor/Room:  
**Priority:** 1  
 Quantity/Unit of Measure: 2/  
 Total Deficiency Cost:  
 Deficiency Description:

Comments: *Lights replaced 2018, CIP Project No. 2016-10.*

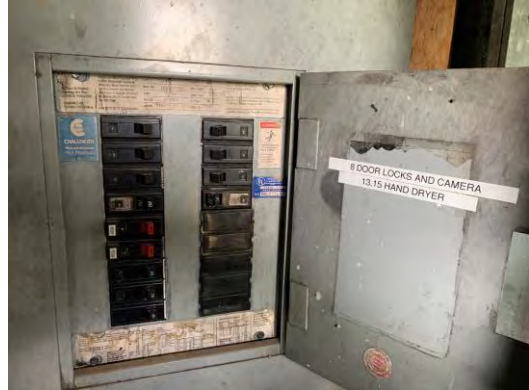
Record ID: 453  
System: D5020 - ELECTRICAL SERVICE AND DISTRIBUTION  
Year Installed / Industry Life / Remaining Useful Life: 1988 / 30 / -4  
Item No.: D5020.30.4001  
Floor/Room: 1st  
**Priority:** 1  
Quantity/Unit of Measure: 1/EA  
Total Deficiency Cost: \$4,910  
Deficiency Description: *The load center is past its expected useful life.*

Description of Work: *Replace the existing load center with a new load center.*

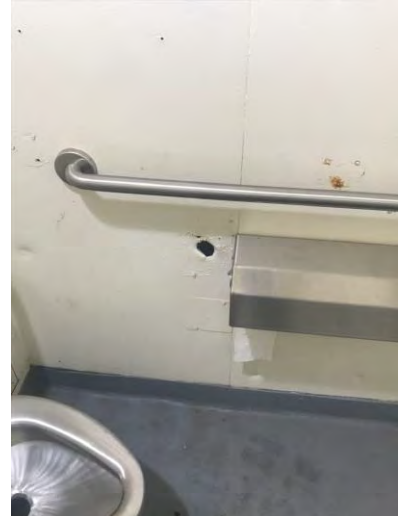
Record ID: 694  
System: C2010 - WALL FINISHES  
Year Installed / Industry Life / Remaining Useful Life: - / 20 / -  
Item No.: C2010.20.003  
Floor/Room: 1 / Restroom  
**Priority:** 1  
Quantity/Unit of Measure: 100/SF  
Total Deficiency Cost: \$1,960  
Deficiency Description: *Metal interior wall is damaged.*

Description of Work: *Repair or replace metal interior wall panel.*

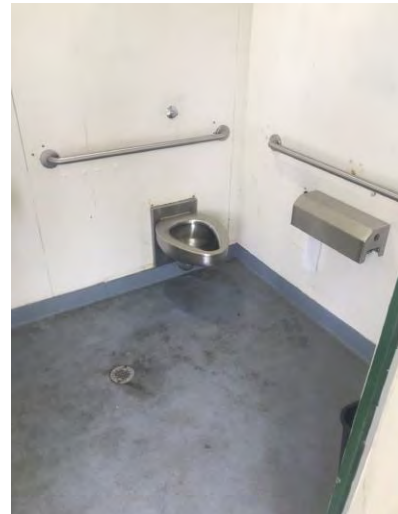
Record ID: 695  
System: C2030 - FLOORING  
Year Installed / Industry Life / Remaining Useful Life: - / 40 / -  
Item No.: C2030.10.002  
Floor/Room: 1 / Restroom  
**Priority:** 3  
Quantity/Unit of Measure: 100/SF  
Total Deficiency Cost: \$5,280  
Deficiency Description: *Epoxy is approaching the end of its useful life.*

Description of Work: *Remove the existing epoxy and replace.*

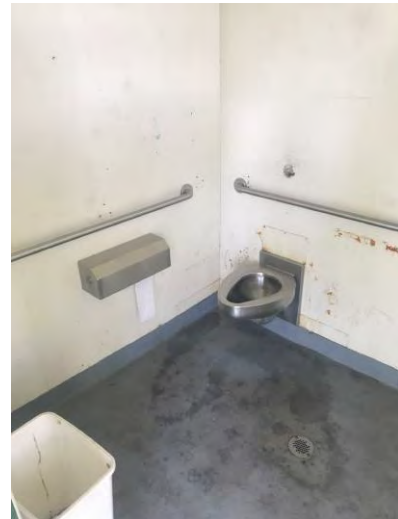
Record ID 697  
System C2030 - FLOORING  
Year Installed / Industry Life / Remaining Useful Life - / 40 / -  
Item No. C2030.10.002  
Floor/Room: 1 / Restroom  
**Priority:** 3  
Quantity/Unit of Measure: 100/SF  
Total Deficiency Cost: \$5,280  
Deficiency Description: *Epoxy is approaching the end of its useful life.*

Description of Work: *Remove the existing epoxy and replace.*

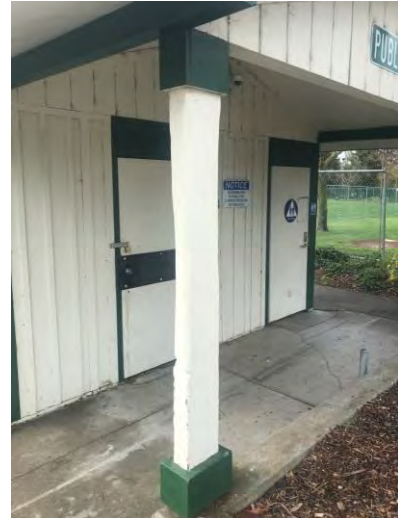
Record ID 698  
System B2010 - EXTERIOR WALLS  
Year Installed / Industry Life / Remaining Useful Life - / 30 / -  
Item No. B2010.10.001  
Floor/Room: 1 / Exterior  
**Priority:** 7  
Quantity/Unit of Measure: 600/SF  
Total Deficiency Cost: \$11,900  
Deficiency Description: *Plywood siding is approaching the end of its useful life.*

Description of Work: *Remove and replace the existing plywood siding with new plywood siding. Prime and paint.*

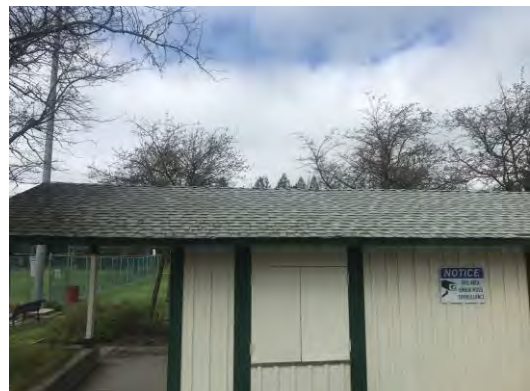
Record ID 700  
System B3010 - ROOFING  
Year Installed / Industry Life / Remaining Useful Life - / 30 / -  
Item No. B3010.10.001  
Floor/Room:  
**Priority:** 7  
Quantity/Unit of Measure: 300/SF  
Total Deficiency Cost: \$17,810  
Deficiency Description: *Asphalt composition roof is approaching the end of its useful life.*

Description of Work: *Remove and replace asphalt composition shingle roofing.*

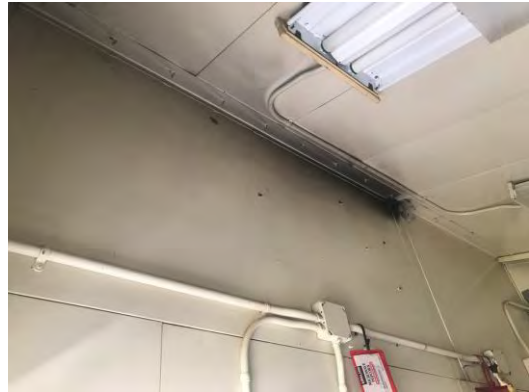
Record ID: 1646  
 System: C2010 - WALL FINISHES  
 Year Installed / Industry Life / Remaining Useful Life: - / - / -  
 Item No.: C2010.30.004  
 Floor/Room: 1 / All  
**Priority:** 3  
 Quantity/Unit of Measure: 400/SF  
 Total Deficiency Cost: \$2,980  
 Deficiency Description: *Interior wall surfaces are showing signs of wear.*  
 Description of Work: *Paint interior wall and ceiling surfaces throughout.*  
 Comments:

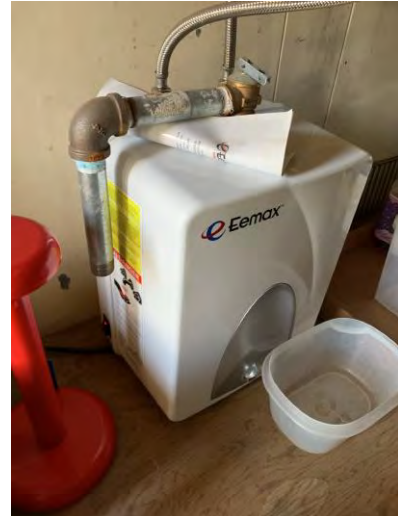
Record ID: 1650  
 System: D2010 - DOMESTIC WATER DISTRIBUTION  
 Year Installed / Industry Life / Remaining Useful Life: 2014 / 15 / 7  
 Item No.: D2010.20.015  
 Floor/Room:  
**Priority:** 7  
 Quantity/Unit of Measure: 1/EA  
 Total Deficiency Cost: \$3,900  
 Deficiency Description: *Small under-counter electric water heater less than 10 Gal is approaching the end of its expected useful life.*  
 Description of Work: *Provide equipment replacement and installation.*  
 Comments:

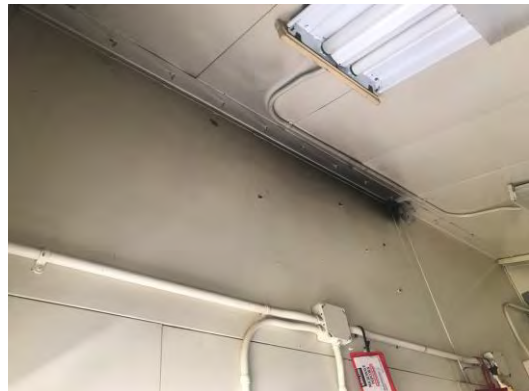
Record ID: 1765  
 System: D5040 - LIGHTING  
 Year Installed / Industry Life / Remaining Useful Life: 1988 / 20 / -14  
 Item No.: D5040.50.411  
 Floor/Room:  
**Priority:** 1  
 Quantity/Unit of Measure: 225/SF  
 Total Deficiency Cost: \$12,900  
 Deficiency Description: *Interior lighting system is past its expected useful life and signs of smoke..*  
 Description of Work: *Provide new interior lighting and control system throughout building per current CEC T24 code.*  
 Comments:

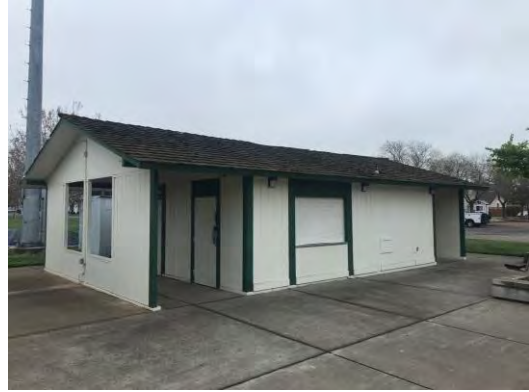
Deficiency Description: *Plywood siding is approaching the end of its useful life.*

Description of Work: *Remove and replace the existing plywood siding with new plywood siding. Prime and paint.*

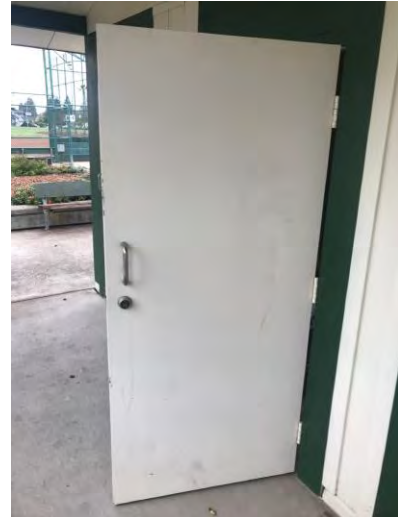
Deficiency Description: *Exterior doors and frames are showing signs of wear.*

Description of Work: *Refinish metal doors and frames.*

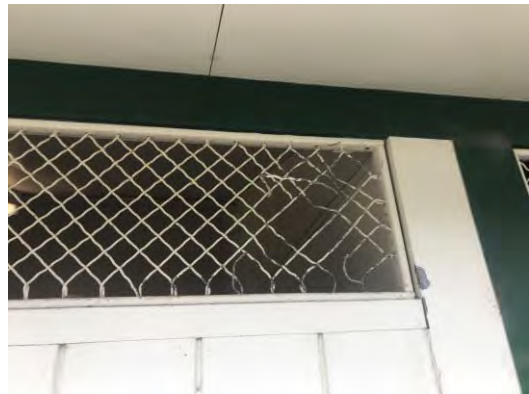
Deficiency Description: *Chain link steel mesh is damaged or missing.*

Description of Work: *Replace chain link section.*

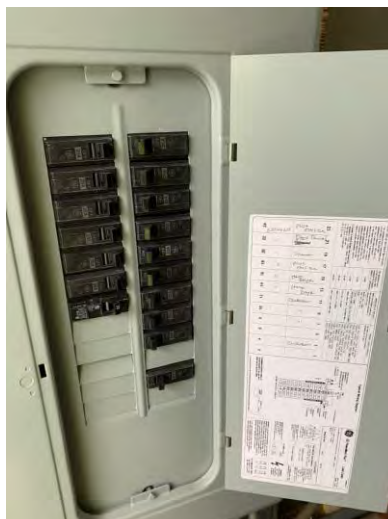
Record ID: 433  
 System: D5020 - ELECTRICAL SERVICE AND DISTRIBUTION  
 Year Installed / Industry Life / Remaining Useful Life: 2001 / 30 / 9  
 Item No.: D5020.30.4001  
 Floor/Room: 1st  
**Priority:** 7  
 Quantity/Unit of Measure: 1/EA  
 Total Deficiency Cost: \$6,040  
 Deficiency Description: *The 100A (18 ckts, 20A plug-in breakers, 1P) load center is approaching the end of its expected useful life.*  
 Description of Work: *Replace the existing load center with a new load center.*  
 Comments:

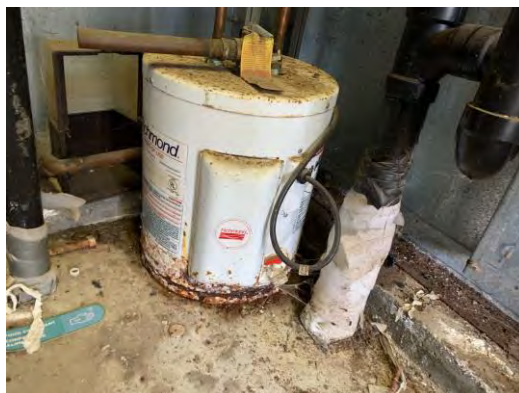
Record ID: 435  
 System: D2010 - DOMESTIC WATER DISTRIBUTION  
 Year Installed / Industry Life / Remaining Useful Life: 2001 / 15 / -6  
 Item No.: D2010.20.015  
 Floor/Room:  
**Priority:** 1  
 Quantity/Unit of Measure: 1/EA  
 Total Deficiency Cost: \$3,170  
 Deficiency Description: *Small under-counter electric water heater less than 10 Gal is approaching the end of its expected useful life.*  
 Description of Work: *Provide equipment replacement and installation.*  
 Comments:

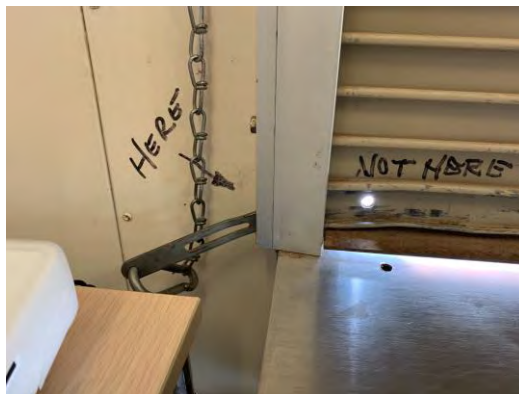
Record ID: 1162  
 System: C2010 - WALL FINISHES  
 Year Installed / Industry Life / Remaining Useful Life: - / - / -  
 Item No.: C2010.30.004  
 Floor/Room: 1 / Concession  
**Priority:** 2  
 Quantity/Unit of Measure: 100/SF  
 Total Deficiency Cost: \$720  
 Deficiency Description: *Interior surfaces are showing signs of wear.*  
 Description of Work: *Paint interior surfaces.*  
 Comments:

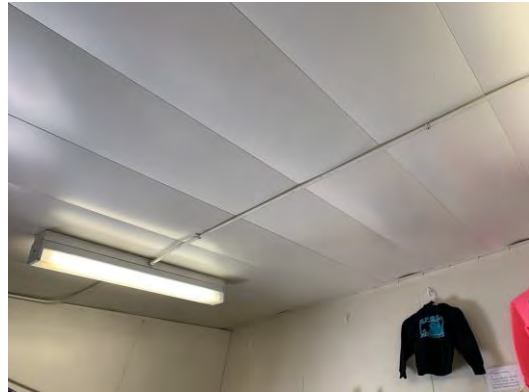
Year Installed / Industry Life / Remaining Useful Life 2001 / 20 / -1  
Item No. D5040.50.411  
Floor/Room:  
**Priority:** 1  
Quantity/Unit of Measure: 600/SF  
Total Deficiency Cost: \$34,360  
Deficiency Description: *Interior lighting system is past its expected useful life but in operational.*

Description of Work: *Provide new interior lighting and control system throughout building per current CEC T24 code.*

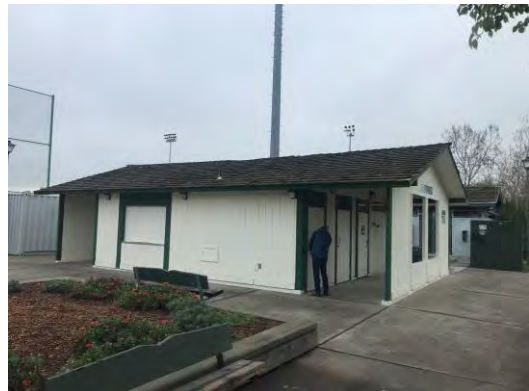
Year Installed / Industry Life / Remaining Useful Life 2001 / 20 / -1  
Item No. D5040.50.302  
Floor/Room: 1st  
**Priority:** 1  
Quantity/Unit of Measure: 6/EA  
Total Deficiency Cost: \$13,650  
Deficiency Description: *The exterior light fixture is past its expected useful life.*

Description of Work: *Replace the existing light fixture with an LED lighting fixture.*

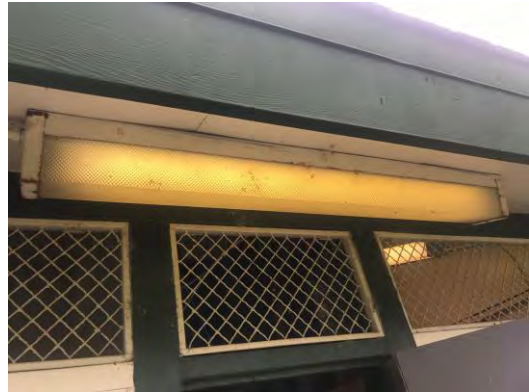
Comments: *Fixture is rusted and the diffuser is discolored.*

Description of Work: *Provide new interior lighting and control system throughout building per current CEC T24 code.*

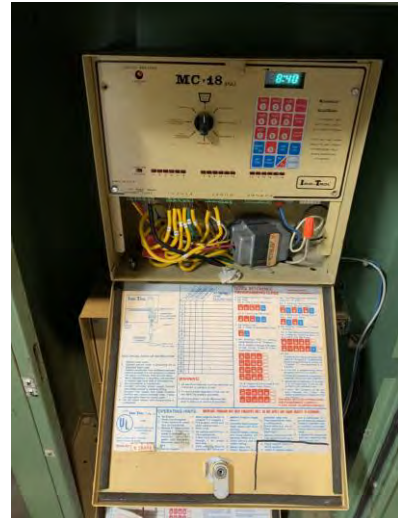
Record ID: 437  
 System: G2080 - LANDSCAPING  
 Year Installed / Industry Life / Remaining Useful Life: - / 15 / -  
 Item No.: G2080.10.027  
 Floor/Room:  
**Priority:** 3  
 Quantity/Unit of Measure: 1/EA  
 Total Deficiency Cost: \$3,590  
 Deficiency Description: *Irrigation Controller is approaching the end of its expected useful life.*

Description of Work: *Replace existing irrigation controller.*

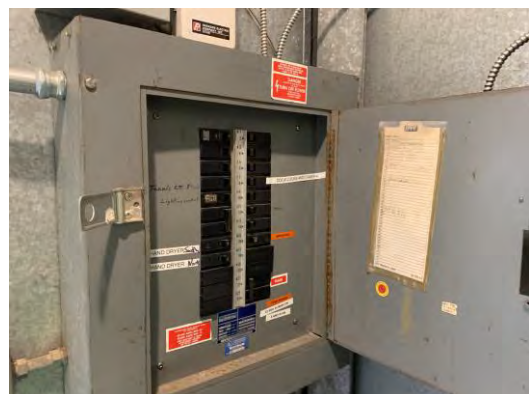
Record ID: 438  
 System: D5020 - ELECTRICAL SERVICE AND DISTRIBUTION  
 Year Installed / Industry Life / Remaining Useful Life: 1980 / 30 / -12  
 Item No.: D5020.30.4001  
 Floor/Room: 1st  
**Priority:** 1  
 Quantity/Unit of Measure: 1/EA  
 Total Deficiency Cost: \$4,910  
 Deficiency Description: *The load center is past its expected useful life.*

Description of Work: *Replace the existing load center with a new load center.*

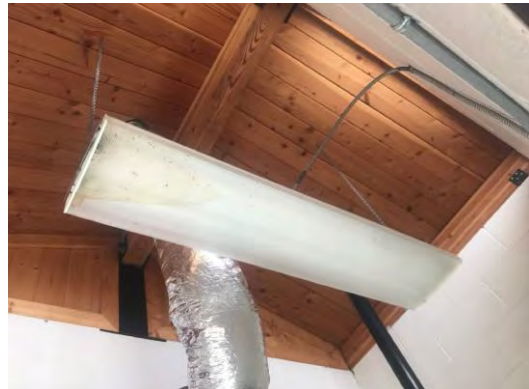
Comments: *Signs of water intrusion.*

Description of Work: *Replace the existing interior light fixture with a new interior light fixture.*

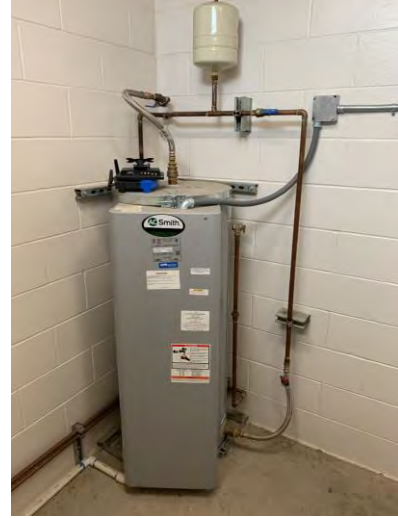
Quantity/Unit of Measure: 1/EA  
Total Deficiency Cost: \$12,240  
Deficiency Description: *Electric water heater is approaching the end of its expected useful life.*

Description of Work: *Provide equipment replacement and installation.*

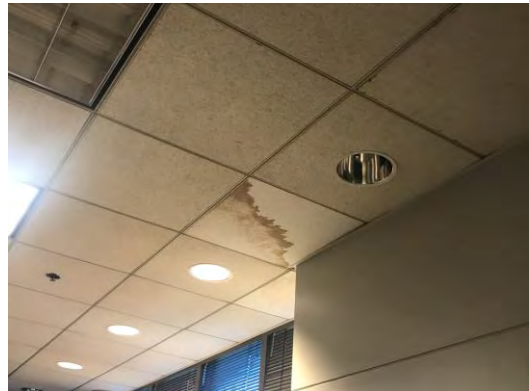
Comments: *Further investigation is recommended to determine the source of water damage.*

Description of Work: *Remove existing lay-in Acoustical Tiles and replace with new lay-in Acoustical Tiles.*

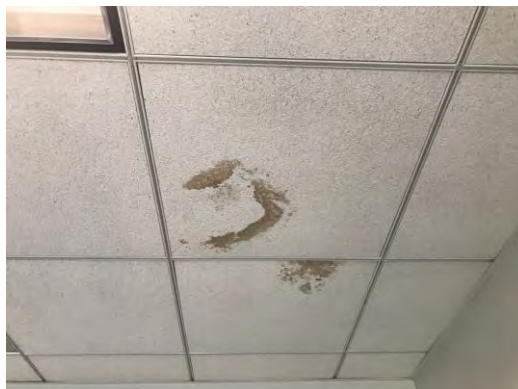
Record ID: 1069  
 System: C2050 - CEILING FINISHES  
 Year Installed / Industry Life / Remaining Useful Life: - / 50 / -  
 Item No.: C2050.80.001  
 Floor/Room: 2 / IS Operations Manager  
**Priority:** 3  
 Quantity/Unit of Measure: 100/SF  
 Total Deficiency Cost: \$1,680  
 Deficiency Description: *Lay-in Acoustical Tile is in poor condition.*

Description of Work: *Remove existing lay-in Acoustical Tiles and replace with new lay-in Acoustical Tiles.*

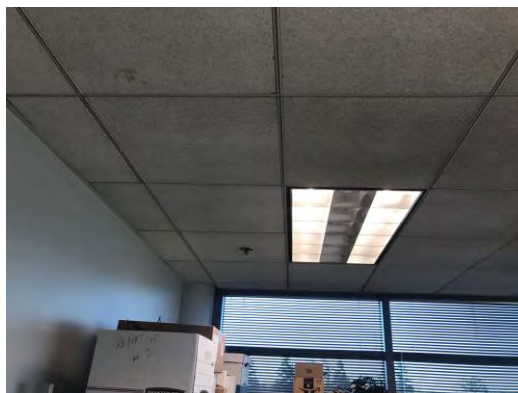
Record ID: 1070  
 System: C2050 - CEILING FINISHES  
 Year Installed / Industry Life / Remaining Useful Life: - / 50 / -  
 Item No.: C2050.80.001  
 Floor/Room: 2 / IS Technician  
**Priority:** 3  
 Quantity/Unit of Measure: 1,000/SF  
 Total Deficiency Cost: \$16,420  
 Deficiency Description: *Lay-in Acoustical Tile is in poor condition.*

Description of Work: *Remove existing lay-in Acoustical Tiles and replace with new lay-in Acoustical Tiles.*

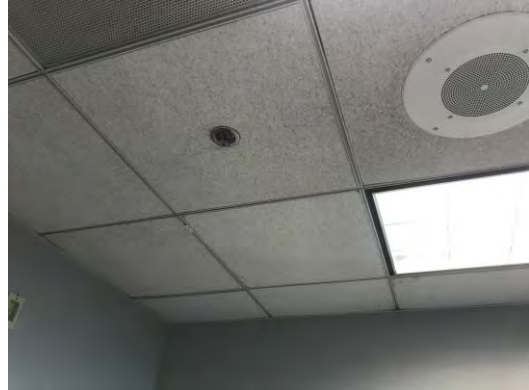
Comments: *Ceiling leak from HVAC.*

Description of Work: *Remove existing lay-in Acoustical Tiles and replace with new lay-in Acoustical Tiles.*

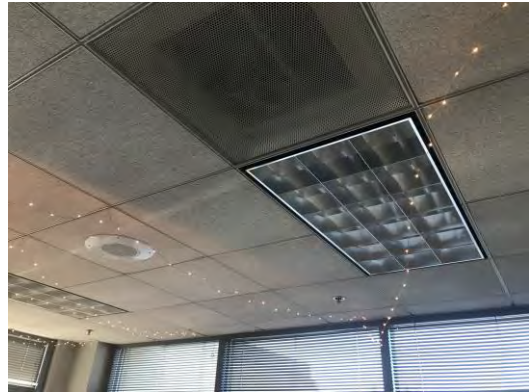
Record ID: 1075  
 System: C2050 - CEILING FINISHES  
 Year Installed / Industry Life / Remaining Useful Life: - / 50 / -  
 Item No.: C2050.80.001  
 Floor/Room: 2 / Comm Supervisor Office  
**Priority:** 3  
 Quantity/Unit of Measure: 1,000/SF  
 Total Deficiency Cost: \$16,420  
 Deficiency Description: *Lay-in Acoustical Tile is in poor condition.*

Description of Work: *Remove existing lay-in Acoustical Tiles and replace with new lay-in Acoustical Tiles.*

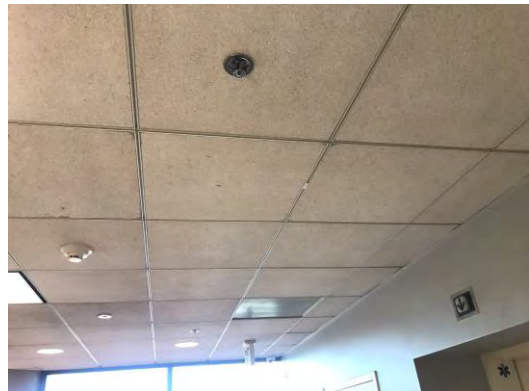
Record ID: 1077  
 System: C2050 - CEILING FINISHES  
 Year Installed / Industry Life / Remaining Useful Life: - / 50 / -  
 Item No.: C2050.80.001  
 Floor/Room: 3 / Lobby/Halls  
**Priority:** 3  
 Quantity/Unit of Measure: 600/SF  
 Total Deficiency Cost: \$9,870  
 Deficiency Description: *Lay-in Acoustical Tile is in poor condition.*

Description of Work: *Remove existing lay-in Acoustical Tiles and replace with new lay-in Acoustical Tiles.*

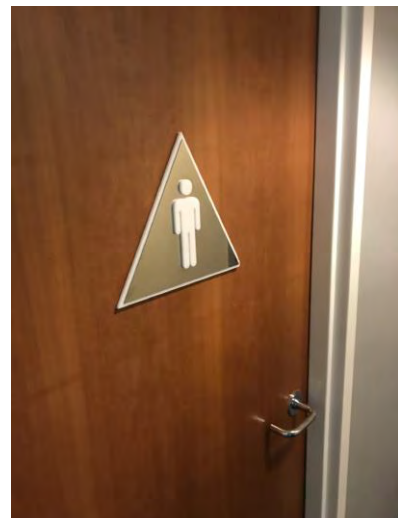
Record ID: 1080  
 System: C1090 - INTERIOR SPECIALTIES  
 Year Installed / Industry Life / Remaining Useful Life: - / - / -  
 Item No.: C1090.20.001  
 Floor/Room: 3 / Men's Restroom  
**Priority:** 1  
 Quantity/Unit of Measure: 2/LS  
 Total Deficiency Cost: \$1,000  
 Deficiency Description: *Door lacks accessible signage.*

Comments: *Also Women's Restroom signage.*

Description of Work: *Provide accessible signage.*

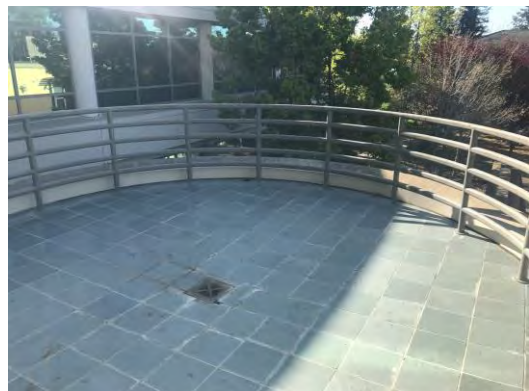
Record ID 1087  
System B3010 - ROOFING  
Year Installed / Industry Life / Remaining Useful Life - / 30 / -  
Item No. B3010.10.005  
Floor/Room: Roof / Exterior  
**Priority:** 3  
Quantity/Unit of Measure: 200/SF  
Total Deficiency Cost: \$12,650  
Deficiency Description: *Slate tile flooring is showing signs of wear.*

Description of Work: *Replace slate tile flooring.*

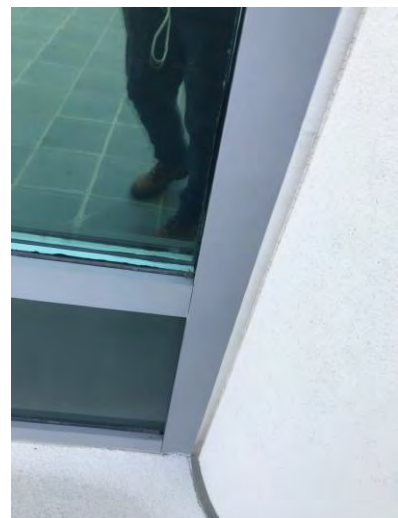
Record ID 1088  
System B2020 - EXTERIOR WINDOWS  
Year Installed / Industry Life / Remaining Useful Life - / 40 / -  
Item No. B2020.20.010  
Floor/Room: Roof / Fire Marshal Office  
**Priority:** 1  
Quantity/Unit of Measure: 25/LF  
Total Deficiency Cost: \$660  
Deficiency Description: *Window is leaking.*

Comments: *Investigation and repair is currently under contract.*

Description of Work: *Replace window sealant.*

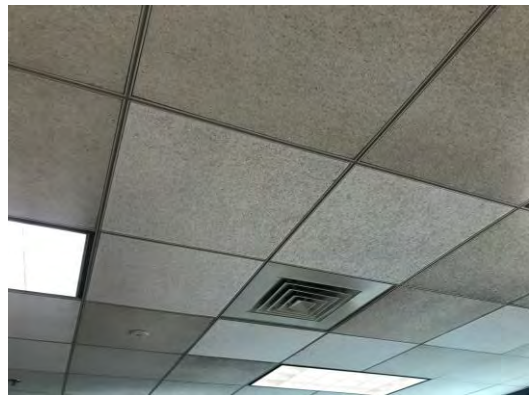
Comments: *Motion light does not work.*

Description of Work: *Remove existing lay-in Acoustical Tiles and replace with new lay-in Acoustical Tiles.*

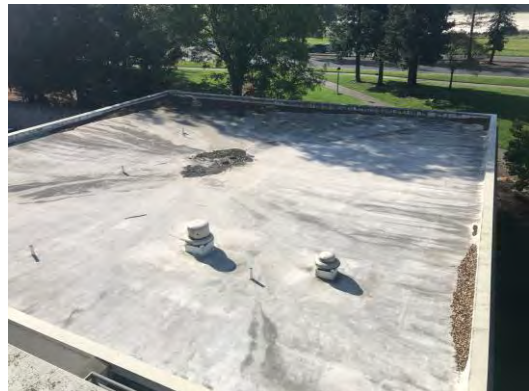
Record ID 1098  
System B3010 - ROOFING  
Year Installed / Industry Life / Remaining Useful Life - / 30 / -  
Item No. B3010.90.007  
Floor/Room: Roof / 1st Floor Roof  
**Priority:** 3  
Quantity/Unit of Measure: 100/SF  
Total Deficiency Cost: \$8,800  
Deficiency Description: *The roof is covered with debris which will shorten its useful life.*

Description of Work: *Clean off debris regularly.*

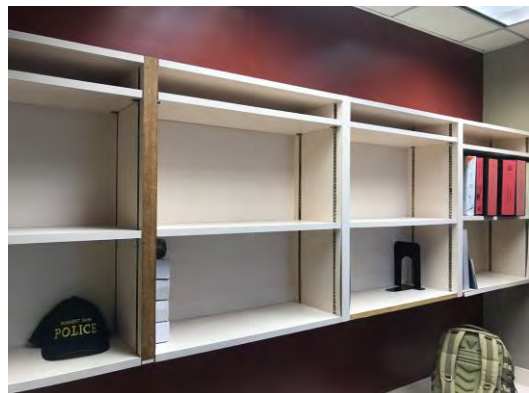
Record ID 1099  
System E2010 - FIXED FURNISHINGS  
Year Installed / Industry Life / Remaining Useful Life - / 50 / -  
Item No. E2010.30.006  
Floor/Room: 1 / Lieutenant  
**Priority:** 3  
Quantity/Unit of Measure: 10/LF  
Total Deficiency Cost: \$1,420  
Deficiency Description: *Casework laminate panel is in poor condition and peeling away.*

Description of Work: *Repair plastic laminate finish.*

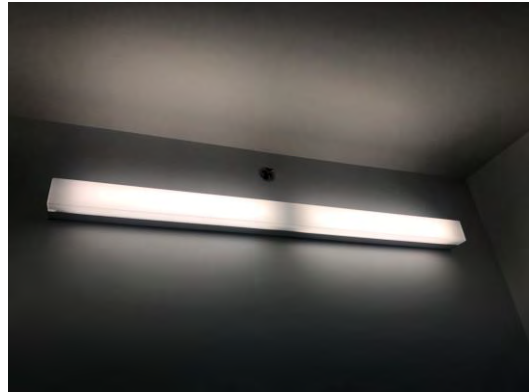
Comments: *Stairwell light sensor do not work well. Recommend replacing*

Description of Work: *Provide a new sensor for the existing lights.*

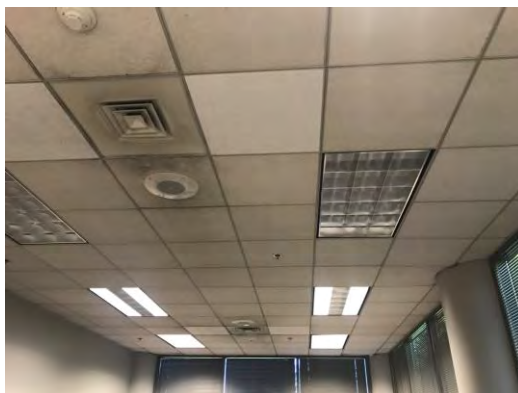
Deficiency Description: *Lay-in Acoustical Tile is in poor condition.*

Description of Work: *Remove existing lay-in Acoustical Tiles and replace with new lay-in Acoustical Tiles.*

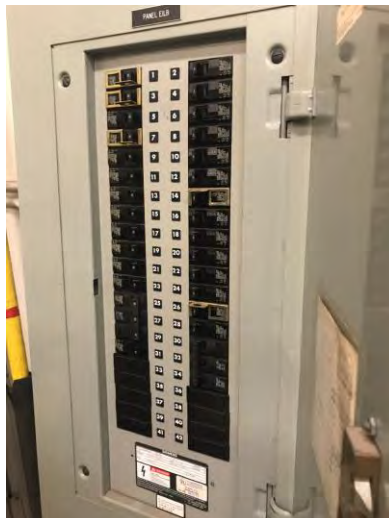
Deficiency Description: *The panelboard is past its expected useful life.*

Description of Work: *Replace the existing panelboard with a new panelboard.*

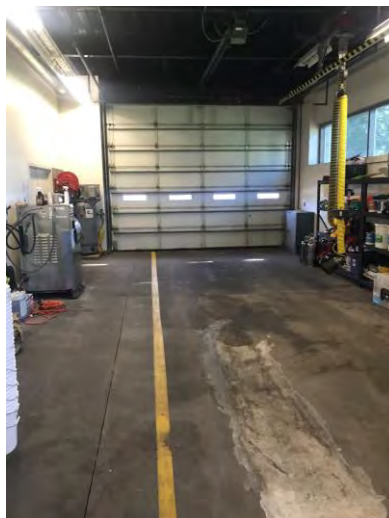
Deficiency Description: *Concrete floor is approaching the end of its useful life.*

Comments: *Damaged from chemicals.*

Description of Work: *Repair and refinish the concrete floor.*

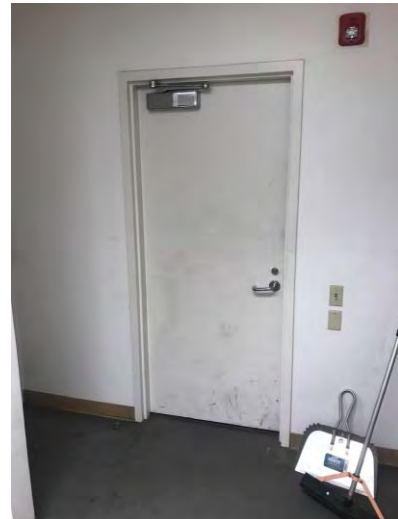
Record ID 1108  
System C1030 - INTERIOR DOORS

Year Installed / Industry Life / Remaining Useful Life - / 60 / -  
Item No. C1030.90.003  
Floor/Room: 1 / Detention Area  
**Priority:** 3  
Quantity/Unit of Measure: 1/EA  
Total Deficiency Cost: \$900  
Deficiency Description: *Metal door is showing signs of wear.*

Description of Work: *Repair and refinish the metal door.*

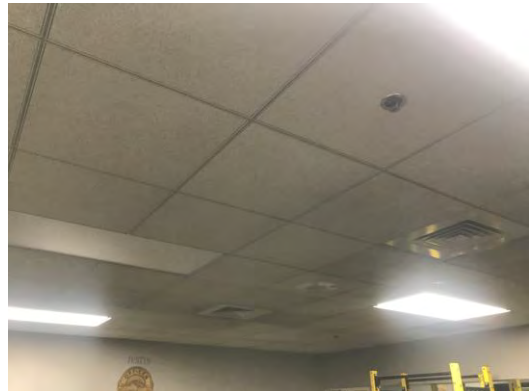
Record ID 1109  
System C2050 - CEILING FINISHES

Year Installed / Industry Life / Remaining Useful Life - / 50 / -  
Item No. C2050.80.001  
Floor/Room: 1 / Fitness Center  
**Priority:** 3  
Quantity/Unit of Measure: 400/SF  
Total Deficiency Cost: \$6,590  
Deficiency Description: *Lay-in Acoustical Tile is in poor condition.*

Description of Work: *Remove existing lay-in Acoustical Tiles and replace with new lay-in Acoustical Tiles.*
