# City of Rohnert Park

## Facility Condition Assessment

Final Report

October 17, 2022

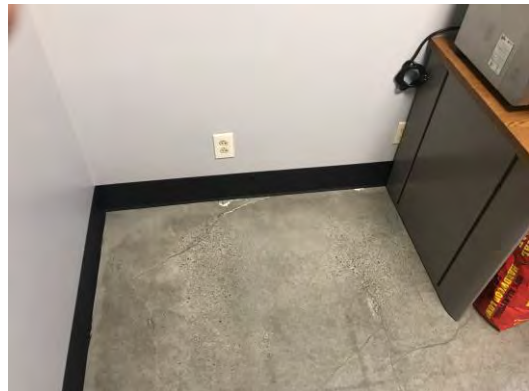
Record ID 1110  
System C2030 - FLOORING

Year Installed / Industry Life / Remaining Useful Life - / 50 / -  
Item No. C2030.10.001  
Floor/Room: 1 / Break Room  
**Priority:** 5  
Quantity/Unit of Measure: 1,000/SF  
Total Deficiency Cost: \$19,060  
Deficiency Description: *Sealed concrete floor is showing signs of minor damage.*

Description of Work: *Repair and refinish the concrete floor.*

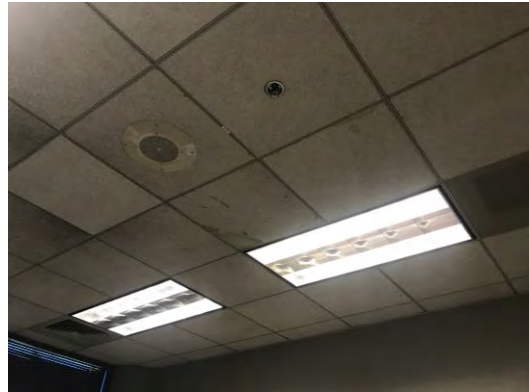
Year Installed / Industry Life / Remaining Useful Life - / 50 / -  
Item No. C2050.80.001  
Floor/Room: 1 / Sergeant's Office  
**Priority:** 3  
Quantity/Unit of Measure: 400/SF  
Total Deficiency Cost: \$6,590  
Deficiency Description: *Lay-in Acoustical Tile is in poor condition.*

Description of Work: *Remove existing lay-in Acoustical Tiles and replace with new lay-in Acoustical Tiles.*

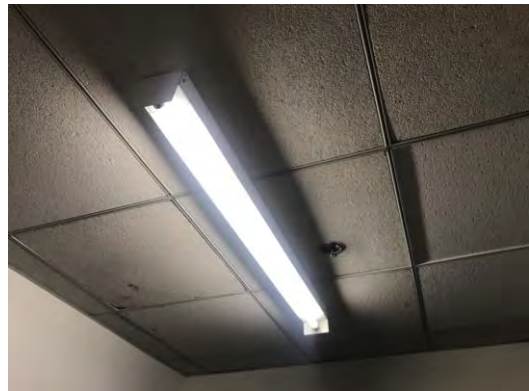
Record ID 1112  
System C2050 - CEILING FINISHES

Year Installed / Industry Life / Remaining Useful Life - / 50 / -  
Item No. C2050.80.001  
Floor/Room: 1 / Equipment  
**Priority:** 3  
Quantity/Unit of Measure: 100/SF  
Total Deficiency Cost: \$1,680  
Deficiency Description: *Lay-in Acoustical Tile is in poor condition.*

Description of Work: *Remove existing lay-in Acoustical Tiles and replace with new lay-in Acoustical Tiles.*

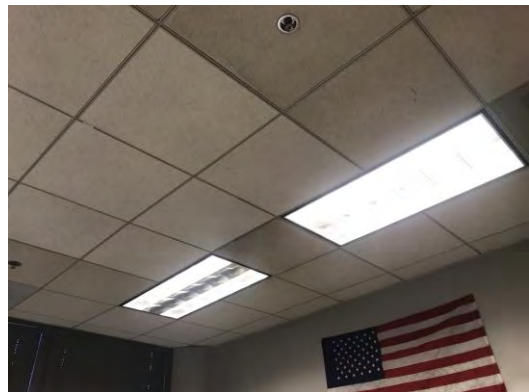
Record ID 1113  
System C2050 - CEILING FINISHES

Year Installed / Industry Life / Remaining Useful Life - / 50 / -  
Item No. C2050.80.001  
Floor/Room: 1 / Sergeant's Office  
**Priority:** 3  
Quantity/Unit of Measure: 400/SF  
Total Deficiency Cost: \$6,590  
Deficiency Description: *Lay-in Acoustical Tile is in poor condition.*

Description of Work: *Remove existing lay-in Acoustical Tiles and replace with new lay-in Acoustical Tiles.*

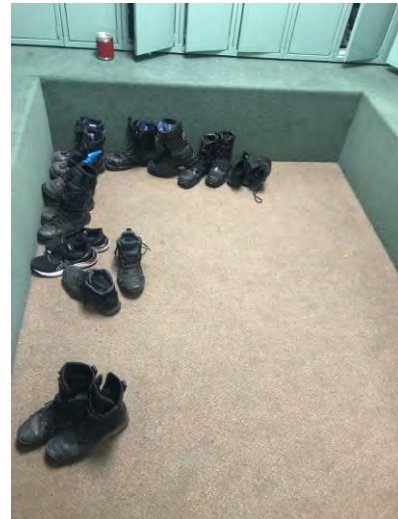
Deficiency Description: *Carpet flooring is showing signs of wear.*

Description of Work: *Replace carpet flooring.*

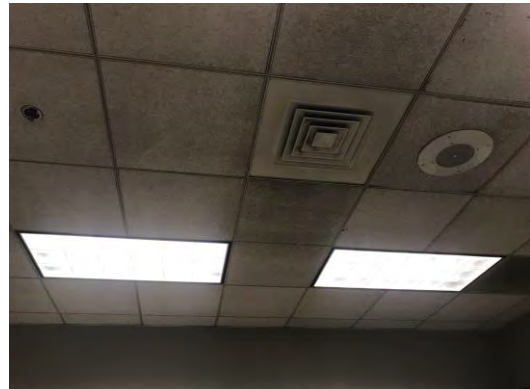
Deficiency Description: *Lay-in Acoustical Tile is in poor condition.*

Description of Work: *Remove existing lay-in Acoustical Tiles and replace with new lay-in Acoustical Tiles.*

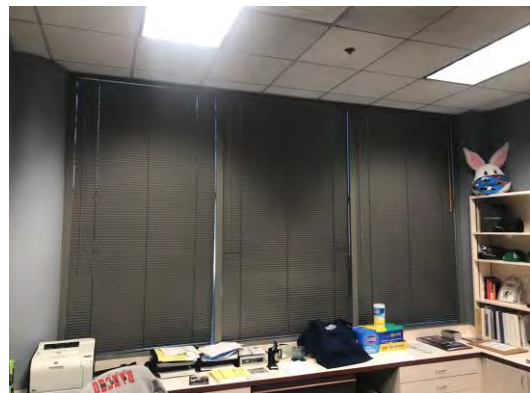
Deficiency Description: *Lay-in Acoustical Tile is in poor condition.*

Description of Work: *Remove existing lay-in Acoustical Tiles and replace with new lay-in Acoustical Tiles.*

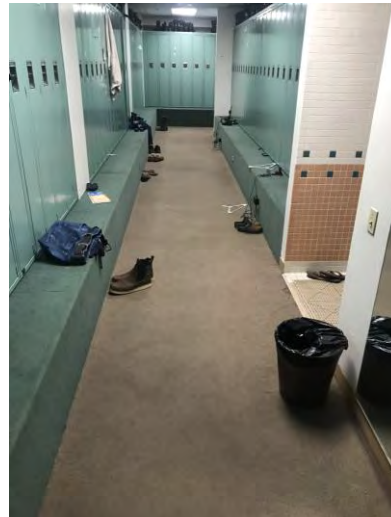
Record ID 1117  
System C2030 - FLOORING  
Year Installed / Industry Life / Remaining Useful Life - / 20 / -  
Item No. C2030.75.001  
Floor/Room: 1 / Men's Locker Room  
**Priority:** 7  
Quantity/Unit of Measure: 800/SF  
Total Deficiency Cost: \$25,310  
Deficiency Description: *Carpet flooring is showing signs of wear.*

Description of Work: *Replace carpet flooring.*

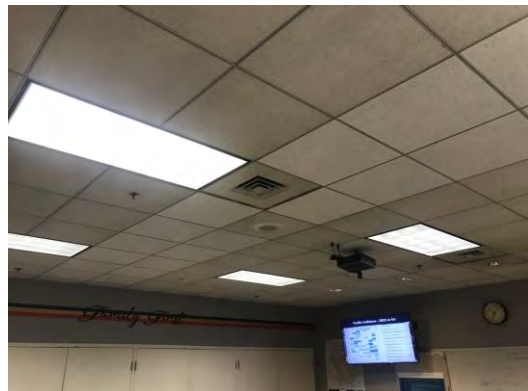
Record ID 1118  
System C2050 - CEILING FINISHES  
Year Installed / Industry Life / Remaining Useful Life - / 50 / -  
Item No. C2050.80.001  
Floor/Room: 1 / Briefing Room  
**Priority:** 3  
Quantity/Unit of Measure: 800/SF  
Total Deficiency Cost: \$13,140  
Deficiency Description: *Lay-in Acoustical Tile is in poor condition.*

Description of Work: *Remove existing lay-in Acoustical Tiles and replace with new lay-in Acoustical Tiles.*

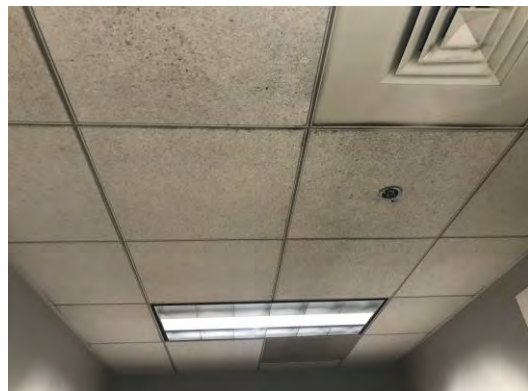
Record ID 1119  
System C2050 - CEILING FINISHES  
Year Installed / Industry Life / Remaining Useful Life - / 50 / -  
Item No. C2050.80.001  
Floor/Room: 1 / Kitchen  
**Priority:** 3  
Quantity/Unit of Measure: 400/SF  
Total Deficiency Cost: \$6,590  
Deficiency Description: *Lay-in Acoustical Tile is in poor condition.*

Description of Work: *Remove existing lay-in Acoustical Tiles and replace with new lay-in Acoustical Tiles.*

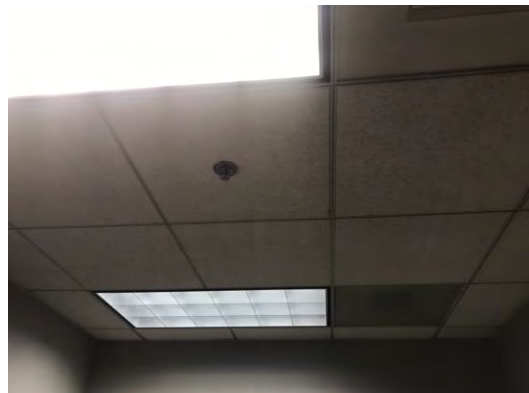
Year Installed / Industry Life / Remaining Useful Life - / 50 / -  
Item No. C2050.80.001  
Floor/Room: 1 / Interview Room  
**Priority:** 3  
Quantity/Unit of Measure: 200/SF  
Total Deficiency Cost: \$3,310  
Deficiency Description: *Lay-in Acoustical Tile is in poor condition.*

Description of Work: *Remove existing lay-in Acoustical Tiles and replace with new lay-in Acoustical Tiles.*

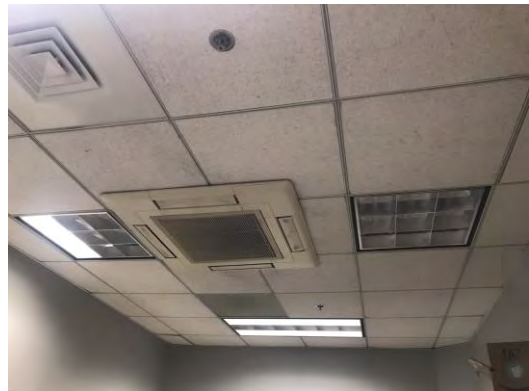
Record ID 1121  
System C2050 - CEILING FINISHES

Year Installed / Industry Life / Remaining Useful Life - / 50 / -  
Item No. C2050.80.001  
Floor/Room: 1 / Report Writing  
**Priority:** 2  
Quantity/Unit of Measure: 200/SF  
Total Deficiency Cost: \$3,170  
Deficiency Description: *Lay-in Acoustical Tile is in poor condition.*

Description of Work: *Remove existing lay-in Acoustical Tiles and replace with new lay-in Acoustical Tiles.*

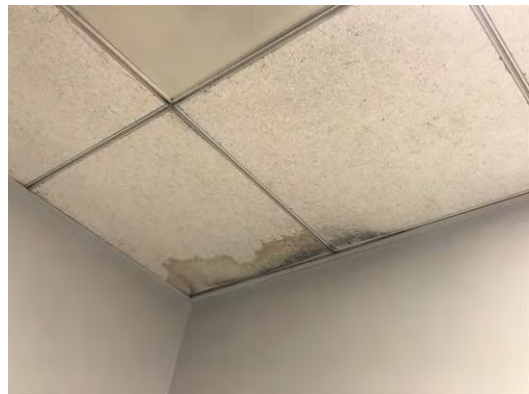
Record ID 1123  
System C2050 - CEILING FINISHES

Year Installed / Industry Life / Remaining Useful Life - / 50 / -  
Item No. C2050.80.001  
Floor/Room: 1 / Armory  
**Priority:** 3  
Quantity/Unit of Measure: 200/SF  
Total Deficiency Cost: \$3,310  
Deficiency Description: *Lay-in Acoustical Tile is in poor condition.*

Description of Work: *Remove existing lay-in Acoustical Tiles and replace with new lay-in Acoustical Tiles.*

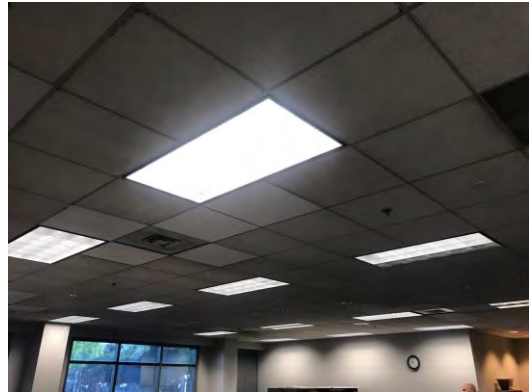
Year Installed / Industry Life / Remaining Useful Life - / 50 / -  
Item No. C2050.80.001  
Floor/Room: 1 / Records  
**Priority:** 3  
Quantity/Unit of Measure: 1,000/SF  
Total Deficiency Cost: \$16,420  
Deficiency Description: *Lay-in Acoustical Tile is in poor condition.*

Description of Work: *Remove existing lay-in Acoustical Tiles and replace with new lay-in Acoustical Tiles.*

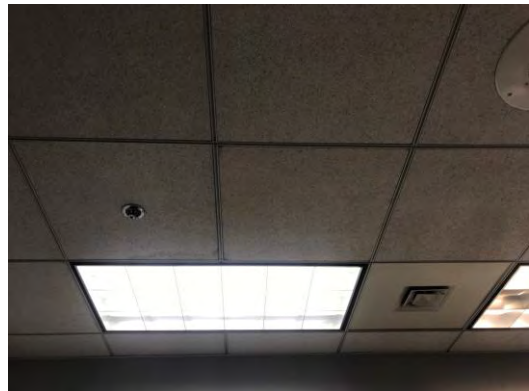
Record ID 1125  
System C2050 - CEILING FINISHES

Year Installed / Industry Life / Remaining Useful Life - / 50 / -  
Item No. C2050.80.001  
Floor/Room: 1 / Records Supervisor  
**Priority:** 3  
Quantity/Unit of Measure: 100/SF  
Total Deficiency Cost: \$1,680  
Deficiency Description: *Lay-in Acoustical Tile is in poor condition.*

Description of Work: *Remove existing lay-in Acoustical Tiles and replace with new lay-in Acoustical Tiles.*

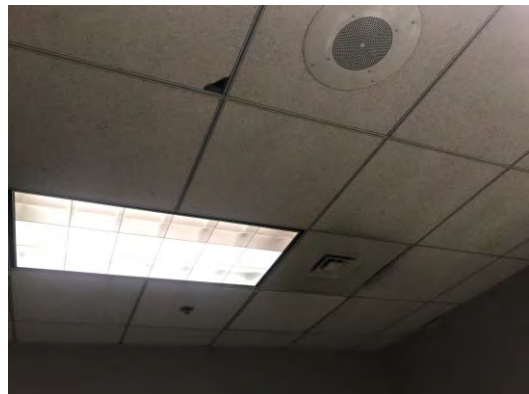
Record ID 1127  
System C2050 - CEILING FINISHES

Year Installed / Industry Life / Remaining Useful Life - / 50 / -  
Item No. C2050.80.001  
Floor/Room: / Property/Evidence  
**Priority:** 3  
Quantity/Unit of Measure: 400/SF  
Total Deficiency Cost: \$6,590  
Deficiency Description: *Lay-in Acoustical Tile is in poor condition.*

Description of Work: *Remove existing lay-in Acoustical Tiles and replace with new lay-in Acoustical Tiles.*

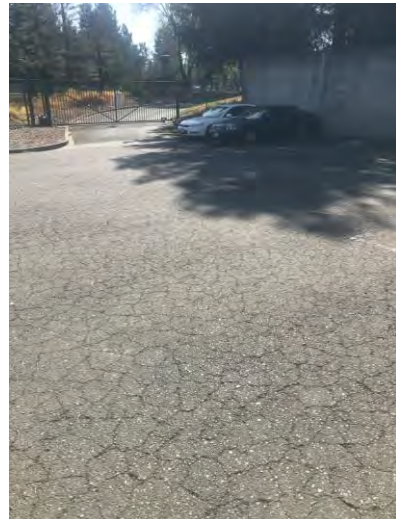
Record ID: 1128  
System: G2020 - PARKING LOTS  
Year Installed / Industry Life / Remaining Useful Life: - / - / -  
Item No.: G2020.10.002  
Floor/Room: Site / Parking Lots  
Priority: 5  
Quantity/Unit of Measure: 20,000/SF  
Total Deficiency Cost: \$661,970  
Deficiency Description: *AC paving is in poor condition.*

Comments: *Entire parking lot.*

Description of Work: *Replace AC pavement section.*

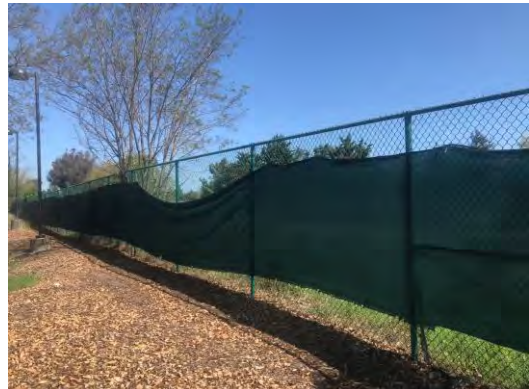
Record ID: 1129  
System: G2060 - SITE DEVELOPMENT  
Year Installed / Industry Life / Remaining Useful Life: - / - / -  
Item No.: G2060.20.020  
Floor/Room: Site / Fencing  
Priority: 3  
Quantity/Unit of Measure: 300/LF  
Total Deficiency Cost: \$9,480  
Deficiency Description: *Chain link fencing is showing signs of wear.*

Description of Work: *Replace entire fence, including mesh, posts, and concrete bases.*

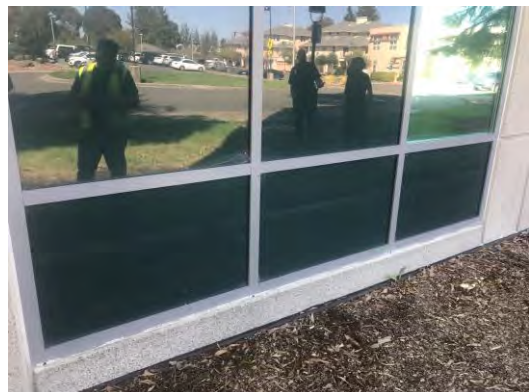
Record ID: 1134  
System: B2020 - EXTERIOR WINDOWS  
Year Installed / Industry Life / Remaining Useful Life: - / - / -  
Item No.: B2020.20.005  
Floor/Room: 1 / Exterior  
Priority: 2  
Quantity/Unit of Measure: 100/SF  
Total Deficiency Cost: \$16,830  
Deficiency Description: *Glazing is damaged.*

Comments: *Windows have been damaged from rocks thrown from mowing.*

Description of Work: *Re-glaze single glazing window.*

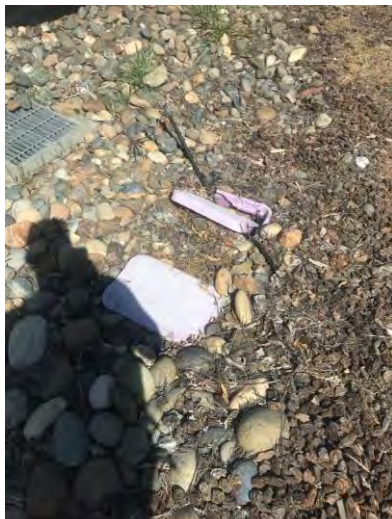
Record ID: 1137  
System: G3010 - WATER UTILITIES  
Year Installed / Industry Life / Remaining Useful Life: - / - / -  
Item No.: G3010.50.001  
Floor/Room: Site / Exterior  
Priority: 1  
Quantity/Unit of Measure: 1/EA  
Total Deficiency Cost: \$780  
Deficiency Description: *Water valve lid is approaching the end of its useful service life.*  
Description of Work: *Replace water valve box lid.*

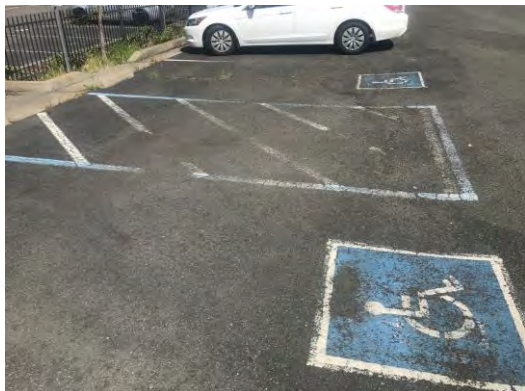
Record ID: 1139  
System: G2020 - PARKING LOTS  
Year Installed / Industry Life / Remaining Useful Life: - / - / -  
Item No.: G2020.40.005  
Floor/Room: Site / Parking Lot  
Priority: 1  
Quantity/Unit of Measure: 1,000/LF  
Total Deficiency Cost: \$2,140  
Deficiency Description: *Parking stall striping is worn.*

Comments: *Throughout parking lot.*

Description of Work: *Restripe parking stall striping.*

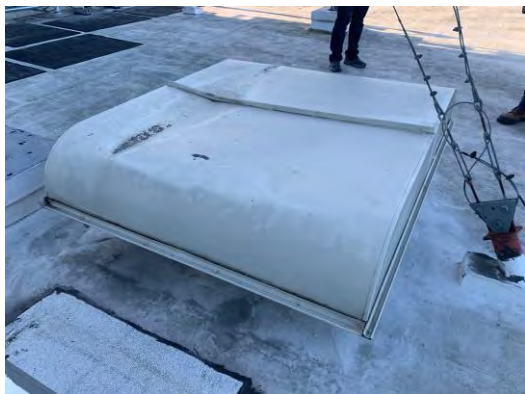
Record ID: 1164  
System: D3060 - VENTILATION  
Year Installed / Industry Life / Remaining Useful Life: - / 30 / -  
Item No.: D3060.30.007  
Floor/Room:  
Priority: 5  
Quantity/Unit of Measure: 1/EA  
Total Deficiency Cost: \$7,620  
Deficiency Description: *Ventilator is approaching the end of its expected useful life.*

Description of Work: *Provide equipment replacement and installation.*

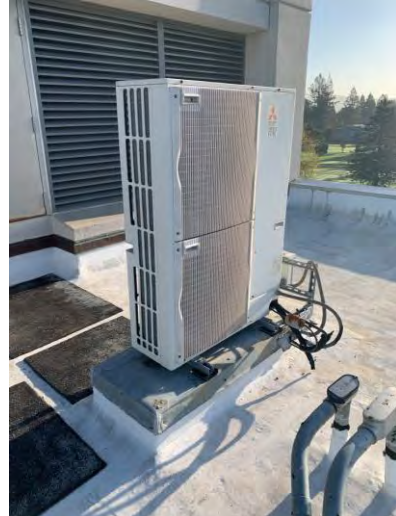
Deficiency Description: *Split system with fan coil and outdoor condensing unit is approaching the end of its expected useful life.*

Description of Work: *Provide equipment replacement and installation.*

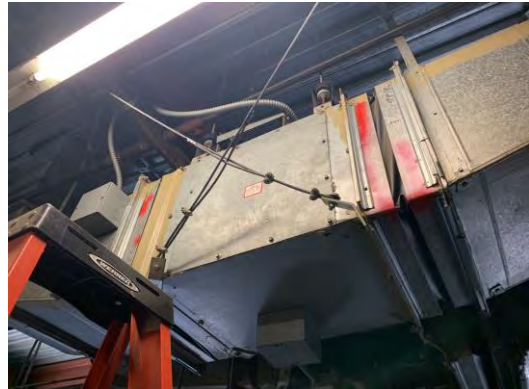
Record ID 1166  
System D3060 - VENTILATION

Deficiency Description: *In-Line building exhaust fan is approaching the end of its expected useful life.*

Description of Work: *Provide equipment replacement and installation.*

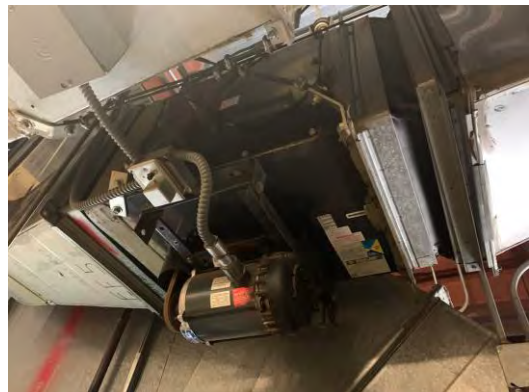
Record ID 1167  
System D3060 - VENTILATION

Deficiency Description: *In-Line building exhaust fan is approaching the end of its expected useful life.*

Description of Work: *Provide equipment replacement and installation.*

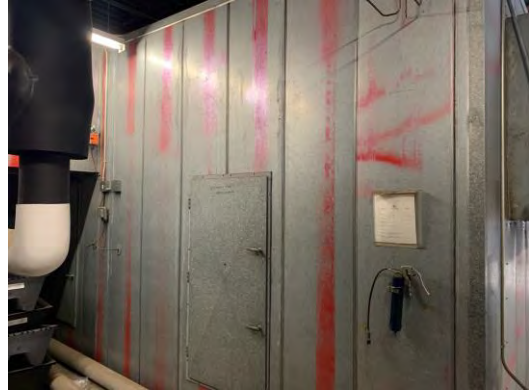
Record ID 1168  
System D3050 - FACILITY HVAC DISTRIBUTION SYSTEMS  
Year Installed / Industry Life / Remaining Useful Life - / 30 / -  
Item No. D3050.50.006  
Floor/Room:  
**Priority:** 4  
Quantity/Unit of Measure: 1/EA  
Total Deficiency Cost: \$82,280  
Deficiency Description: *Air handler is approaching the end of its expected useful life.*

Description of Work: *Provide equipment replacement and installation.*

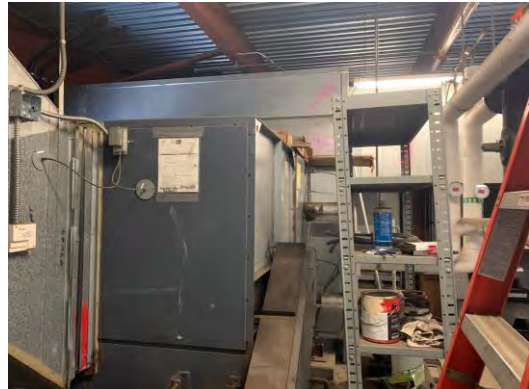
Record ID 1169  
System D3050 - FACILITY HVAC DISTRIBUTION SYSTEMS  
Year Installed / Industry Life / Remaining Useful Life - / 30 / -  
Item No. D3050.50.006  
Floor/Room:  
**Priority:** 5  
Quantity/Unit of Measure: 1/EA  
Total Deficiency Cost: \$85,620  
Deficiency Description: *Air handler is approaching the end of its expected useful life.*

Description of Work: *Provide equipment replacement and installation.*

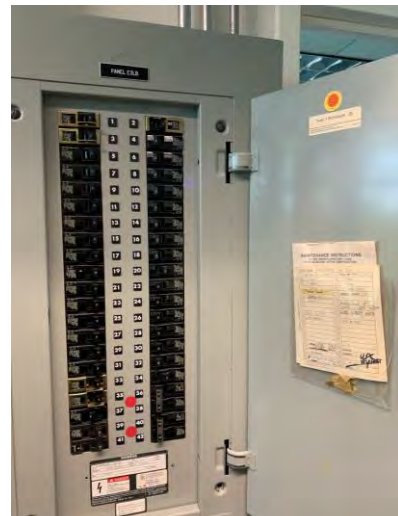
Record ID 1170  
System D5020 - ELECTRICAL SERVICE AND DISTRIBUTION  
Year Installed / Industry Life / Remaining Useful Life 1992 / 30 / 0  
Item No. D5020.30.1008  
Floor/Room:  
**Priority:** 1  
Quantity/Unit of Measure: 1/EA  
Total Deficiency Cost: \$18,570  
Deficiency Description: *The panelboard is past its expected useful life.*

Description of Work: *Replace the existing panelboard with a new panelboard.*

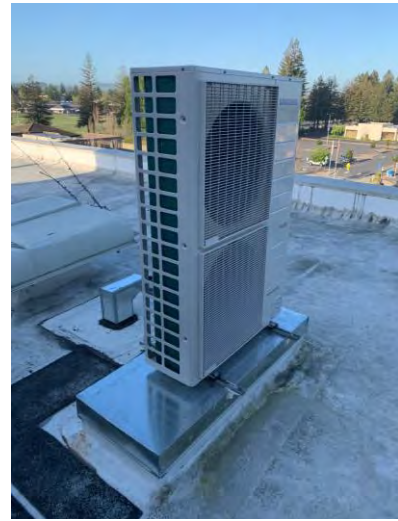
Deficiency Description: *Split system with fan coil and outdoor condensing unit is approaching the end of its expected useful life.*

Description of Work: *Provide equipment replacement and installation.*

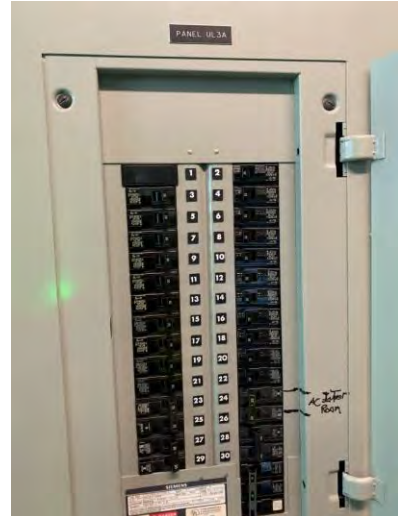
Record ID: 1174  
 System: D5020 - ELECTRICAL SERVICE AND DISTRIBUTION

Deficiency Description: *The panelboard is past its expected useful life.*

Description of Work: *Replace the existing panelboard with a new panelboard.*

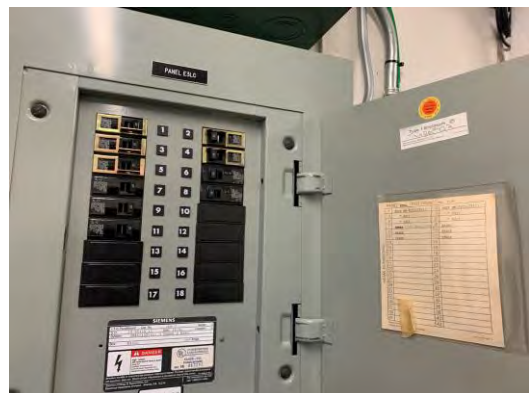
Record ID: 1176  
 System: D5020 - ELECTRICAL SERVICE AND DISTRIBUTION

Deficiency Description: *The panelboard is past its expected useful life.*

Description of Work: *Replace the existing panelboard with a new panelboard.*

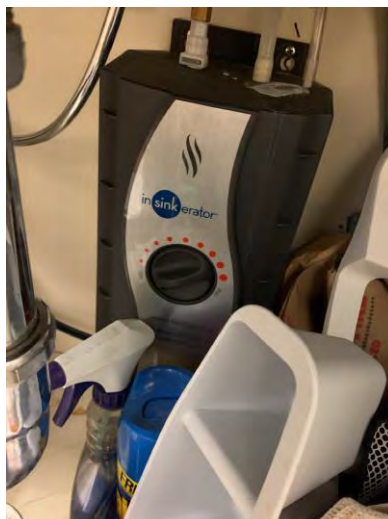
Deficiency Description: *Instantaneous water heater is approaching the end of its expected useful life.*

Description of Work: *Provide equipment replacement and installation.*

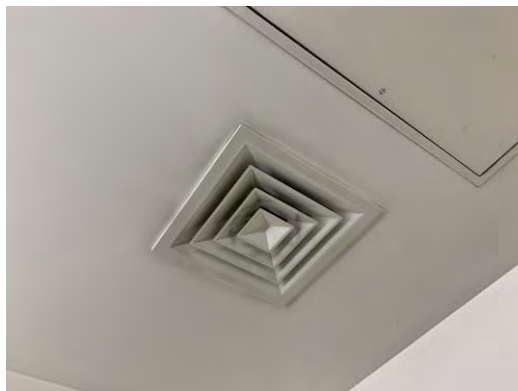
Deficiency Description: *Diffuser vibration adding significant noise in the space.*

Description of Work: *Secure rattling diffuser and investigate if motor balance is causing additional issues.*

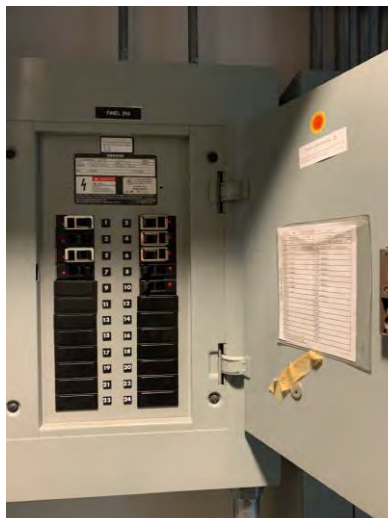
Deficiency Description: *The panelboard is past its expected useful life.*

Description of Work: *Replace the existing panelboard with a new panelboard.*

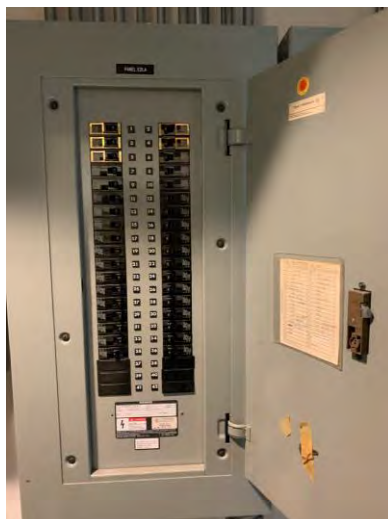
Record ID: 1180  
 System: D5020 - ELECTRICAL SERVICE AND DISTRIBUTION  
 Year Installed / Industry Life / Remaining Useful Life: 1992 / 30 / 0  
 Item No.: D5020.30.1012  
 Floor/Room:  
**Priority:** 1  
 Quantity/Unit of Measure: 1/EA  
 Total Deficiency Cost: \$26,230  
 Deficiency Description: *The panelboard is past its expected useful life.*

Description of Work: *Replace the existing panelboard with a new panelboard.*

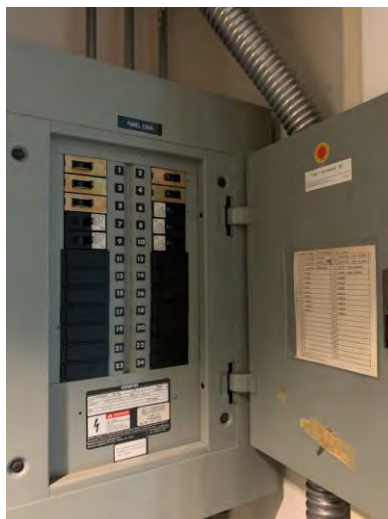
Record ID: 1181  
 System: D5020 - ELECTRICAL SERVICE AND DISTRIBUTION  
 Year Installed / Industry Life / Remaining Useful Life: 1992 / 30 / 0  
 Item No.: D5020.30.1007  
 Floor/Room:  
**Priority:** 1  
 Quantity/Unit of Measure: 1/EA  
 Total Deficiency Cost: \$11,460  
 Deficiency Description: *The panelboard is past its expected useful life.*

Description of Work: *Replace the existing panelboard with a new panelboard.*

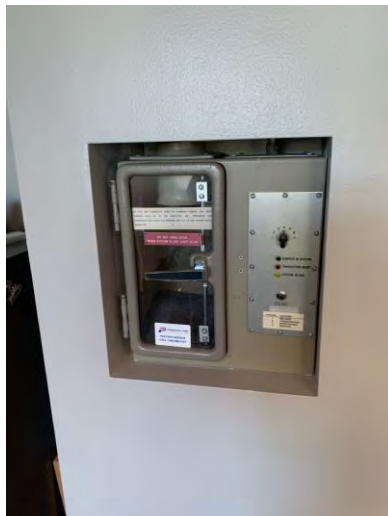
Record ID: 1182  
 System: D1050 - MATERIAL HANDLING  
 Year Installed / Industry Life / Remaining Useful Life: - / 25 / -  
 Item No.: D1050.70.001  
 Floor/Room:  
**Priority:** 1  
 Quantity/Unit of Measure: 1/EA  
 Total Deficiency Cost: \$64,210  
 Deficiency Description: *Pneumatic tube system is at or approaching end of expected useful service life.*

Comments: *Pneumatic tube system failed and would like it fixed or replaced, but expensive to maintain due to access to parts?*

Description of Work: *Provide an equivalent equipment replacement and installation.*

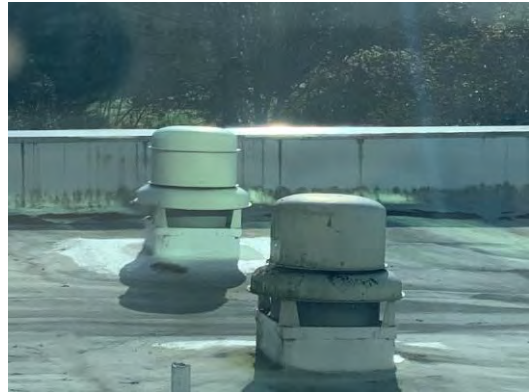
Deficiency Description: *Roof exhaust fan is approaching the end of its expected useful life.*

Comments: *No roof access*

Description of Work: *Provide equipment replacement and installation.*

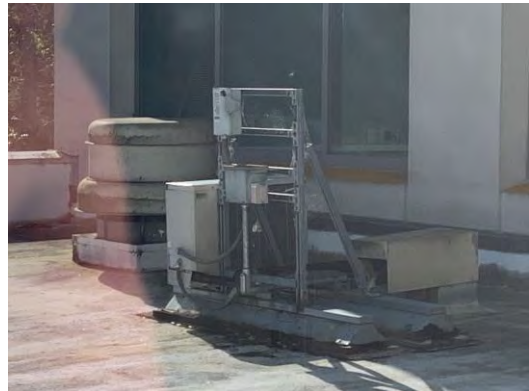
Record ID: 1184  
 System: D3030 - COOLING SYSTEMS

Deficiency Description: *Split system with wall mounted AC and outdoor condensing unit is approaching the end of its expected useful life.*

Description of Work: *Provide equipment replacement and installation.*

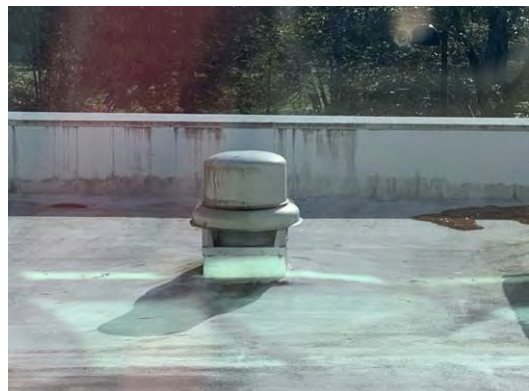
Record ID: 1185  
 System: D3060 - VENTILATION

Deficiency Description: *Roof exhaust fan is approaching the end of its expected useful life.*

Description of Work: *Provide equipment replacement and installation.*

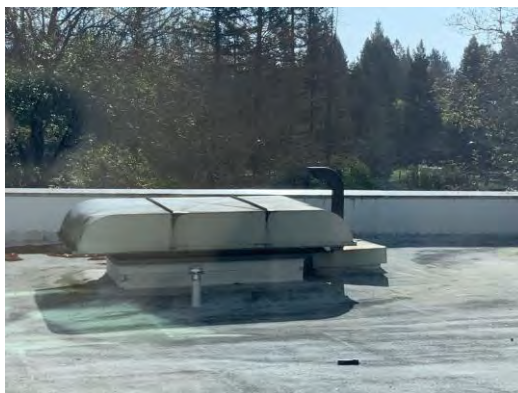
Record ID: 1186  
System: D3060 - VENTILATION  
Year Installed / Industry Life / Remaining Useful Life: - / 30 / -  
Item No.: D3060.30.007  
Floor/Room:  
**Priority:** 4  
Quantity/Unit of Measure: 1/EA  
Total Deficiency Cost: \$7,320  
Deficiency Description: *Ventilator is approaching the end of its expected useful life.*  
Description of Work: *Provide equipment replacement and installation.*  
Comments:

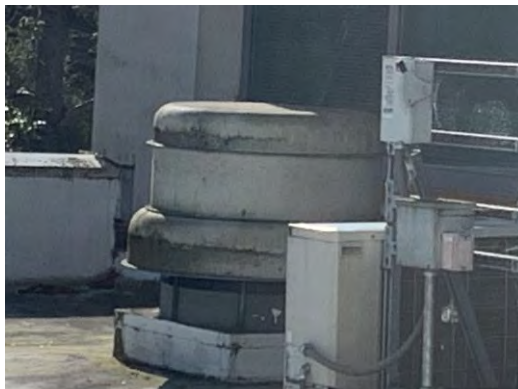
Record ID: 1187  
System: D3060 - VENTILATION  
Year Installed / Industry Life / Remaining Useful Life: - / 25 / -  
Item No.: D3060.30.005  
Floor/Room:  
**Priority:** 4  
Quantity/Unit of Measure: 1/EA  
Total Deficiency Cost: \$8,070  
Deficiency Description: *Roof exhaust fan is approaching the end of its expected useful life.*  
Description of Work: *Provide equipment replacement and installation.*  
Comments:

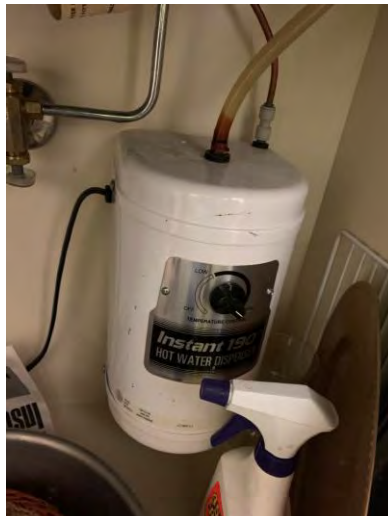
Record ID: 1189  
System: D2010 - DOMESTIC WATER DISTRIBUTION  
Year Installed / Industry Life / Remaining Useful Life: - / 5 / -  
Item No.: D2010.20.006  
Floor/Room:  
**Priority:** 5  
Quantity/Unit of Measure: 1/EA  
Total Deficiency Cost: \$1,920  
Deficiency Description: *Instantaneous water heater is approaching the end of its expected useful life.*  
Description of Work: *Provide equipment replacement and installation.*  
Comments:

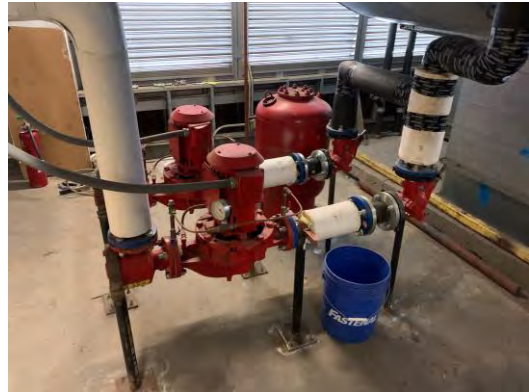
Record ID: 1191  
 System: D3050 - FACILITY HVAC DISTRIBUTION SYSTEMS  
 Year Installed / Industry Life / Remaining Useful Life: - / 15 / -  
 Item No.: D3050.10.002  
 Floor/Room:  
**Priority:** 7  
 Quantity/Unit of Measure: 2/EA  
 Total Deficiency Cost: \$30,450  
 Deficiency Description: *Hydronic pump is approaching the end of its expected useful life.*

Description of Work: *Provide equipment replacement and installation.*

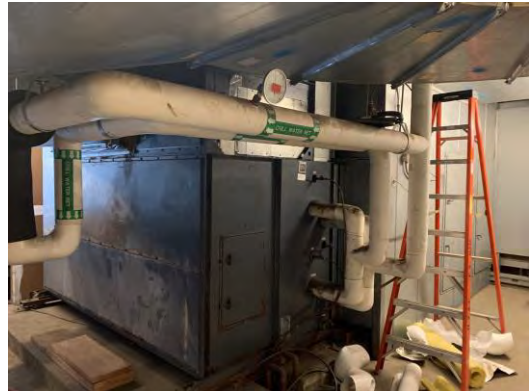
Record ID: 1192  
 System: D3050 - FACILITY HVAC DISTRIBUTION SYSTEMS  
 Year Installed / Industry Life / Remaining Useful Life: - / 30 / -  
 Item No.: D3050.50.006  
 Floor/Room:  
**Priority:** 4  
 Quantity/Unit of Measure: 1/EA  
 Total Deficiency Cost: \$82,280  
 Deficiency Description: *Air handler is approaching the end of its expected useful life.*

Comments: *Unbalanced filter motor, difficulty getting filters to room*

Description of Work: *Provide equipment replacement and installation.*

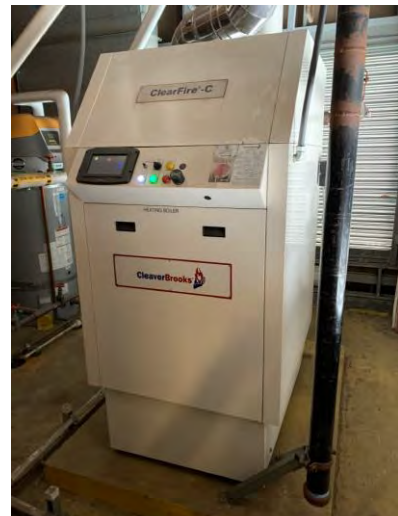
Record ID: 1193  
 System: D3020 - HEATING SYSTEMS  
 Year Installed / Industry Life / Remaining Useful Life: 2016 / 30 / 24  
 Item No.: D3020.10.003  
 Floor/Room:  
**Priority:** 7  
 Quantity/Unit of Measure: 1/EA  
 Total Deficiency Cost: \$154,210  
 Deficiency Description: *Boiler is approaching the end of its expected useful life.*

Description of Work: *Provide equipment replacement and installation.*

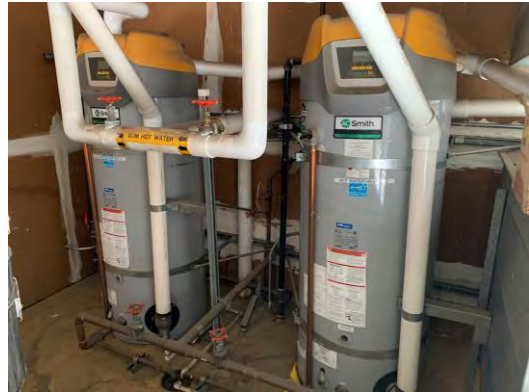
Deficiency Description: *Gas fired water heater is approaching the end of its expected useful life.*

Description of Work: *Provide equipment replacement and installation.*

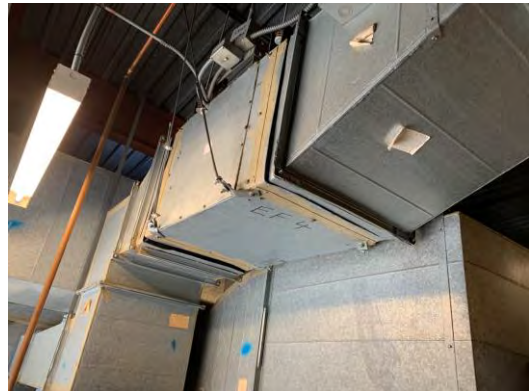
Deficiency Description: *In-Line building exhaust fan is approaching the end of its expected useful life.*

Description of Work: *Provide equipment replacement and installation.*

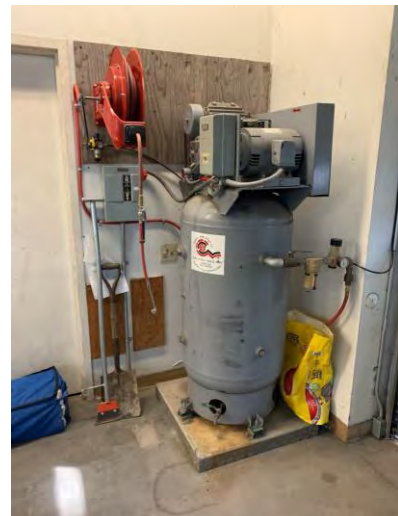
Deficiency Description: *Air compressor is approaching the end of its expected useful life.*

Description of Work: *Provide equipment replacement and installation.*

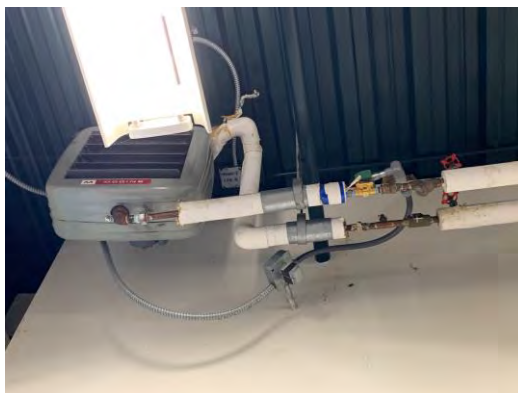
Deficiency Description: *Unit heater is approaching the end of its expected useful life.*

Description of Work: *Provide equipment replacement and installation.*

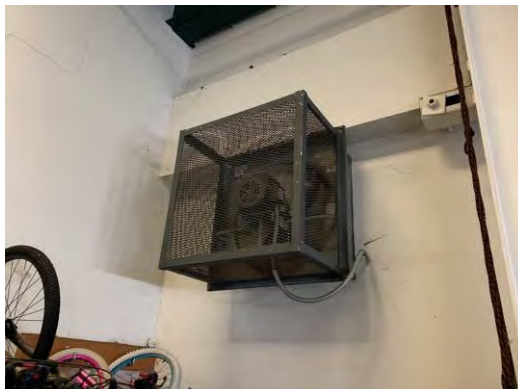
Deficiency Description: *Sidewall propeller fan is approaching the end of its expected useful life.*

Description of Work: *Provide equipment replacement and installation.*

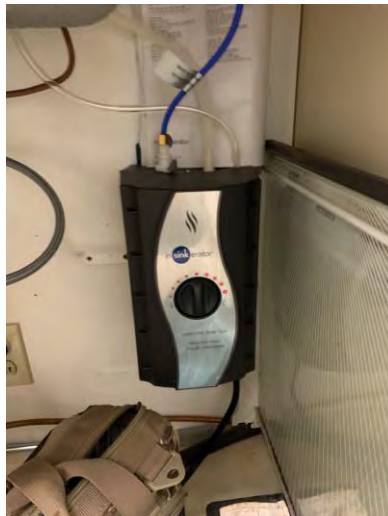
Deficiency Description: *Instantaneous water heater is approaching the end of its expected useful life.*

Description of Work: *Provide equipment replacement and installation.*

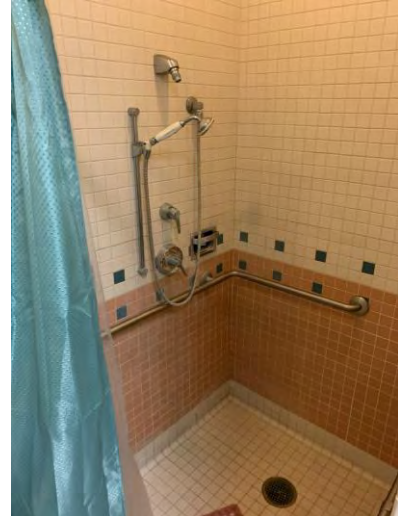
Deficiency Description: *Further investigation required to determine source of shower issues with smell.*

Comments: *Shower issues with smell*

Description of Work: *Provide additional investigation to remedy shower smell issues in building.*

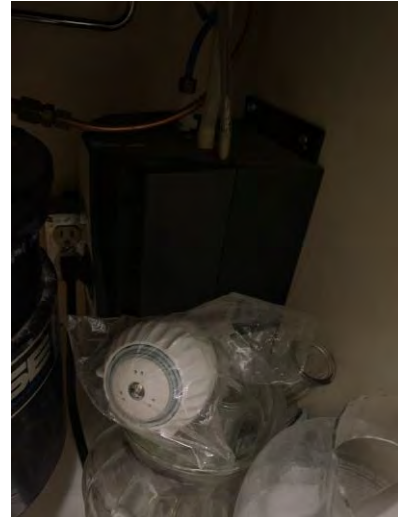
Deficiency Description: *Instantaneous water heater is approaching the end of its expected useful life.*

Description of Work: *Provide equipment replacement and installation.*

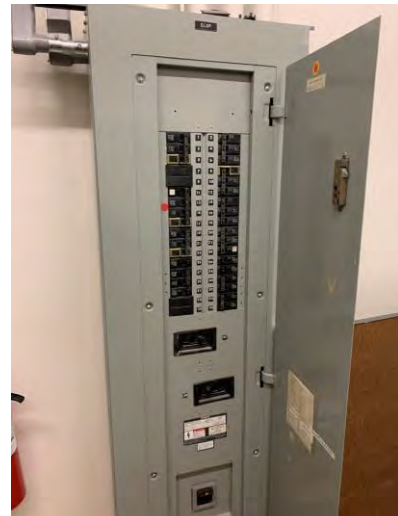
Deficiency Description: *The panelboard is past its expected useful life.*

Description of Work: *Replace the existing panelboard with a new panelboard.*

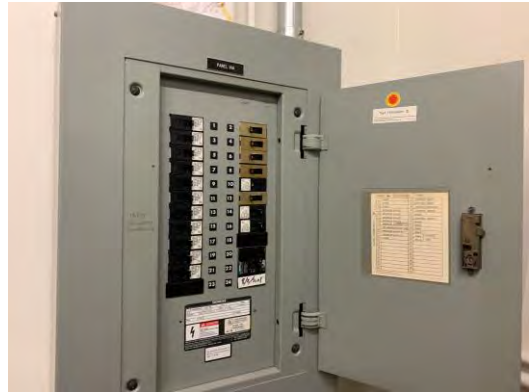
Record ID: 1205  
System: D5020 - ELECTRICAL SERVICE AND DISTRIBUTION  
Year Installed / Industry Life / Remaining Useful Life: 1992 / 30 / 0  
Item No.: D5020.30.1007  
Floor/Room:  
**Priority:** 1  
Quantity/Unit of Measure: 1/EA  
Total Deficiency Cost: \$11,460  
Deficiency Description: *The panelboard is past its expected useful life.*

Description of Work: *Replace the existing panelboard with a new panelboard.*

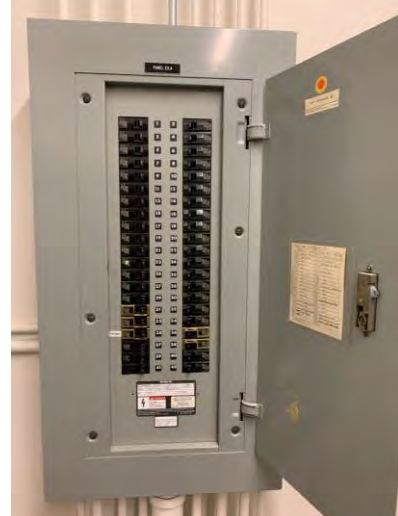
Record ID: 1206  
System: D5020 - ELECTRICAL SERVICE AND DISTRIBUTION  
Year Installed / Industry Life / Remaining Useful Life: 1992 / 30 / 0  
Item No.: D5020.30.1008  
Floor/Room:  
**Priority:** 1  
Quantity/Unit of Measure: 1/EA  
Total Deficiency Cost: \$18,570  
Deficiency Description: *The panelboard is past its expected useful life.*

Description of Work: *Replace the existing panelboard with a new panelboard.*

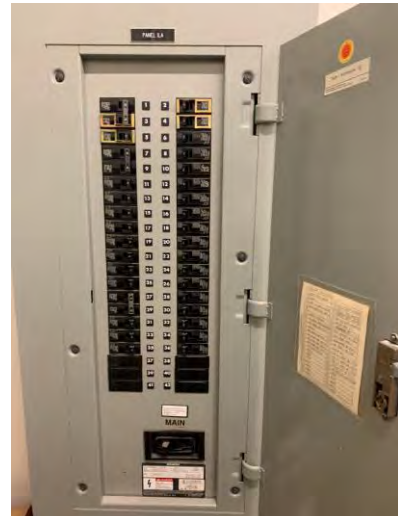
Record ID: 1208  
System: D5020 - ELECTRICAL SERVICE AND DISTRIBUTION  
Year Installed / Industry Life / Remaining Useful Life: 1992 / 30 / 0  
Item No.: D5020.30.1008  
Floor/Room:  
**Priority:** 1  
Quantity/Unit of Measure: 1/EA  
Total Deficiency Cost: \$18,570  
Deficiency Description: *The panelboard is past its expected useful life.*

Description of Work: *Replace the existing panelboard with a new panelboard.*

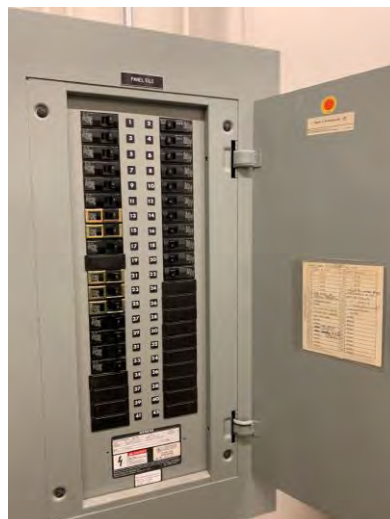
Record ID: 1209  
System: D5020 - ELECTRICAL SERVICE AND DISTRIBUTION  
Year Installed / Industry Life / Remaining Useful Life: 1992 / 30 / 0  
Item No.: D5020.30.1007  
Floor/Room:  
**Priority:** 1  
Quantity/Unit of Measure: 1/EA  
Total Deficiency Cost: \$11,460  
Deficiency Description: *The panelboard is past its expected useful life.*  
Description of Work: *Replace the existing panelboard with a new panelboard.*  
Comments:

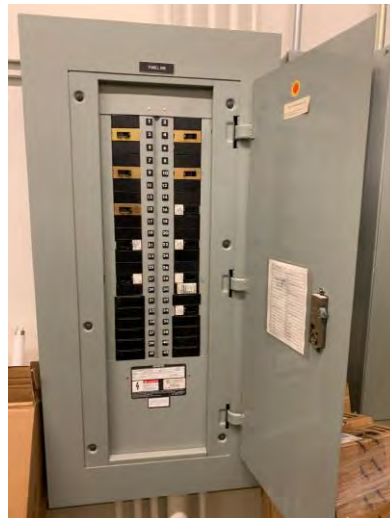
Record ID: 1210  
System: D5020 - ELECTRICAL SERVICE AND DISTRIBUTION  
Year Installed / Industry Life / Remaining Useful Life: 1992 / 30 / 0  
Item No.: D5020.30.1012  
Floor/Room:  
**Priority:** 1  
Quantity/Unit of Measure: 1/EA  
Total Deficiency Cost: \$26,230  
Deficiency Description: *The panelboard is past its expected useful life.*  
Description of Work: *Replace the existing panelboard with a new panelboard.*  
Comments:

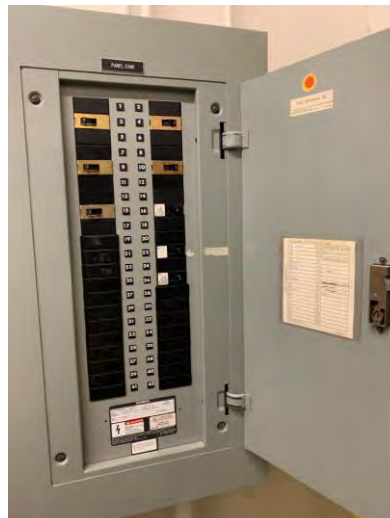
Record ID: 1211  
System: D5020 - ELECTRICAL SERVICE AND DISTRIBUTION  
Year Installed / Industry Life / Remaining Useful Life: 1992 / 30 / 0  
Item No.: D5020.30.1004  
Floor/Room:  
**Priority:** 1  
Quantity/Unit of Measure: 1/EA  
Total Deficiency Cost: \$8,610  
Deficiency Description: *The 100A panelboard is past its expected useful life.*  
Description of Work: *Replace the existing panelboard with a new panelboard.*  
Comments:

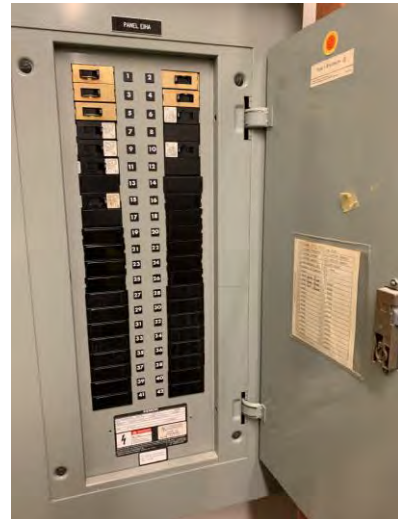
Record ID: 1212  
 System: D5020 - ELECTRICAL SERVICE AND DISTRIBUTION  
 Year Installed / Industry Life / Remaining Useful Life: 1992 / 30 / 0  
 Item No.: D5020.30.1004  
 Floor/Room:  
**Priority:** 1  
 Quantity/Unit of Measure: 1/EA  
 Total Deficiency Cost: \$8,610  
 Deficiency Description: *The 100A panelboard is past its expected useful life.*

Description of Work: *Replace the existing panelboard with a new panelboard.*

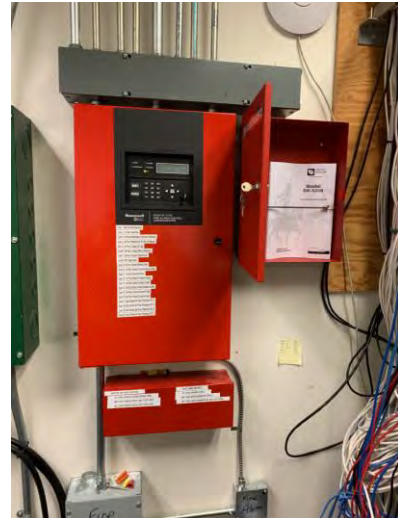
Record ID: 1213  
 System: D7050 - DETECTION AND ALARM  
 Year Installed / Industry Life / Remaining Useful Life: 2000 / 15 / -7  
 Item No.: D7050.10.025  
 Floor/Room:  
**Priority:** 1  
 Quantity/Unit of Measure: 52,000/SF  
 Total Deficiency Cost: \$1,151,730  
 Deficiency Description: *The existing fire alarm system is past its expected useful life.*

Comments: *Age is estimated*

Description of Work: *Replace the existing fire alarm system with a complete, site-wide, fully addressable fire alarm system.*

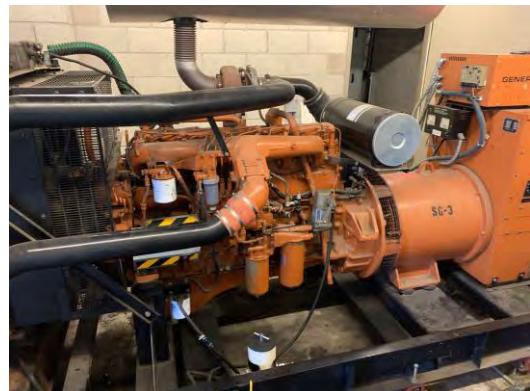
Record ID: 1219  
 System: D5010 - FACILITY POWER GENERATION  
 Year Installed / Industry Life / Remaining Useful Life: 1992 / 25 / -5  
 Item No.: D5010.10.017  
 Floor/Room:  
**Priority:** 1  
 Quantity/Unit of Measure: 276/KW  
 Total Deficiency Cost: \$458,490  
 Deficiency Description: *The standby generator is past its expected useful life.*

Description of Work: *Install a new diesel genset with the appropriate diesel fuel tank.*

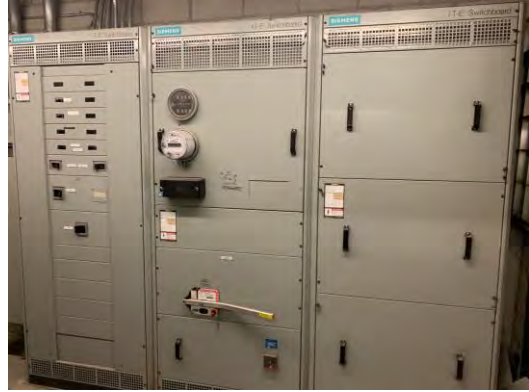
Record ID 1221  
System D5020 - ELECTRICAL SERVICE AND DISTRIBUTION  
Year Installed / Industry Life / Remaining Useful Life 1992 / 20 / -10  
Item No. D5020.10.313  
Floor/Room:  
**Priority:** 1  
Quantity/Unit of Measure: 1/EA  
Total Deficiency Cost: \$42,470  
Deficiency Description: *The 1200A metered main switchboard is past its expected useful life.*

Description of Work: *Replace the existing metered main switchboard with a new metered main switchboard.*

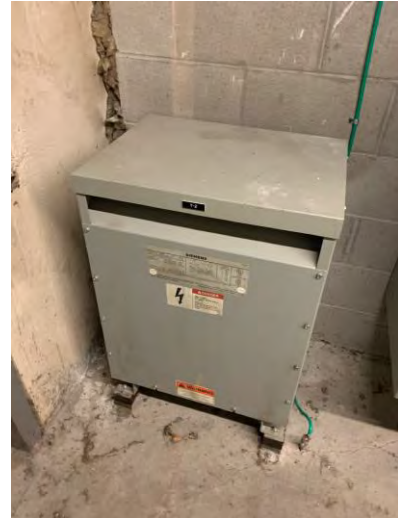
Record ID 1223  
System D5020 - ELECTRICAL SERVICE AND DISTRIBUTION  
Year Installed / Industry Life / Remaining Useful Life 1992 / 30 / 0  
Item No. D5020.10.207  
Floor/Room:  
**Priority:** 1  
Quantity/Unit of Measure: 1/EA  
Total Deficiency Cost: \$20,230  
Deficiency Description: *The 50kVA transformer is past its expected useful life.*

Description of Work: *Replace the existing transformer with a new transformer.*

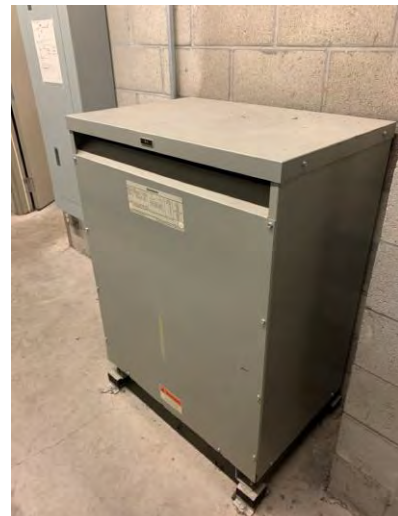
Record ID 1224  
System D5020 - ELECTRICAL SERVICE AND DISTRIBUTION  
Year Installed / Industry Life / Remaining Useful Life 1992 / 30 / 0  
Item No. D5020.10.219  
Floor/Room:  
**Priority:** 1  
Quantity/Unit of Measure: 1/EA  
Total Deficiency Cost: \$25,850  
Deficiency Description: *The 150kVA is past its expected useful life.*

Description of Work: *Replace the existing transformer with a new transformer.*

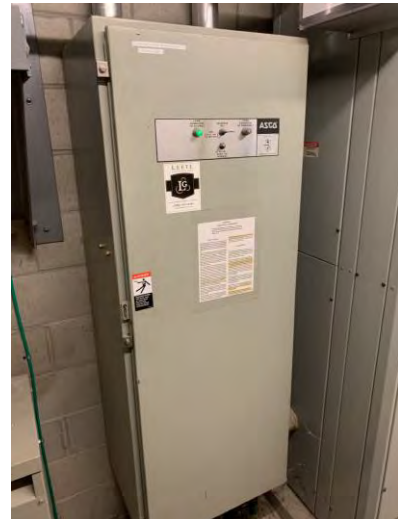
Deficiency Description: *The 800A 3-pole automatic transfer switch (ATS) is approaching the end of its expected useful life.*

Description of Work: *Replace the existing 3-pole ATS with a new 3-pole ATS.*

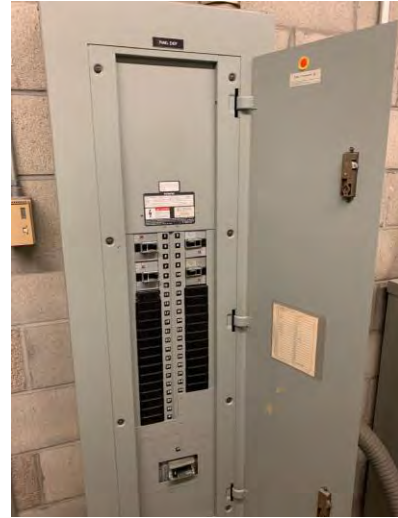
Deficiency Description: *The 600A, (main lugs only), switchboard is approaching the end of its expected useful life.*

Description of Work: *Replace the existing switchboard with a new switchboard.*

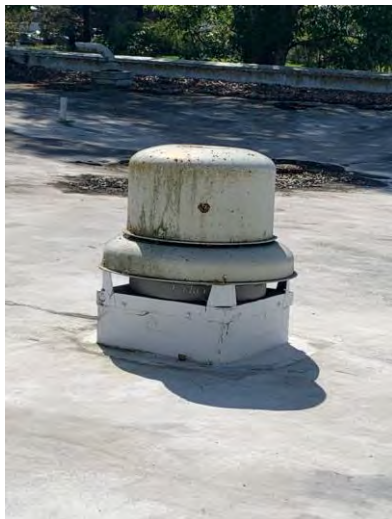
Deficiency Description: *Roof exhaust fan is approaching the end of its expected useful life.*

Description of Work: *Provide equipment replacement and installation.*

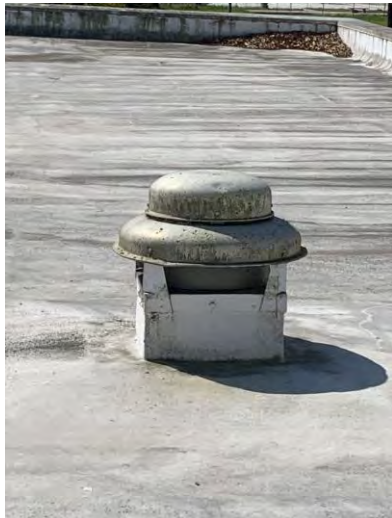
Deficiency Description: *Roof exhaust fan is approaching the end of its expected useful life.*

Description of Work: *Provide equipment replacement and installation.*

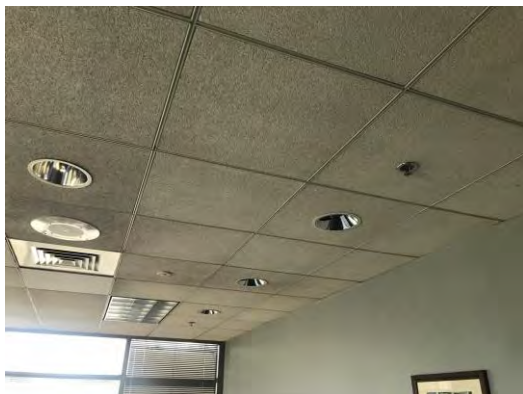
Deficiency Description: *Interior lighting system is past its expected useful life but in working condition.*

Description of Work: *Provide new interior lighting and control system throughout building per current CEC T24 code.*

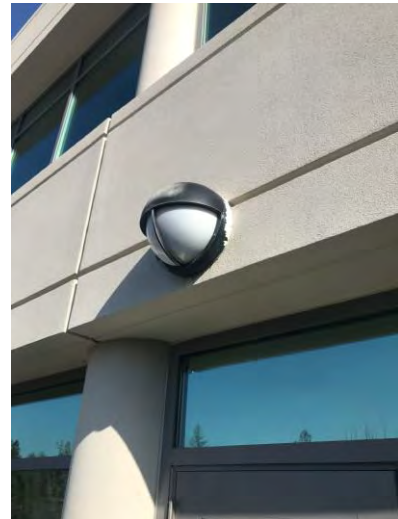
Deficiency Description: *The exterior light fixture is past its expected useful life.*

Description of Work: *Replace the existing light fixture with an LED lighting fixture.*

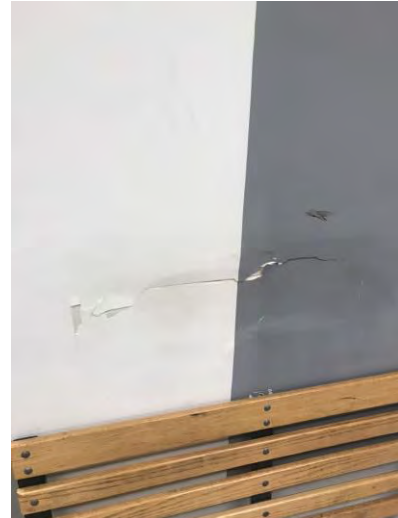
Deficiency Description: *Painted gypsum wallboard is in poor condition with several cracks.*

Description of Work: *Remove and replace existing gypsum board with a new gypsum board and expansion joints. Tape and paint.*

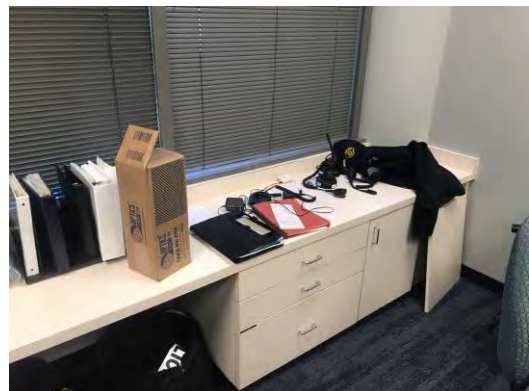
Deficiency Description: *Plastic laminate base cabinet (with countertop) is in poor condition.*

Description of Work: *Remove and replace with new plastic laminate base cabinet and countertop.*

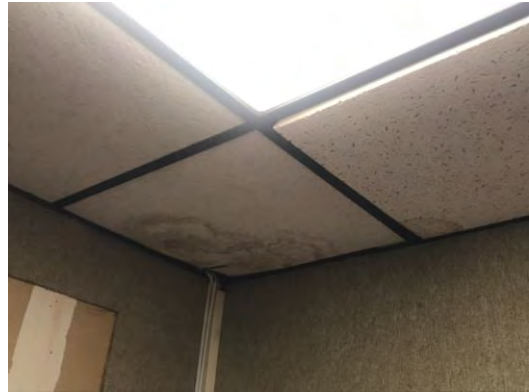
Record ID: 1141  
 System: C2050 - CEILING FINISHES  
 Year Installed / Industry Life / Remaining Useful Life: - / 50 / -  
 Item No.: C2050.80.001  
 Floor/Room: 1 / Office  
**Priority:** 1  
 Quantity/Unit of Measure: 100/SF  
 Total Deficiency Cost: \$1,540  
 Deficiency Description: *Lay-in Acoustical Tile is in poor condition.*

Description of Work: *Remove existing lay-in Acoustical Tiles and replace with new lay-in Acoustical Tiles.*
