# City of Rohnert Park

## Facility Condition Assessment

Final Report

October 17, 2022

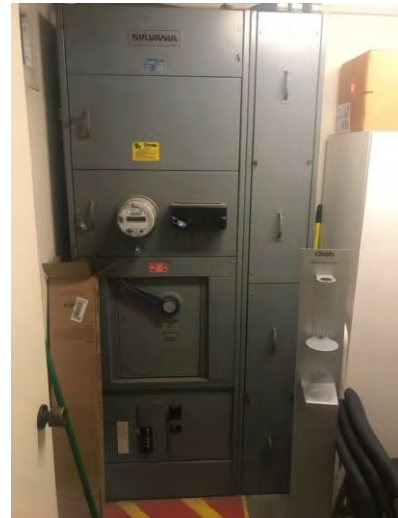
Record ID: 1142  
 System: D5020 - ELECTRICAL SERVICE AND DISTRIBUTION  
 Year Installed / Industry Life / Remaining Useful Life: 1978 / 20 / -24  
 Item No.: D5020.10.302  
 Floor/Room: 1  
**Priority:** 1  
 Quantity/Unit of Measure: 1/EA  
 Total Deficiency Cost: \$17,750  
 Deficiency Description: *The 400A metered main switchboard is past its expected useful life.*

Description of Work: *Replace the existing metered main switchboard with a new metered main switchboard.*

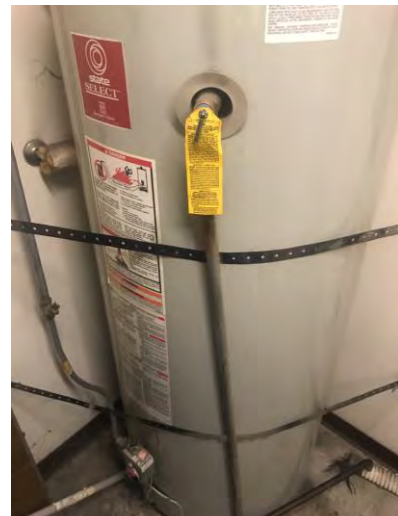
Record ID: 1143  
 System: D2010 - DOMESTIC WATER DISTRIBUTION  
 Year Installed / Industry Life / Remaining Useful Life: 1998 / 15 / -9  
 Item No.: D2010.20.002  
 Floor/Room: 1 / Water Heater  
**Priority:** 1  
 Quantity/Unit of Measure: 1/EA  
 Total Deficiency Cost: \$13,250  
 Deficiency Description: *Gas fired water heater is approaching the end of its expected useful life.*

Description of Work: *Provide equipment replacement and installation.*

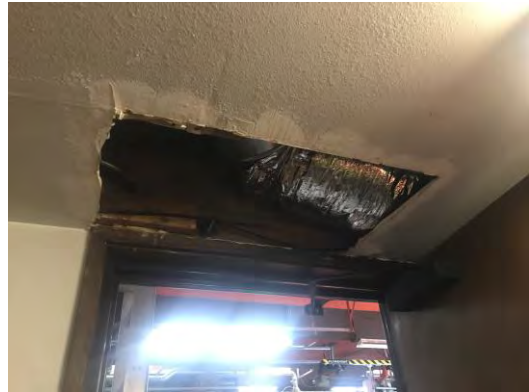
Year Installed / Industry Life / Remaining Useful Life: - / 30 / -  
Item No.: C2050.10.001  
Floor/Room: 1 / Ceiling  
**Priority:** 1  
Quantity/Unit of Measure: 100/SF  
Total Deficiency Cost: \$2,020  
Deficiency Description: *Painted gypsum wallboard ceiling is approaching the end of its useful life.*

Description of Work: *Remove the existing gypsum board ceiling and replace. Tape and paint.*

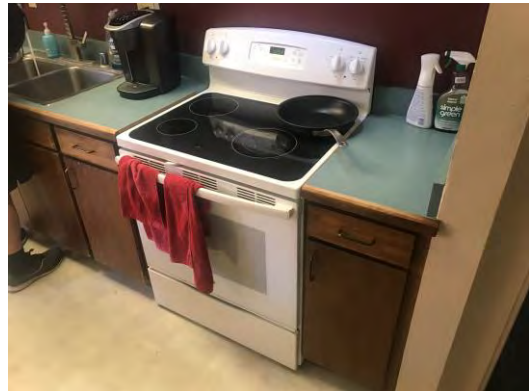
Year Installed / Industry Life / Remaining Useful Life: - / - / -  
Item No.: E2010.30.008  
Floor/Room: 1 / Kitchen  
**Priority:** 3  
Quantity/Unit of Measure: 15/LF  
Total Deficiency Cost: \$21,060  
Deficiency Description: *Plastic laminate base cabinet (with countertop) is in poor condition.*

Description of Work: *Remove and replace with new plastic laminate base cabinet and countertop.*

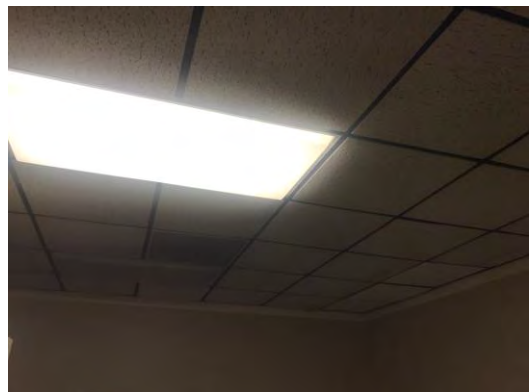
Year Installed / Industry Life / Remaining Useful Life: - / 50 / -  
Item No.: C2050.80.001  
Floor/Room: 1 / Dormitory  
**Priority:** 3  
Quantity/Unit of Measure: 3,000/SF  
Total Deficiency Cost: \$49,210  
Deficiency Description: *Lay-in Acoustical Tile is in poor condition.*

Description of Work: *Remove existing lay-in Acoustical Tiles and replace with new lay-in Acoustical Tiles.*

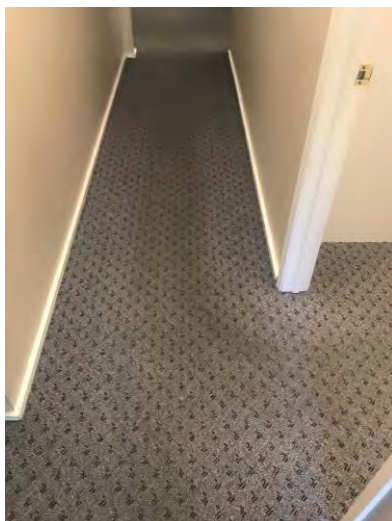
Deficiency Description: *Rolled carpeting is approaching the end of its useful life.*

Description of Work: *Replace carpet flooring.*

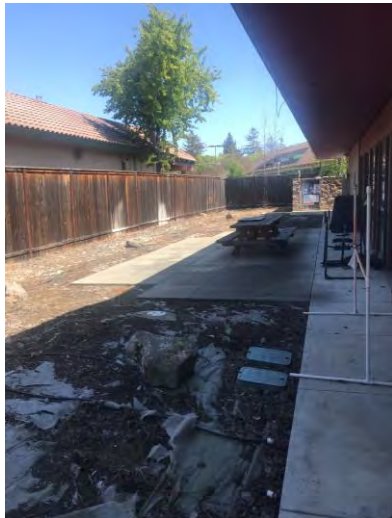
Deficiency Description: *Mulch or topsoil protection missing.*

Description of Work: *Provide additional mulch to address exposed soil areas.*

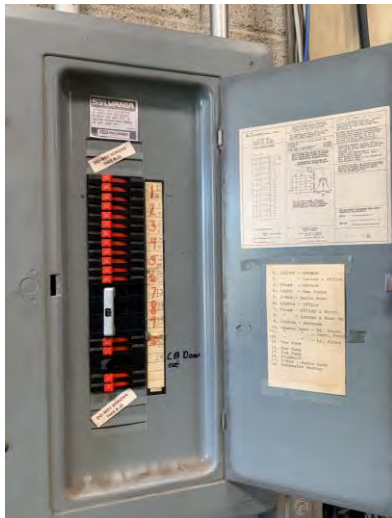
Deficiency Description: *The 100A panelboard is past its expected useful life.*

Description of Work: *Replace the existing panelboard with a new panelboard.*

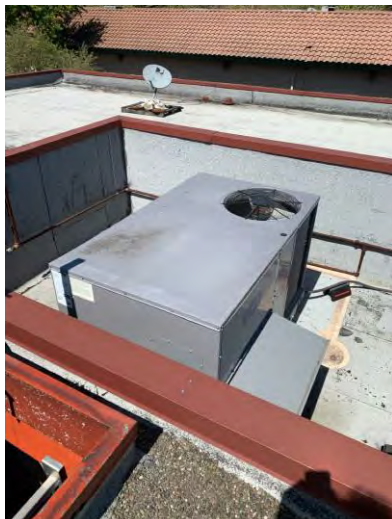
Deficiency Description: *Packaged AC unit is approaching the end of its expected useful life.*

Description of Work: *Provide equipment replacement and installation.*

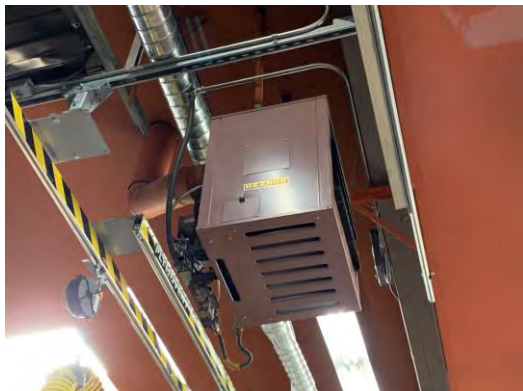
Deficiency Description: *Unit heater is approaching the end of its expected useful life.*

Description of Work: *Provide equipment replacement and installation.*

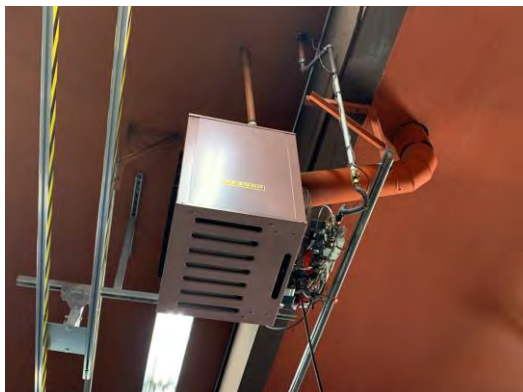
Deficiency Description: *Unit heater is approaching the end of its expected useful life.*

Description of Work: *Provide equipment replacement and installation.*

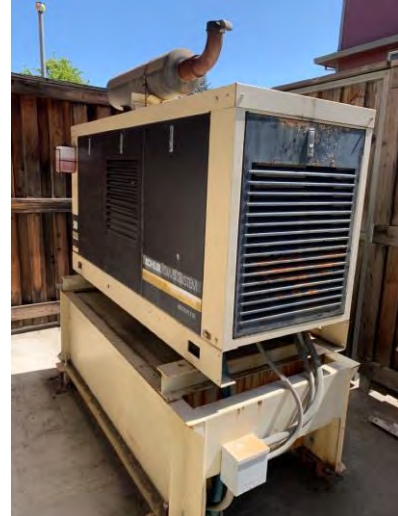
Deficiency Description: *The existing diesel generator is past its expected useful life.*

Description of Work: *Replace the existing generator with a new generator..*

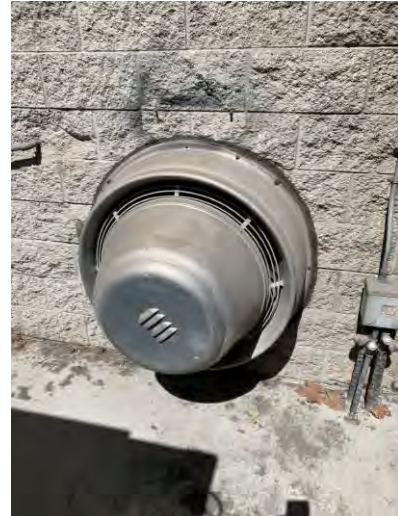
Deficiency Description: *Ventilator is approaching the end of its expected useful life.*

Comments: *Old exhaust system*

Description of Work: *Provide equipment replacement and installation.*

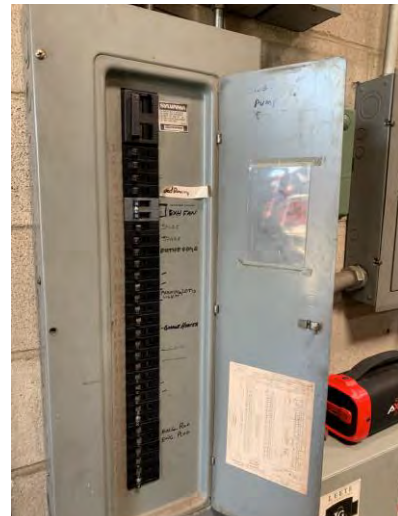
Deficiency Description: *The 225A panelboard is past its expected useful life.*

Description of Work: *Replace the existing panelboard with a new panelboard.*

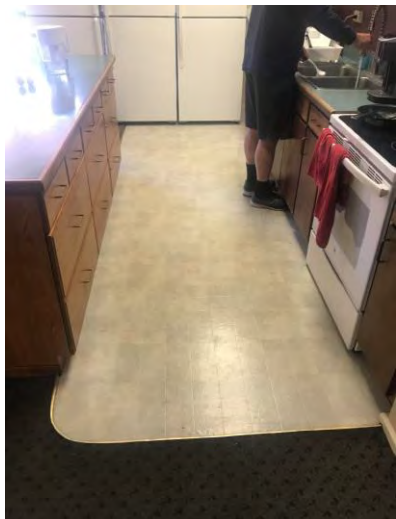
Year Installed / Industry Life / Remaining Useful Life: - / 60 / -  
Item No.: C2030.50.002  
Floor/Room: 1 / Kitchen  
**Priority:** 2  
Quantity/Unit of Measure: 100/SF  
Total Deficiency Cost: \$4,280  
Deficiency Description: *Linoleum flooring is showing signs of wear.*

Description of Work: *Replace linoleum flooring.*

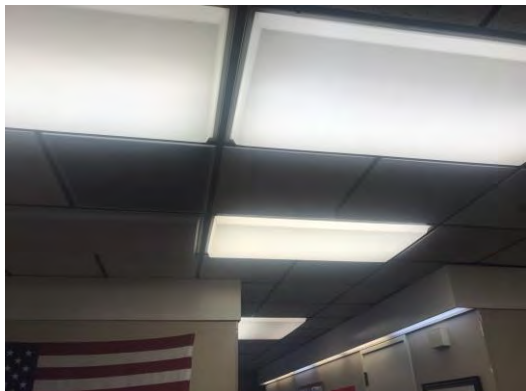
Year Installed / Industry Life / Remaining Useful Life: 1978 / 20 / -24  
Item No.: D5040.50.411  
Floor/Room:  
**Priority:** 1  
Quantity/Unit of Measure: 4,488/SF  
Total Deficiency Cost: \$256,810  
Deficiency Description: *Interior lighting system is past its expected useful life.*

Description of Work: *Provide new interior lighting and control system throughout building per current CEC T24 code.*

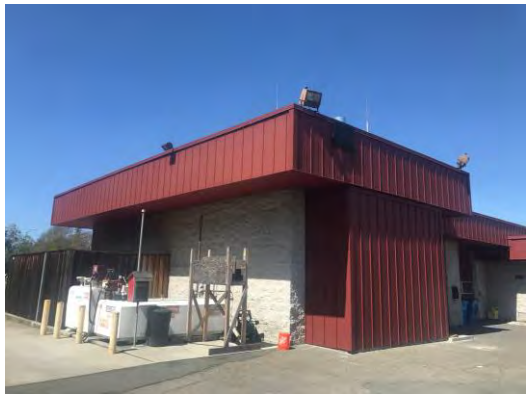
Year Installed / Industry Life / Remaining Useful Life: 1978 / 20 / -24  
Item No.: D5040.50.302  
Floor/Room: Site  
**Priority:** 1  
Quantity/Unit of Measure: 10/EA  
Total Deficiency Cost: \$22,720  
Deficiency Description: *The exterior light fixture is past its expected useful life.*

Description of Work: *Replace the existing light fixture with an LED lighting fixture.*

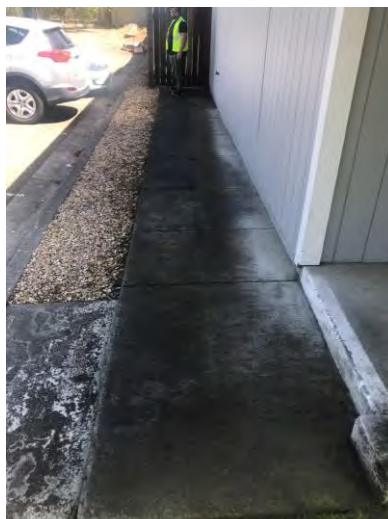
Record ID: 1153  
System: G2030 - PEDESTRIAN PLAZAS AND WALKWAYS  
Year Installed / Industry Life / Remaining Useful Life: - / - / -  
Item No.: G2030.10.012  
Floor/Room: Site / Pavement  
**Priority:** 3  
Quantity/Unit of Measure: 800/SF  
Total Deficiency Cost: \$1,210  
Deficiency Description: *Concrete pavement is worn.*

Description of Work: *Power wash concrete pavement.*

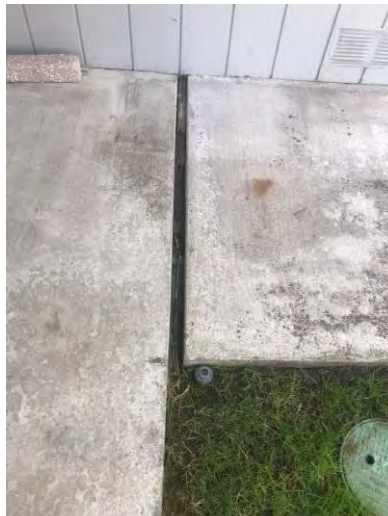
Record ID: 1154  
System: G2030 - PEDESTRIAN PLAZAS AND WALKWAYS  
Year Installed / Industry Life / Remaining Useful Life: - / - / -  
Item No.: G2030.40.005  
Floor/Room: Site / Pavement  
**Priority:** 2  
Quantity/Unit of Measure: 4/LF  
Total Deficiency Cost: \$80  
Deficiency Description: *Wood expansion joints have deteriorated or are missing.*

Description of Work: *Replace wood expansion joint material (up to 1 inch thick).*

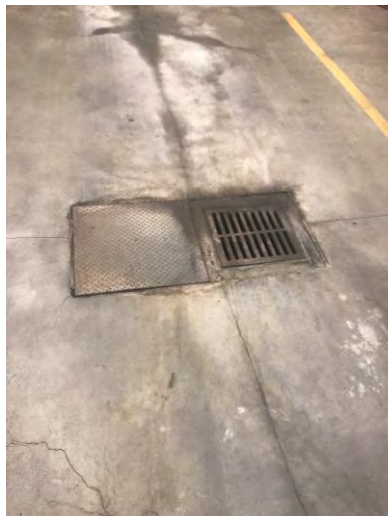
The interior finish materials consist of vinyl flooring, carpet flooring, painted gypsum board wall and ceiling, and concrete flooring in the apparatus room. The concrete flooring is showing signs of cracking and is recommended for repair within the next five years. The carpet flooring in the second-floor hallway and bedrooms are showing signs of wear and are recommended for replacement. Overall, the interior finish materials appear to be in fair condition.

Record ID: 1156  
System: C2030 - FLOORING  
Year Installed / Industry Life / Remaining Useful Life: - / 50 / -  
Item No.: C2030.10.001  
Floor/Room: 1 / Apparatus Room  
**Priority:** 4  
Quantity/Unit of Measure: 800/SF  
Total Deficiency Cost: \$14,630  
Deficiency Description: *Concrete floor is showing signs of cracking and wear.*

Description of Work: *Repair and refinish the concrete floor.*

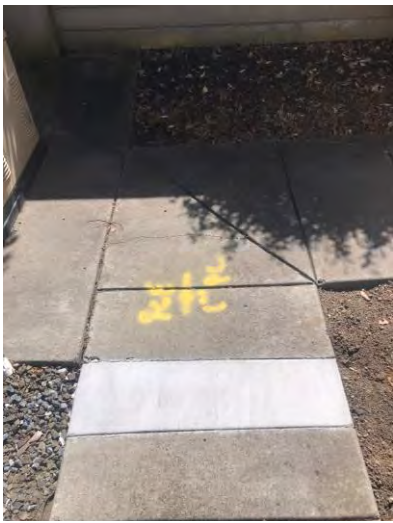
The site surfaces primarily consist of landscaping, concrete-paved walkways, and AC-paved parking lot. The concrete walkways are showing signs of cracking in several areas. Overall, the site surfaces are in fair condition.

Record ID: 1157  
 System: G2030 - PEDESTRIAN PLAZAS AND WALKWAYS  
 Year Installed / Industry Life / Remaining Useful Life: - / - / -  
 Item No.: G2030.10.006  
 Floor/Room: Site / Exterior  
**Priority:** 5  
 Quantity/Unit of Measure: 800/SF  
 Total Deficiency Cost: \$32,890  
 Deficiency Description: *Areas of the concrete walkways and apron are cracking.*

Description of Work: *Replace concrete paving.*

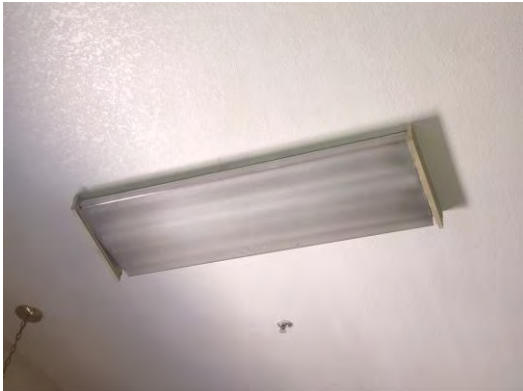
Record ID: 1158  
 System: D5040 - LIGHTING  
 Year Installed / Industry Life / Remaining Useful Life: 1992 / 20 / -10  
 Item No.: D5040.50.411  
 Floor/Room: 1  
**Priority:** 1  
 Quantity/Unit of Measure: 3,058/SF  
 Total Deficiency Cost: \$174,990  
 Deficiency Description: *Interior lighting system is past its expected useful life but operational and fixtures have no evidence of deterioration.*

Description of Work: *Provide new interior lighting and control system throughout building per current CEC T24 code.*

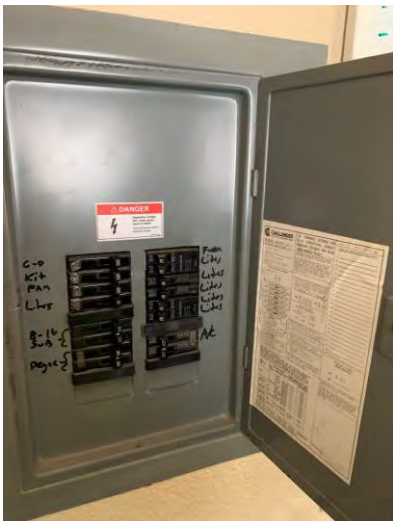
Record ID: 1241  
 System: D5020 - ELECTRICAL SERVICE AND DISTRIBUTION  
 Year Installed / Industry Life / Remaining Useful Life: 1992 / 30 / 0  
 Item No.: D5020.30.4001  
 Floor/Room:  
**Priority:** 1  
 Quantity/Unit of Measure: 1/EA  
 Total Deficiency Cost: \$4,910  
 Deficiency Description: *The load center is past its expected useful life.*

Description of Work: *Replace the existing load center with a new load center.*

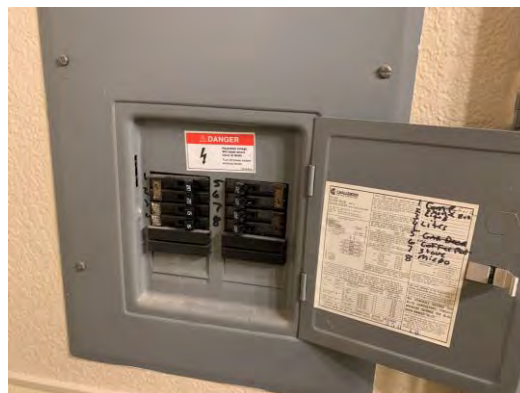
Record ID: 1242  
 System: D5020 - ELECTRICAL SERVICE AND DISTRIBUTION  
 Year Installed / Industry Life / Remaining Useful Life: 1992 / 30 / 0  
 Item No.: D5020.30.4001  
 Floor/Room:  
**Priority:** 1  
 Quantity/Unit of Measure: 1/EA  
 Total Deficiency Cost: \$4,910  
 Deficiency Description: *The load center is past its expected useful life.*

Description of Work: *Replace the existing load center with a new load center.*

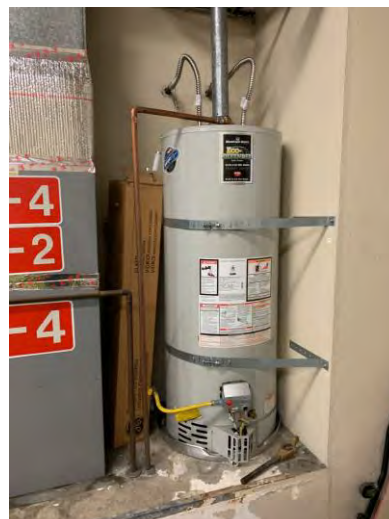
Record ID: 1243  
 System: D2010 - DOMESTIC WATER DISTRIBUTION  
 Year Installed / Industry Life / Remaining Useful Life: 2006 / 15 / -1  
 Item No.: D2010.20.002  
 Floor/Room:  
**Priority:** 2  
 Quantity/Unit of Measure: 1/EA  
 Total Deficiency Cost: \$13,860  
 Deficiency Description: *Gas fired water heater is approaching the end of its expected useful life.*

Description of Work: *Provide equipment replacement and installation.*

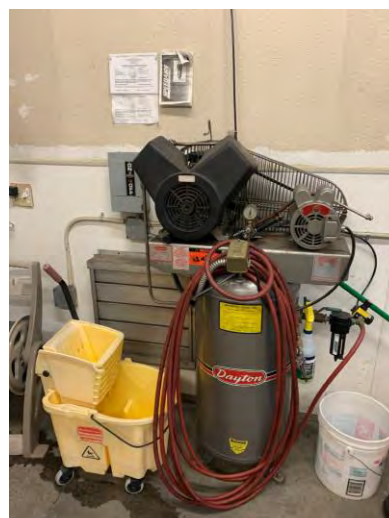
Record ID: 1244  
 System: D2060 - PROCESS SUPPORT PLUMBING SYSTEMS  
 Year Installed / Industry Life / Remaining Useful Life: - / 25 / -  
 Item No.: D2060.10.001  
 Floor/Room:  
**Priority:** 7  
 Quantity/Unit of Measure: 1/EA  
 Total Deficiency Cost: \$19,810  
 Deficiency Description: *Air compressor is approaching the end of its expected useful life.*

Description of Work: *Provide equipment replacement and installation.*

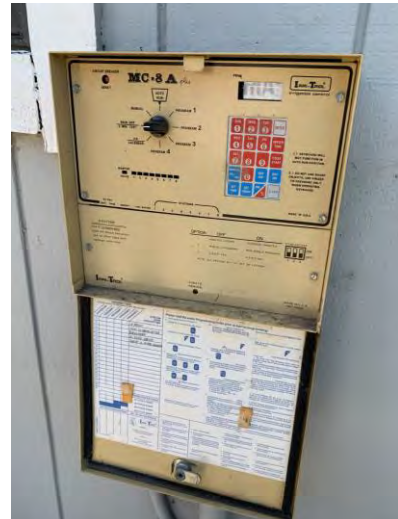
Deficiency Description: *Irrigation Controller is approaching the end of its expected useful life.*

Description of Work: *Replace existing irrigation controller.*

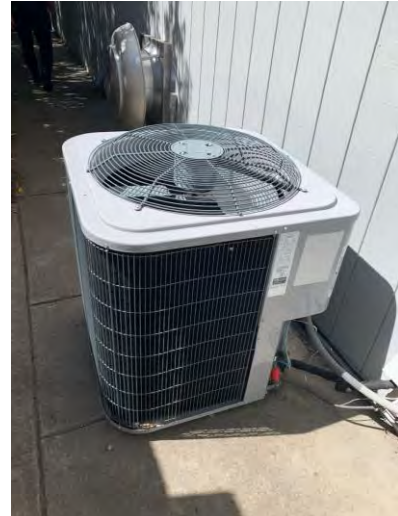
Deficiency Description: *Split system with fan coil and outdoor condensing unit is approaching the end of its expected useful life.*

Comments: *System looks to be in great condition for manufacturer age.*

Description of Work: *Provide equipment replacement and installation.*

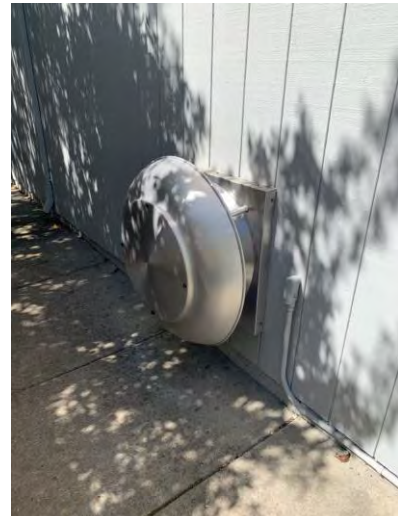
Deficiency Description: *Ventilator is approaching the end of its expected useful life.*

Description of Work: *Provide equipment replacement and installation.*

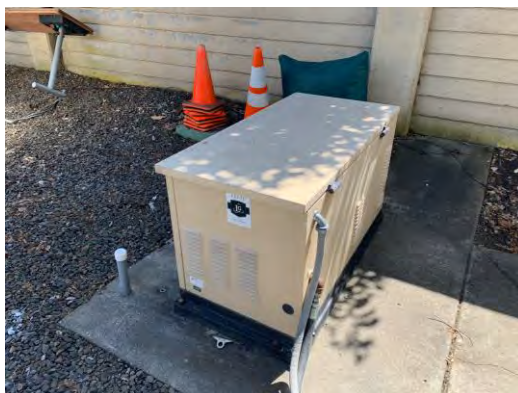
Deficiency Description: *The natural gas standby generator is approaching the end of its expected useful life.*

Comments: *Manufactured in 2006.*

Description of Work: *Replace the existing generator with an upsized new generator.*

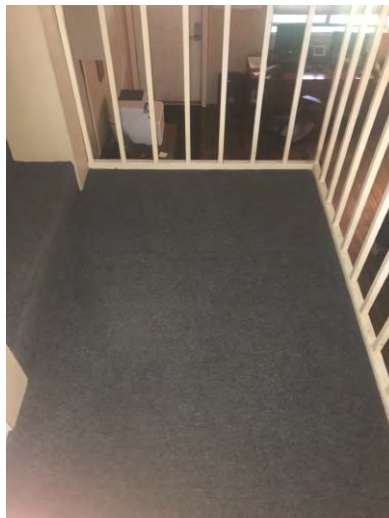
Deficiency Description: *Carpet flooring is worn.*

Description of Work: *Replace carpet flooring.*

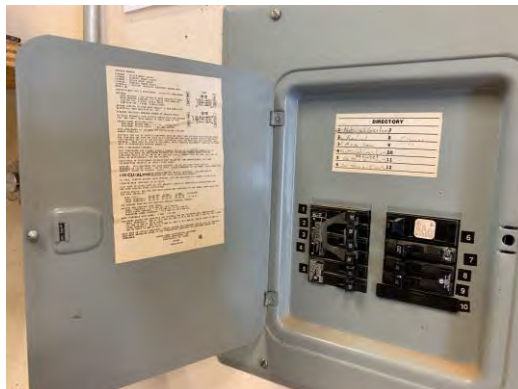
Record ID: 457  
System: D5020 - ELECTRICAL SERVICE AND DISTRIBUTION

Description of Work: *Replace the existing load center with a new load center.*

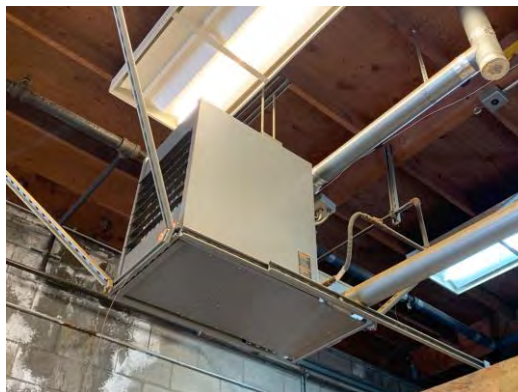
Record ID: 460  
System: D3020 - HEATING SYSTEMS

Description of Work: *Provide equipment replacement and installation.*

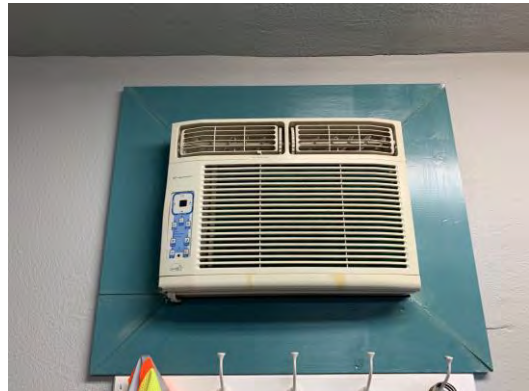
Record ID 462  
System D3030 - COOLING SYSTEMS

Description of Work: *Provide equipment replacement and installation.*

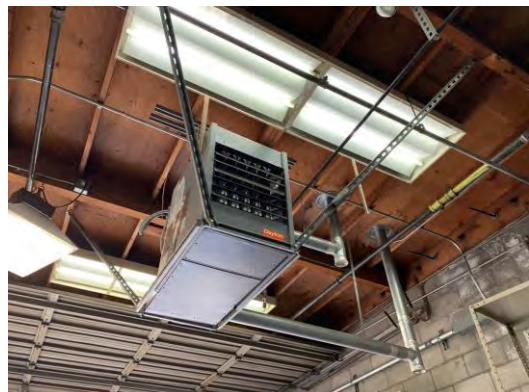
Record ID 463  
System D3020 - HEATING SYSTEMS

Description of Work: *Provide equipment replacement and installation.*

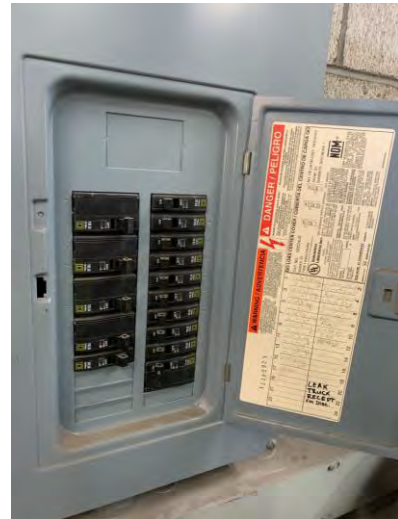
Record ID 464  
System D5020 - ELECTRICAL SERVICE AND DISTRIBUTION  
Year Installed / Industry Life / Remaining Useful Life 1975 / 30 / -17  
Item No. D5020.30.4001  
Floor/Room:  
**Priority: 1**  
Quantity/Unit of Measure: 1/EA  
Total Deficiency Cost: \$4,910  
Deficiency Description: *The load center is past its expected useful life.*

Description of Work: *Replace the existing load center with a new load center.*

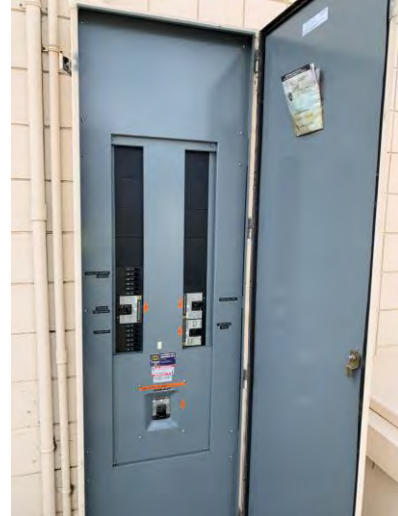
Record ID 465  
System D5020 - ELECTRICAL SERVICE AND DISTRIBUTION  
Year Installed / Industry Life / Remaining Useful Life 1975 / 30 / -17  
Item No. D5020.30.1008  
Floor/Room:  
**Priority: 1**  
Quantity/Unit of Measure: 1/EA  
Total Deficiency Cost: \$18,570  
Deficiency Description: *The 225A (120/208, 3P) panelboard is past its expected useful life.*

Description of Work: *Replace the existing panelboard with a new panelboard.*

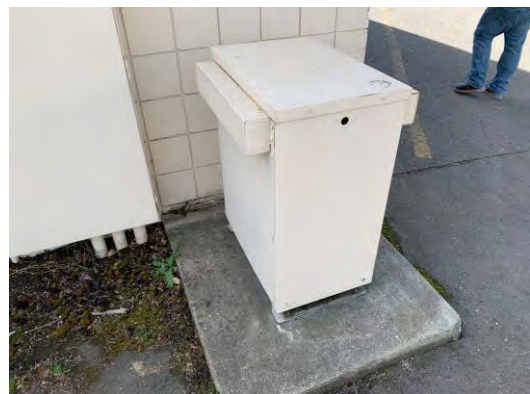
Record ID 466  
System D5020 - ELECTRICAL SERVICE AND DISTRIBUTION  
Year Installed / Industry Life / Remaining Useful Life 1975 / 30 / -17  
Item No. D5020.10.217  
Floor/Room:  
**Priority: 1**  
Quantity/Unit of Measure: 1/EA  
Total Deficiency Cost: \$16,550  
Deficiency Description: *The 75kVA transformer (3P dry-type, 480-120/208V) is approaching the end of its expected useful life.*

Description of Work: *Replace the existing transformer with a new transformer.*

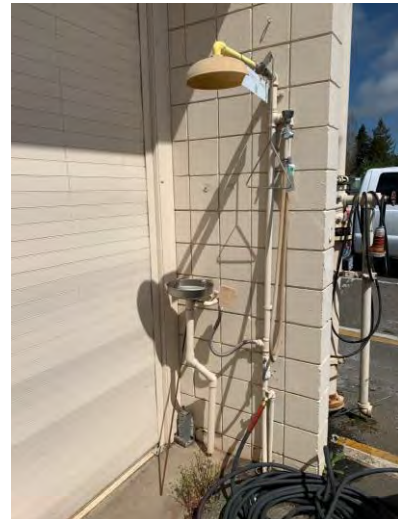
Deficiency Description: *Eyewash station is approaching the end of its expected useful life.*

Description of Work: *Provide equipment replacement and installation.*

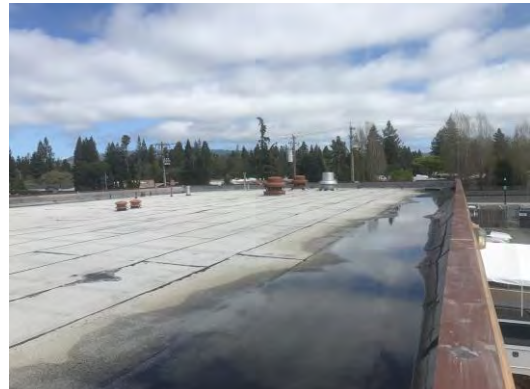
Deficiency Description: *Single-ply (modified bitumen) roofing is at or approaching the end of its useful life.*

Description of Work: *Replace single-ply (modified bitumen) roofing.*

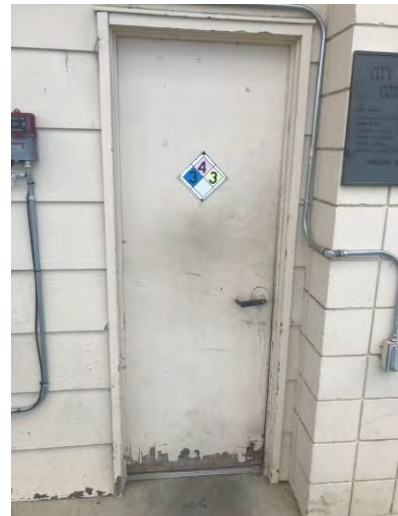
Deficiency Description: *Exterior wood entrance door is approaching the end of its useful life.*

Description of Work: *Replace wood door.*

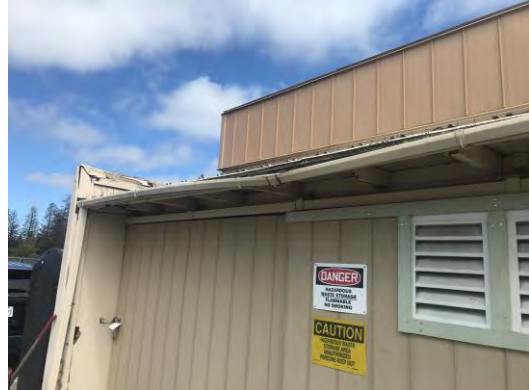
Deficiency Description:            *Rain gutters are damaged.*

Description of Work:                *Replace rain gutters.*

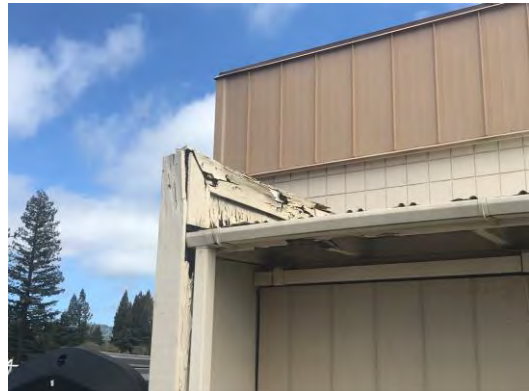
Deficiency Description:            *The wood fascia shows signs of deterioration.*

Description of Work:                *Selectively remove deteriorated fascia and replace with new material to match.*

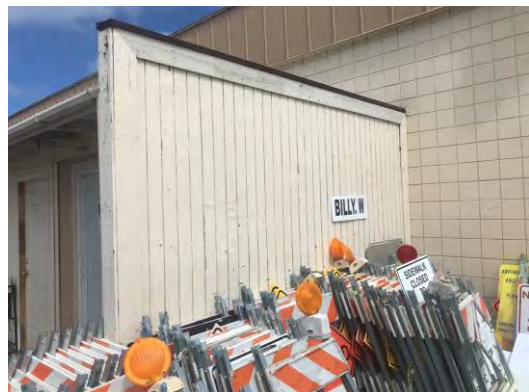
Deficiency Description:            *Plywood siding is approaching the end of its useful life.*

Description of Work:                *Remove and replace the existing plywood siding with new plywood siding. Prime and paint.*

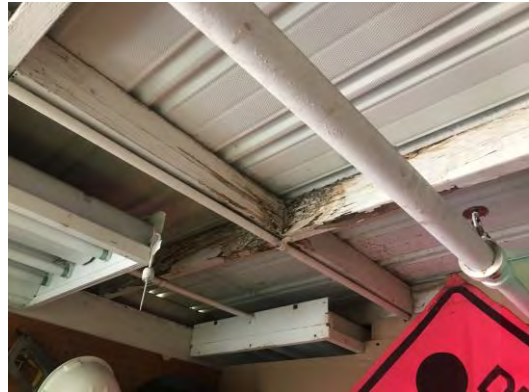
Record ID: 721  
 System: B1020 - ROOF CONSTRUCTION  
 Year Installed / Industry Life / Remaining Useful Life: - / 50 / -  
 Item No.: B1020.10.004  
 Floor/Room: Roof / Exterior  
**Priority:** 1  
 Quantity/Unit of Measure: 2/EA  
 Total Deficiency Cost: \$1,300  
 Deficiency Description: *The roof beam appears to be rotted.*

Comments: *Potential water damage.*

Description of Work: *Replace the roof beam.*

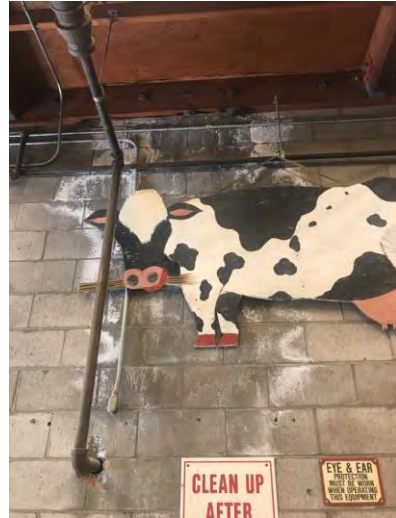
Record ID: 722  
 System: B2010 - EXTERIOR WALLS  
 Year Installed / Industry Life / Remaining Useful Life: - / 50 / -  
 Item No.: B2010.20.005  
 Floor/Room: 1  
**Priority:** 1  
 Quantity/Unit of Measure: 100/SF  
 Total Deficiency Cost: \$830  
 Deficiency Description: *CMU walls are showing signs of wear due to water penetration.*

Description of Work: *Clean CMU walls.*

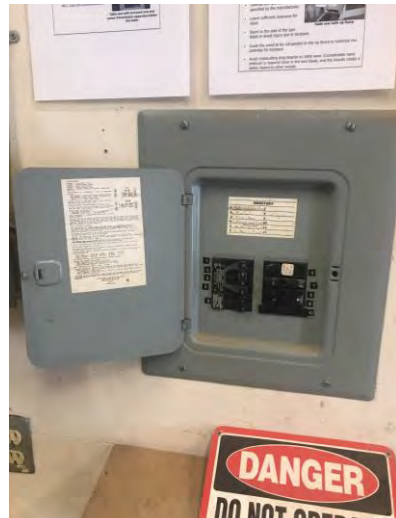
Record ID: 723  
 System: D5020 - ELECTRICAL SERVICE AND DISTRIBUTION  
 Year Installed / Industry Life / Remaining Useful Life: 1975 / 30 / -17  
 Item No.: D5020.30.4001  
 Floor/Room:  
**Priority:** 1  
 Quantity/Unit of Measure: 1/EA  
 Total Deficiency Cost: \$4,910  
 Deficiency Description: *The load center is past its expected useful life.*

Description of Work: *Replace the existing load center with a new load center.*

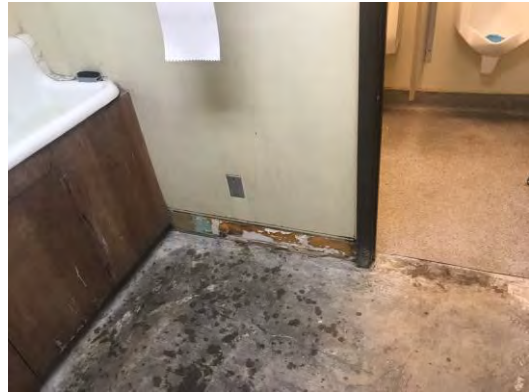
Year Installed / Industry Life / Remaining Useful Life: - / - / -  
Item No.: C2030.90.001  
Floor/Room: 1 / Restroom  
**Priority:** 1  
Quantity/Unit of Measure: 20/LF  
Total Deficiency Cost: \$340  
Deficiency Description: *Vinyl wall base is approaching the end of its useful life.*

Description of Work: *Replace the vinyl wall base.*

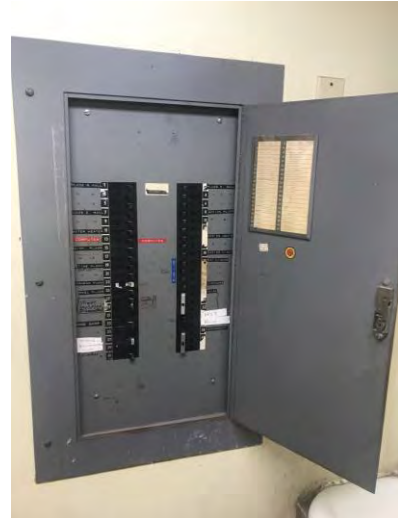
Year Installed / Industry Life / Remaining Useful Life: 1975 / 30 / -17  
Item No.: D5020.30.4001  
Floor/Room:  
**Priority:** 1  
Quantity/Unit of Measure: 1/EA  
Total Deficiency Cost: \$4,910  
Deficiency Description: *The load center is past its expected useful life.*

Description of Work: *Replace the existing load center with a new load center.*

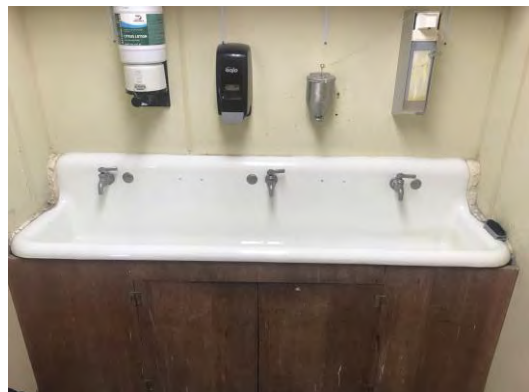
Year Installed / Industry Life / Remaining Useful Life: - / - / -  
Item No.: E2010.30.008  
Floor/Room: 1 / Restroom  
**Priority:** 2  
Quantity/Unit of Measure: 6/LF  
Total Deficiency Cost: \$8,070  
Deficiency Description: *Plastic laminate base cabinet (with countertop) is in poor condition.*

Description of Work: *Remove and replace with new plastic laminate base cabinet and countertop.*

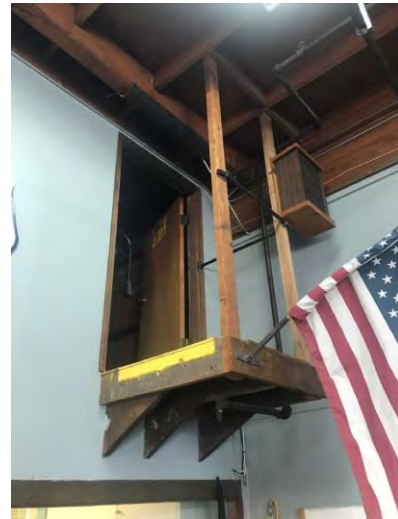
Record ID: 727  
System: G2030 - PEDESTRIAN PLAZAS AND WALKWAYS  
Year Installed / Industry Life / Remaining Useful Life: - / - / -  
Item No.: G2030.30.009  
Floor/Room: 1 / Attic  
**Priority:** 1  
Quantity/Unit of Measure: 60/LFNS  
Total Deficiency Cost: \$23,140  
Deficiency Description: *Stairs are missing.*

Description of Work: *Install entire new wood stair system, including steps, handrails, and landings.*

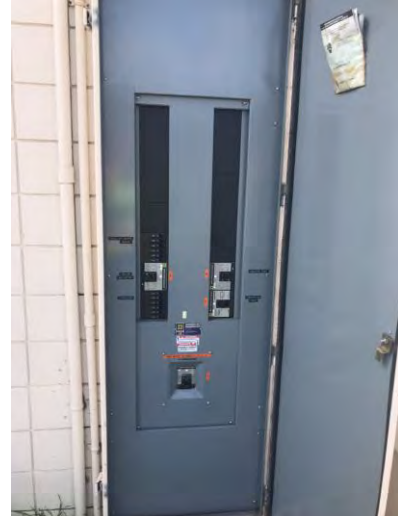
Record ID: 728  
System: D5020 - ELECTRICAL SERVICE AND DISTRIBUTION  
Year Installed / Industry Life / Remaining Useful Life: 1975 / 30 / -17  
Item No.: D5020.30.1008  
Floor/Room:  
**Priority:** 1  
Quantity/Unit of Measure: 1/EA  
Total Deficiency Cost: \$18,570  
Deficiency Description: *The panelboard is past its expected useful life.*

Description of Work: *Replace the existing panelboard with a new panelboard.*

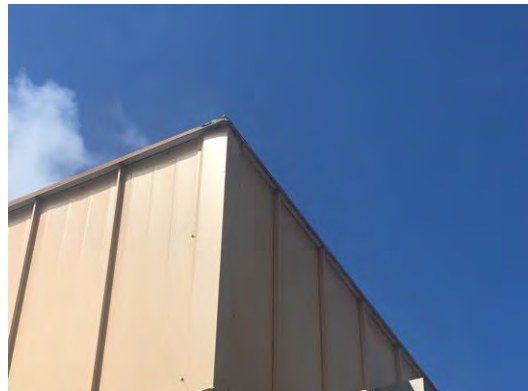
Record ID: 730  
System: B2010 - EXTERIOR WALLS  
Year Installed / Industry Life / Remaining Useful Life: - / 15 / -  
Item No.: B2010.10.012  
Floor/Room: Roof / Exterior  
**Priority:** 3  
Quantity/Unit of Measure: 10/SF  
Total Deficiency Cost: \$570  
Deficiency Description: *Top of metal siding panel is damaged.*

Description of Work: *Repair metal siding panel.*

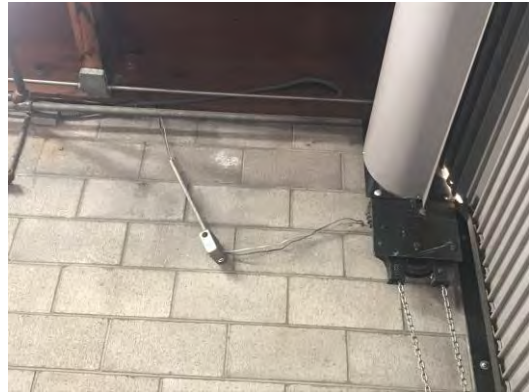
Record ID: 731  
System: D5020 - ELECTRICAL SERVICE AND DISTRIBUTION  
Year Installed / Industry Life / Remaining Useful Life: - / 50 / -  
Item No.: D5020.30.9021  
Floor/Room:   
**Priority:** 1  
Quantity/Unit of Measure: 5/LF  
Total Deficiency Cost: \$120  
Deficiency Description: *The conduit falling off the wall and needs to be properly supported.*

Description of Work: *Install/ replace the existing conduit with new conduit.*

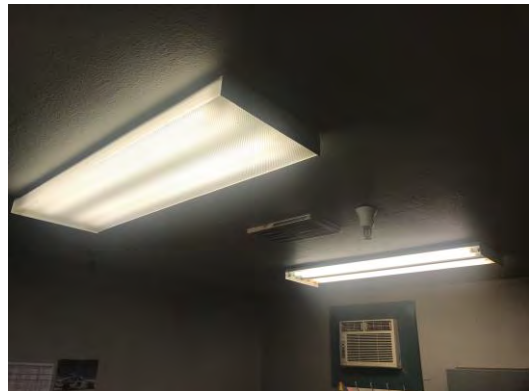
Record ID: 732  
System: D5040 - LIGHTING  
Year Installed / Industry Life / Remaining Useful Life: 1975 / 20 / -27  
Item No.: D5040.50.411  
Floor/Room: 1 / Throughout  
**Priority:** 1  
Quantity/Unit of Measure: 2,500/SF  
Total Deficiency Cost: \$143,070  
Deficiency Description: *The interior light fixtures are past their expected useful life.*

Comments: *Diffusers missing.*

Description of Work: *Replace existing fixtures with LED fixtures.*

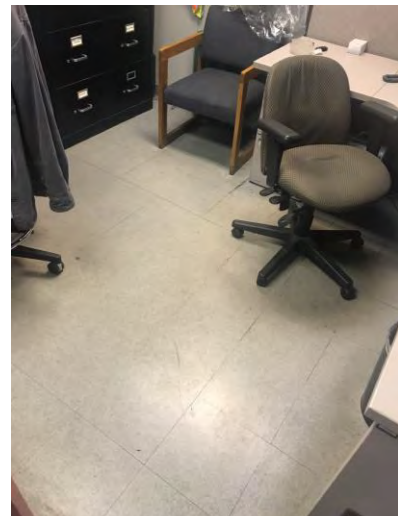
Record ID: 733  
System: C2030 - FLOORING  
Year Installed / Industry Life / Remaining Useful Life: - / 60 / -  
Item No.: C2030.50.001  
Floor/Room: 1 / Office  
**Priority:** 3  
Quantity/Unit of Measure: 132/SF  
Total Deficiency Cost: \$3,500  
Deficiency Description: *Vinyl composition tile is approaching the end of its useful life.*

Description of Work: *Remove the existing vinyl composition tile and replace.*

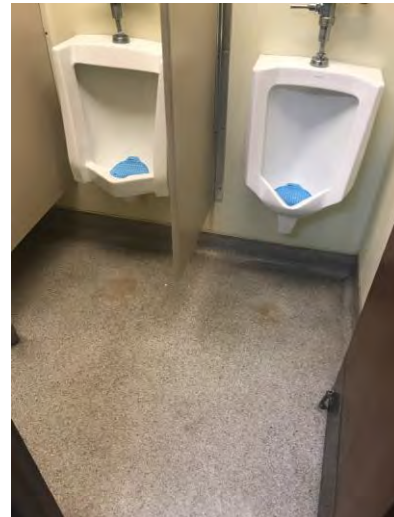
Quantity/Unit of Measure: 100/SF  
 Total Deficiency Cost: \$5,730  
 Deficiency Description: *Epoxy is approaching the end of its useful life.*

Description of Work: *Remove the existing epoxy and replace.*

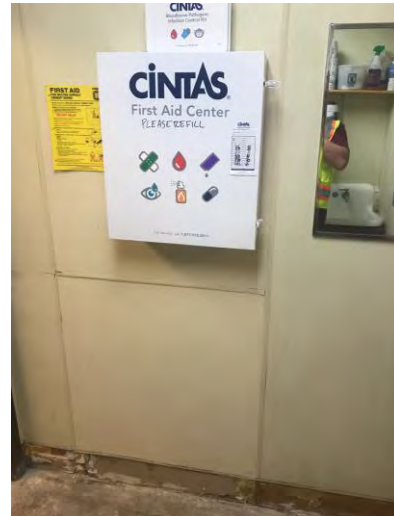
Quantity/Unit of Measure: 400/SF  
 Total Deficiency Cost: \$8,430  
 Deficiency Description: *Fiberglass reinforced paneling is at or approaching the end of its useful life.*

Description of Work: *Replace the fiberglass reinforced paneling.*

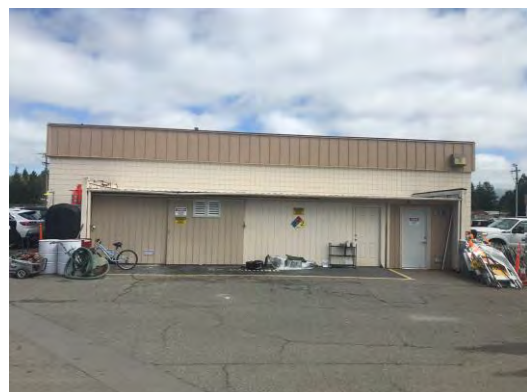
Quantity/Unit of Measure: 6/EA  
 Total Deficiency Cost: \$15,540  
 Deficiency Description: *The exterior light fixture is past its expected useful life.*

Comments: *Diffuser discolored.*

Description of Work: *Replace the existing light fixture with an LED lighting fixture.*

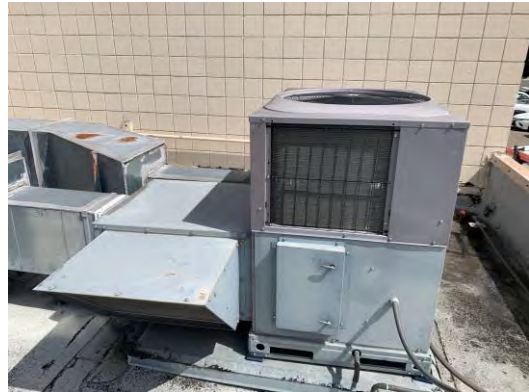
Deficiency Description: *Packaged AC unit is approaching the end of its expected useful life.*

Description of Work: *Provide equipment replacement and installation.*

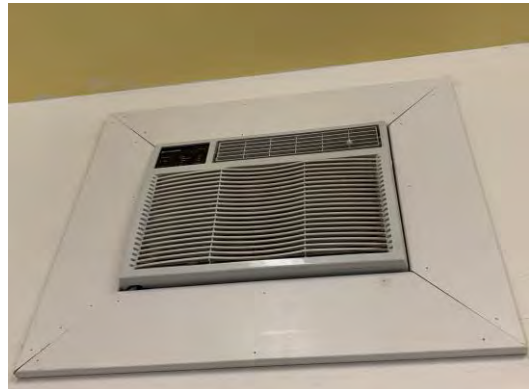
Deficiency Description: *Wall mounted AC unit is approaching the end of its expected useful life.*

Description of Work: *Provide equipment replacement and installation.*

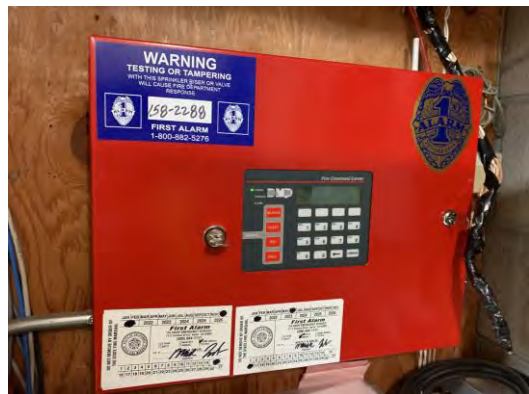
Deficiency Description: *The existing fire alarm system is past its expected useful life.*

Description of Work: *Replace the existing fire alarm system with a complete, site-wide, fully addressable fire alarm system.*

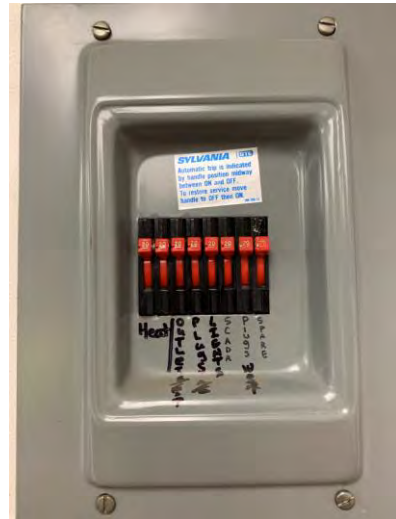
Record ID: 475  
 System: D5020 - ELECTRICAL SERVICE AND DISTRIBUTION  
 Year Installed / Industry Life / Remaining Useful Life: 1982 / 30 / -10  
 Item No.: D5020.30.4001  
 Floor/Room:  
**Priority:** 1  
 Quantity/Unit of Measure: 1/EA  
 Total Deficiency Cost: \$4,910  
 Deficiency Description: *The load center is past its expected useful life.*  
 Description of Work: *Replace the existing load center with a new load center.*  
 Comments:

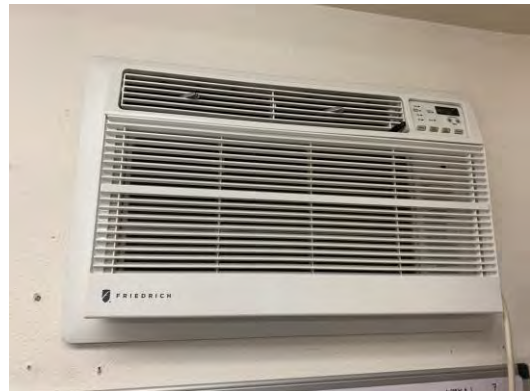
Record ID: 476  
 System: D3030 - COOLING SYSTEMS  
 Year Installed / Industry Life / Remaining Useful Life: - / 10 / -  
 Item No.: D3030.70.032  
 Floor/Room:  
**Priority:** 7  
 Quantity/Unit of Measure: 1/EA  
 Total Deficiency Cost: \$7,920  
 Deficiency Description: *Wall mounted AC unit is approaching the end of its expected useful life.*  
 Description of Work: *Provide equipment replacement and installation.*  
 Comments:

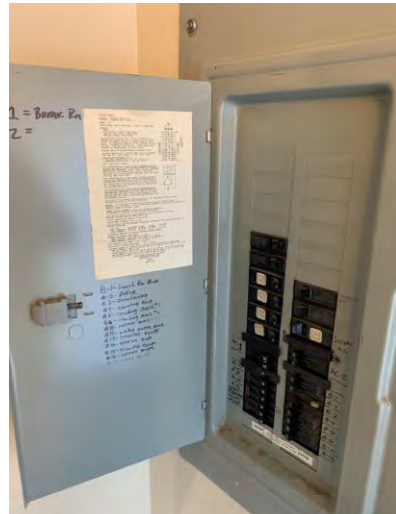
Record ID: 477  
 System: D5020 - ELECTRICAL SERVICE AND DISTRIBUTION  
 Year Installed / Industry Life / Remaining Useful Life: 1982 / 30 / -10  
 Item No.: D5020.30.1008  
 Floor/Room:  
**Priority:** 1  
 Quantity/Unit of Measure: 1/EA  
 Total Deficiency Cost: \$18,570  
 Deficiency Description: *The panelboard is past its expected useful life.*  
 Description of Work: *Replace the existing panelboard with a new panelboard.*  
 Comments:

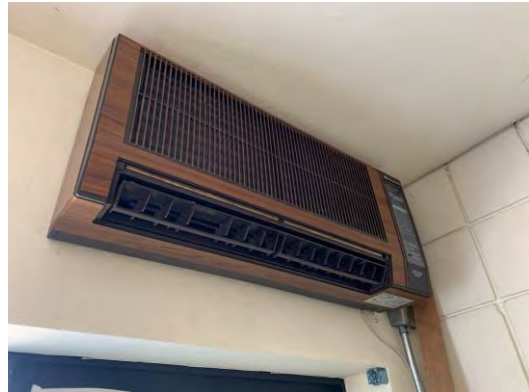
Quantity/Unit of Measure: 1/EA  
 Total Deficiency Cost: \$16,490  
 Deficiency Description: *Split system with wall mounted AC and outdoor condensing unit is approaching the end of its expected useful life.*

Comments: *Abandoned unit - fan coil still on roof*

Description of Work: *Provide equipment replacement and installation.*

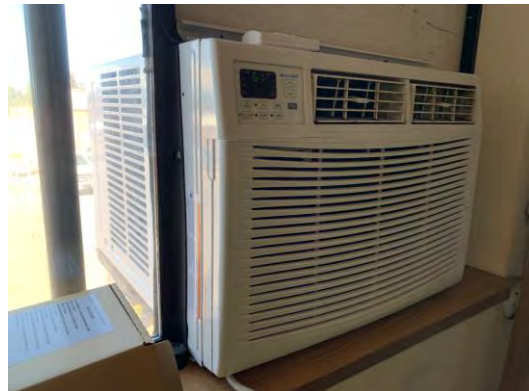
Quantity/Unit of Measure: 1/EA  
 Total Deficiency Cost: \$7,920  
 Deficiency Description: *Wall mounted AC unit is approaching the end of its expected useful life.*

Description of Work: *Provide equipment replacement and installation.*

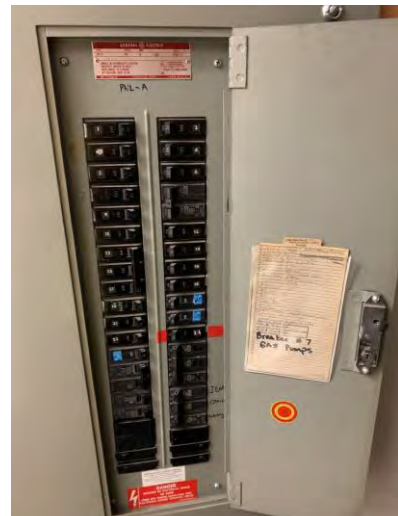
Quantity/Unit of Measure: 1/EA  
 Total Deficiency Cost: \$18,570  
 Deficiency Description: *The 225A panelboard is past its expected useful life.*

Description of Work: *Replace the existing panelboard with a new panelboard.*

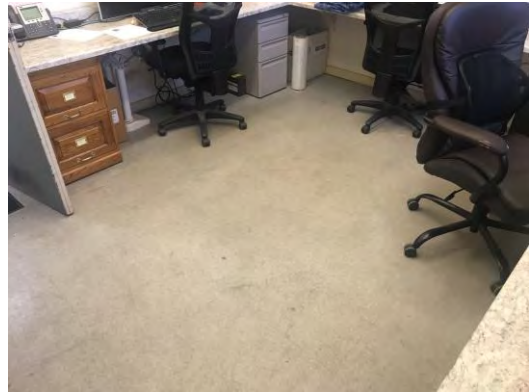
Deficiency Description: *Vinyl composition tile is approaching the end of its useful life.*

Description of Work: *Remove the existing vinyl composition tile and replace.*

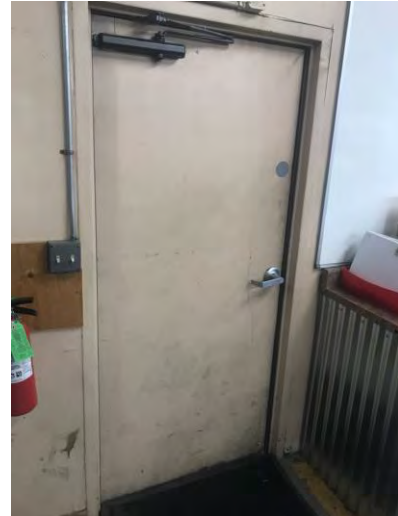
Deficiency Description: *Exterior aluminum door is damaged or deteriorating.*

Description of Work: *Refurbish/repair aluminum door.*

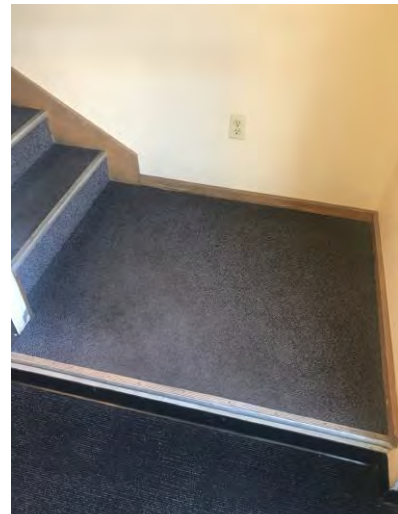
Deficiency Description: *Carpet flooring is showing signs of wear.*

Description of Work: *Replace carpet flooring.*

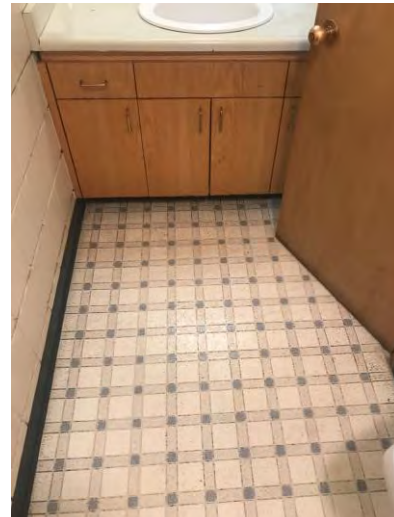
Year Installed / Industry Life / Remaining Useful Life: - / 60 / -  
Item No.: C2030.50.002  
Floor/Room: 1 / Restroom  
**Priority:** 2  
Quantity/Unit of Measure: 100/SF  
Total Deficiency Cost: \$4,280  
Deficiency Description: *Linoleum flooring is showing signs of wear.*

Description of Work: *Replace linoleum flooring.*

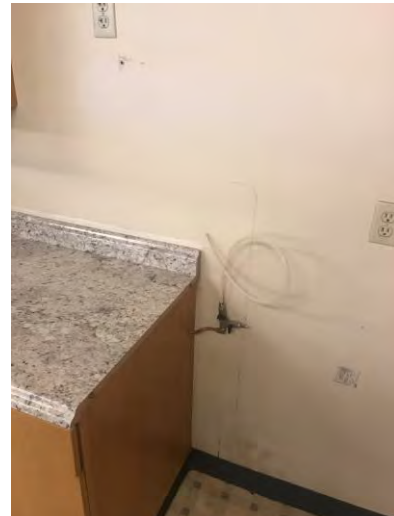
Year Installed / Industry Life / Remaining Useful Life: - / 20 / -  
Item No.: C1010.10.001  
Floor/Room: 1  
**Priority:** 3  
Quantity/Unit of Measure: 100/SF  
Total Deficiency Cost: \$750  
Deficiency Description: *Painted gypsum wallboard is in poor condition with several cracks.*

Description of Work: *Remove and replace existing gypsum board with a new gypsum board and expansion joints. Tape and paint.*

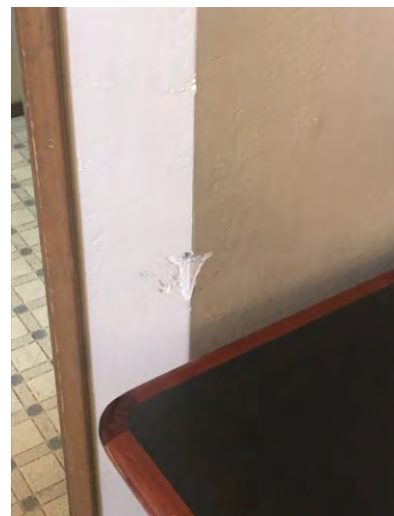
Record ID: 746  
System: C2010 - WALL FINISHES

Year Installed / Industry Life / Remaining Useful Life: - / 30 / -  
Item No.: C2010.70.001  
Floor/Room: 1  
**Priority:** 2  
Quantity/Unit of Measure: 100/SF  
Total Deficiency Cost: \$2,120  
Deficiency Description: *Painted gypsum wallboard is showing signs of wear.*

Description of Work: *Patch and paint the gypsum wallboard.*

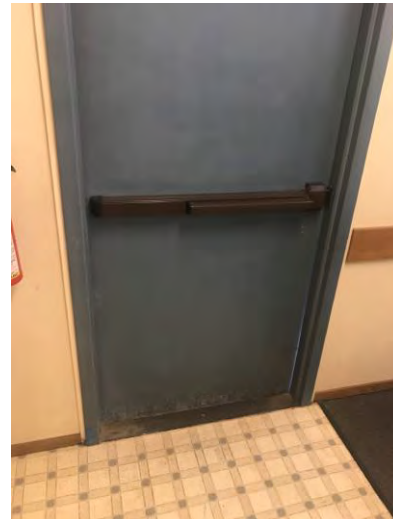
Deficiency Description: *Exterior aluminum door is damaged or deteriorating.*

Description of Work: *Refurbish/repair aluminum door.*

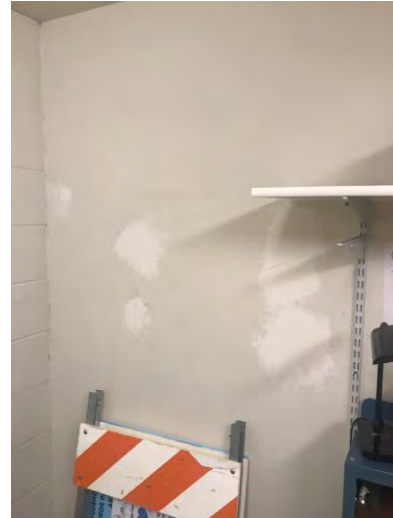
Record ID 749  
System C1010 - INTERIOR PARTITIONS

Deficiency Description: *Painted gypsum wallboard is in poor condition with several cracks.*

Description of Work: *Remove and replace existing gypsum board with a new gypsum board and expansion joints. Tape and paint.*

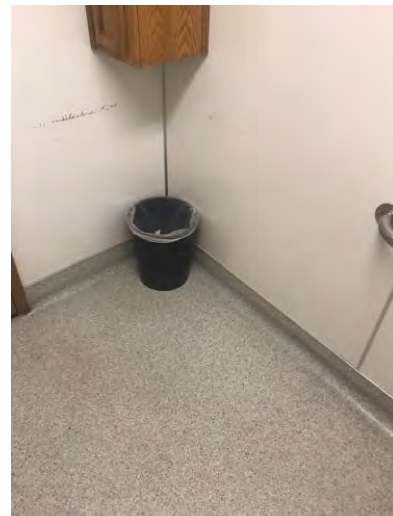
Record ID 750  
System C2030 - FLOORING

Deficiency Description: *Epoxy is approaching the end of its useful life.*

Description of Work: *Remove the existing epoxy and replace.*

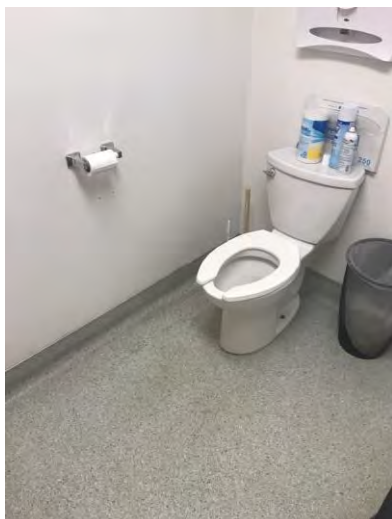
Quantity/Unit of Measure: 100/SF  
Total Deficiency Cost: \$5,280  
Deficiency Description: *Epoxy is approaching the end of its useful life.*

Description of Work: *Remove the existing epoxy and replace.*
