# City of Rohnert Park

## Facility Condition Assessment

Final Report

October 17, 2022

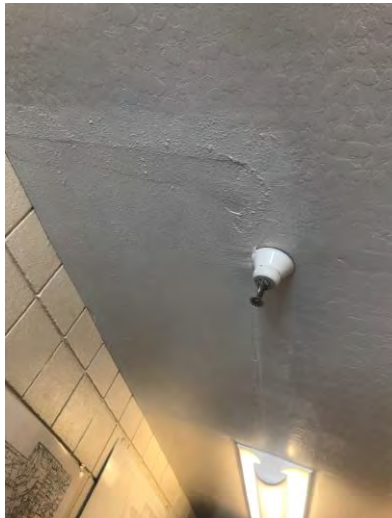
Record ID: 753  
System: C2050 - CEILING FINISHES

Quantity/Unit of Measure: 100/SF  
Total Deficiency Cost: \$750  
Deficiency Description: *Paint is approaching the end of its useful life.*

Description of Work: *Paint the ceiling and/or walls (prime + 2 finish coats).*

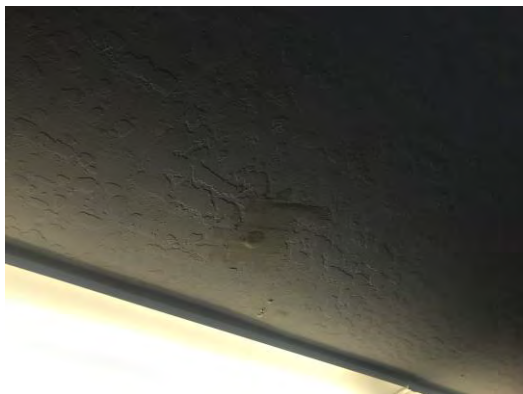
Record ID: 754  
System: C2050 - CEILING FINISHES

Quantity/Unit of Measure: 100/SF  
Total Deficiency Cost: \$750  
Deficiency Description: *Paint is approaching the end of its useful life.*

Description of Work: *Paint the ceiling and/or walls (prime + 2 finish coats).*

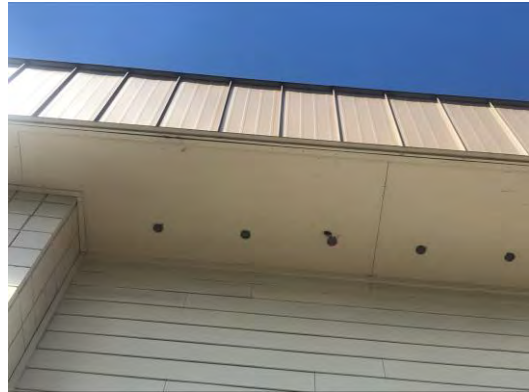
Deficiency Description: *Soffit is damaged.*

Description of Work: *Replace gypsum board soffit.*

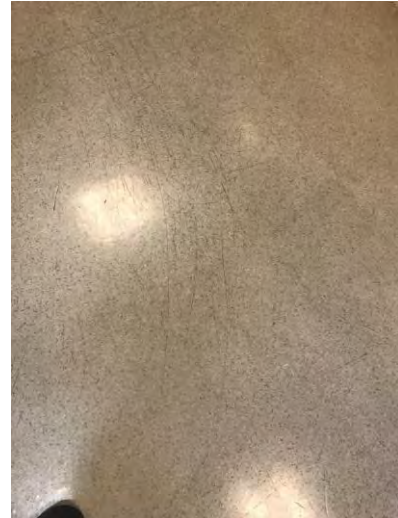
Record ID 759  
System C2030 - FLOORING

Deficiency Description: *Vinyl composition tile is approaching the end of its useful life.*

Description of Work: *Remove the existing vinyl composition tile and replace.*

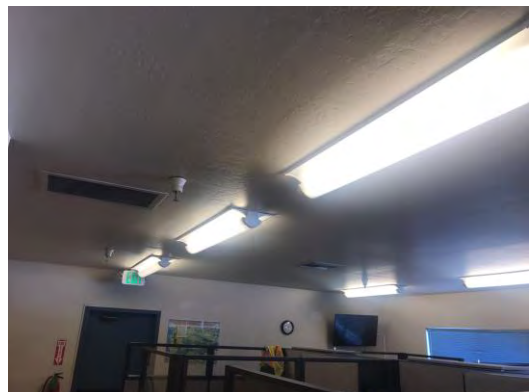
Record ID 1773  
System D5040 - LIGHTING

Deficiency Description: *Interior lighting system is past its expected useful life.*

Comments: *Assume approximately 50% of interior lighting replaced.*

Description of Work: *Provide new interior lighting and control system throughout building per current CEC T24 code.*

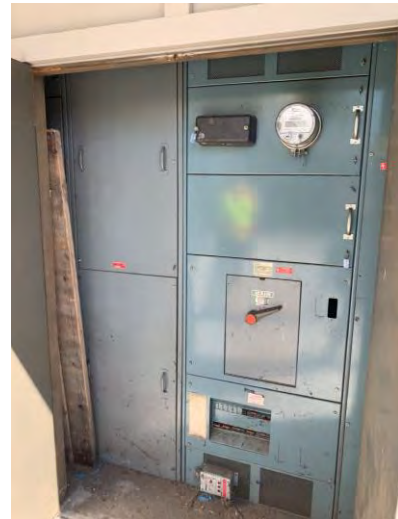
Record ID 1288  
 System D5020 - ELECTRICAL SERVICE AND DISTRIBUTION  
 Year Installed / Industry Life / Remaining Useful Life 1990 / 20 / -12  
 Item No. D5020.10.302  
 Floor/Room:  
**Priority: 1**  
 Quantity/Unit of Measure: 1/EA  
 Total Deficiency Cost: \$17,750  
 Deficiency Description: *The 400A metered main switchboard is approaching the end of its expected useful life.*  
 Description of Work: *Replace the existing metered main switchboard with a new metered main switchboard.*  
 Comments:

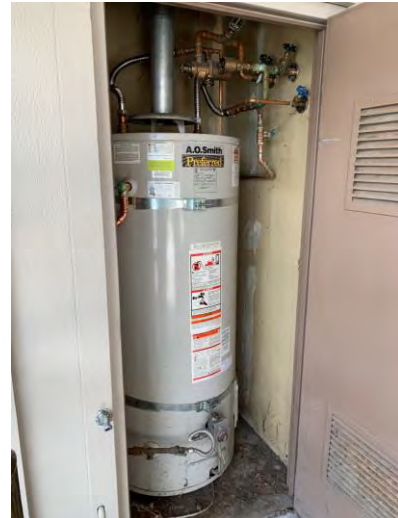
Record ID 1292  
 System D2010 - DOMESTIC WATER DISTRIBUTION  
 Year Installed / Industry Life / Remaining Useful Life 2008 / 15 / 1  
 Item No. D2010.20.002  
 Floor/Room:  
**Priority: 3**  
 Quantity/Unit of Measure: 1/EA  
 Total Deficiency Cost: \$14,470  
 Deficiency Description: *Gas fired water heater is approaching the end of its expected useful life.*  
 Description of Work: *Provide equipment replacement and installation.*  
 Comments:

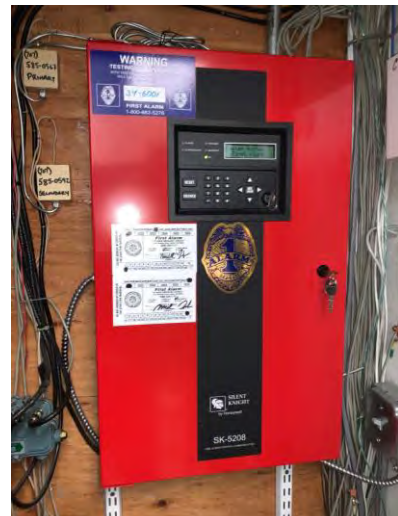
Record ID 1293  
 System D7050 - DETECTION AND ALARM  
 Year Installed / Industry Life / Remaining Useful Life 1990 / 15 / -17  
 Item No. D7050.10.022  
 Floor/Room:  
**Priority: 1**  
 Quantity/Unit of Measure: 14,977/SF  
 Total Deficiency Cost: \$359,380  
 Deficiency Description: *The existing fire alarm system is past its expected useful life*  
 Description of Work: *Provide a fully addressable fire alarm control panel with associated initiating and signaling devices.*  
 Comments:

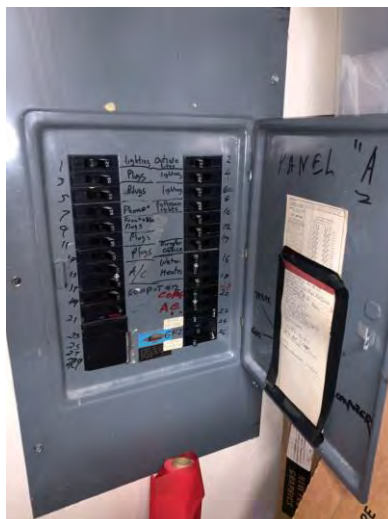
Record ID: 1294  
 System: D5020 - ELECTRICAL SERVICE AND DISTRIBUTION  
 Year Installed / Industry Life / Remaining Useful Life: 1990 / 30 / -2  
 Item No.: D5020.30.4001  
 Floor/Room:  
**Priority:** 1  
 Quantity/Unit of Measure: 1/EA  
 Total Deficiency Cost: \$4,910  
 Deficiency Description: *The load center is past its expected useful life.*

Description of Work: *Replace the existing load center with a new load center.*

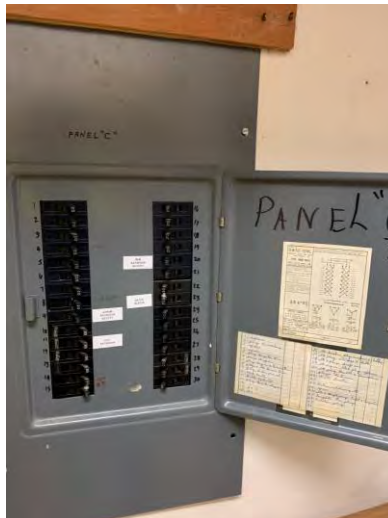
Record ID: 1295  
 System: D5020 - ELECTRICAL SERVICE AND DISTRIBUTION  
 Year Installed / Industry Life / Remaining Useful Life: 1990 / 30 / -2  
 Item No.: D5020.30.4001  
 Floor/Room:  
**Priority:** 1  
 Quantity/Unit of Measure: 1/EA  
 Total Deficiency Cost: \$4,910  
 Deficiency Description: *The load center is past its expected useful life.*

Description of Work: *Replace the existing load center with a new load center.*

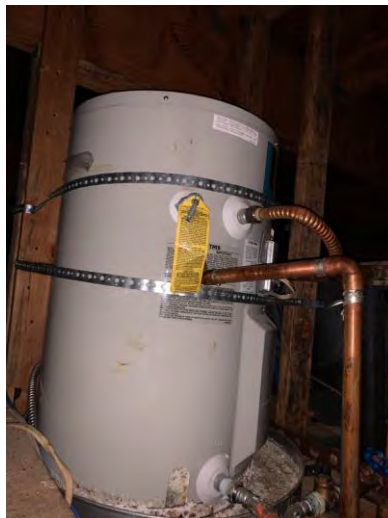
Record ID: 1297  
 System: D2010 - DOMESTIC WATER DISTRIBUTION  
 Year Installed / Industry Life / Remaining Useful Life: - / 15 / -  
 Item No.: D2010.20.023  
 Floor/Room:  
**Priority:** 4  
 Quantity/Unit of Measure: 1/EA  
 Total Deficiency Cost: \$15,080  
 Deficiency Description: *Electric water heater is approaching the end of its expected useful life.*

Description of Work: *Provide equipment replacement and installation.*

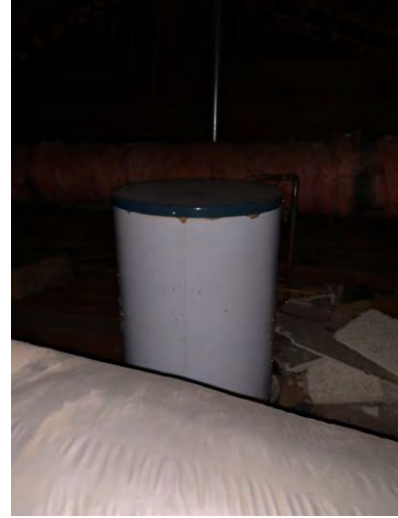
Record ID: 1298  
 System: D2010 - DOMESTIC WATER DISTRIBUTION  
 Year Installed / Industry Life / Remaining Useful Life: - / 15 / -  
 Item No.: D2010.20.021  
 Floor/Room:  
**Priority:** 4  
 Quantity/Unit of Measure: 1/EA  
 Total Deficiency Cost: \$13,570  
 Deficiency Description: *Electric water heater is approaching the end of its expected useful life.*  
 Description of Work: *Provide equipment replacement and installation.*  
 Comments:

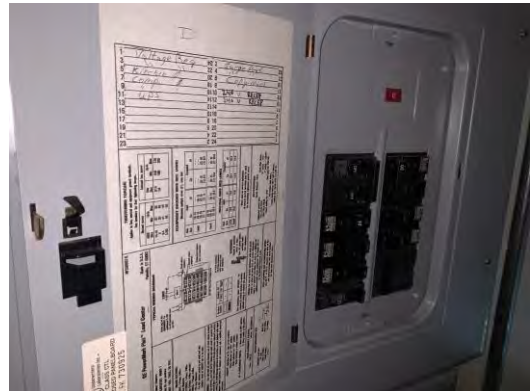
Record ID: 1300  
 System: D5020 - ELECTRICAL SERVICE AND DISTRIBUTION  
 Year Installed / Industry Life / Remaining Useful Life: 1990 / 30 / -2  
 Item No.: D5020.30.4001  
 Floor/Room:  
**Priority:** 1  
 Quantity/Unit of Measure: 1/EA  
 Total Deficiency Cost: \$4,910  
 Deficiency Description: *The load center is past its expected useful life.*  
 Description of Work: *Replace the existing load center with a new load center.*  
 Comments:

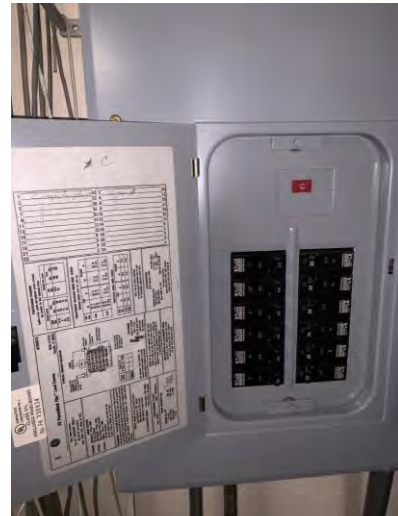
Record ID: 1301  
 System: D5020 - ELECTRICAL SERVICE AND DISTRIBUTION  
 Year Installed / Industry Life / Remaining Useful Life: 1990 / 30 / -2  
 Item No.: D5020.30.4001  
 Floor/Room:  
**Priority:** 1  
 Quantity/Unit of Measure: 1/EA  
 Total Deficiency Cost: \$4,910  
 Deficiency Description: *The load center is past its expected useful life.*  
 Description of Work: *Replace the existing load center with a new load center.*  
 Comments:

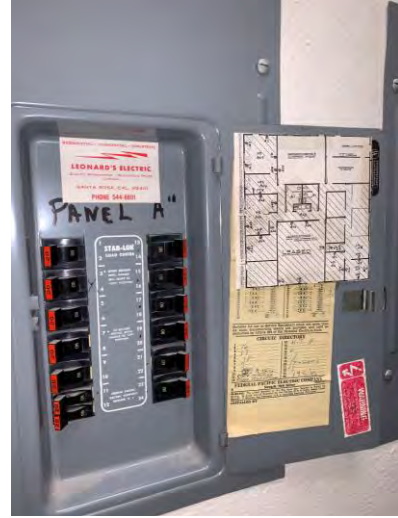
Record ID: 1302  
 System: D5020 - ELECTRICAL SERVICE AND DISTRIBUTION  
 Year Installed / Industry Life / Remaining Useful Life: 1990 / 30 / -2  
 Item No.: D5020.30.4001  
 Floor/Room:  
**Priority:** 1  
 Quantity/Unit of Measure: 1/EA  
 Total Deficiency Cost: \$4,910  
 Deficiency Description: *The load center is past its expected useful life.*

Description of Work: *Replace the existing load center with a new load center.*

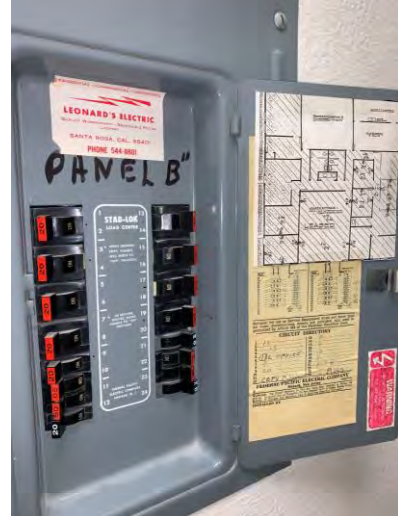
Record ID: 1303  
 System: D5020 - ELECTRICAL SERVICE AND DISTRIBUTION  
 Year Installed / Industry Life / Remaining Useful Life: 1990 / 30 / -2  
 Item No.: D5020.30.4001  
 Floor/Room:  
**Priority:** 1  
 Quantity/Unit of Measure: 1/EA  
 Total Deficiency Cost: \$4,910  
 Deficiency Description: *The load center is past its expected useful life.*

Description of Work: *Replace the existing load center with a new load center.*

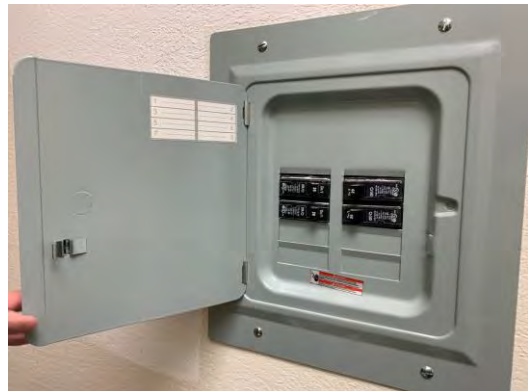
Record ID: 1304  
 System: D5020 - ELECTRICAL SERVICE AND DISTRIBUTION  
 Year Installed / Industry Life / Remaining Useful Life: 1990 / 30 / -2  
 Item No.: D5020.30.4001  
 Floor/Room:  
**Priority:** 1  
 Quantity/Unit of Measure: 1/EA  
 Total Deficiency Cost: \$4,910  
 Deficiency Description: *The load center is past its expected useful life.*

Description of Work: *Replace the existing load center with a new load center.*

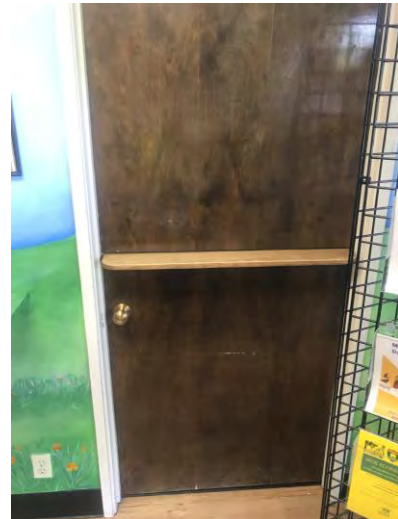
Record ID 1489  
System C1030 - INTERIOR DOORS

Year Installed / Industry Life / Remaining Useful Life - / 30 / -  
Item No. C1030.10.008  
Floor/Room: 1  
**Priority:** 3  
Quantity/Unit of Measure: 1/EA  
Total Deficiency Cost: \$1,090  
Deficiency Description: *Interior wood door is in visual need of refurbishment.*

Description of Work: *Refurbish and restain the wood door.*

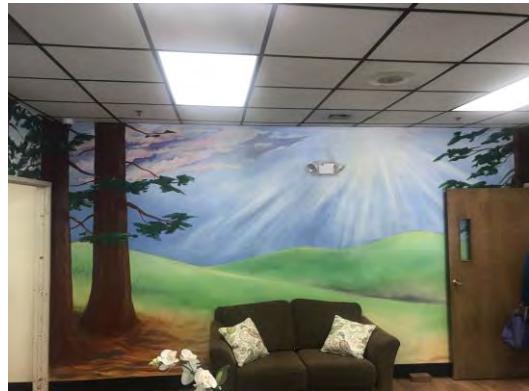
Record ID 1490  
System C2050 - CEILING FINISHES

Year Installed / Industry Life / Remaining Useful Life - / 50 / -  
Item No. C2050.80.001  
Floor/Room: 1 / Waiting Area  
**Priority:** 3  
Quantity/Unit of Measure: 400/SF  
Total Deficiency Cost: \$6,590  
Deficiency Description: *Lay-in Acoustical Tile is in poor condition.*

Description of Work: *Remove existing lay-in Acoustical Tiles and replace with new lay-in Acoustical Tiles.*

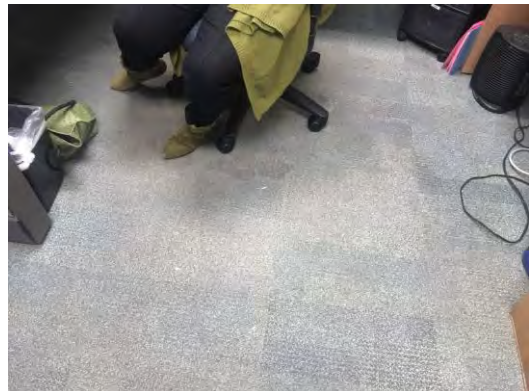
Record ID 1491  
System C2030 - FLOORING

Year Installed / Industry Life / Remaining Useful Life - / 20 / -  
Item No. C2030.75.001  
Floor/Room: 1 / Office  
**Priority:** 3  
Quantity/Unit of Measure: 400/SF  
Total Deficiency Cost: \$11,250  
Deficiency Description: *Carpet tile is missing or damaged.*

Description of Work: *Replace carpet tile.*

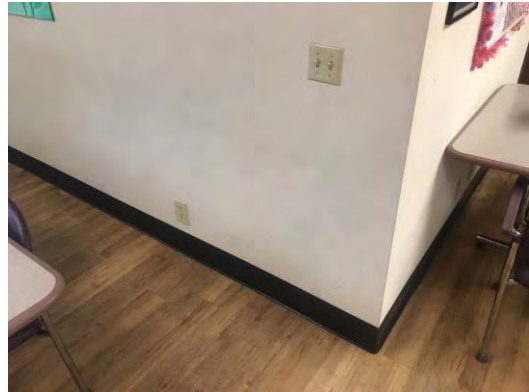
Record ID: 1492  
 System: C2010 - WALL FINISHES  
 Year Installed / Industry Life / Remaining Useful Life: - / 30 / -  
 Item No.: C2010.70.001  
 Floor/Room: 1 / Reception  
**Priority:** 3  
 Quantity/Unit of Measure: 1,000/SF  
 Total Deficiency Cost: \$21,950  
 Deficiency Description: *Painted gypsum wallboard is showing signs of wear.*  
 Description of Work: *Patch and paint the gypsum wallboard.*  
 Comments:

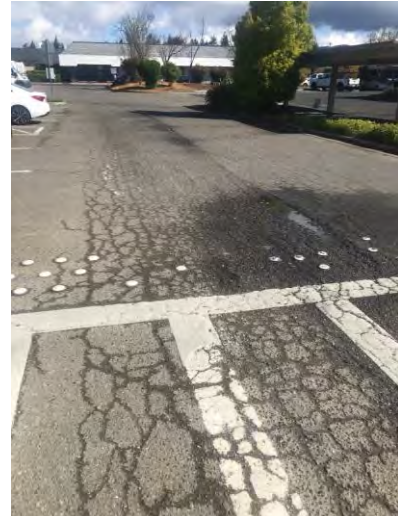
Record ID: 1494  
 System: G2020 - PARKING LOTS  
 Year Installed / Industry Life / Remaining Useful Life: - / - / -  
 Item No.: G2020.10.002  
 Floor/Room: Site / Parking Lot  
**Priority:** 5  
 Quantity/Unit of Measure: 2,000/SF  
 Total Deficiency Cost: \$66,210  
 Deficiency Description: *AC paving shows evidence of fatigue cracking.*  
 Description of Work: *Replace AC pavement section.*  
 Comments:

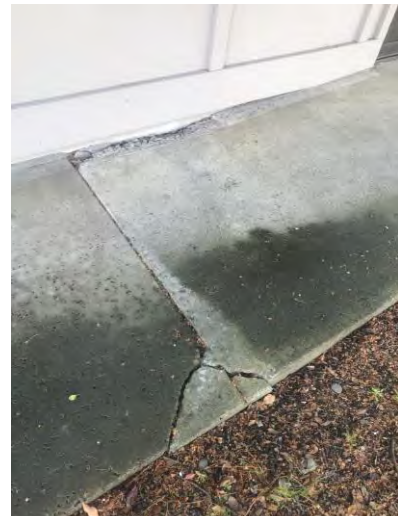
Record ID: 1496  
 System: G2030 - PEDESTRIAN PLAZAS AND WALKWAYS  
 Year Installed / Industry Life / Remaining Useful Life: - / 30 / -  
 Item No.: G2030.10.005  
 Floor/Room: Site / Pavement  
**Priority:** 2  
 Quantity/Unit of Measure: 100/SF  
 Total Deficiency Cost: \$3,640  
 Deficiency Description: *Concrete pavement has major damage / structural failure.*  
 Description of Work: *Replace concrete and base to match existing.*  
 Comments:

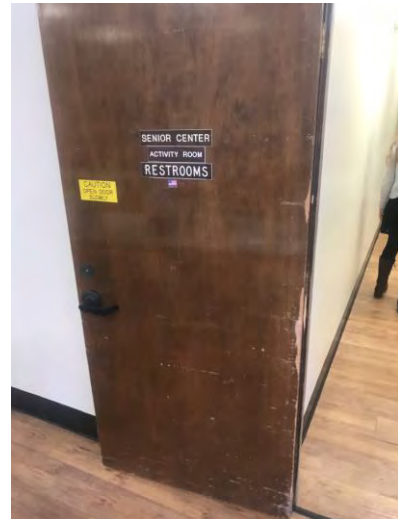
Deficiency Description: *Interior wood door is at or approaching the end of its useful life.*

Description of Work: *Replace with new wood door.*

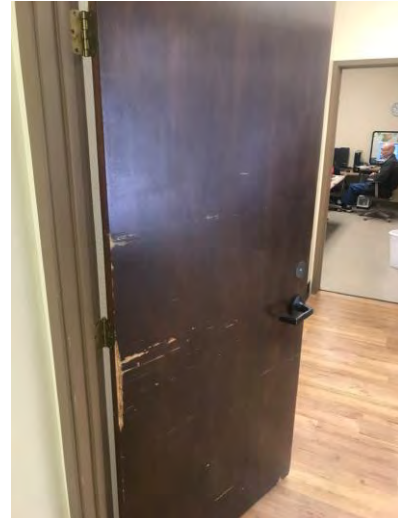
Deficiency Description: *Interior wood door is at or approaching the end of its useful life.*

Description of Work: *Replace with new wood door.*

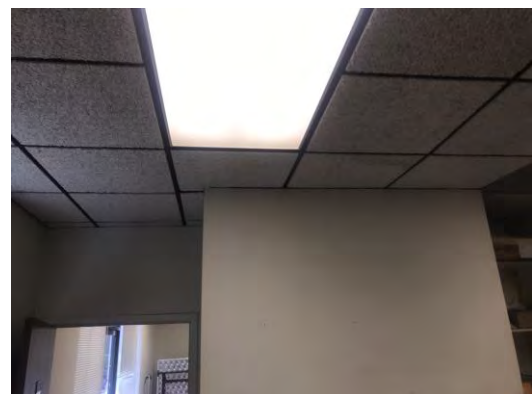
Deficiency Description: *Lay-in Acoustical Tile is in poor condition.*

Description of Work: *Remove existing lay-in Acoustical Tiles and replace with new lay-in Acoustical Tiles.*

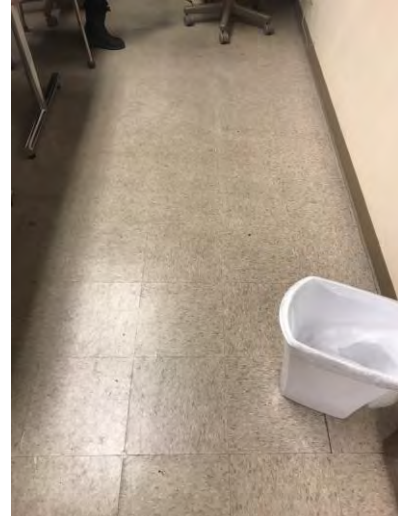
Deficiency Description: *Vinyl composition tile is approaching the end of its useful life.*

Description of Work: *Remove the existing vinyl composition tile and replace.*

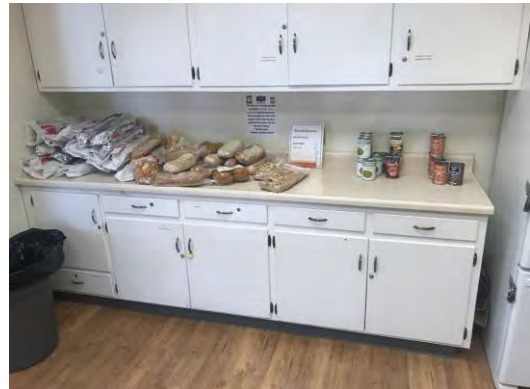
Deficiency Description: *Plastic laminate casework is at or will be approaching the end of its expected useful life.*

Description of Work: *Provide new plastic laminate casework (upper, lower, and countertop)*

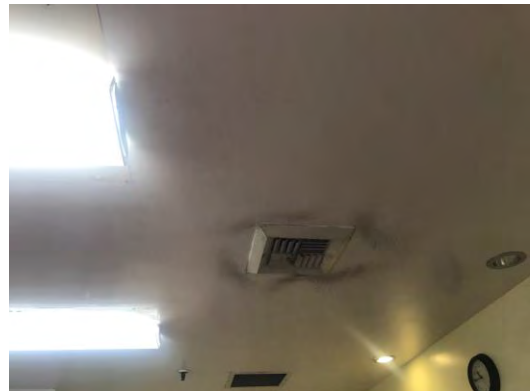
Deficiency Description: *Painted gypsum wallboard ceiling is approaching the end of its useful life.*

Description of Work: *Remove the existing gypsum board ceiling and replace. Tape and paint.*

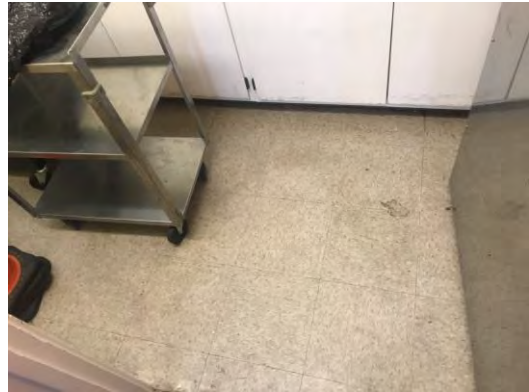
Deficiency Description: *Vinyl composition tile is approaching the end of its useful life.*

Description of Work: *Remove the existing vinyl composition tile and replace.*

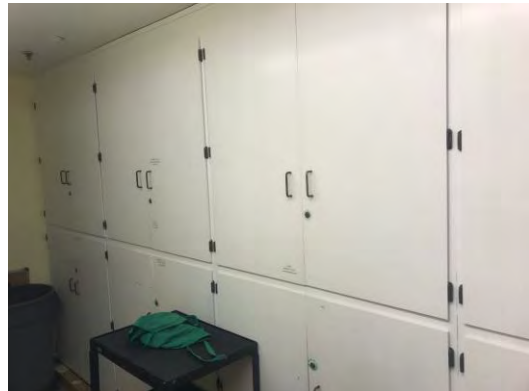
Deficiency Description: *The existing casework is in need of refurbishment.*

Description of Work: *Repair, refurbish, and refinish the existing wood casework.*

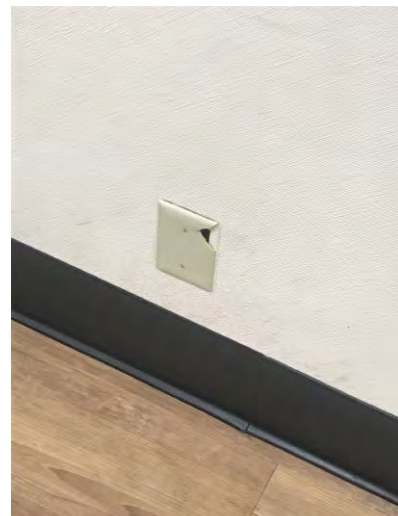
Deficiency Description: *An outlet cover is missing or damaged and should be replaced.*

Description of Work: *Replace the damaged or missing outlet cover.*

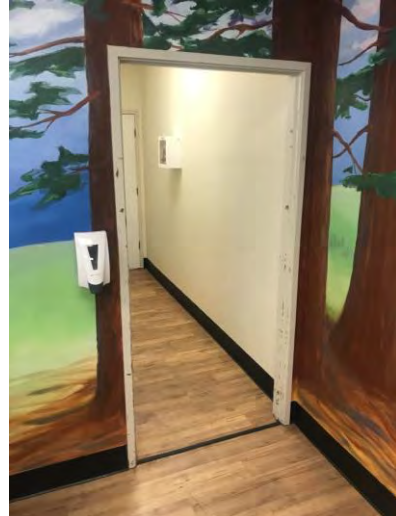
Deficiency Description: *Wood door frames are in fair to poor condition.*

Description of Work: *Replace the door frames with a wood frame.*

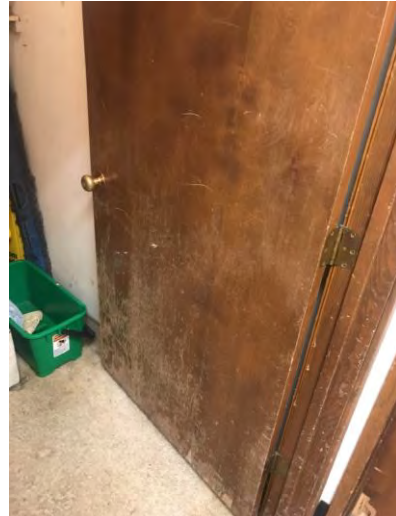
Deficiency Description: *Interior wood door is at or approaching the end of its useful life.*

Description of Work: *Replace with new wood door.*

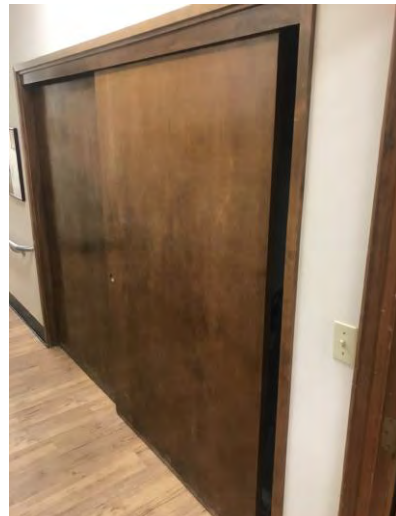
Deficiency Description: *Interior wood door is in visual need of refurbishment.*

Description of Work: *Refurbish and restain the wood door.*

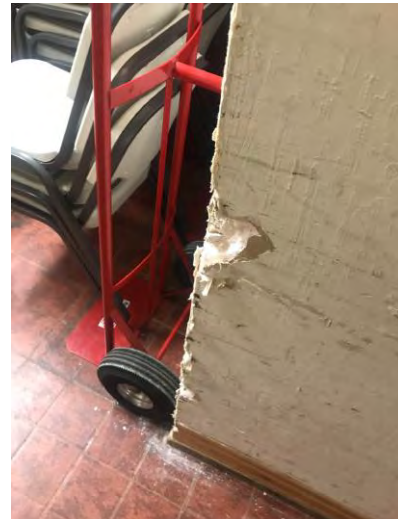
Record ID 1517  
System C1010 - INTERIOR PARTITIONS

Year Installed / Industry Life / Remaining Useful Life - / 20 / -  
Item No. C1010.10.001  
Floor/Room: 1 / Storage  
**Priority: 1**  
Quantity/Unit of Measure: 200/SF  
Total Deficiency Cost: \$1,370  
Deficiency Description: *Painted gypsum wallboard is in poor condition with several cracks.*

Description of Work: *Remove and replace existing gypsum board with a new gypsum board and expansion joints. Tape and paint.*

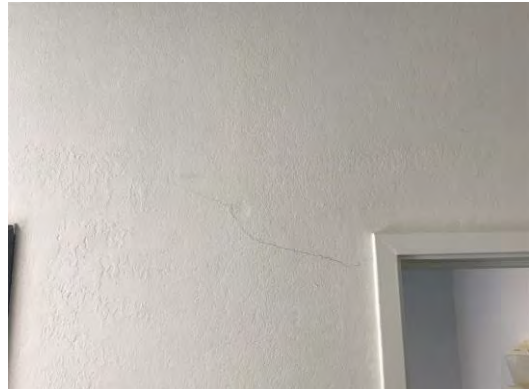
Record ID 1518  
System C1010 - INTERIOR PARTITIONS

Year Installed / Industry Life / Remaining Useful Life - / 20 / -  
Item No. C1010.10.001  
Floor/Room: 1  
**Priority: 3**  
Quantity/Unit of Measure: 100/SF  
Total Deficiency Cost: \$750  
Deficiency Description: *Painted gypsum wallboard is in poor condition with several cracks.*

Description of Work: *Remove and replace existing gypsum board with a new gypsum board and expansion joints. Tape and paint.*

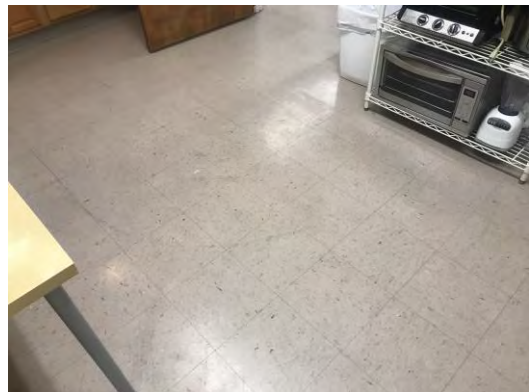
Record ID 1520  
System C2030 - FLOORING

Year Installed / Industry Life / Remaining Useful Life - / 60 / -  
Item No. C2030.50.001  
Floor/Room: 1 / Kitchen  
**Priority: 4**  
Quantity/Unit of Measure: 800/SF  
Total Deficiency Cost: \$21,950  
Deficiency Description: *Vinyl composition tile is approaching the end of its useful life.*

Description of Work: *Remove the existing vinyl composition tile and replace.*

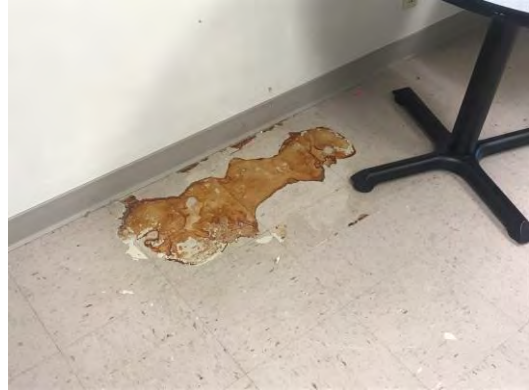
Year Installed / Industry Life / Remaining Useful Life - / 60 / -  
Item No. C2030.50.001  
Floor/Room: 1 / Classroom  
**Priority: 1**  
Quantity/Unit of Measure: 100/SF  
Total Deficiency Cost: \$2,420  
Deficiency Description: *Vinyl composition tile is approaching the end of its useful life.*

Description of Work: *Remove the existing vinyl composition tile and replace.*

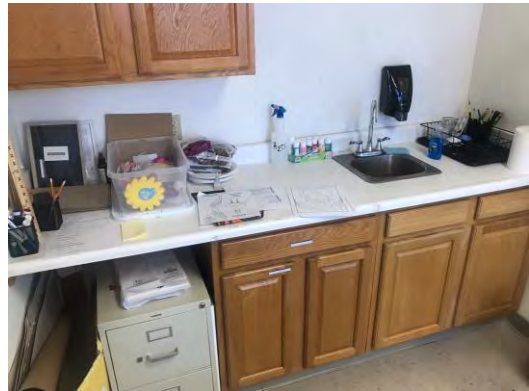
Year Installed / Industry Life / Remaining Useful Life - / - / -  
Item No. E2010.30.008  
Floor/Room: 1 / Classroom  
**Priority: 4**  
Quantity/Unit of Measure: 10/LF  
Total Deficiency Cost: \$14,630  
Deficiency Description: *Plastic laminate base cabinet (with countertop) is in poor condition.*

Description of Work: *Remove and replace with new plastic laminate base cabinet and countertop.*

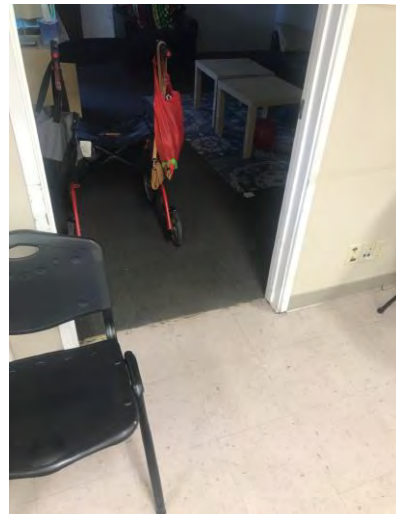
Year Installed / Industry Life / Remaining Useful Life - / 20 / -  
Item No. C2030.75.001  
Floor/Room: 1 / Lounge  
**Priority: 2**  
Quantity/Unit of Measure: 200/SF  
Total Deficiency Cost: \$5,410  
Deficiency Description: *Carpet flooring is worn.*

Description of Work: *Replace carpet flooring.*

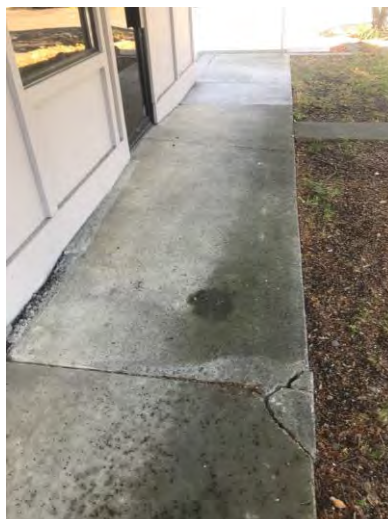
Record ID: 1526  
System: G2030 - PEDESTRIAN PLAZAS AND WALKWAYS  
Year Installed / Industry Life / Remaining Useful Life: - / 30 / -  
Item No.: G2030.10.005  
Floor/Room: Site / Exterior  
**Priority:** 2  
Quantity/Unit of Measure: 100/SF  
Total Deficiency Cost: \$3,640  
Deficiency Description: *Concrete pavement has major damage / structural failure.*

Description of Work: *Replace concrete and base to match existing.*

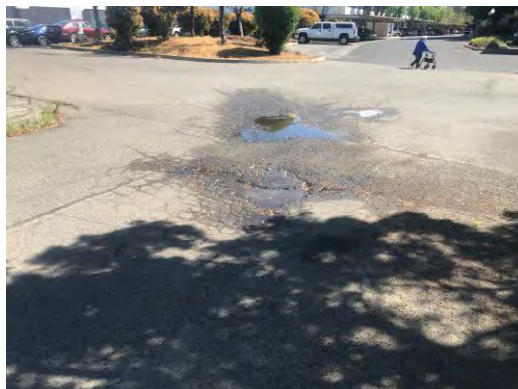
Record ID: 1527  
System: G2020 - PARKING LOTS  
Year Installed / Industry Life / Remaining Useful Life: - / - / -  
Item No.: G2020.10.002  
Floor/Room: Site / Exterior  
**Priority:** 2  
Quantity/Unit of Measure: 400/SF  
Total Deficiency Cost: \$11,700  
Deficiency Description: *AC paving shows evidence of potholing.*

Description of Work: *Replace AC pavement section.*

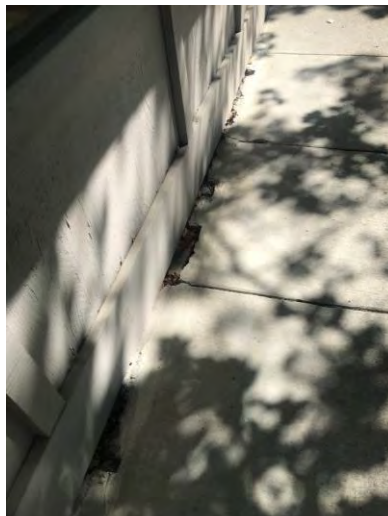
Record ID: 1531  
System: G2030 - PEDESTRIAN PLAZAS AND WALKWAYS  
Year Installed / Industry Life / Remaining Useful Life: - / 30 / -  
Item No.: G2030.10.005  
Floor/Room: Site / Pavement  
**Priority:** 1  
Quantity/Unit of Measure: 200/SF  
Total Deficiency Cost: \$6,950  
Deficiency Description: *Concrete pavement has major damage / structural failure.*

Description of Work: *Replace concrete and base to match existing.*

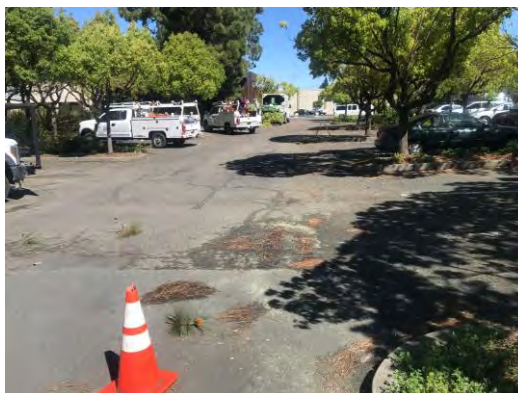
Record ID: 1532  
System: G2020 - PARKING LOTS  
Year Installed / Industry Life / Remaining Useful Life: - / - / -  
Item No.: G2020.10.002  
Floor/Room: Site / Parking Lot  
**Priority:** 3  
Quantity/Unit of Measure: 1,000/SF  
Total Deficiency Cost: \$30,520  
Deficiency Description: *AC paving shows evidence of potholing.*

Description of Work: *Replace AC pavement section.*

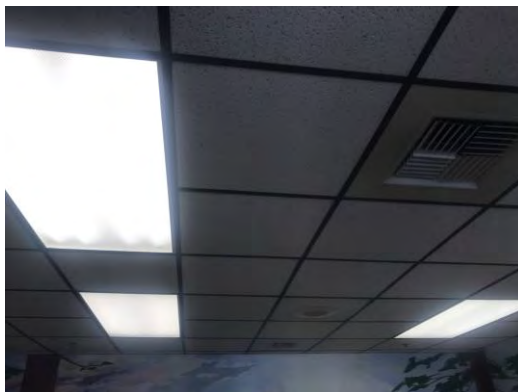
Record ID: 1777  
System: D5040 - LIGHTING  
Year Installed / Industry Life / Remaining Useful Life: 1990 / 20 / -12  
Item No.: D5040.50.411  
Floor/Room:  
**Priority:** 1  
Quantity/Unit of Measure: 14,977/SF  
Total Deficiency Cost: \$856,960  
Deficiency Description: *Interior lighting system is past its expected useful life but operational.*

Description of Work: *Provide new interior lighting and control system throughout building per current CEC T24 code.*

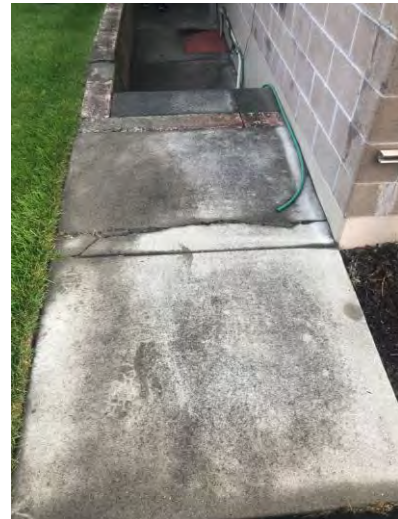
Record ID: 44  
 System: G2030 - PEDESTRIAN PLAZAS AND WALKWAYS  
 Year Installed / Industry Life / Remaining Useful Life: - / 30 / -  
 Item No.: G2030.10.005  
 Floor/Room: Site / Pavement  
**Priority:** 2  
 Quantity/Unit of Measure: 25/SF  
 Total Deficiency Cost: \$920  
 Deficiency Description: *Concrete pavement has major damage / structural failure.*

Description of Work: *Replace concrete and base to match existing.*

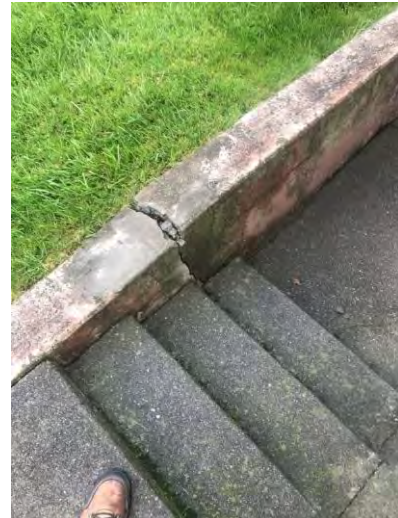
Record ID: 45  
 System: G2060 - SITE DEVELOPMENT  
 Year Installed / Industry Life / Remaining Useful Life: - / - / -  
 Item No.: G2060.60.012  
 Floor/Room: Site / Retaining Wall  
**Priority:** 2  
 Quantity/Unit of Measure: 10/SF  
 Total Deficiency Cost: \$2,240  
 Deficiency Description: *Retaining wall is cracked.*

Description of Work: *Replace portion of concrete wall.*

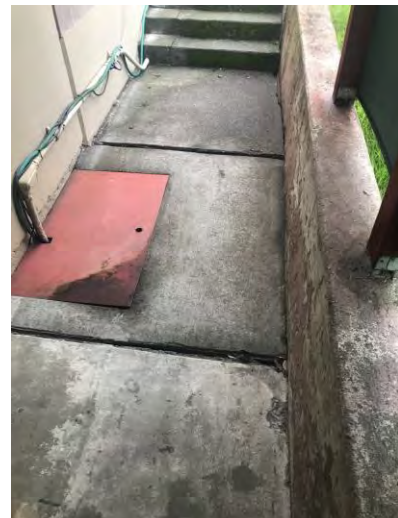
Record ID: 46  
 System: G2030 - PEDESTRIAN PLAZAS AND WALKWAYS  
 Year Installed / Industry Life / Remaining Useful Life: - / 30 / -  
 Item No.: G2030.10.005  
 Floor/Room: Site / Pavement  
**Priority:** 2  
 Quantity/Unit of Measure: 100/SF  
 Total Deficiency Cost: \$3,640  
 Deficiency Description: *Concrete pavement has major damage / structural failure.*

Description of Work: *Replace concrete and base to match existing.*

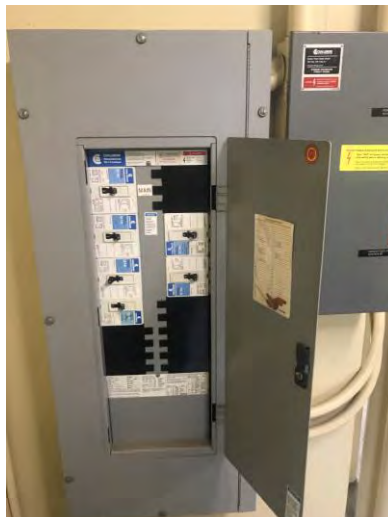
Record ID 47  
System D5020 - ELECTRICAL SERVICE AND DISTRIBUTION  
Year Installed / Industry Life / Remaining Useful Life 1990 / 30 / -2  
Item No. D5020.30.1001  
Floor/Room:  
**Priority:** 1  
Quantity/Unit of Measure: 1/EA  
Total Deficiency Cost: \$8,230  
Deficiency Description: *The 100A panelboard is past its expected useful life.*

Description of Work: *Replace the existing panelboard with a new panelboard.*

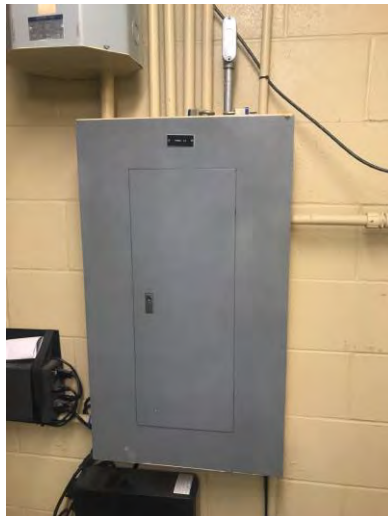
Record ID 49  
System D5020 - ELECTRICAL SERVICE AND DISTRIBUTION  
Year Installed / Industry Life / Remaining Useful Life 1976 / 30 / -16  
Item No. D5020.30.1002  
Floor/Room:  
**Priority:** 1  
Quantity/Unit of Measure: 1/EA  
Total Deficiency Cost: \$18,290  
Deficiency Description: *The panelboard is past its expected useful life.*

Description of Work: *Replace the existing panelboard with a new panelboard.*

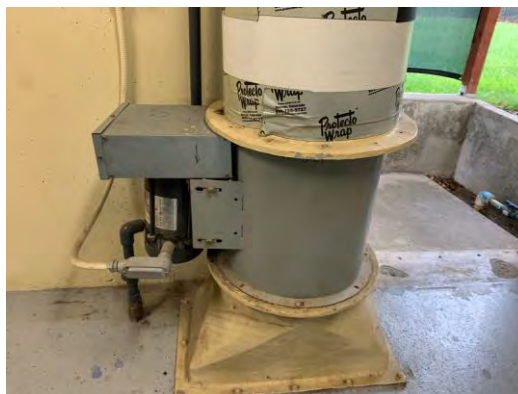
Record ID 295  
System D3060 - VENTILATION  
Year Installed / Industry Life / Remaining Useful Life - / 25 / -  
Item No. D3060.30.009  
Floor/Room:  
**Priority:** 7  
Quantity/Unit of Measure: 1/EA  
Total Deficiency Cost: \$36,980  
Deficiency Description: *In-Line building exhaust fan is approaching the end of its expected useful life.*

Description of Work: *Provide equipment replacement and installation.*

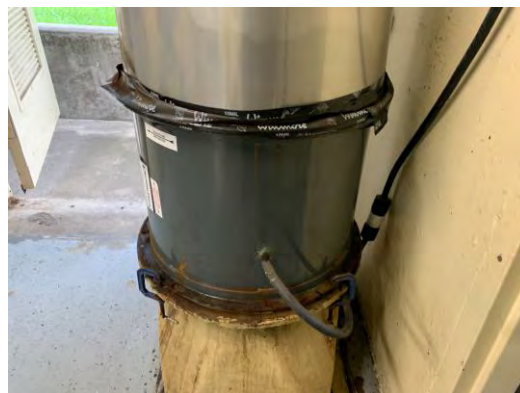
Year Installed / Industry Life / Remaining Useful Life: - / 25 / -  
Item No.: D3060.30.009  
Floor/Room:  
**Priority:** 7  
Quantity/Unit of Measure: 1/EA  
Total Deficiency Cost: \$36,980  
Deficiency Description: *In-Line building exhaust fan is approaching the end of its expected useful life.*

Description of Work: *Provide equipment replacement and installation.*

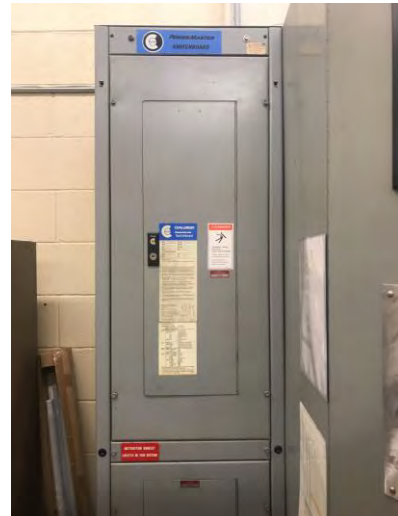
Record ID: 40  
System: D5020 - ELECTRICAL SERVICE AND DISTRIBUTION  
Year Installed / Industry Life / Remaining Useful Life: 1992 / 30 / 0  
Item No.: D5020.30.1008  
Floor/Room:  
**Priority:** 1  
Quantity/Unit of Measure: 1/EA  
Total Deficiency Cost: \$18,570  
Deficiency Description: *The panelboard is past its expected useful life.*

Description of Work: *Replace the existing panelboard with a new panelboard.*

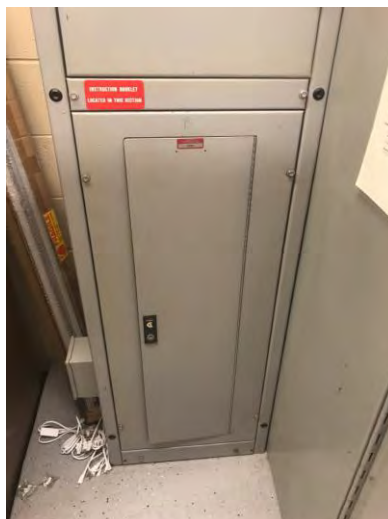
Record ID: 41  
 System: D5020 - ELECTRICAL SERVICE AND DISTRIBUTION  
 Year Installed / Industry Life / Remaining Useful Life: 1992 / 30 / 0  
 Item No.: D5020.30.1008  
 Floor/Room:  
**Priority:** 1  
 Quantity/Unit of Measure: 1/EA  
 Total Deficiency Cost: \$18,570  
 Deficiency Description: *The panelboard is past its expected useful life.*

Description of Work: *Replace the existing panelboard with a new panelboard.*

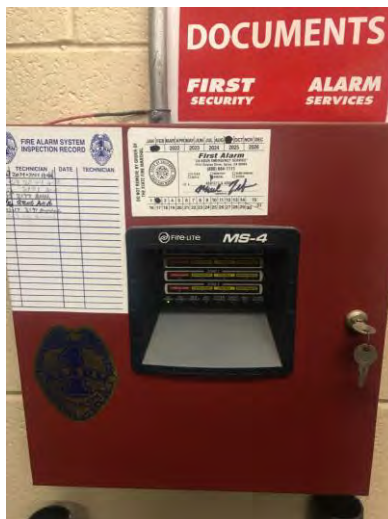
Record ID: 42  
 System: D7050 - DETECTION AND ALARM  
 Year Installed / Industry Life / Remaining Useful Life: 2012 / 15 / 5  
 Item No.: D7050.10.022  
 Floor/Room:  
**Priority:** 7  
 Quantity/Unit of Measure: 5,197/SF  
 Total Deficiency Cost: \$153,590  
 Deficiency Description: *The existing fire alarm system is nearing its expected useful life*

Description of Work: *Provide a fully addressable fire alarm control panel with associated initiating and signaling devices.*

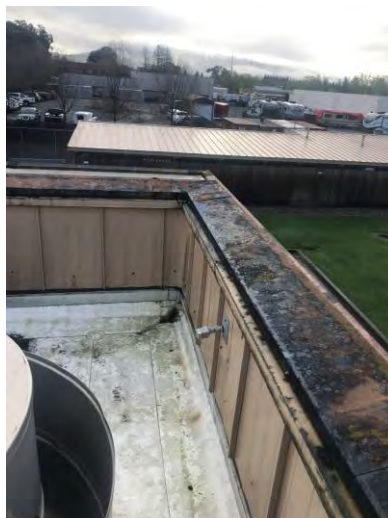
Record ID: 43  
 System: B2010 - EXTERIOR WALLS  
 Year Installed / Industry Life / Remaining Useful Life: - / 40 / -  
 Item No.: B2010.50.001  
 Floor/Room: Roof / Upper Roof  
**Priority:** 2  
 Quantity/Unit of Measure: 300/LF  
 Total Deficiency Cost: \$20,160  
 Deficiency Description: *Metal parapet cap is deteriorating.*

Description of Work: *Replace sheet metal cap.*

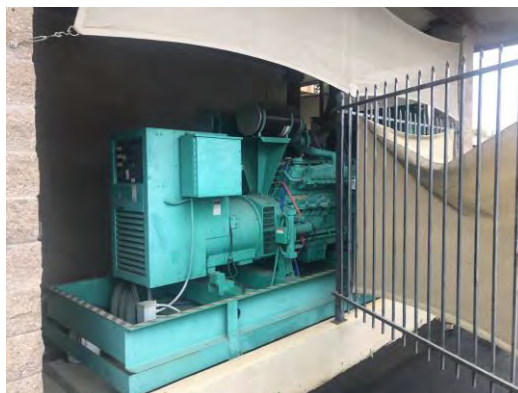
Deficiency Description: *The existing diesel generator is past its expected useful life.*

Description of Work: *Replace the existing generator with a new generator.*

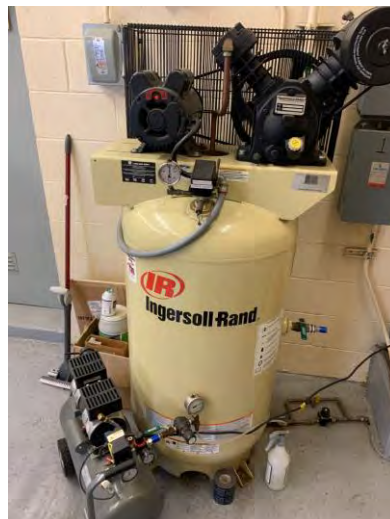
Deficiency Description: *Air compressor is approaching the end of its expected useful life.*

Description of Work: *Provide equipment replacement and installation.*

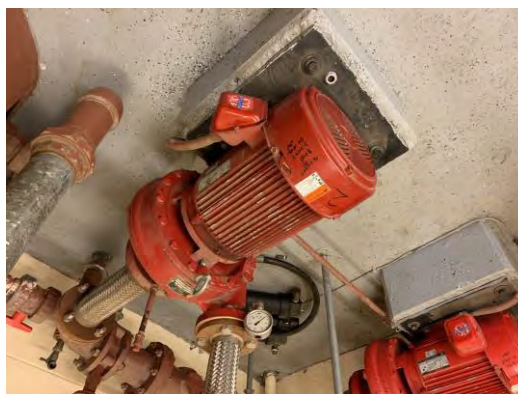
Deficiency Description: *Pump requires rebuild or replacement.*

Comments: *Leak on pump - Warren issued rebuilding*

Description of Work: *Rebuild or replace existing pump.*

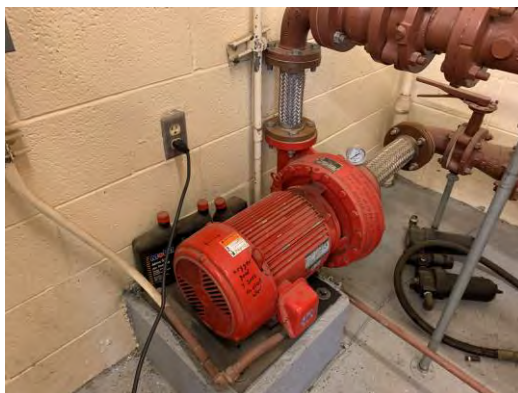
Record ID: 279  
System: D2030 - BUILDING SUPPORT PLUMBING SYSTEMS  
Year Installed / Industry Life / Remaining Useful Life: - / 20 / -  
Item No.: D2030.10.002  
Floor/Room:  
**Priority:** 3  
Quantity/Unit of Measure: 1/EA  
Total Deficiency Cost: \$53,150  
Deficiency Description: *Pump requires rebuild or replacement.*

Comments: *Model no longer made, being rebuilt instead*

Description of Work: *Rebuild or replace existing pump.*

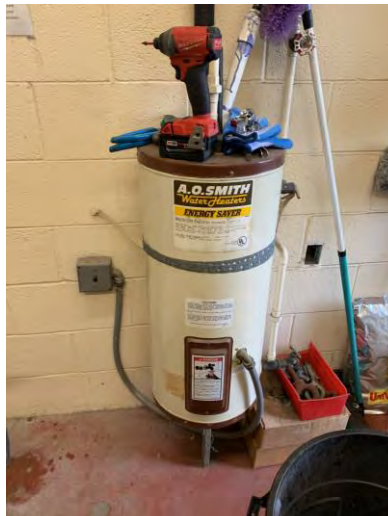
Record ID: 282  
System: D2010 - DOMESTIC WATER DISTRIBUTION  
Year Installed / Industry Life / Remaining Useful Life: - / 15 / -  
Item No.: D2010.20.023  
Floor/Room:  
**Priority:** 1  
Quantity/Unit of Measure: 1/EA  
Total Deficiency Cost: \$13,250  
Deficiency Description: *Electric water heater is approaching the end of its expected useful life.*

Description of Work: *Provide equipment replacement and installation.*

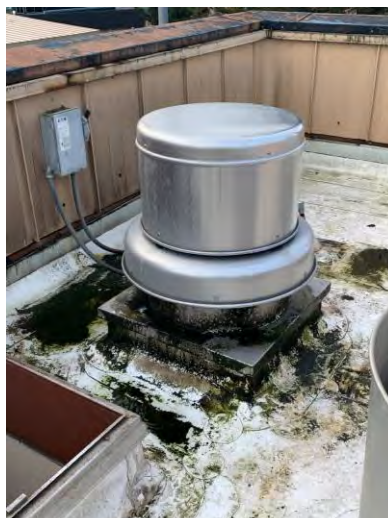
Record ID: 284  
System: D3060 - VENTILATION  
Year Installed / Industry Life / Remaining Useful Life: - / 25 / -  
Item No.: D3060.30.005  
Floor/Room:  
**Priority:** 1  
Quantity/Unit of Measure: 1/EA  
Total Deficiency Cost: \$7,090  
Deficiency Description: *Roof exhaust fan is approaching the end of its expected useful life.*

Comments: *Replacement needed*

Description of Work: *Provide equipment replacement and installation.*

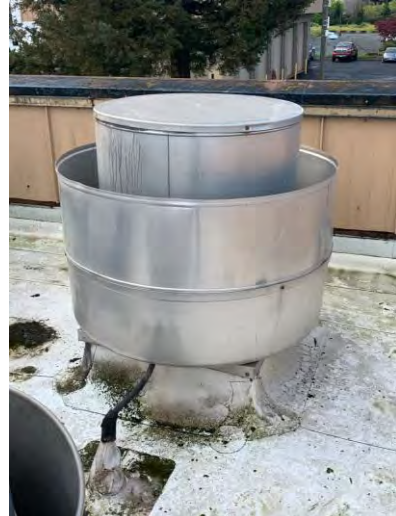
Year Installed / Industry Life / Remaining Useful Life: - / 25 / -  
Item No.: D3060.30.005  
Floor/Room:  
**Priority:** 3  
Quantity/Unit of Measure: 1/EA  
Total Deficiency Cost: \$7,750  
Deficiency Description: *Roof exhaust fan is approaching the end of its expected useful life.*

Description of Work: *Provide equipment replacement and installation.*

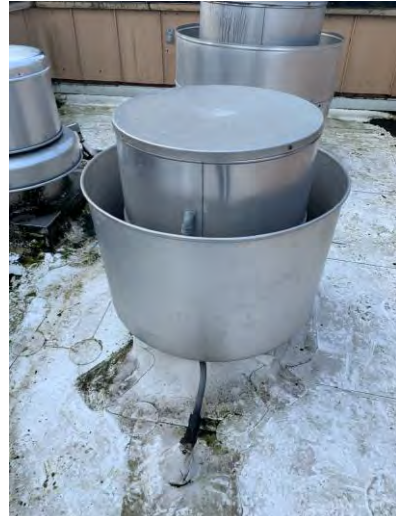
Year Installed / Industry Life / Remaining Useful Life: - / 25 / -  
Item No.: D3060.30.005  
Floor/Room:  
**Priority:** 3  
Quantity/Unit of Measure: 1/EA  
Total Deficiency Cost: \$7,750  
Deficiency Description: *Roof exhaust fan is approaching the end of its expected useful life.*

Description of Work: *Provide equipment replacement and installation.*

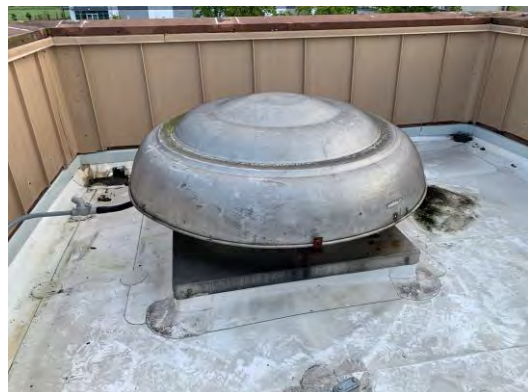
Year Installed / Industry Life / Remaining Useful Life: - / 25 / -  
Item No.: D3060.30.005  
Floor/Room:  
**Priority:** 3  
Quantity/Unit of Measure: 1/EA  
Total Deficiency Cost: \$7,750  
Deficiency Description: *Roof exhaust fan is approaching the end of its expected useful life.*

Description of Work: *Provide equipment replacement and installation.*

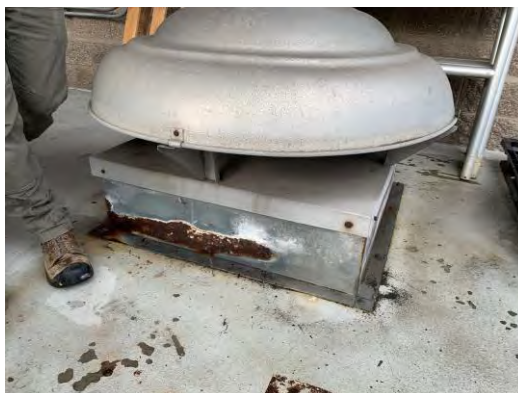
Record ID: 288  
 System: D3060 - VENTILATION  
 Year Installed / Industry Life / Remaining Useful Life: - / 25 / -  
 Item No.: D3060.30.005  
 Floor/Room:  
 Priority: 1  
 Quantity/Unit of Measure: 1/EA  
 Total Deficiency Cost: \$7,090  
 Deficiency Description: *Roof exhaust fan is approaching the end of its expected useful life.*  
 Description of Work: *Provide equipment replacement and installation.*  
 Comments: *Replacement needed*

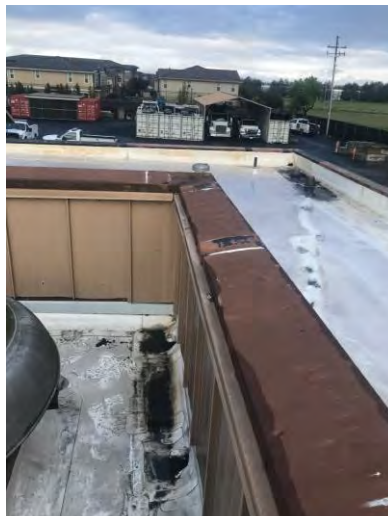
Record ID: 1794  
 System: B3010 - ROOFING  
 Year Installed / Industry Life / Remaining Useful Life: - / 30 / -  
 Item No.: B3010.50.002  
 Floor/Room: Roof / Entire Roof  
 Priority: 7  
 Quantity/Unit of Measure: 2,500/SF  
 Total Deficiency Cost: \$113,670  
 Deficiency Description: *Single-ply roofing is beyond its expected useful service life and needs replacement.*  
 Description of Work: *Remove and replace single-ply roofing.*  
 Comments: *Ponding throughout.*

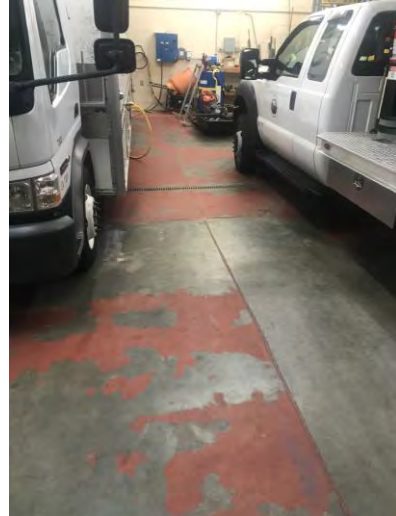
Year Installed / Industry Life / Remaining Useful Life: - / 50 / -  
Item No.: C2030.10.001  
Floor/Room: 1 / Equipment Storage  
**Priority:** 3  
Quantity/Unit of Measure: 2,000/SF  
Total Deficiency Cost: \$35,090  
Deficiency Description: *Concrete floor finish is approaching the end of its useful life.*

Description of Work: *Repair and refinish the concrete floor.*

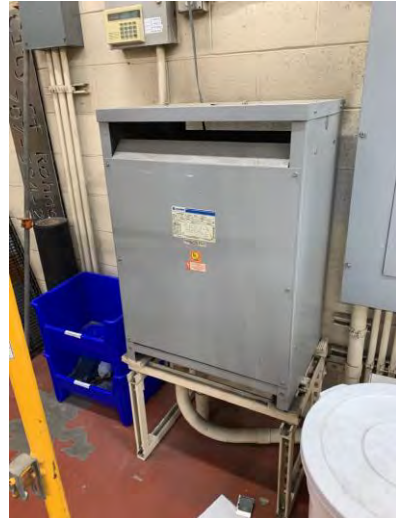
Year Installed / Industry Life / Remaining Useful Life: 1992 / 30 / 0  
Item No.: D5020.10.207  
Floor/Room:  
**Priority:** 1  
Quantity/Unit of Measure: 1/EA  
Total Deficiency Cost: \$20,230  
Deficiency Description: *The 50kVA transformer is past expected useful life.*

Description of Work: *Replace the existing transformer with a new transformer.*

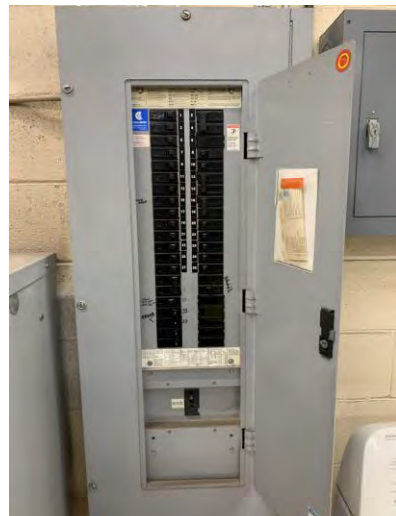
Year Installed / Industry Life / Remaining Useful Life: 1992 / 30 / 0  
Item No.: D5020.30.1008  
Floor/Room:  
**Priority:** 1  
Quantity/Unit of Measure: 1/EA  
Total Deficiency Cost: \$18,570  
Deficiency Description: *The panelboard is past its expected useful life.*

Description of Work: *Replace the existing panelboard with a new panelboard.*

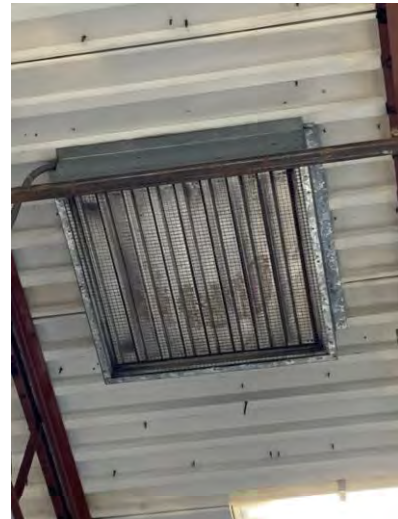
Deficiency Description: *Ventilator is approaching the end of its expected useful life.*

Comments: *Only rooftop equipment*

Description of Work: *Provide equipment replacement and installation.*

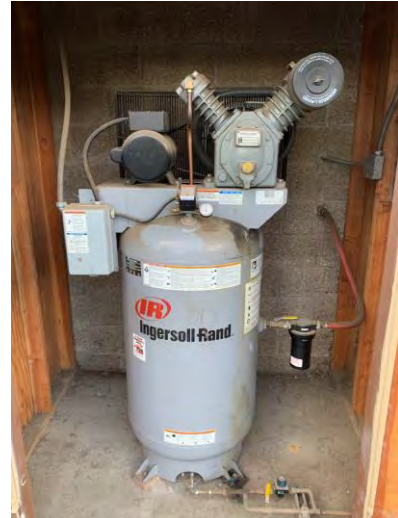
Deficiency Description: *Air compressor is approaching the end of its expected useful life.*

Comments: *Only rooftop equipment*

Description of Work: *Provide equipment replacement and installation.*

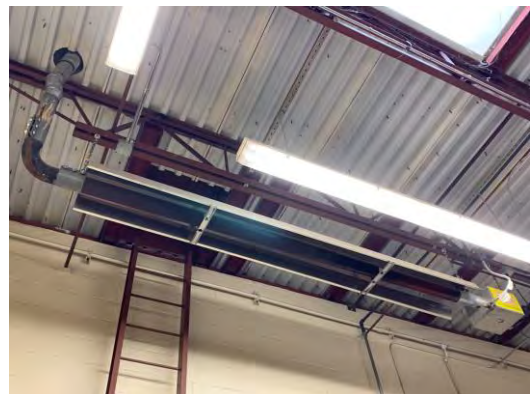
Deficiency Description: *Interior lighting system is past its expected useful life.*

Description of Work: *Provide new interior lighting and control system throughout building per current CEC T24 code.*
