# City of Rohnert Park

## Facility Condition Assessment

Final Report

October 17, 2022

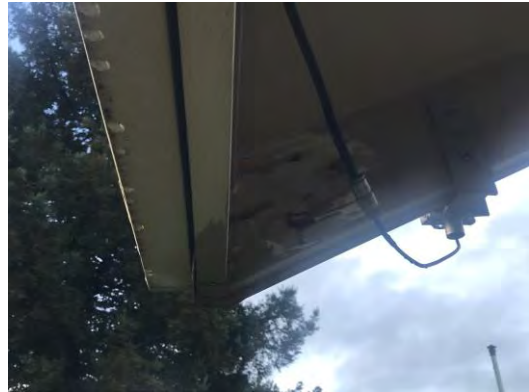
Record ID: 32  
 System: B3010 - ROOFING  
 Year Installed / Industry Life / Remaining Useful Life: - / 20 / -  
 Item No.: B3010.90.010  
 Floor/Room: Roof / Exterior  
**Priority:** 2  
 Quantity/Unit of Measure: 10/LF  
 Total Deficiency Cost: \$360  
 Deficiency Description: *The 2' fascia is appears deteriorated.*

Description of Work: *Selectively remove deteriorated fascia and replace with new material to match.*

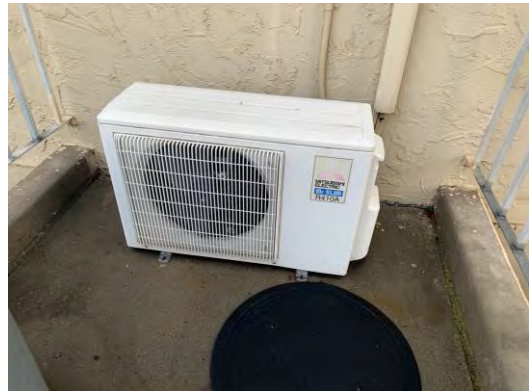
Record ID: 267  
 System: D3030 - COOLING SYSTEMS  
 Year Installed / Industry Life / Remaining Useful Life: 2006 / 10 / -6  
 Item No.: D3030.70.032  
 Floor/Room:  
**Priority:** 3  
 Quantity/Unit of Measure: 1/EA  
 Total Deficiency Cost: \$7,030  
 Deficiency Description: *Window mounted AC unit is approaching the end of its expected useful life.*

Description of Work: *Provide equipment replacement and installation.*

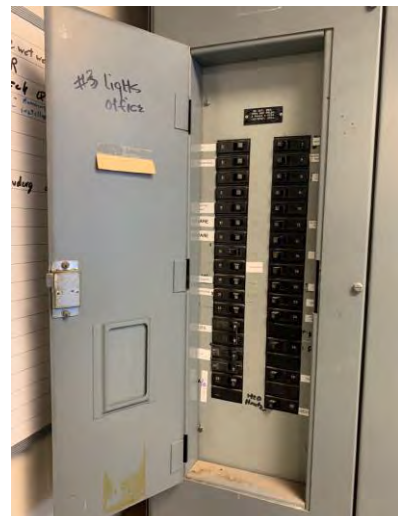
Record ID: 268  
 System: D5020 - ELECTRICAL SERVICE AND DISTRIBUTION  
 Year Installed / Industry Life / Remaining Useful Life: 1972 / 30 / -20  
 Item No.: D5020.30.1008  
 Floor/Room:  
**Priority:** 1  
 Quantity/Unit of Measure: 1/EA  
 Total Deficiency Cost: \$18,570  
 Deficiency Description: *The panelboard is past its expected useful life.*

Description of Work: *Replace the existing panelboard with a new panelboard.*

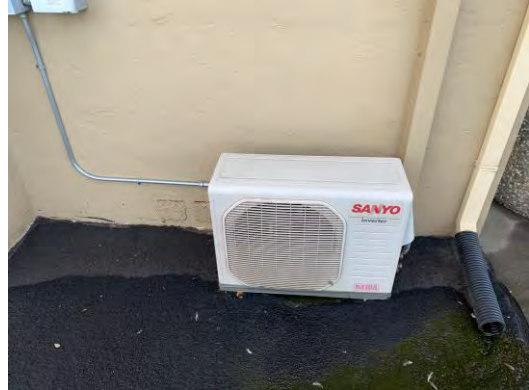
Deficiency Description: *Split system with wall mounted AC and outdoor condensing unit is approaching the end of its expected useful life.*

Description of Work: *Provide equipment replacement and installation.*

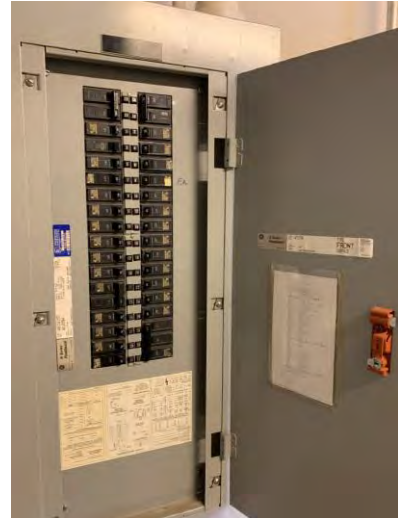
Record ID 497  
System D5020 - ELECTRICAL SERVICE AND DISTRIBUTION  
Year Installed / Industry Life / Remaining Useful Life 1991 / 30 / -1  
Item No. D5020.30.1007  
Floor/Room:  
**Priority:** 1  
Quantity/Unit of Measure: 1/EA  
Total Deficiency Cost: \$11,460  
Deficiency Description: *The panelboard is past its expected useful life.*

Description of Work: *Replace the existing panelboard with a new panelboard.*

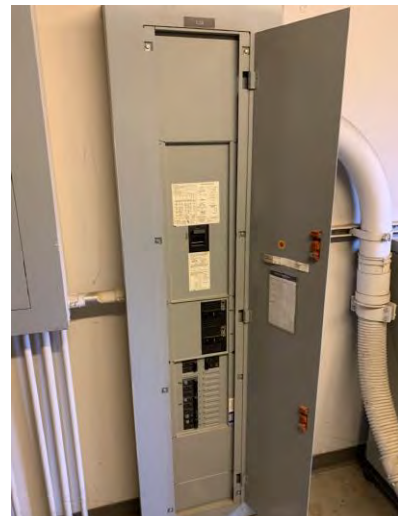
Record ID 498  
System D5020 - ELECTRICAL SERVICE AND DISTRIBUTION  
Year Installed / Industry Life / Remaining Useful Life 1991 / 30 / -1  
Item No. D5020.30.1008  
Floor/Room:  
**Priority:** 1  
Quantity/Unit of Measure: 1/EA  
Total Deficiency Cost: \$18,570  
Deficiency Description: *The panelboard is past its expected useful life.*

Description of Work: *Replace the existing panelboard with a new panelboard.*

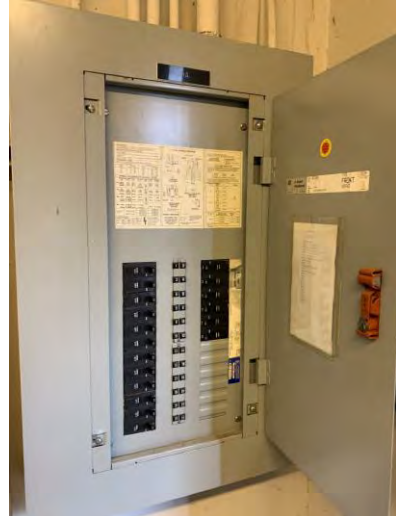
Record ID: 500  
System: D5020 - ELECTRICAL SERVICE AND DISTRIBUTION  
Year Installed / Industry Life / Remaining Useful Life: 1991 / 30 / -1  
Item No.: D5020.30.1011  
Floor/Room:  
**Priority:** 1  
Quantity/Unit of Measure: 1/EA  
Total Deficiency Cost: \$17,750  
Deficiency Description: *The panelboard is past its expected useful life.*

Description of Work: *Replace the existing panelboard with a new panelboard.*

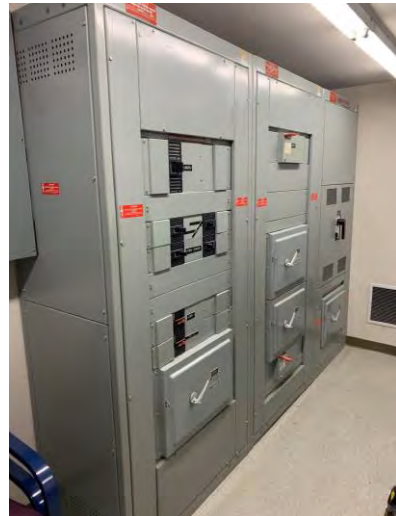
Record ID: 503  
System: D5020 - ELECTRICAL SERVICE AND DISTRIBUTION  
Year Installed / Industry Life / Remaining Useful Life: 1991 / 20 / -11  
Item No.: D5020.30.0014  
Floor/Room:  
**Priority:** 1  
Quantity/Unit of Measure: 1/EA  
Total Deficiency Cost: \$67,200  
Deficiency Description: *The 2000A switchboard is past its expected useful life.*

Description of Work: *Replace the existing switchboard with a new switchboard.*

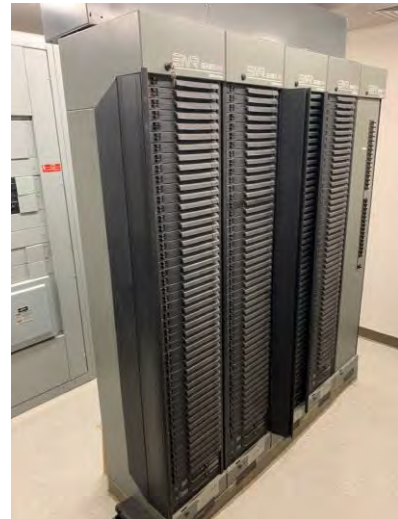
Deficiency Description: *The existing lighting controls are at or are approaching end of their expected useful life.*

Comments: *Functional, but 30 years old, several dead circuits, system on last legs, dimmer system, company no longer in service (100k?+)*

Description of Work: *Replace the existing switches and provide a new lighting control system.*

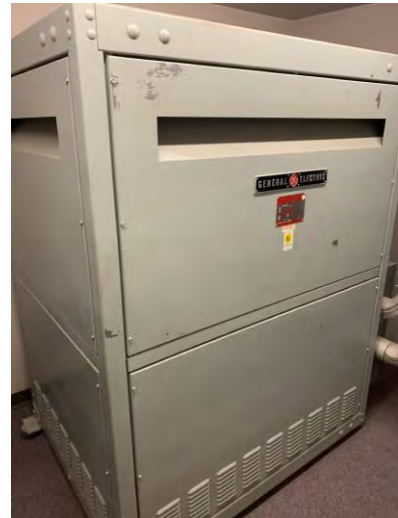
Record ID: 506  
 System: D5020 - ELECTRICAL SERVICE AND DISTRIBUTION

Deficiency Description: *The 500kVA transformer is past its expected useful life.*

Description of Work: *Replace the existing transformer with a new transformer.*

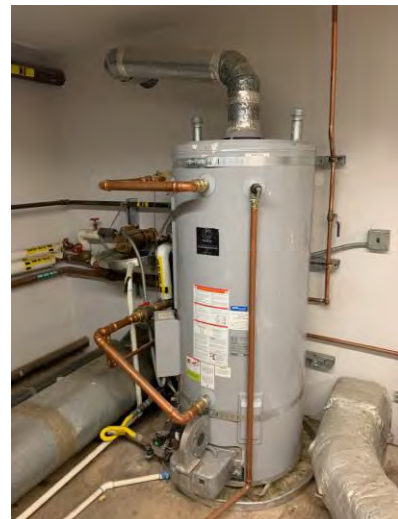
Record ID: 507  
 System: D2010 - DOMESTIC WATER DISTRIBUTION

Deficiency Description: *Booster pump serving water heater is at the end of its expected useful service life.*

Comments: *Issues due to no use during the COVID season. Booster pump fails often.*

Description of Work: *Provide equipment replacement and installation.*

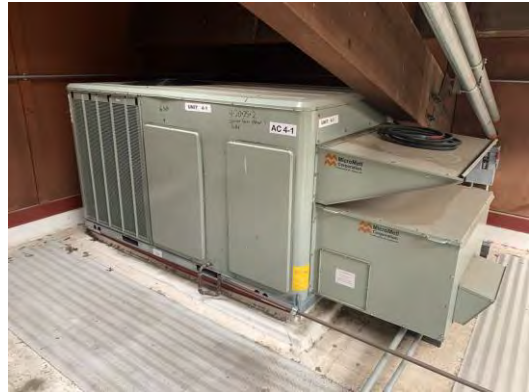
Quantity/Unit of Measure: 1/EA  
Total Deficiency Cost: \$98,860  
Deficiency Description: *Packaged AC unit is approaching the end of its expected useful life.*

Description of Work: *Provide equipment replacement and installation.*

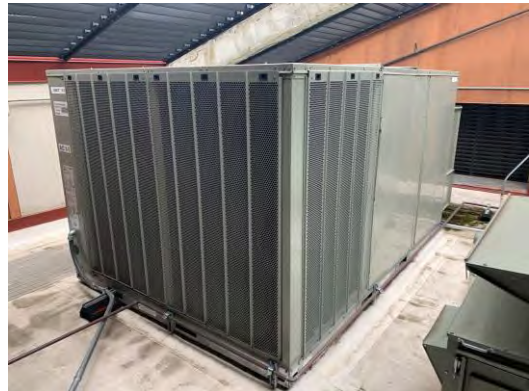
Record ID 509  
System D3030 - COOLING SYSTEMS

Quantity/Unit of Measure: 1/EA  
Total Deficiency Cost: \$158,130  
Deficiency Description: *Packaged AC unit is approaching the end of its expected useful life.*

Description of Work: *Provide equipment replacement and installation.*

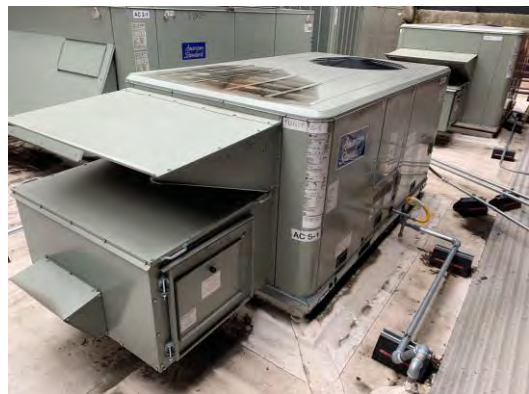
Record ID 510  
System D3030 - COOLING SYSTEMS

Quantity/Unit of Measure: 1/EA  
Total Deficiency Cost: \$59,340  
Deficiency Description: *Packaged AC unit is approaching the end of its expected useful life.*

Description of Work: *Provide equipment replacement and installation.*

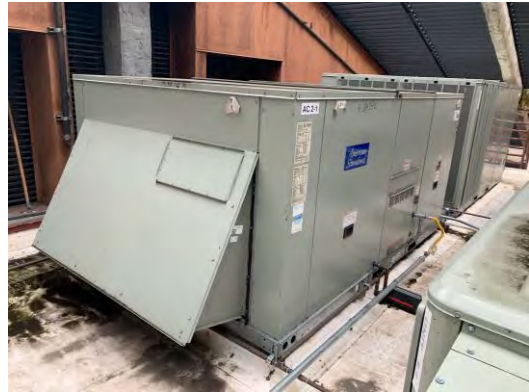
Quantity/Unit of Measure: 1/EA  
Total Deficiency Cost: \$158,130  
Deficiency Description: *Packaged AC unit is approaching the end of its expected useful life.*

Description of Work: *Provide equipment replacement and installation.*

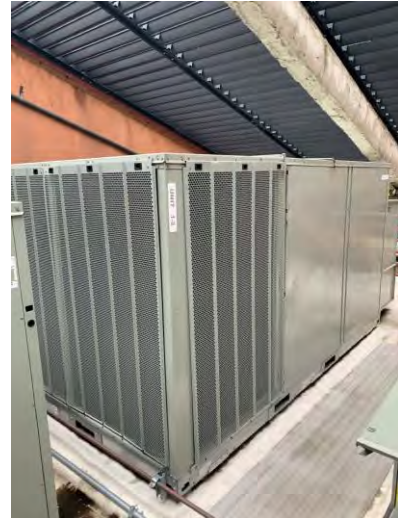
Record ID: 512  
System: D3030 - COOLING SYSTEMS

Quantity/Unit of Measure: 1/EA  
Total Deficiency Cost: \$158,130  
Deficiency Description: *Packaged AC unit is approaching the end of its expected useful life.*

Description of Work: *Provide equipment replacement and installation.*

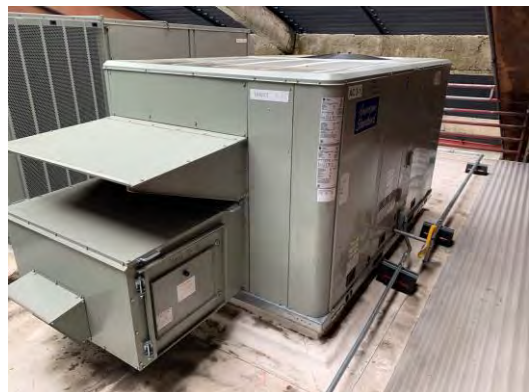
Record ID: 513  
System: D3030 - COOLING SYSTEMS

Quantity/Unit of Measure: 1/EA  
Total Deficiency Cost: \$98,860  
Deficiency Description: *Packaged AC unit is approaching the end of its expected useful life.*

Description of Work: *Provide equipment replacement and installation.*

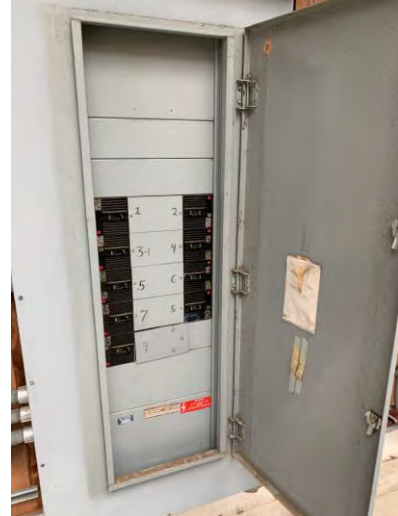
Record ID: 514  
System: D5020 - ELECTRICAL SERVICE AND DISTRIBUTION  
Year Installed / Industry Life / Remaining Useful Life: 1991 / 30 / -1  
Item No.: D5020.30.1014  
Floor/Room:  
**Priority:** 1  
Quantity/Unit of Measure: 1/EA  
Total Deficiency Cost: \$41,740  
Deficiency Description: *The 600A panelboard is past expected useful life.*

Description of Work: *Replace the existing panelboard with a new panelboard.*

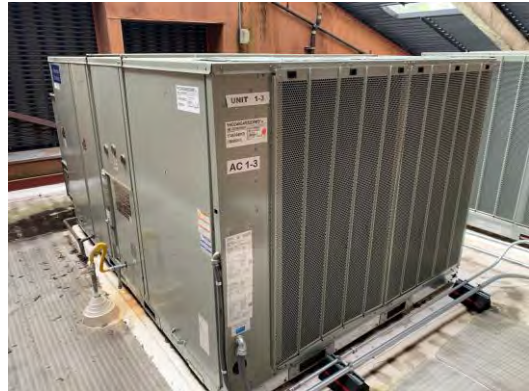
Record ID: 515  
System: D3030 - COOLING SYSTEMS  
Year Installed / Industry Life / Remaining Useful Life: 2017 / 15 / 10  
Item No.: D3030.10.020  
Floor/Room:  
**Priority:** 7  
Quantity/Unit of Measure: 1/EA  
Total Deficiency Cost: \$158,130  
Deficiency Description: *Packaged AC unit is approaching the end of its expected useful life.*

Description of Work: *Provide equipment replacement and installation.*

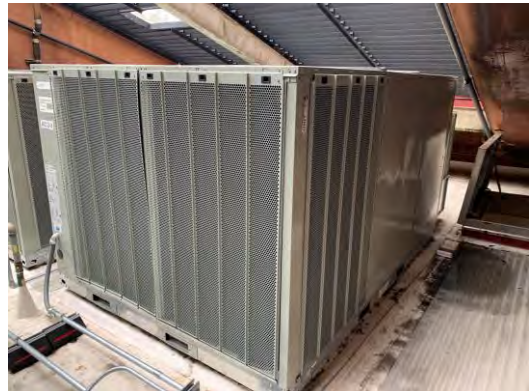
Record ID: 516  
System: D3030 - COOLING SYSTEMS  
Year Installed / Industry Life / Remaining Useful Life: 2017 / 15 / 10  
Item No.: D3030.10.020  
Floor/Room:  
**Priority:** 7  
Quantity/Unit of Measure: 1/EA  
Total Deficiency Cost: \$158,130  
Deficiency Description: *Packaged AC unit is approaching the end of its expected useful life.*

Description of Work: *Provide equipment replacement and installation.*

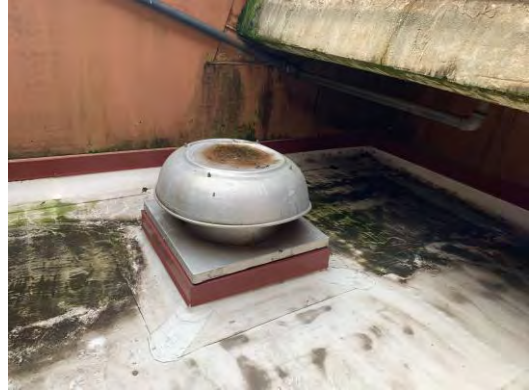
Deficiency Description: *Roof exhaust fan is approaching the end of its expected useful life.*

Description of Work: *Provide equipment replacement and installation.*

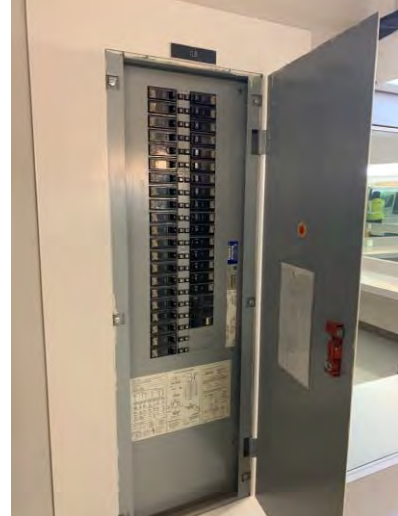
Record ID: 519  
 System: D5020 - ELECTRICAL SERVICE AND DISTRIBUTION

Deficiency Description: *The panelboard is past its expected useful life.*

Description of Work: *Replace the existing panelboard with a new panelboard.*

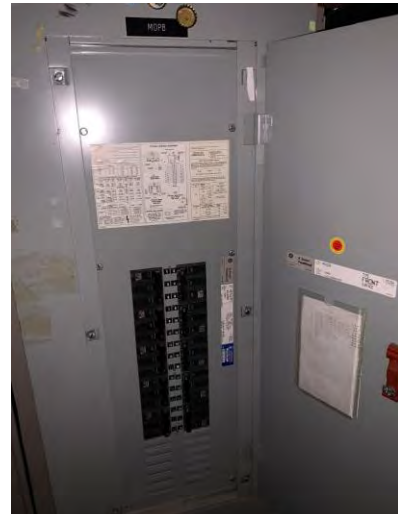
Record ID: 520  
 System: D5020 - ELECTRICAL SERVICE AND DISTRIBUTION

Deficiency Description: *The panelboard is past its expected useful life.*

Description of Work: *Replace the existing panelboard with a new panelboard.*

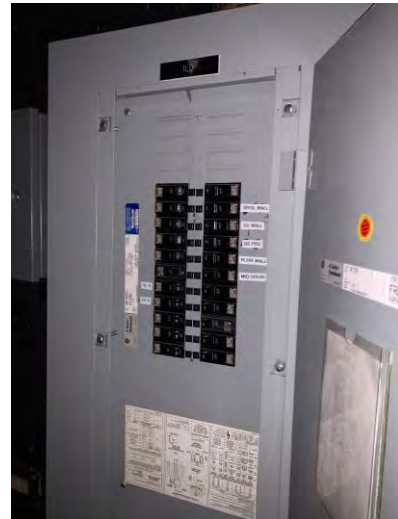
Record ID: 521  
 System: D5020 - ELECTRICAL SERVICE AND DISTRIBUTION  
 Year Installed / Industry Life / Remaining Useful Life: 1991 / 30 / -1  
 Item No.: D5020.30.1007  
 Floor/Room:  
**Priority:** 1  
 Quantity/Unit of Measure: 1/EA  
 Total Deficiency Cost: \$11,460  
 Deficiency Description: *The panelboard is past its expected useful life.*

Description of Work: *Replace the existing panelboard with a new panelboard.*

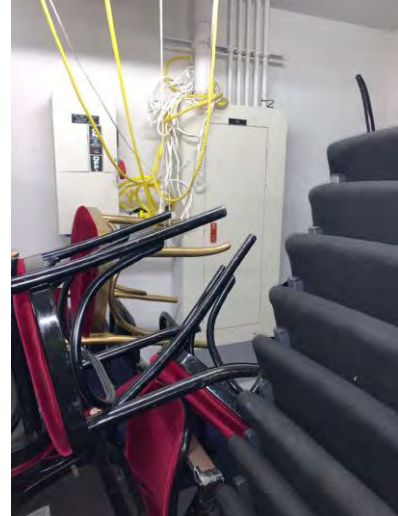
Record ID: 522  
 System: D5020 - ELECTRICAL SERVICE AND DISTRIBUTION  
 Year Installed / Industry Life / Remaining Useful Life: 1991 / 30 / -1  
 Item No.: D5020.30.1008  
 Floor/Room:  
**Priority:** 1  
 Quantity/Unit of Measure: 1/EA  
 Total Deficiency Cost: \$18,570  
 Deficiency Description: *The panelboard is past its expected useful life.*

Comments: *Panel accessibility 1LE*

Description of Work: *Replace the existing panelboard with a new panelboard.*

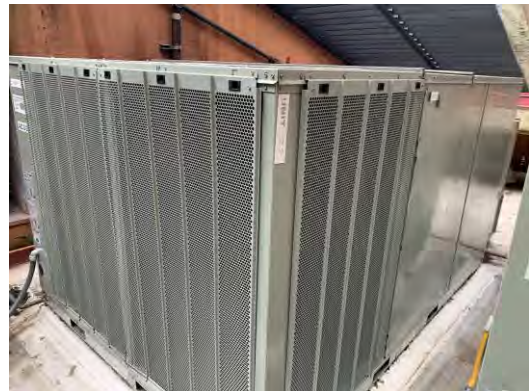
Record ID: 524  
 System: D3030 - COOLING SYSTEMS  
 Year Installed / Industry Life / Remaining Useful Life: 2017 / 15 / 10  
 Item No.: D3030.10.020  
 Floor/Room:  
**Priority:** 7  
 Quantity/Unit of Measure: 1/EA  
 Total Deficiency Cost: \$158,130  
 Deficiency Description: *Packaged AC unit is approaching the end of its expected useful life.*

Description of Work: *Provide equipment replacement and installation.*

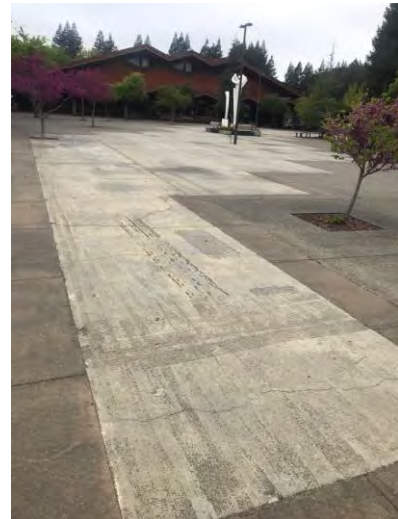
Record ID: 806  
 System: G2030 - PEDESTRIAN PLAZAS AND WALKWAYS  
 Year Installed / Industry Life / Remaining Useful Life: - / 30 / -  
 Item No.: G2030.10.005  
 Floor/Room: Site / Pavement  
**Priority:** 5  
 Quantity/Unit of Measure: 10,000/SF  
 Total Deficiency Cost: \$410,880  
 Deficiency Description: *Concrete pavement has major damage / structural failure.*

Description of Work: *Replace concrete and base to match existing.*

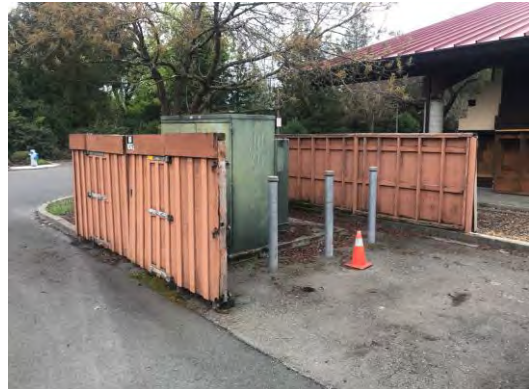
Record ID: 807  
 System: G2060 - SITE DEVELOPMENT  
 Year Installed / Industry Life / Remaining Useful Life: - / - / -  
 Item No.: G2060.20.004  
 Floor/Room: Site / Electrical Enclosure  
**Priority:** 3  
 Quantity/Unit of Measure: 200/SF  
 Total Deficiency Cost: \$7,180  
 Deficiency Description: *Wood fence is deteriorated or at end-of-life.*

Description of Work: *Replace wood fencing, including slats and posts.*

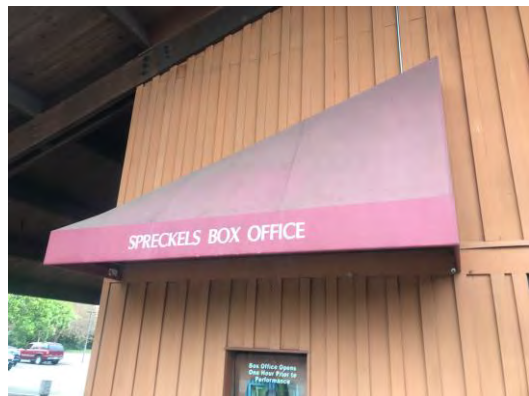
Record ID: 810  
 System: B2080 - EXTERIOR WALL APPURTENANCES  
 Year Installed / Industry Life / Remaining Useful Life: - / 15 / -  
 Item No.: B2080.30.002  
 Floor/Room: 1 / Box Office  
**Priority:** 3  
 Quantity/Unit of Measure: 1/LS  
 Total Deficiency Cost: \$1,780  
 Deficiency Description: *Awning (fabric) is approaching the end of its useful life.*

Comments: *Awning is faded.*

Description of Work: *Replace fabric awning.*

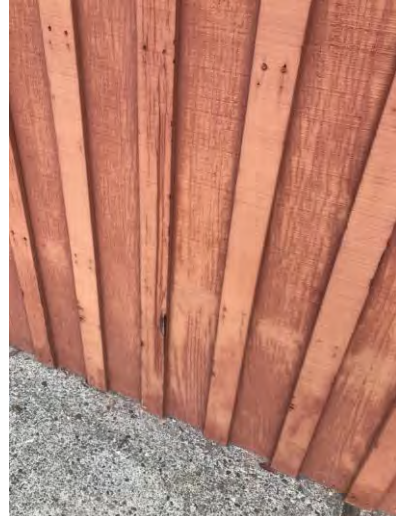
Deficiency Description: *Wood board siding is approaching the end of its useful life.*

Description of Work: *Replace or repair the existing wood siding.*

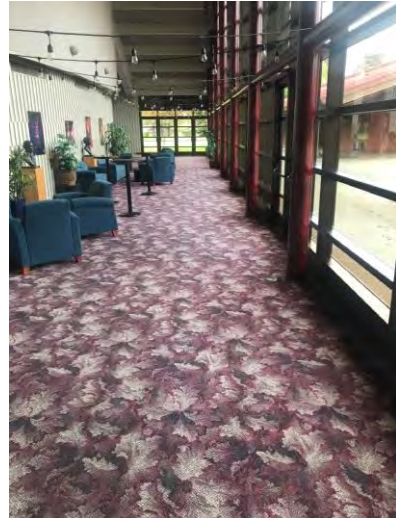
Record ID: 813  
System: C2030 - FLOORING

Deficiency Description: *Carpet flooring is approaching the end of its useful life.*

Description of Work: *Replace carpet flooring.*

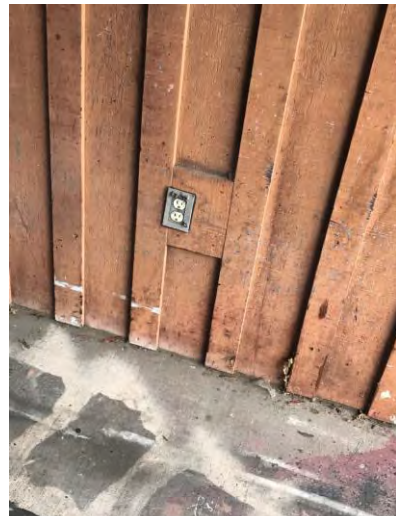
Record ID: 814  
System: D5040 - LIGHTING

Deficiency Description: *An outlet cover is missing or damaged and should be replaced.*

Description of Work: *Replace the damaged or missing outlet cover.*

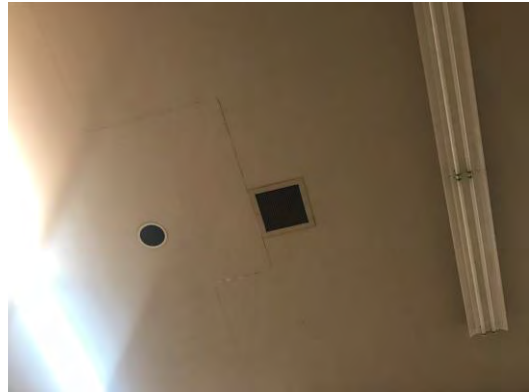
Deficiency Description: *Painted gypsum wallboard ceiling is approaching the end of its useful life.*

Description of Work: *Remove the existing gypsum board ceiling and replace. Tape and paint.*

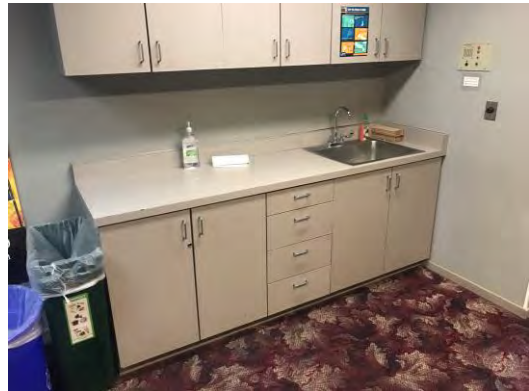
Record ID 817  
System E2010 - FIXED FURNISHINGS

Deficiency Description: *Plastic laminate casework is at or will be approaching the end of its expected useful life.*

Description of Work: *Provide new plastic laminate casework (upper, lower, and countertop)*

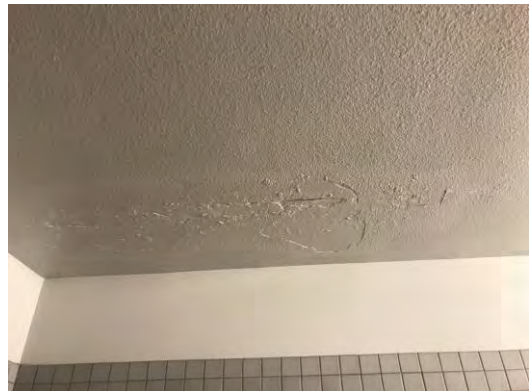
Record ID 818  
System C2050 - CEILING FINISHES

Deficiency Description: *Painted gypsum wallboard ceiling is approaching the end of its useful life.*

Description of Work: *Remove the existing gypsum board ceiling and replace. Tape and paint.*

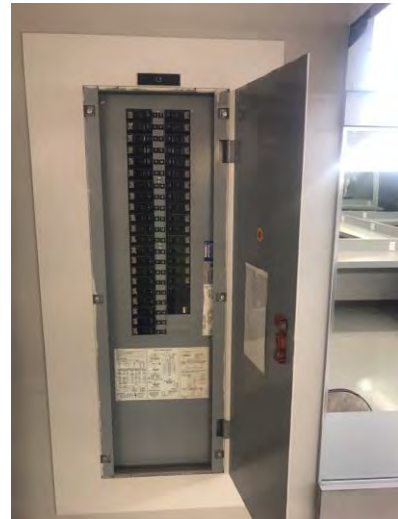
Record ID 821  
System D5020 - ELECTRICAL SERVICE AND DISTRIBUTION  
Year Installed / Industry Life / Remaining Useful Life 1991 / 30 / -1  
Item No. D5020.30.1007  
Floor/Room:  
**Priority:** 1  
Quantity/Unit of Measure: 1/EA  
Total Deficiency Cost: \$11,460  
Deficiency Description: *The 100A (30 ckts, 120/208, 3P) panelboard is approaching the end of its expected useful life.*  
Description of Work: *Replace the existing panelboard with a new panelboard.*  
Comments:

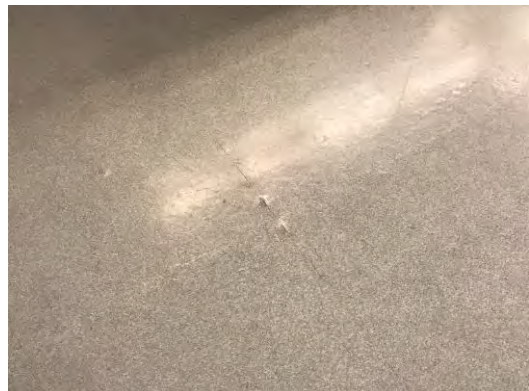
Record ID 824  
System C2030 - FLOORING  
Year Installed / Industry Life / Remaining Useful Life - / 60 / -  
Item No. C2030.50.001  
Floor/Room: 1 / Chorus Dressing West  
**Priority:** 3  
Quantity/Unit of Measure: 400/SF  
Total Deficiency Cost: \$10,550  
Deficiency Description: *Vinyl composition tile is approaching the end of its useful life.*  
Description of Work: *Remove the existing vinyl composition tile and replace.*  
Comments:

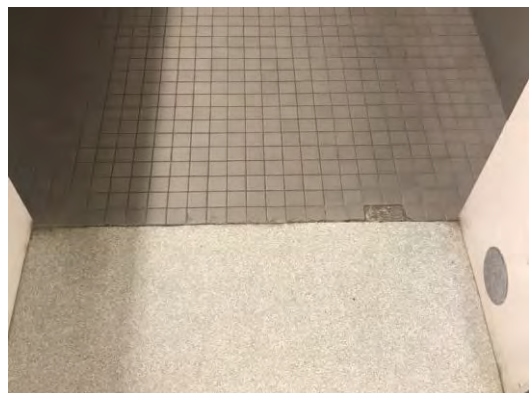
Record ID 825  
System C2030 - FLOORING  
Year Installed / Industry Life / Remaining Useful Life - / 60 / -  
Item No. C2030.20.001  
Floor/Room: 1 / Chorus Dressing West  
**Priority:** 3  
Quantity/Unit of Measure: 50/SF  
Total Deficiency Cost: \$3,500  
Deficiency Description: *Ceramic tile floor is approaching the end of its useful life.*  
Description of Work: *Remove the existing ceramic tile flooring and replace.*  
Comments:

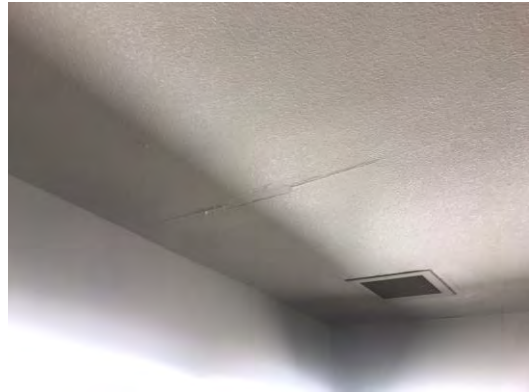
**Priority:** 3  
Quantity/Unit of Measure: 100/SF  
Total Deficiency Cost: \$2,210  
Deficiency Description: *Painted gypsum wallboard ceiling is approaching the end of its useful life.*

Description of Work: *Remove the existing gypsum board ceiling and replace. Tape and paint.*

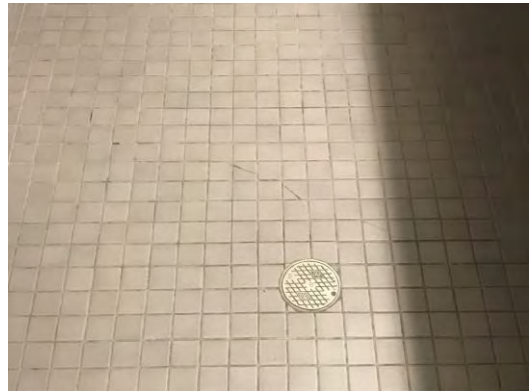
Record ID 830  
System C2030 - FLOORING

**Priority:** 3  
Quantity/Unit of Measure: 50/SF  
Total Deficiency Cost: \$3,500  
Deficiency Description: *Ceramic tile floor is approaching the end of its useful life.*

Description of Work: *Remove the existing ceramic tile flooring and replace.*

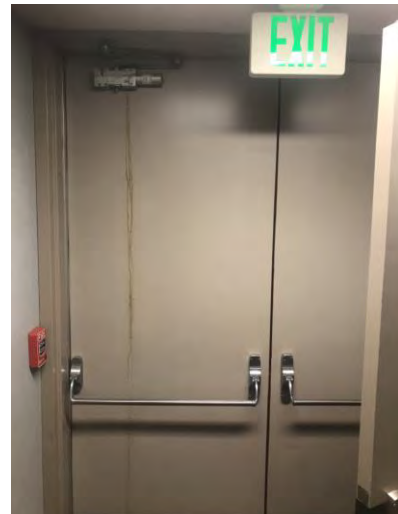
Record ID 832  
System B2050 - EXTERIOR DOORS AND GRILLES

**Priority:** 2  
Quantity/Unit of Measure: 1/LS  
Total Deficiency Cost: \$520  
Deficiency Description: *Door is showing signs of wear.*

Description of Work: *Refinish exit doors.*

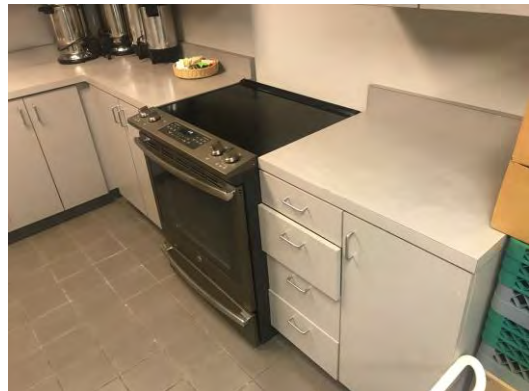
Record ID 838  
System E2010 - FIXED FURNISHINGS

Deficiency Description: *Plastic laminate casework is at or will be approaching the end of its expected useful life.*

Description of Work: *Provide new plastic laminate casework (upper, lower, and countertop)*

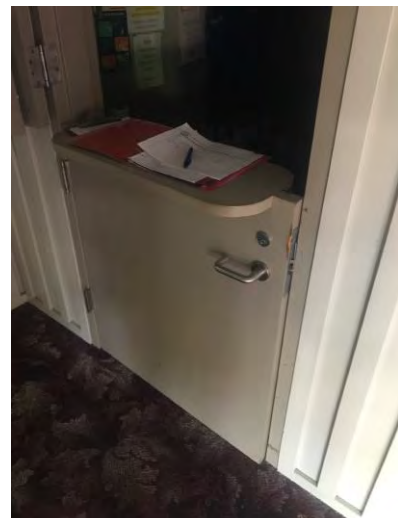
Record ID 840  
System C1030 - INTERIOR DOORS

Deficiency Description: *Interior wood door is in visual need of refurbishment.*

Description of Work: *Refurbish and restrain the wood door.*

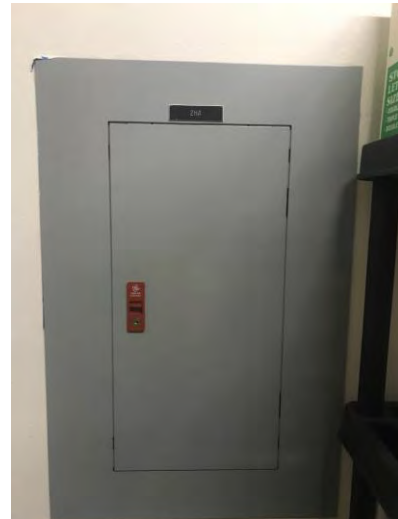
Record ID: 843  
System: D5020 - ELECTRICAL SERVICE AND DISTRIBUTION  
Year Installed / Industry Life / Remaining Useful Life: 1991 / 30 / -1  
Item No.: D5020.30.1007  
Floor/Room: 1  
**Priority:** 1  
Quantity/Unit of Measure: 1/EA  
Total Deficiency Cost: \$11,460  
Deficiency Description: *The panelboard is past its expected useful life.*

Description of Work: *Replace the existing panelboard with a new panelboard.*

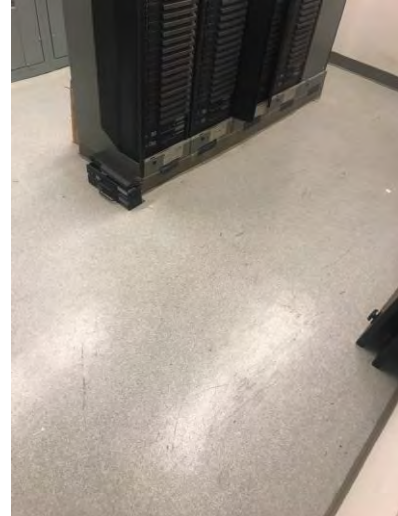
Record ID: 846  
System: C2030 - FLOORING  
Year Installed / Industry Life / Remaining Useful Life: - / 60 / -  
Item No.: C2030.50.001  
Floor/Room: 1 / Dimmer Room  
**Priority:** 3  
Quantity/Unit of Measure: 100/SF  
Total Deficiency Cost: \$2,650  
Deficiency Description: *Vinyl composition tile is approaching the end of its useful life.*

Description of Work: *Remove the existing vinyl composition tile and replace.*

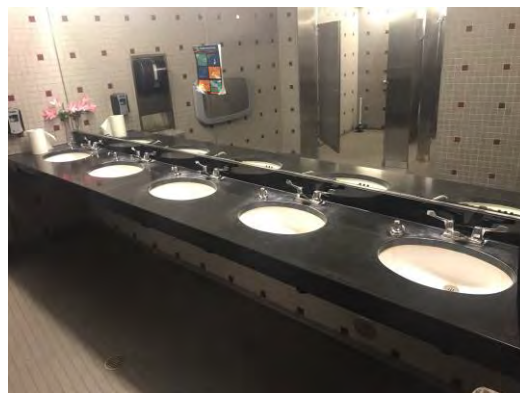
Description of Work: *Remove and replace the solid surface countertops.*

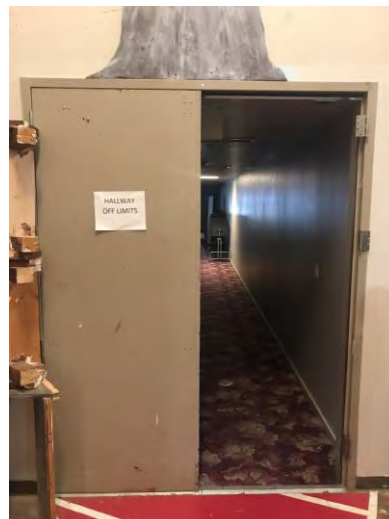
Record ID 850  
System C1030 - INTERIOR DOORS

Item No. C1030.90.003  
Floor/Room: 1 / Hallway  
**Priority:** 3  
Quantity/Unit of Measure: 1/EA  
Total Deficiency Cost: \$900  
Deficiency Description: *Metal door and frames are showing signs of wear.*

Description of Work: *Repair and refinish the metal door and frames.*

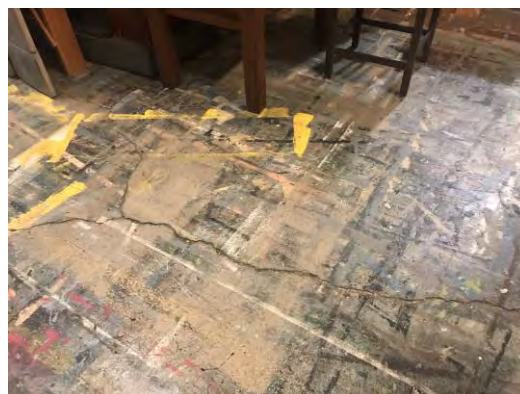
Record ID 851  
System C2030 - FLOORING

Item No. C2030.10.001  
Floor/Room: 1  
**Priority:** 2  
Quantity/Unit of Measure: 200/SF  
Total Deficiency Cost: \$3,400  
Deficiency Description: *Concrete floor is showing signs of damage and cracking.*

Description of Work: *Repair and refinish the concrete floor.*

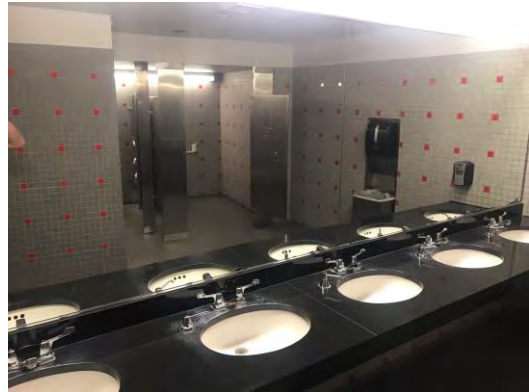
Record ID: 853  
 System: E2010 - FIXED FURNISHINGS  
 Year Installed / Industry Life / Remaining Useful Life: - / - / -  
 Item No.: E2010.30.002  
 Floor/Room: 1 / Restroom  
 Priority: 4  
 Quantity/Unit of Measure: 15/LF  
 Total Deficiency Cost: \$2,830  
 Deficiency Description: *Solid Surface countertops are at or are approaching the end of their useful life.*  
 Description of Work: *Remove and replace the solid surface countertops.*  
 Comments:

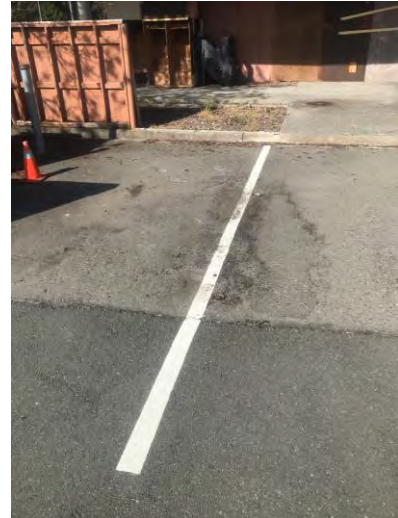
Record ID: 1018  
 System: G2020 - PARKING LOTS  
 Year Installed / Industry Life / Remaining Useful Life: - / - / -  
 Item No.: G2020.10.002  
 Floor/Room: Site / AC Paving  
 Priority: 3  
 Quantity/Unit of Measure: 400/SF  
 Total Deficiency Cost: \$12,220  
 Deficiency Description: *AC paving is showing signs of wear.*  
 Description of Work: *Replace AC pavement section.*  
 Comments:

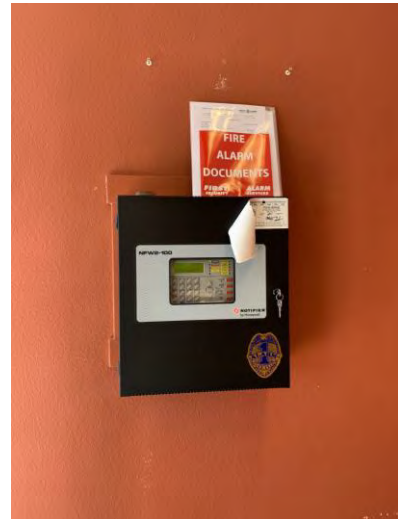
Deficiency Description: *The existing fire alarm system is past its expected useful life*

Description of Work: *Provide a fully addressable fire alarm control panel with associated initiating and signaling devices.*

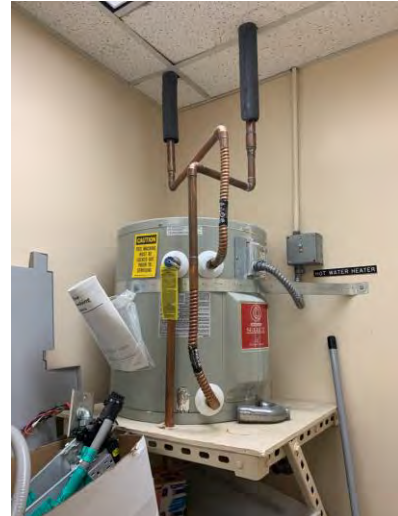
Record ID: 675  
 System: D2010 - DOMESTIC WATER DISTRIBUTION

Deficiency Description: *Electric water heater is approaching the end of its expected useful life.*

Description of Work: *Provide equipment replacement and installation.*

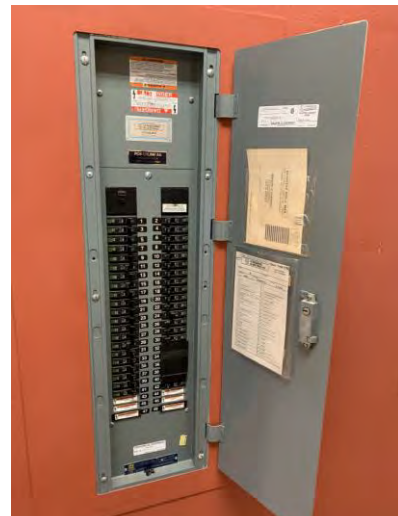
Record ID: 676  
 System: D5020 - ELECTRICAL SERVICE AND DISTRIBUTION

Deficiency Description: *The 225A panelboard is past its expected useful life.*

Description of Work: *Replace the existing panelboard with a new panelboard.*

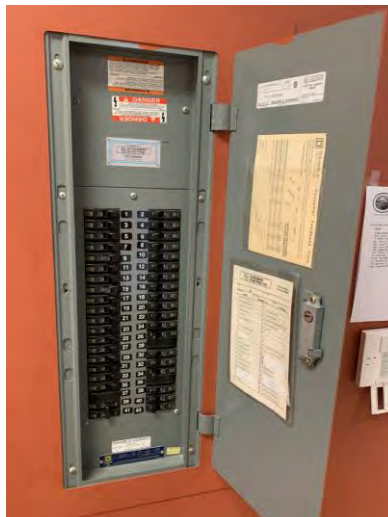
Record ID 677  
System D5020 - ELECTRICAL SERVICE AND DISTRIBUTION  
Year Installed / Industry Life / Remaining Useful Life 1980 / 30 / -12  
Item No. D5020.30.1008  
Floor/Room:  
**Priority:** 1  
Quantity/Unit of Measure: 1/EA  
Total Deficiency Cost: \$18,570  
Deficiency Description: *The 225A panelboard is past its expected useful life.*

Description of Work: *Replace the existing panelboard with a new panelboard.*

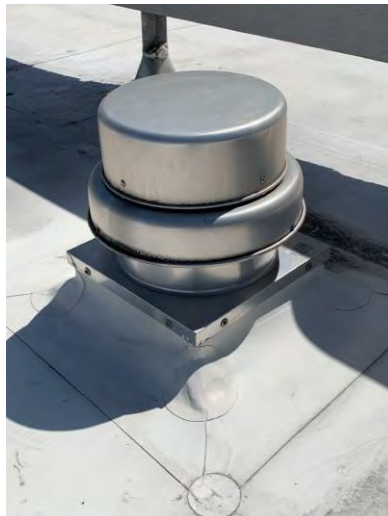
Record ID 679  
System D3060 - VENTILATION  
Year Installed / Industry Life / Remaining Useful Life - / 25 / -  
Item No. D3060.30.005  
Floor/Room:  
**Priority:** 7  
Quantity/Unit of Measure: 1/EA  
Total Deficiency Cost: \$8,730  
Deficiency Description: *Roof exhaust fan is approaching the end of its expected useful life.*

Description of Work: *Provide equipment replacement and installation.*

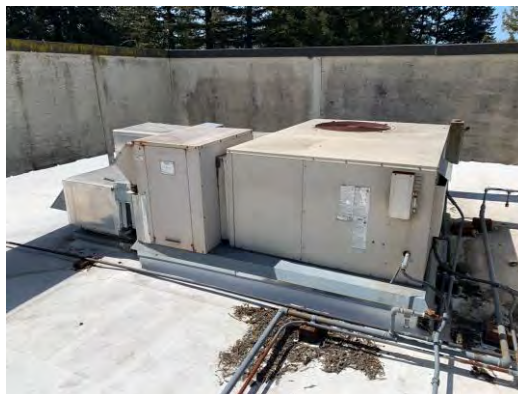
Record ID 680  
System D3030 - COOLING SYSTEMS  
Year Installed / Industry Life / Remaining Useful Life - / 15 / -  
Item No. D3030.10.018  
Floor/Room:  
**Priority:** 2  
Quantity/Unit of Measure: 1/EA  
Total Deficiency Cost: \$50,410  
Deficiency Description: *Packaged AC unit is approaching the end of its expected useful life.*

Comments: R-22 Unit

Description of Work: *Provide equipment replacement and installation.*

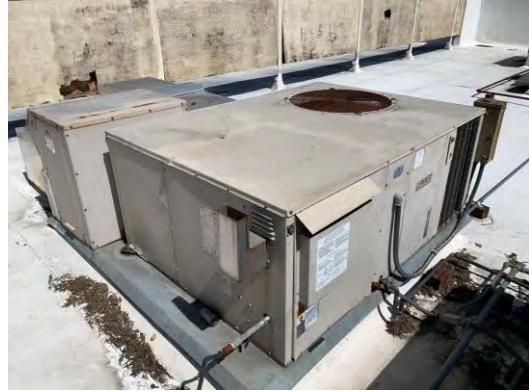
Year Installed / Industry Life / Remaining Useful Life - / 15 / -  
Item No. D3030.10.018  
Floor/Room:  
**Priority:** 2  
Quantity/Unit of Measure: 1/EA  
Total Deficiency Cost: \$50,410  
Deficiency Description: *Packaged AC unit is approaching the end of its expected useful life.*

Description of Work: *Provide equipment replacement and installation.*

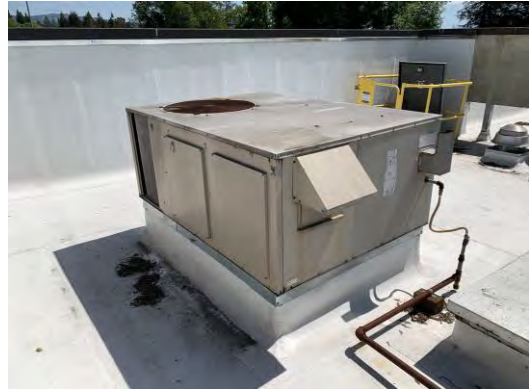
Record ID 682  
System D3030 - COOLING SYSTEMS

Year Installed / Industry Life / Remaining Useful Life - / 15 / -  
Item No. D3030.10.018  
Floor/Room:  
**Priority:** 2  
Quantity/Unit of Measure: 1/EA  
Total Deficiency Cost: \$50,410  
Deficiency Description: *Packaged AC unit is approaching the end of its expected useful life.*

Description of Work: *Provide equipment replacement and installation.*

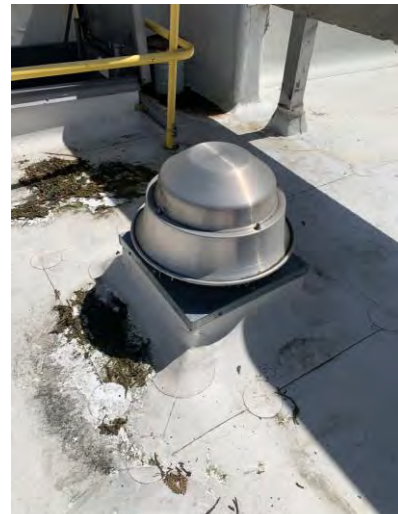
Record ID 683  
System D3060 - VENTILATION

Year Installed / Industry Life / Remaining Useful Life - / 25 / -  
Item No. D3060.30.005  
Floor/Room:  
**Priority:** 7  
Quantity/Unit of Measure: 1/EA  
Total Deficiency Cost: \$8,730  
Deficiency Description: *Roof exhaust fan is approaching the end of its expected useful life.*

Description of Work: *Provide equipment replacement and installation.*

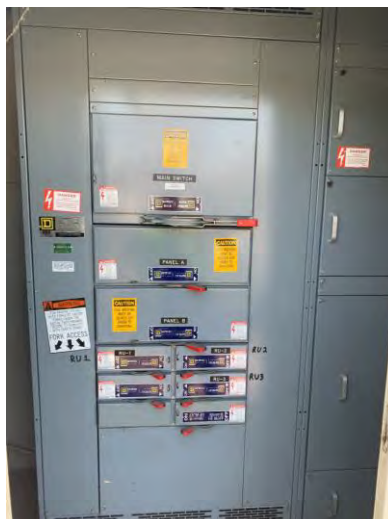
Record ID: 685  
System: D5020 - ELECTRICAL SERVICE AND DISTRIBUTION  
Year Installed / Industry Life / Remaining Useful Life: 1980 / 20 / -22  
Item No.: D5020.10.302  
Floor/Room:  
**Priority:** 1  
Quantity/Unit of Measure: 1/EA  
Total Deficiency Cost: \$17,750  
Deficiency Description: *The 400A metered main switchboard is past its expected useful life.*

Description of Work: *Replace the existing metered main switchboard with a new metered main switchboard.*

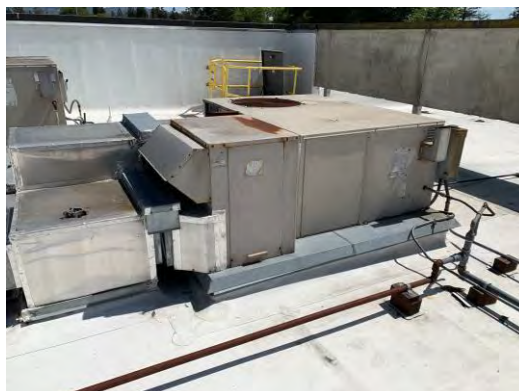
Record ID: 686  
System: D3030 - COOLING SYSTEMS  
Year Installed / Industry Life / Remaining Useful Life: - / 15 / -  
Item No.: D3030.10.018  
Floor/Room:  
**Priority:** 2  
Quantity/Unit of Measure: 1/EA  
Total Deficiency Cost: \$50,410  
Deficiency Description: *Packaged AC unit is approaching the end of its expected useful life.*

Description of Work: *Provide equipment replacement and installation.*

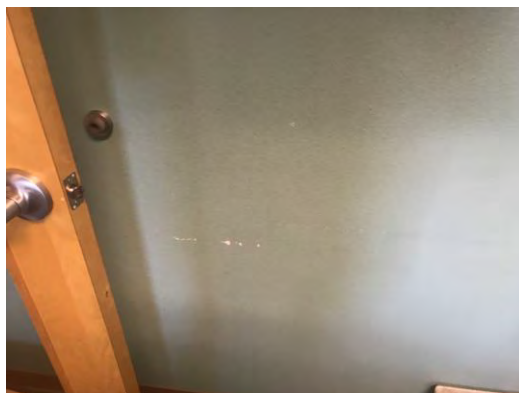
Record ID: 1038  
System: C2010 - WALL FINISHES  
Year Installed / Industry Life / Remaining Useful Life: - / 30 / -  
Item No.: C2010.70.001  
Floor/Room: 1 / Meeting Room  
**Priority:** 3  
Quantity/Unit of Measure: 100/SF  
Total Deficiency Cost: \$2,210  
Deficiency Description: *Painted gypsum wallboard is showing signs of wear.*

Description of Work: *Patch and paint the gypsum wallboard.*

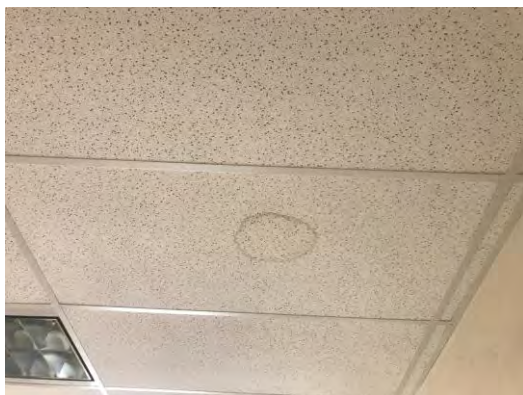
Record ID 1039  
System C2050 - CEILING FINISHES

Year Installed / Industry Life / Remaining Useful Life - / 50 / -  
Item No. C2050.80.001  
Floor/Room: 1 / Ceiling  
**Priority: 1**  
Quantity/Unit of Measure: 25/SF  
Total Deficiency Cost: \$400  
Deficiency Description: *Lay-in Acoustical Tile is in poor condition.*

Comments: *Further investigation recommended to determine source of water damage.*

Description of Work: *Remove existing lay-in Acoustical Tiles and replace with new lay-in Acoustical Tiles.*

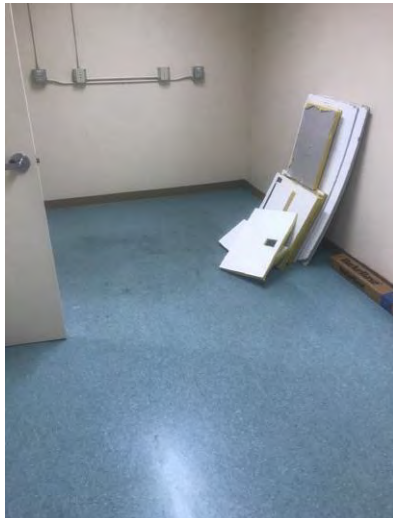
Record ID 1041  
System C2030 - FLOORING

Year Installed / Industry Life / Remaining Useful Life - / 60 / -  
Item No. C2030.50.001  
Floor/Room: 1 / Storage  
**Priority: 3**  
Quantity/Unit of Measure: 150/SF  
Total Deficiency Cost: \$3,980  
Deficiency Description: *Vinyl composition tile is approaching the end of its useful life.*

Description of Work: *Remove the existing vinyl composition tile and replace.*

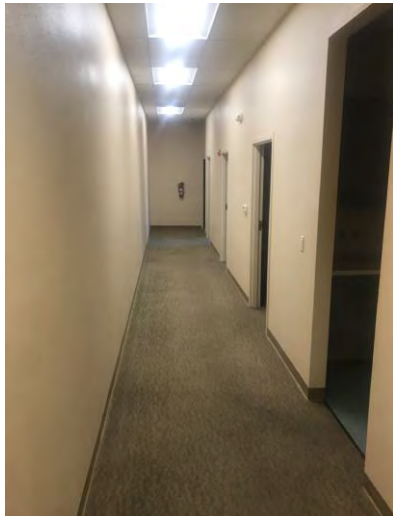
Record ID 1042  
System C2030 - FLOORING

Year Installed / Industry Life / Remaining Useful Life - / 20 / -  
Item No. C2030.75.001  
Floor/Room: 1 / Throughout  
**Priority: 5**  
Quantity/Unit of Measure: 4,000/SF  
Total Deficiency Cost: \$121,750  
Deficiency Description: *Carpet flooring is showing signs of wear.*

Description of Work: *Replace carpet flooring.*

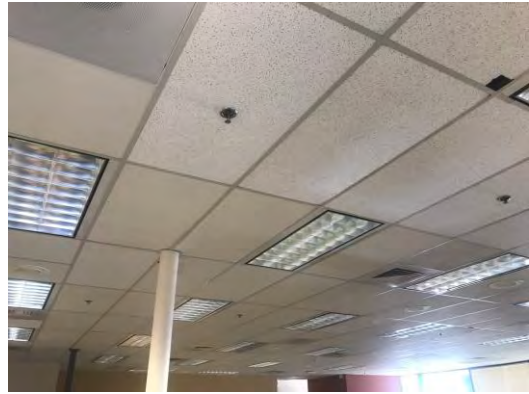
Year Installed / Industry Life / Remaining Useful Life - / 50 / -  
Item No. C2050.80.001  
Floor/Room: 1 / Throughout  
**Priority:** 3  
Quantity/Unit of Measure: 3,000/SF  
Total Deficiency Cost: \$49,210  
Deficiency Description: *Lay-in Acoustical Tile is in poor condition.*

Description of Work: *Remove existing lay-in Acoustical Tiles and replace with new lay-in Acoustical Tiles.*

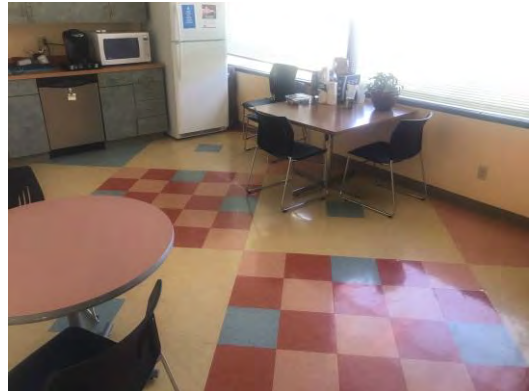
Record ID 1046  
System C2030 - FLOORING

Year Installed / Industry Life / Remaining Useful Life - / 60 / -  
Item No. C2030.50.001  
Floor/Room: 1 / Break Room  
**Priority:** 3  
Quantity/Unit of Measure: 400/SF  
Total Deficiency Cost: \$10,550  
Deficiency Description: *Vinyl composition tile is approaching the end of its useful life.*

Description of Work: *Remove the existing vinyl composition tile and replace.*

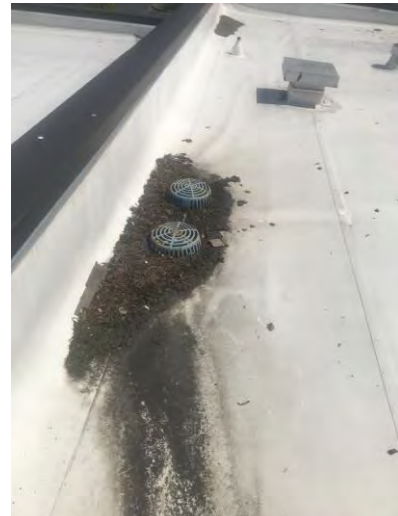
Record ID 1048  
System B3010 - ROOFING

Year Installed / Industry Life / Remaining Useful Life - / 30 / -  
Item No. B3010.90.007  
Floor/Room: Roof / Roof  
**Priority:** 2  
Quantity/Unit of Measure: 100/SF  
Total Deficiency Cost: \$8,420  
Deficiency Description: *The roof is covered with debris which will shorten its useful life.*

Description of Work: *Clean off debris regularly.*

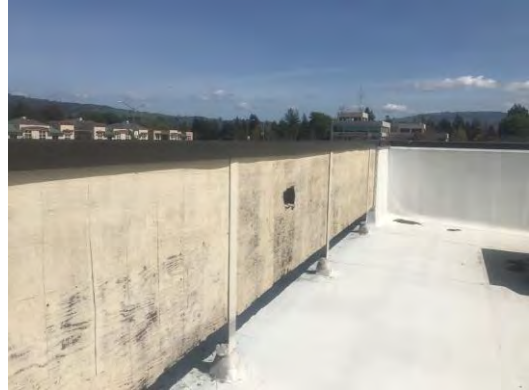
Deficiency Description: *Rooftop mechanical equipment screen is damaged and showing signs of wear.*

Description of Work: *Provide an equipment replacement and installation.*

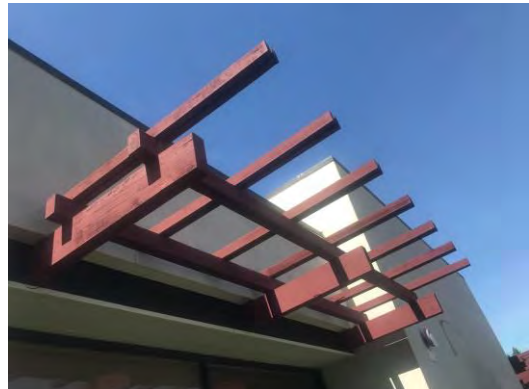
Record ID 1053  
System G2060 - SITE DEVELOPMENT

Deficiency Description: *Wood trellis has minor damage.*

Description of Work: *Repaint wood trellis.*

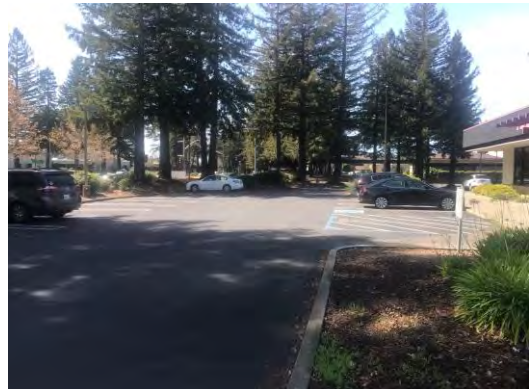
Record ID 1054  
System G2020 - PARKING LOTS

Deficiency Description: *AC paving has faded or has minor weathering.*

Description of Work: *Reseal parking lot.*

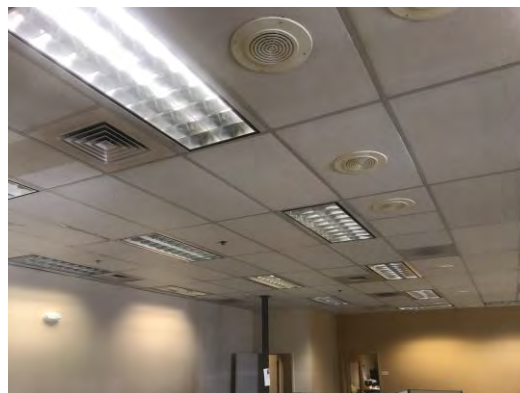
Year Installed / Industry Life / Remaining Useful Life 1980 / 20 / -22  
Item No. D5040.50.411  
Floor/Room:  
**Priority:** 1  
Quantity/Unit of Measure: 6,488/SF  
Total Deficiency Cost: \$371,230  
Deficiency Description: *Interior lighting system is past its expected useful life but operational.*

Description of Work: *Provide new interior lighting and control system throughout building per current CEC T24 code.*

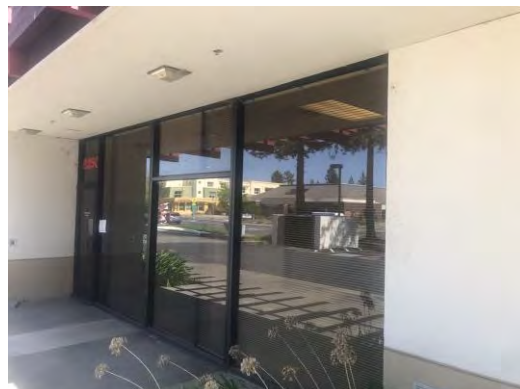
Record ID 1789  
System D5040 - LIGHTING

Year Installed / Industry Life / Remaining Useful Life 1980 / 20 / -22  
Item No. D5040.50.302  
Floor/Room:  
**Priority:** 1  
Quantity/Unit of Measure: 5/EA  
Total Deficiency Cost: \$11,380  
Deficiency Description: *The exterior light fixture is past its expected useful life but operational.*

Description of Work: *Replace the existing light fixture with an LED lighting fixture.*

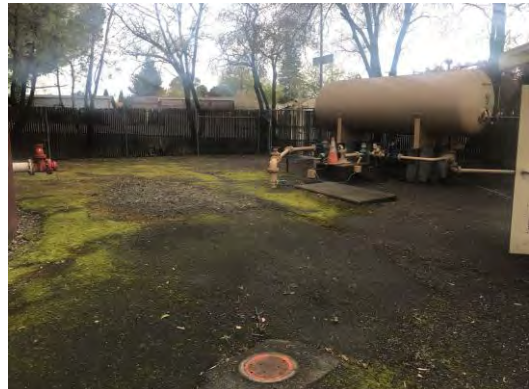
Record ID: 86  
System: G2020 - PARKING LOTS  
Year Installed / Industry Life / Remaining Useful Life: - / - / -  
Item No.: G2020.10.002  
Floor/Room: Site / AC Paving  
Priority: 3  
Quantity/Unit of Measure: 800/SF  
Total Deficiency Cost: \$24,430  
Deficiency Description: *AC paving is showing signs of damage.*

Description of Work: *Replace AC pavement section.*

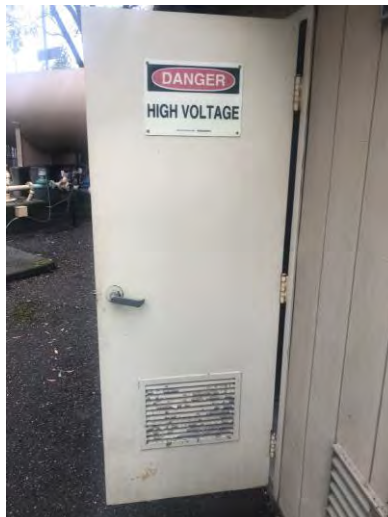
Deficiency Description: *The exterior door is approaching the end of its useful life.*

Description of Work: *Replace metal door.*
