# City of Rohnert Park

## Facility Condition Assessment

Final Report

October 17, 2022

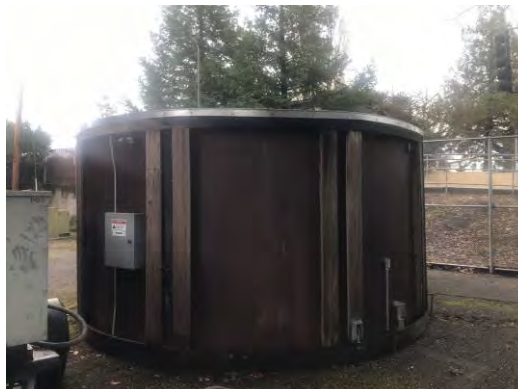
Deficiency Description: *Metal panels are showing signs of wear.*

Description of Work: *Refinish exterior metal panels.*

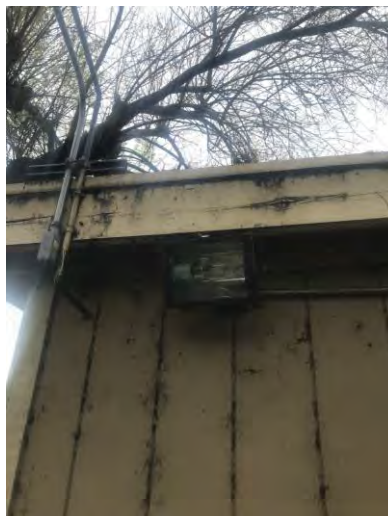
Deficiency Description: *The fascia is appears deteriorated.*

Description of Work: *Selectively remove deteriorated fascia and replace with new material to match.*

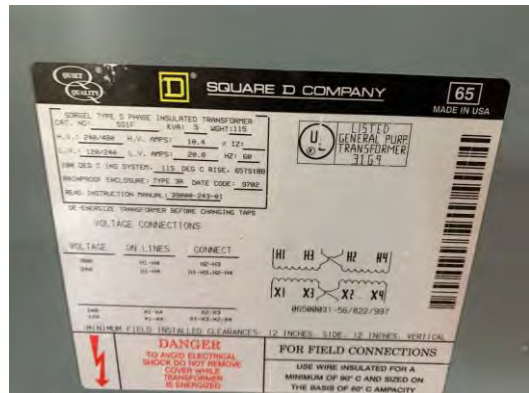
Record ID: 327  
 System: D5020 - ELECTRICAL SERVICE AND DISTRIBUTION  
 Year Installed / Industry Life / Remaining Useful Life: 1990 / 30 / -2  
 Item No.: D5020.10.201  
 Floor/Room:  
 Priority: 1  
 Quantity/Unit of Measure: 1/EA  
 Total Deficiency Cost: \$5,470  
 Deficiency Description: *The 1 - 5kVA transformer (1P dry-type, 240/480-120/240V) is approaching the end of its expected useful life.*  
 Description of Work: *Replace the existing transformer with a new transformer.*  
 Comments: *Age is estimated.*

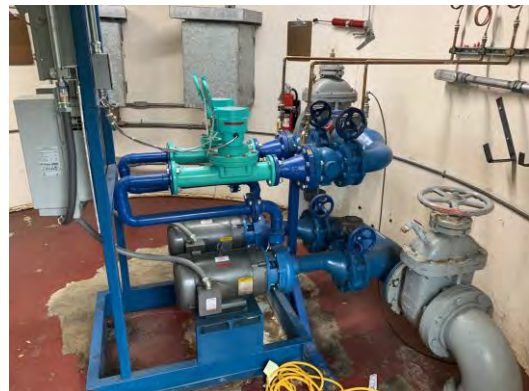
Record ID: 328  
 System: G3010 - WATER UTILITIES  
 Year Installed / Industry Life / Remaining Useful Life: - / 20 / -  
 Item No.: G3010.10.056  
 Floor/Room:  
 Priority: 7  
 Quantity/Unit of Measure: 1/EA  
 Total Deficiency Cost: \$59,340  
 Deficiency Description: *Water supply pump system is approaching the end of its useful life.*  
 Description of Work: *Replace water supply pump system.*  
 Comments: *on VFD*

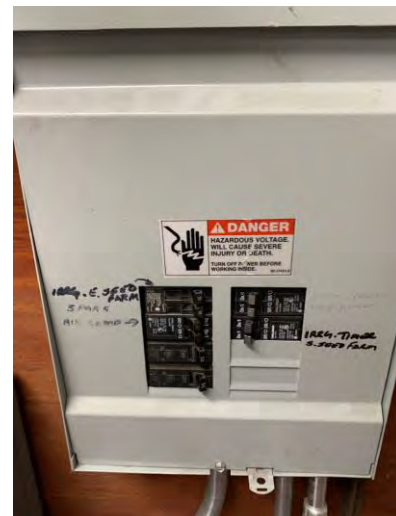
Record ID: 329  
 System: D5020 - ELECTRICAL SERVICE AND DISTRIBUTION  
 Year Installed / Industry Life / Remaining Useful Life: 1990 / 30 / -2  
 Item No.: D5020.30.1001  
 Floor/Room:  
 Priority: 1  
 Quantity/Unit of Measure: 1/EA  
 Total Deficiency Cost: \$8,230  
 Deficiency Description: *The 100A (20 ckt, 120/240V, 3P) panelboard is approaching the end of its expected useful life.*  
 Description of Work: *Replace the existing panelboard with a new panelboard.*  
 Comments: *Age is estimated.*

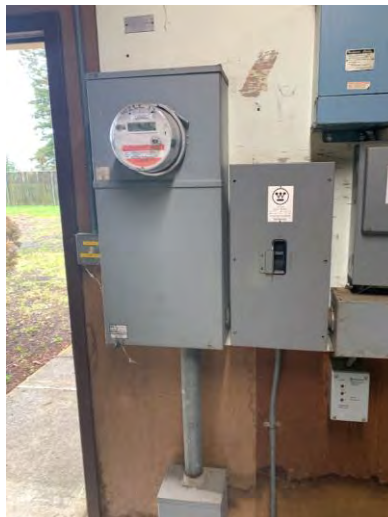
Record ID	1790
System	D5020 - ELECTRICAL SERVICE AND DISTRIBUTION
Year Installed / Industry Life / Remaining Useful Life	1990 / 30 / -2
Item No.	D5020.10.001
Floor/Room:	
Priority:	1
Quantity/Unit of Measure:	1/EA
Total Deficiency Cost:	\$8,230
Deficiency Description:	<i>The all-in-one combination service entrance device is past its expected useful life.</i>
Description of Work:	<i>Replace the existing all-in-one combination service entrance device with a new all-in-one combination service entrance device.</i>
Comments:	<i>Age is estimated.</i>

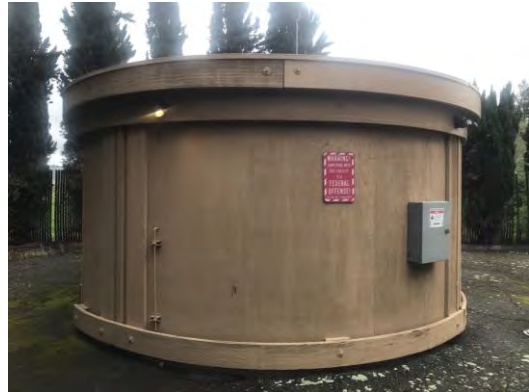
Quantity/Unit of Measure: 400/SF  
Total Deficiency Cost: \$3,840  
Deficiency Description: *The existing veneer plywood is damaged or worn.*

Description of Work: *Clean, prepare, and paint the plywood paneling.*

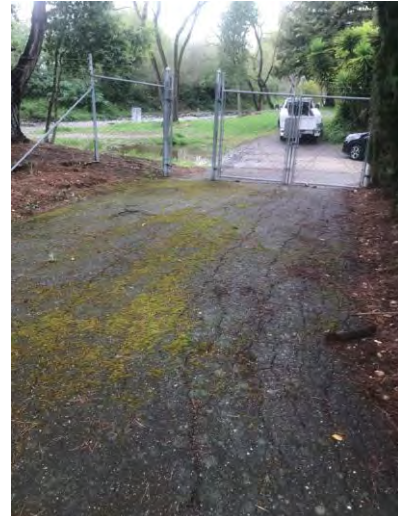
Record ID: 105  
System: G2030 - PEDESTRIAN PLAZAS AND WALKWAYS

Quantity/Unit of Measure: 4,000/SF  
Total Deficiency Cost: \$122,060  
Deficiency Description: *AC paving has major damage and/or structure failure.*

Description of Work: *Replace AC pavement section.*

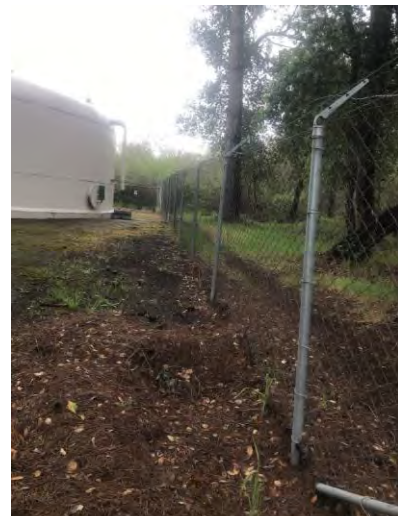
Record ID: 106  
System: G2060 - SITE DEVELOPMENT

Quantity/Unit of Measure: 200/LF  
Total Deficiency Cost: \$6,870  
Deficiency Description: *Chain link fencing is showing signs of wear.*

Description of Work: *Replace entire fence, including mesh, posts, and concrete bases.*

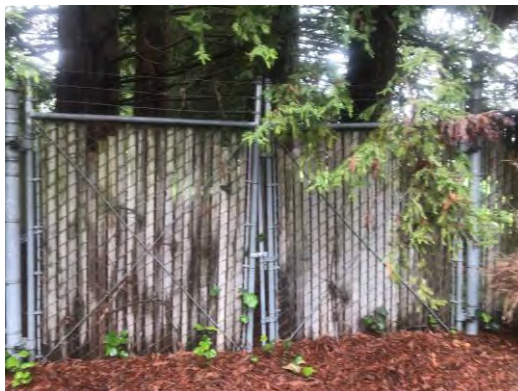
Deficiency Description: *Chain link fencing (up to 6 ft high) shows heavy damage and requires full replacement.*

Description of Work: *Replace entire fence, including mesh, posts, and concrete bases.*

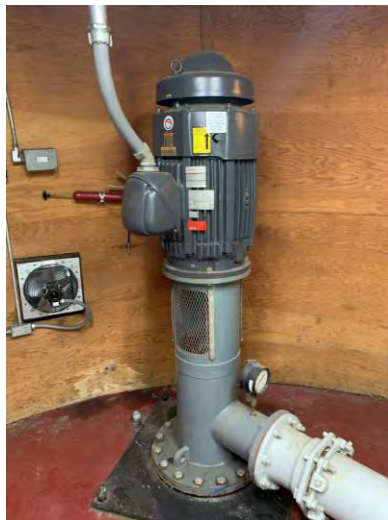
Record ID: 343  
System: G3010 - WATER UTILITIES

Deficiency Description: *Water supply pump system is approaching the end of its useful life.*

Description of Work: *Replace water supply pump system.*

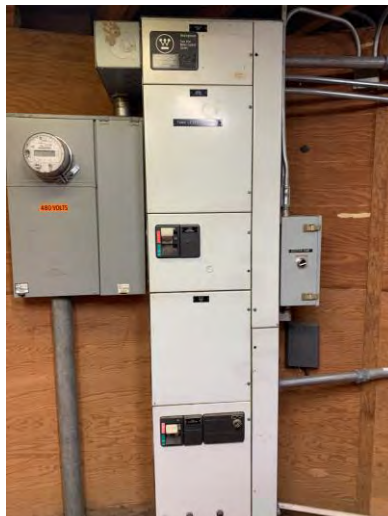
Record ID: 344  
System: D5020 - ELECTRICAL SERVICE AND DISTRIBUTION

Deficiency Description: *The all-in-one combination service entrance device is past its expected useful life.*

Comments: *Age is estimated.*

Description of Work: *Replace the existing all-in-one combination service entrance device with a new all-in-one combination service entrance device.*

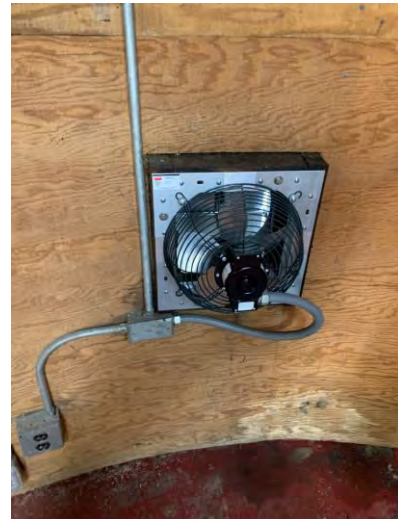
Deficiency Description: *Sidewall propeller fan is approaching the end of its expected useful life.*

Description of Work: *Provide equipment replacement and installation.*

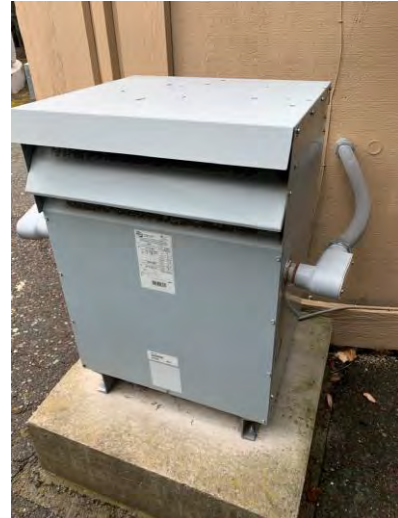
Record ID: 348  
 System: D5020 - ELECTRICAL SERVICE AND DISTRIBUTION

Deficiency Description: *The 75kVA transformer is past its expected useful life.*

Description of Work: *Replace the existing transformer with a new transformer.*

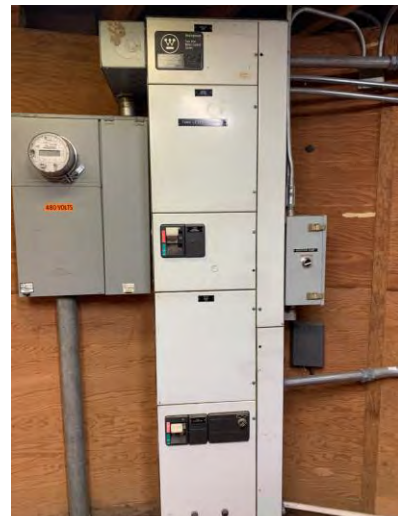
Record ID: 1798  
 System: D5020 - ELECTRICAL SERVICE AND DISTRIBUTION

Deficiency Description: *The motor control center is at or is approaching end of its expected useful life.*

Comments: *Age is estimated.*

Description of Work: *Replace the existing motor control center with a new motor control center.*

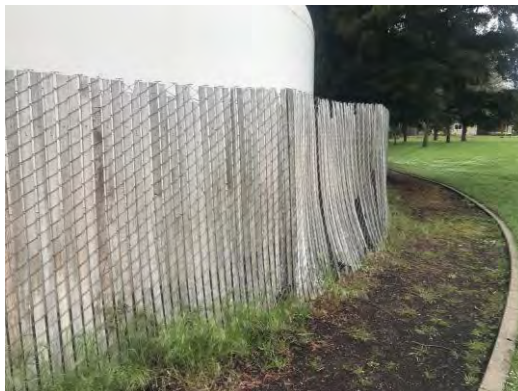
Item No.: G2060.20.020  
Floor/Room: 1 / Fencing  
Priority: 2  
Quantity/Unit of Measure: 150/LF  
Total Deficiency Cost: \$4,550  
Deficiency Description: *Chain link fencing (up to 6 ft high) shows heavy damage and requires full replacement.*

Description of Work: *Replace entire fence, including mesh, posts, and concrete bases.*

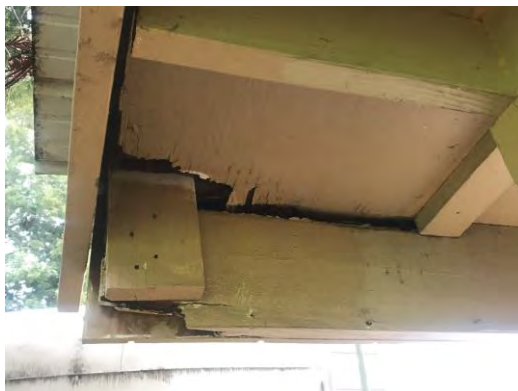
Record ID: 146  
System: B3010 - ROOFING

Item No.: B3010.90.011  
Floor/Room: Roof / Exterior  
Priority: 1  
Quantity/Unit of Measure: 100/SF  
Total Deficiency Cost: \$6,430  
Deficiency Description: *Soffits and overhangs are approaching the end of their expected useful service life.*

Description of Work: *Selectively remove the existing exterior rafter tails and framing members. Install and replace them with new framing.*

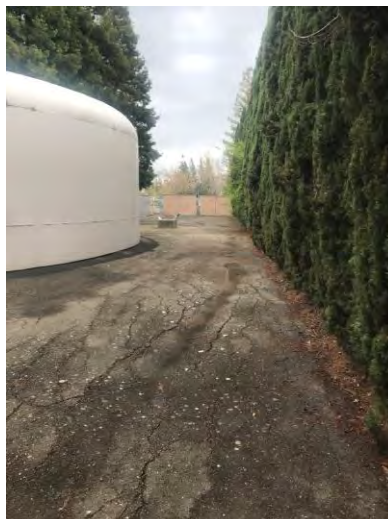
Record ID: 148  
System: G2030 - PEDESTRIAN PLAZAS AND WALKWAYS

Item No.: G2030.10.002  
Floor/Room: Site / AC Paving  
Priority: 3  
Quantity/Unit of Measure: 3,000/SF  
Total Deficiency Cost: \$91,550  
Deficiency Description: *AC paving has major damage and/or structure failure.*

Description of Work: *Replace AC pavement section.*

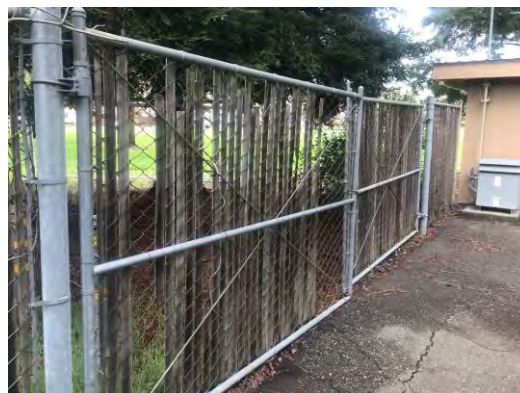
Quantity/Unit of Measure: 1/EA  
Total Deficiency Cost: \$10,120  
Deficiency Description: *Vehicular swing gate is showing signs of wear.*

Description of Work: *Replace double vehicular swing gate.*

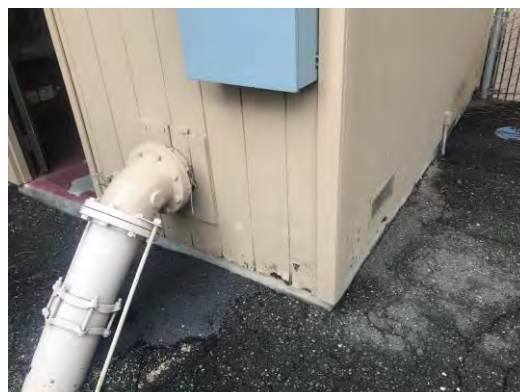
Record ID: 150  
System: B2010 - EXTERIOR WALLS

Quantity/Unit of Measure: 200/SF  
Total Deficiency Cost: \$3,400  
Deficiency Description: *Plywood siding is approaching the end of its useful life.*

Description of Work: *Remove and replace the existing plywood siding with new plywood siding. Prime and paint.*

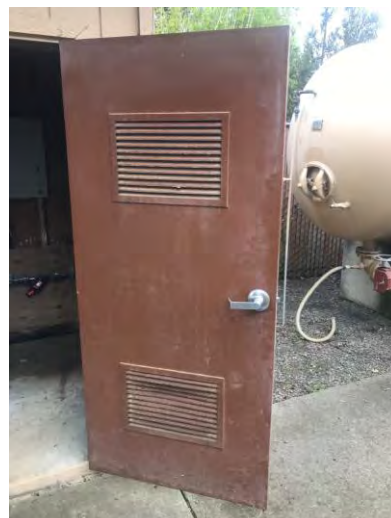
Record ID: 156  
System: B2050 - EXTERIOR DOORS AND GRILLES

Quantity/Unit of Measure: 1/EA  
Total Deficiency Cost: \$790  
Deficiency Description: *Metal entrance door is damaged or deteriorating.*

Description of Work: *Refurbish/repair metal entrance door.*

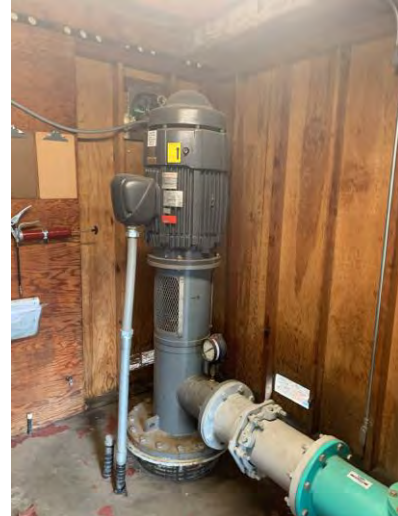
Record ID: 395  
System: G3010 - WATER UTILITIES  
Year Installed / Industry Life / Remaining Useful Life: - / 20 / -  
Item No.: G3010.10.056  
Floor/Room:  
**Priority:** 7  
Quantity/Unit of Measure: 1/EA  
Total Deficiency Cost: \$59,340  
Deficiency Description: *Water supply pump system is approaching the end of its useful life.*  
Description of Work: *Replace water supply pump system.*  
Comments:

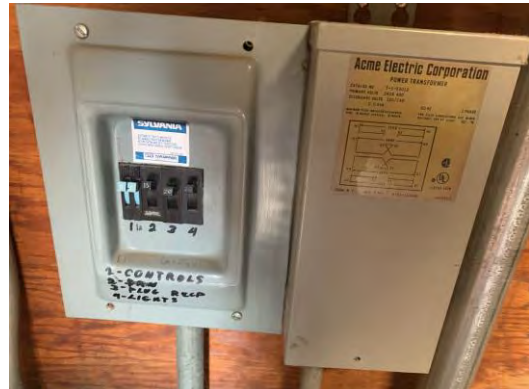
Record ID: 396  
System: D5020 - ELECTRICAL SERVICE AND DISTRIBUTION  
Year Installed / Industry Life / Remaining Useful Life: 1990 / 30 / -2  
Item No.: D5020.30.4001  
Floor/Room:  
**Priority:** 1  
Quantity/Unit of Measure: 1/EA  
Total Deficiency Cost: \$4,910  
Deficiency Description: *The load center is past its expected useful life.*  
Description of Work: *Replace the existing load center with a new load center.*  
Comments: *Age is estimated.*

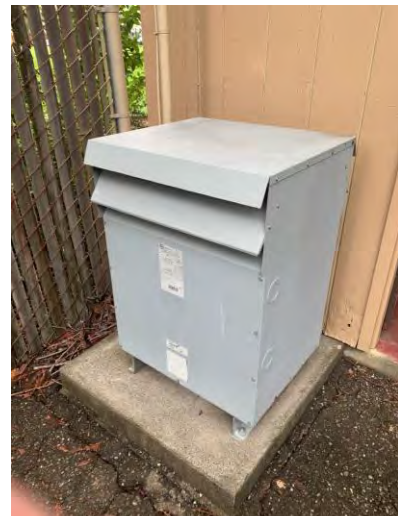
Record ID: 398  
System: D5020 - ELECTRICAL SERVICE AND DISTRIBUTION  
Year Installed / Industry Life / Remaining Useful Life: 1990 / 30 / -2  
Item No.: D5020.10.217  
Floor/Room:  
**Priority:** 1  
Quantity/Unit of Measure: 1/EA  
Total Deficiency Cost: \$16,550  
Deficiency Description: *The 75kVA transformer is past its expected useful life.*  
Description of Work: *Replace the existing transformer with a new transformer.*  
Comments: *Age is estimated.*

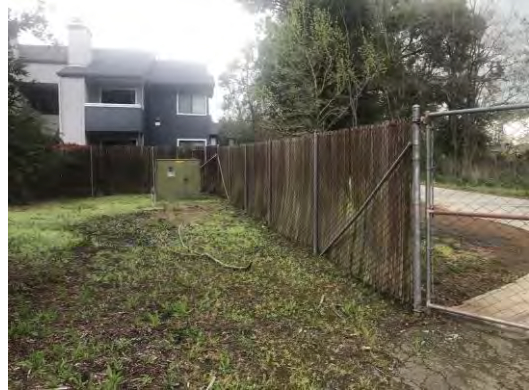
Record ID: 119  
System: G2060 - SITE DEVELOPMENT  
Year Installed / Industry Life / Remaining Useful Life: - / - / -  
Item No.: G2060.20.020  
Floor/Room: Site / Exterior  
**Priority:** 5  
Quantity/Unit of Measure: 400/LF  
Total Deficiency Cost: \$13,730  
Deficiency Description: *Chain link fencing is showing signs of wear.*

Description of Work: *Replace entire fence, including mesh, posts, and concrete bases.*

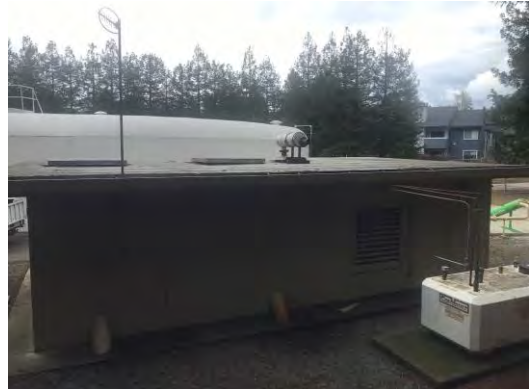
Record ID: 120  
System: B3010 - ROOFING  
Year Installed / Industry Life / Remaining Useful Life: - / 10 / -  
Item No.: B3010.50.004  
Floor/Room: Roof / Roof  
**Priority:** 5  
Quantity/Unit of Measure: 600/SF  
Total Deficiency Cost: \$26,280  
Deficiency Description: *Single-ply (modified bitumen) roofing is at or approaching the end of its useful life.*

Description of Work: *Replace single-ply (modified bitumen) roofing.*

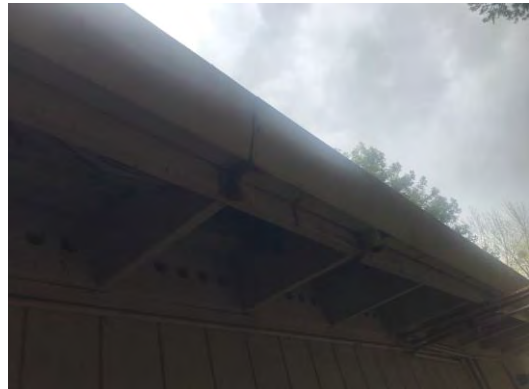
Record ID: 121  
System: B3010 - ROOFING  
Year Installed / Industry Life / Remaining Useful Life: - / 20 / -  
Item No.: B3010.90.011  
Floor/Room: Roof / Roof  
**Priority:** 3  
Quantity/Unit of Measure: 50/SF  
Total Deficiency Cost: \$3,540  
Deficiency Description: *Soffits and overhangs are approaching the end of their expected useful service life.*

Description of Work: *Selectively remove the existing exterior rafter tails and framing members. Install and replace them with new framing.*

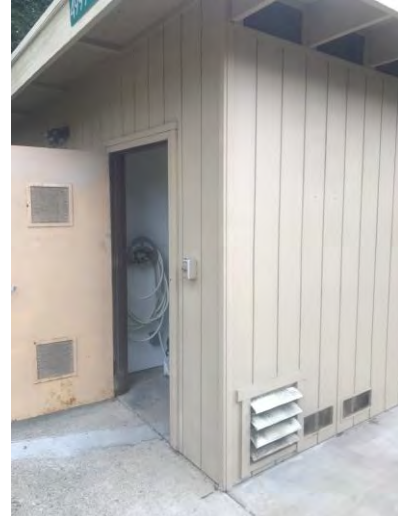
Quantity/Unit of Measure: 300/SF  
 Total Deficiency Cost: \$2,650  
 Deficiency Description: *The existing veneer plywood is damaged or worn.*

Description of Work: *Clean, prepare, and paint the plywood paneling.*

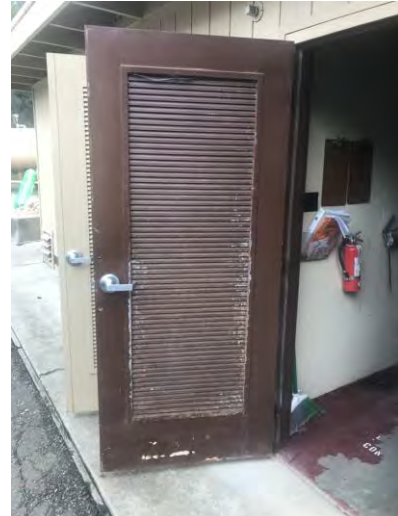
Record ID: 123  
 System: B2050 - EXTERIOR DOORS AND GRILLES

Quantity/Unit of Measure: 2/EA  
 Total Deficiency Cost: \$24,580  
 Deficiency Description: *The exterior door is approaching the end of its useful life.*

Comments: *At two doors.*

Description of Work: *Replace metal door.*

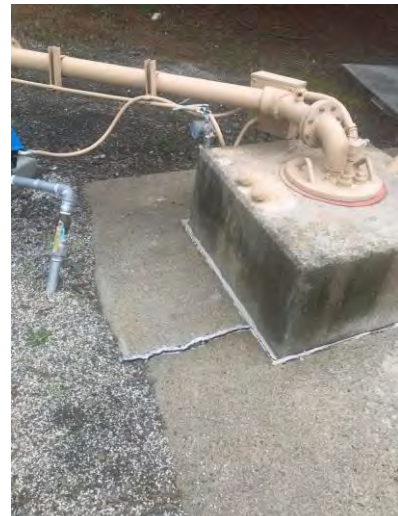
Record ID: 125  
 System: G2030 - PEDESTRIAN PLAZAS AND WALKWAYS

Quantity/Unit of Measure: 100/SF  
 Total Deficiency Cost: \$3,640  
 Deficiency Description: *Concrete pavement has major damage / structural failure.*

Description of Work: *Replace concrete and base to match existing.*

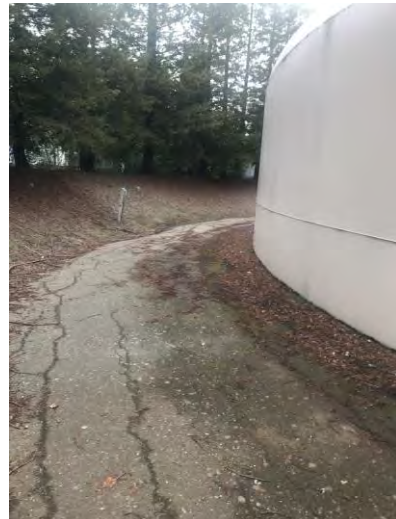
Record ID: 126  
 System: G2030 - PEDESTRIAN PLAZAS AND WALKWAYS  
 Year Installed / Industry Life / Remaining Useful Life: - / - / -  
 Item No.: G2030.10.002  
 Floor/Room: Site / AC Paving  
**Priority:** 2  
 Quantity/Unit of Measure: 2,000/SF  
 Total Deficiency Cost: \$58,450  
 Deficiency Description: *AC paving has major damage and/or structure failure.*

Description of Work: *Replace AC pavement section.*

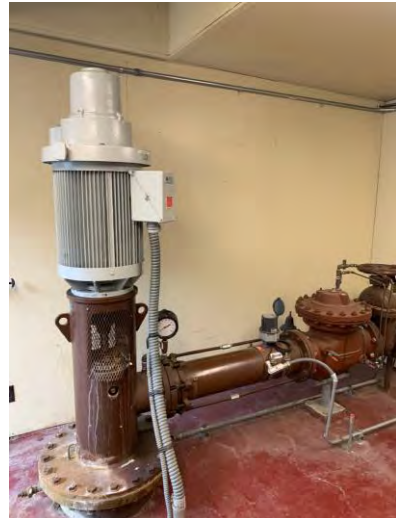
Record ID: 361  
 System: G3010 - WATER UTILITIES  
 Year Installed / Industry Life / Remaining Useful Life: - / 20 / -  
 Item No.: G3010.10.056  
 Floor/Room: 1  
**Priority:** 7  
 Quantity/Unit of Measure: 1/EA  
 Total Deficiency Cost: \$59,340  
 Deficiency Description: *Water supply pump system is approaching the end of its useful life.*

Description of Work: *Replace water supply pump system.*

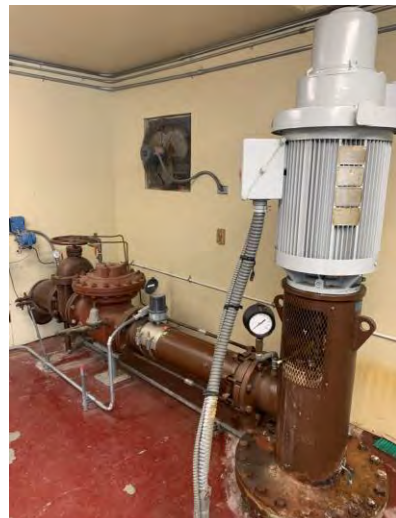
Record ID: 362  
 System: G3010 - WATER UTILITIES  
 Year Installed / Industry Life / Remaining Useful Life: - / 20 / -  
 Item No.: G3010.10.056  
 Floor/Room: 1  
**Priority:** 7  
 Quantity/Unit of Measure: 1/EA  
 Total Deficiency Cost: \$59,340  
 Deficiency Description: *Water supply pump system is approaching the end of its useful life.*

Description of Work: *Replace water supply pump system.*

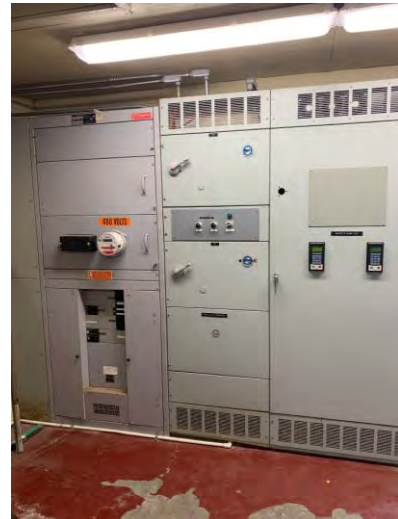
Record ID: 364  
 System: D5020 - ELECTRICAL SERVICE AND DISTRIBUTION  
 Year Installed / Industry Life / Remaining Useful Life: 1984 / 20 / -18  
 Item No.: D5020.10.302  
 Floor/Room:  
 Priority: 1  
 Quantity/Unit of Measure: 1/EA  
 Total Deficiency Cost: \$17,750  
 Deficiency Description: *The 400A metered main switchboard is past its expected useful life.*  
 Description of Work: *Replace the existing metered main switchboard with a new metered main switchboard.*  
 Comments:

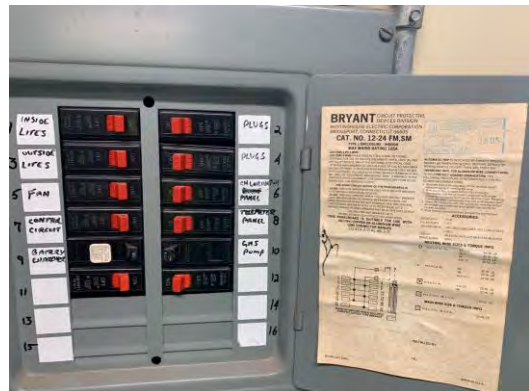
Record ID: 365  
 System: D5020 - ELECTRICAL SERVICE AND DISTRIBUTION  
 Year Installed / Industry Life / Remaining Useful Life: 1984 / 30 / -8  
 Item No.: D5020.30.4001  
 Floor/Room:  
 Priority: 1  
 Quantity/Unit of Measure: 1/EA  
 Total Deficiency Cost: \$4,910  
 Deficiency Description: *The load center is past its expected useful life.*  
 Description of Work: *Replace the existing load center with a new load center.*  
 Comments:

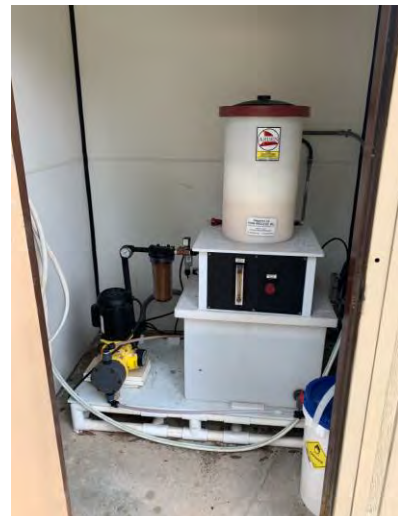
Record ID: 369  
 System: D2010 - DOMESTIC WATER DISTRIBUTION  
 Year Installed / Industry Life / Remaining Useful Life: - / 30 / -  
 Item No.: D2010.20.012  
 Floor/Room:  
 Priority: 7  
 Quantity/Unit of Measure: 1/EA  
 Total Deficiency Cost: \$42,710  
 Deficiency Description: *Water treatment system is at the end of its expected useful service life.*  
 Description of Work: *Provide equipment replacement and installation.*  
 Comments:

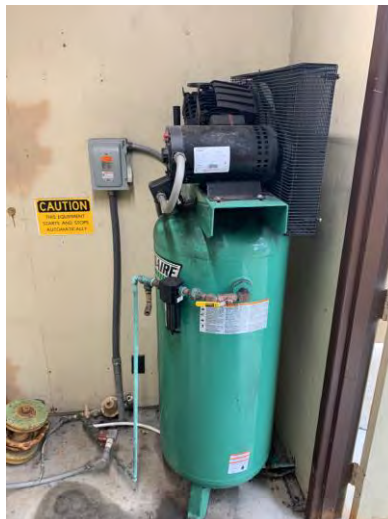
Record ID 370  
System D2060 - PROCESS SUPPORT PLUMBING SYSTEMS  
Year Installed / Industry Life / Remaining Useful Life - / 25 / -  
Item No. D2060.10.001  
Floor/Room:  
**Priority:** 7  
Quantity/Unit of Measure: 1/EA  
Total Deficiency Cost: \$19,810  
Deficiency Description: *Air compressor is approaching the end of its expected useful life.*

Description of Work: *Provide equipment replacement and installation.*

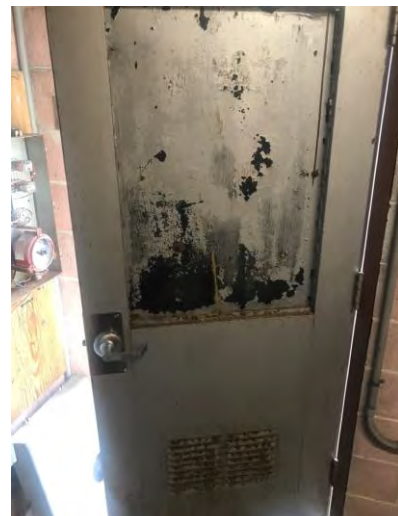
Item No.: B2050.20.001  
Floor/Room: 1 / Exterior  
**Priority:** 2  
Quantity/Unit of Measure: 1/EA  
Total Deficiency Cost: \$11,780  
Deficiency Description: *The exterior door is approaching the end of its useful life.*

Description of Work: *Replace metal door.*

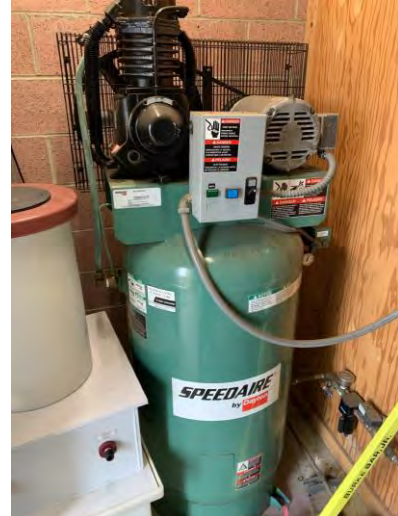
Record ID: 331  
System: D2060 - PROCESS SUPPORT PLUMBING SYSTEMS  
Year Installed / Industry Life / Remaining Useful Life: - / 25 / -  
Item No.: D2060.10.001  
Floor/Room:  
**Priority:** 7  
Quantity/Unit of Measure: 1/EA  
Total Deficiency Cost: \$19,810  
Deficiency Description: *Air compressor is approaching the end of its expected useful life.*  
Description of Work: *Provide equipment replacement and installation.*  
Comments:

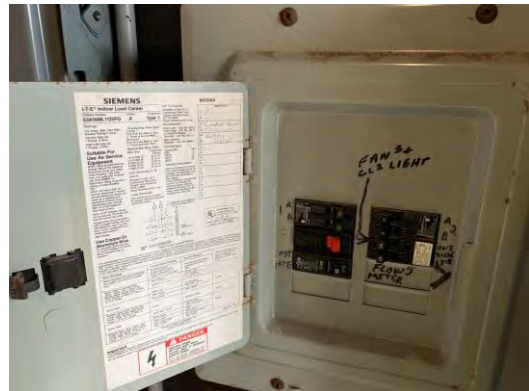
Record ID: 332  
System: D5020 - ELECTRICAL SERVICE AND DISTRIBUTION  
Year Installed / Industry Life / Remaining Useful Life: 1990 / 30 / -2  
Item No.: D5020.30.4001  
Floor/Room:  
**Priority:** 1  
Quantity/Unit of Measure: 1/EA  
Total Deficiency Cost: \$4,910  
Deficiency Description: *The load center is past its expected useful life.*  
Description of Work: *Replace the existing load center with a new load center.*  
Comments: *Age is estimated.*

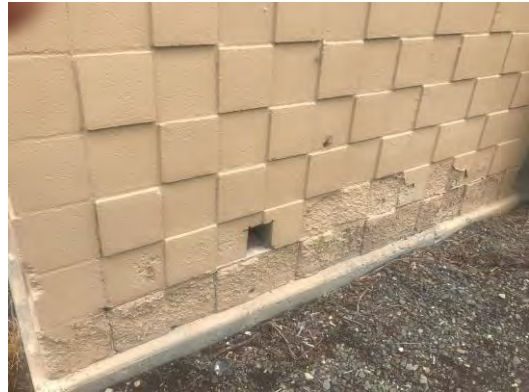
Item No.: B2010.20.004  
Floor/Room: 1 / Exterior  
**Priority:** 2  
Quantity/Unit of Measure: 100/SF  
Total Deficiency Cost: \$10,110  
Deficiency Description: *Concrete masonry units exterior walls are damaged and in need of repair.*

Description of Work: *Repair concrete masonry units exterior walls and repaint.*

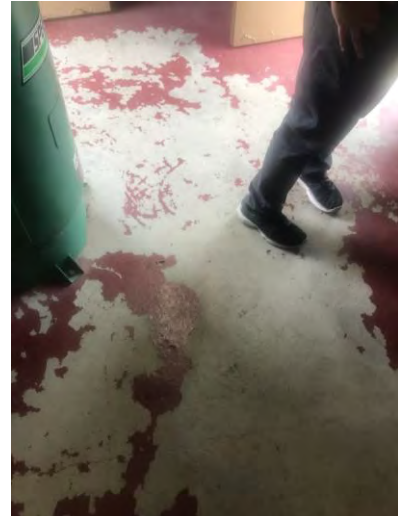
Item No.: C2030.10.001  
Floor/Room: 1 / Pump House  
**Priority:** 3  
Quantity/Unit of Measure: 100/SF  
Total Deficiency Cost: \$1,780  
Deficiency Description: *Concrete floor finish is approaching the end of its useful life.*

Description of Work: *Repair and refinish the concrete floor.*

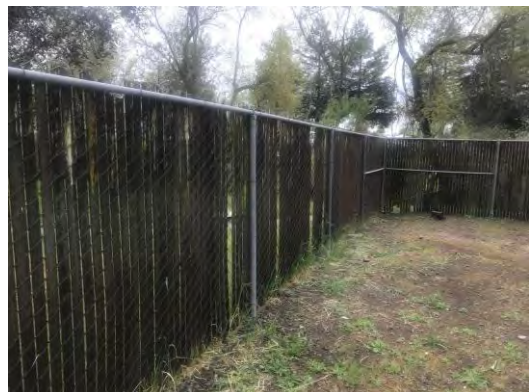
Item No.: G2060.20.020  
Floor/Room: Site / Fencing  
**Priority:** 3  
Quantity/Unit of Measure: 300/LF  
Total Deficiency Cost: \$9,480  
Deficiency Description: *Chain link fencing shows heavy damage and requires full replacement.*

Description of Work: *Replace entire fence, including mesh, posts, and concrete bases.*

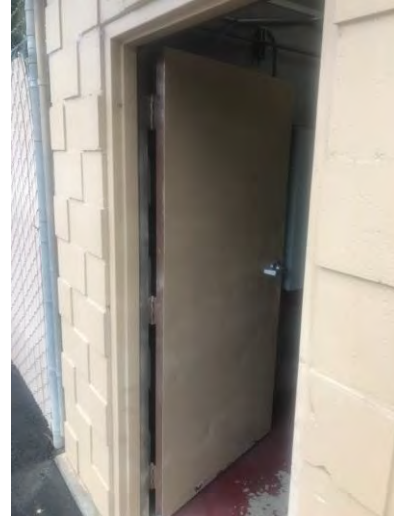
Deficiency Description: *The exterior door is approaching the end of its useful life.*

Description of Work: *Replace metal door.*

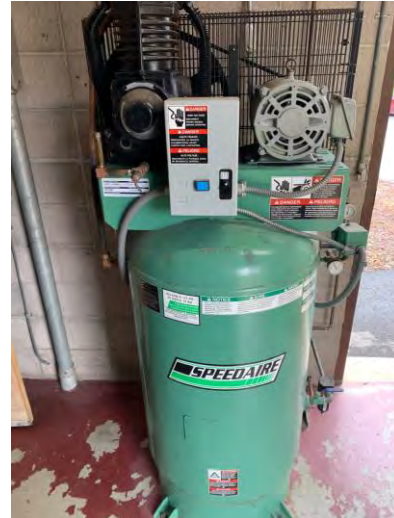
Deficiency Description: *Air compressor is approaching the end of its expected useful life.*

Description of Work: *Provide equipment replacement and installation.*

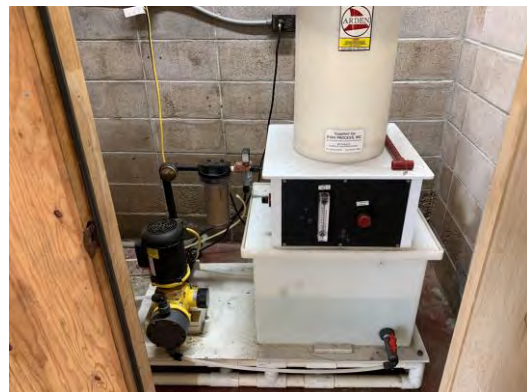
Deficiency Description: *Water treatment system is at the end of its expected useful service life.*

Description of Work: *Provide equipment replacement and installation.*

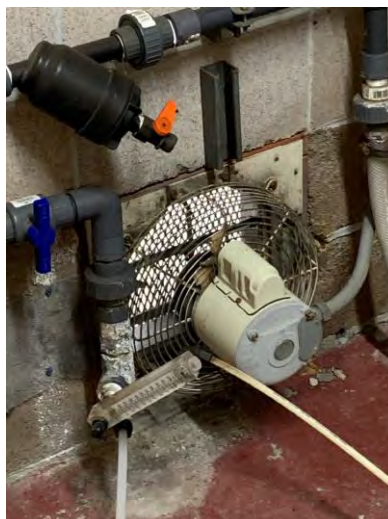
Deficiency Description: *Sidewall propeller fan is approaching the end of its expected useful life.*

Description of Work: *Provide equipment replacement and installation.*

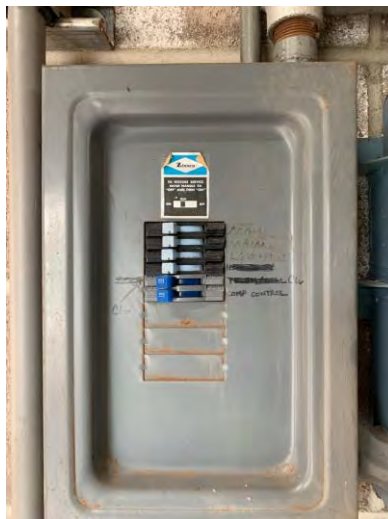
Deficiency Description: *The load center is past its expected useful life.*

Comments: *Age is estimated.*

Description of Work: *Replace the existing load center with a new load center.*

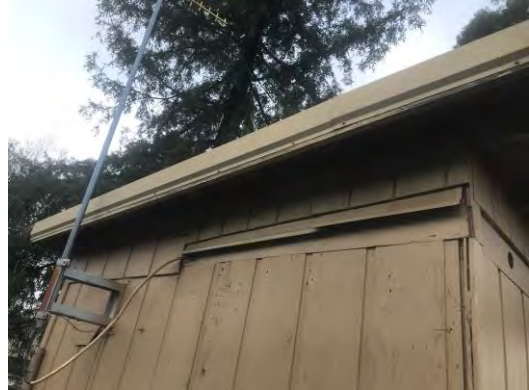
Deficiency Description: *The existing veneer plywood is damaged or worn.*

Description of Work: *Clean, prepare, and paint the plywood paneling.*

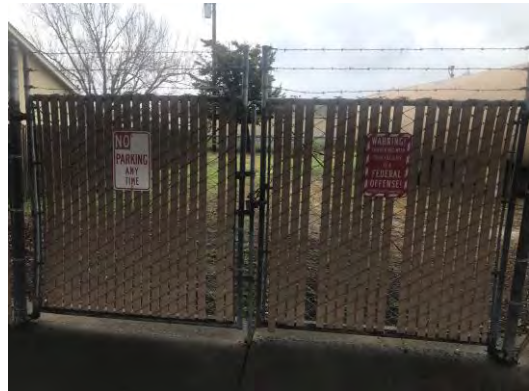
Deficiency Description: *Vehicular swing gate is showing signs of damage.*

Description of Work: *Replace double vehicular swing gate.*

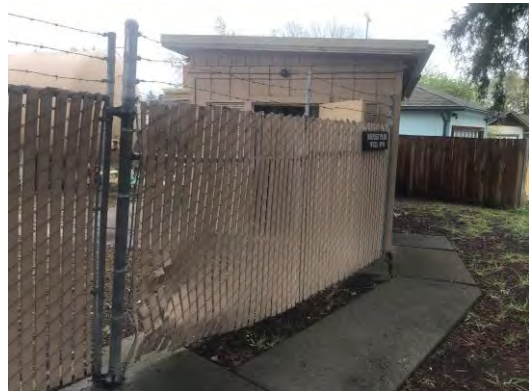
Deficiency Description: *Chain link fencing shows heavy damage and requires full replacement.*

Description of Work: *Replace entire fence, including mesh, posts, and concrete bases.*

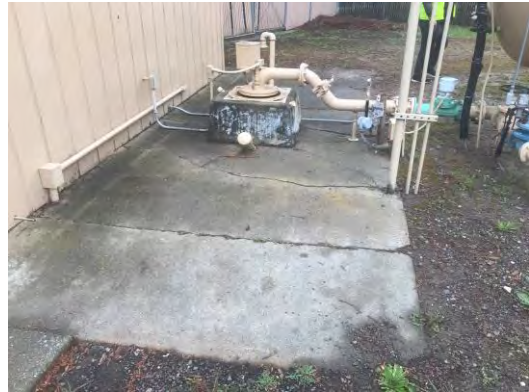
Record ID: 67  
 System: G2030 - PEDESTRIAN PLAZAS AND WALKWAYS  
 Year Installed / Industry Life / Remaining Useful Life: - / 30 / -  
 Item No.: G2030.10.005  
 Floor/Room: Site / Concrete Walkway  
**Priority:** 3  
 Quantity/Unit of Measure: 100/SF  
 Total Deficiency Cost: \$3,800  
 Deficiency Description: *Concrete pavement has major damage / structural failure.*

Description of Work: *Replace concrete and base to match existing.*

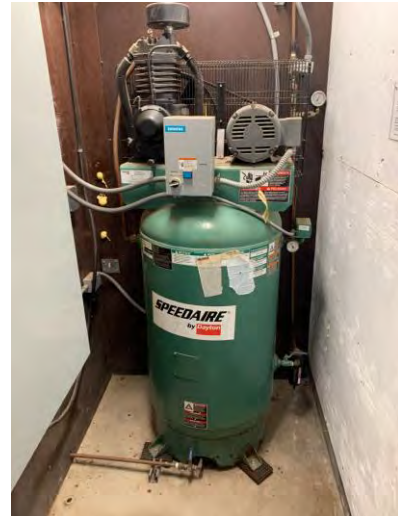
Record ID: 308  
 System: D2060 - PROCESS SUPPORT PLUMBING SYSTEMS  
 Year Installed / Industry Life / Remaining Useful Life: - / 25 / -  
 Item No.: D2060.10.001  
 Floor/Room: 1 / Pump House  
**Priority:** 7  
 Quantity/Unit of Measure: 1/EA  
 Total Deficiency Cost: \$19,810  
 Deficiency Description: *Air compressor is approaching the end of its expected useful life.*

Description of Work: *Provide equipment replacement and installation.*

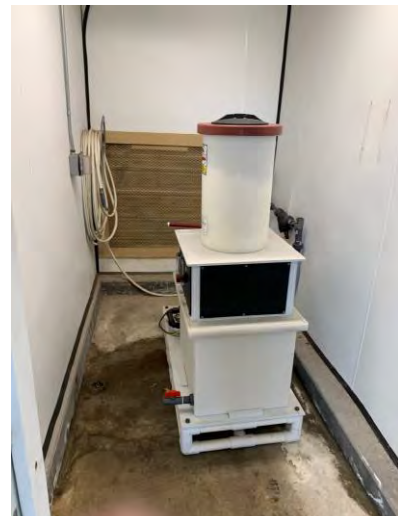
Record ID: 311  
 System: D2010 - DOMESTIC WATER DISTRIBUTION  
 Year Installed / Industry Life / Remaining Useful Life: - / 30 / -  
 Item No.: D2010.20.012  
 Floor/Room: 1 / Pump House  
**Priority:** 7  
 Quantity/Unit of Measure: 1/EA  
 Total Deficiency Cost: \$42,710  
 Deficiency Description: *Water treatment system is at the end of its expected useful service life.*

Description of Work: *Provide equipment replacement and installation.*

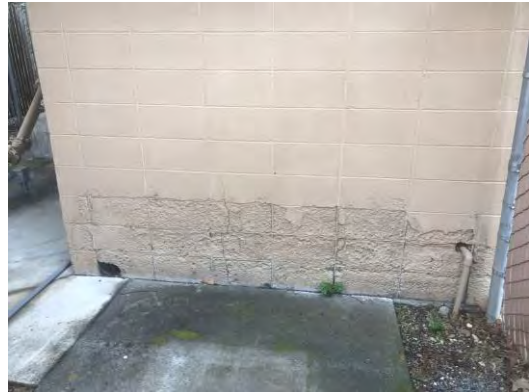
Deficiency Description: *Concrete masonry units exterior walls are damaged and in need of repair.*

Description of Work: *Repair concrete masonry units exterior walls and repaint.*

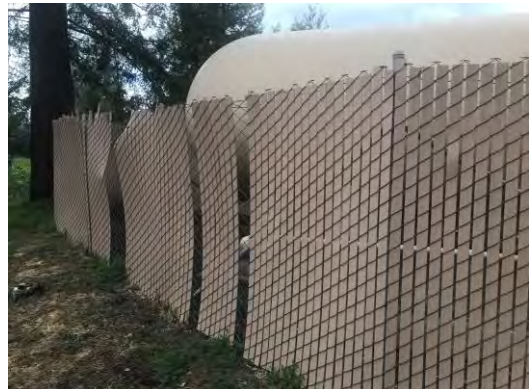
Deficiency Description: *Chain link fencing is showing signs of damage.*

Description of Work: *Replace entire fence, including mesh, posts, and concrete bases.*

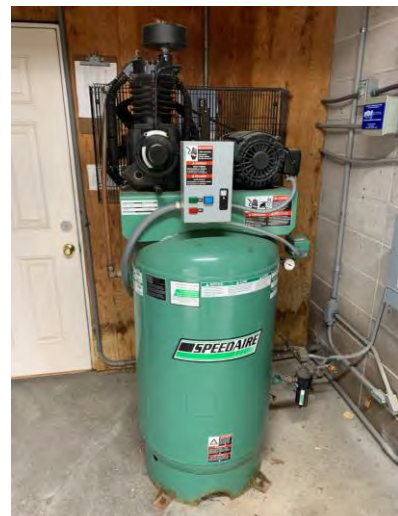
Deficiency Description: *Air compressor is approaching the end of its expected useful life.*

Description of Work: *Provide equipment replacement and installation.*

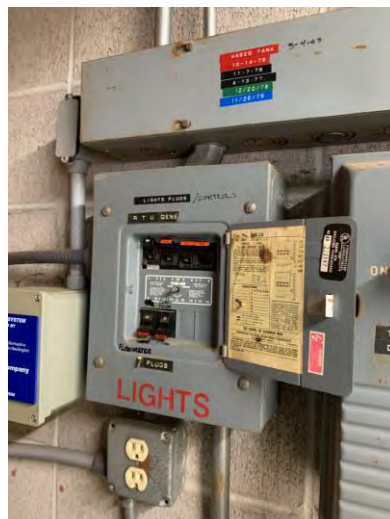
Record ID: 356  
 System: D5020 - ELECTRICAL SERVICE AND DISTRIBUTION  
 Year Installed / Industry Life / Remaining Useful Life: 1990 / 30 / -2  
 Item No.: D5020.30.4001  
 Floor/Room: 1 / Pump House  
**Priority:** 1  
 Quantity/Unit of Measure: 1/EA  
 Total Deficiency Cost: \$4,910  
 Deficiency Description: *The load center is past its expected useful life.*

Comments: *Age is estimated.*

Description of Work: *Replace the existing load center with a new load center.*

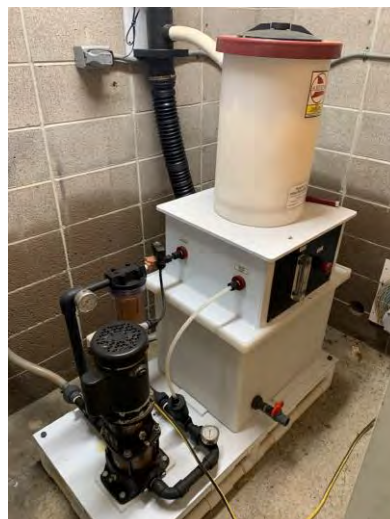
Record ID: 358  
 System: D2010 - DOMESTIC WATER DISTRIBUTION  
 Year Installed / Industry Life / Remaining Useful Life: - / 30 / -  
 Item No.: D2010.20.012  
 Floor/Room: 1 / Pump House  
**Priority:** 7  
 Quantity/Unit of Measure: 1/EA  
 Total Deficiency Cost: \$42,710  
 Deficiency Description: *Water treatment system is at the end of its expected useful service life.*

Description of Work: *Provide equipment replacement and installation.*

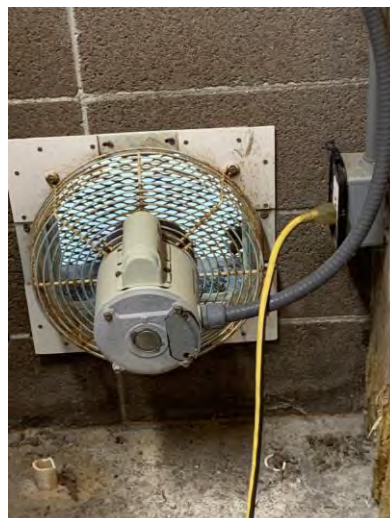
Record ID: 359  
 System: D3060 - VENTILATION  
 Year Installed / Industry Life / Remaining Useful Life: - / 20 / -  
 Item No.: D3060.30.030  
 Floor/Room:  
**Priority:** 7  
 Quantity/Unit of Measure: 1/EA  
 Total Deficiency Cost: \$13,940  
 Deficiency Description: *Sidewall propeller fan is approaching the end of its expected useful life.*

Description of Work: *Provide equipment replacement and installation.*

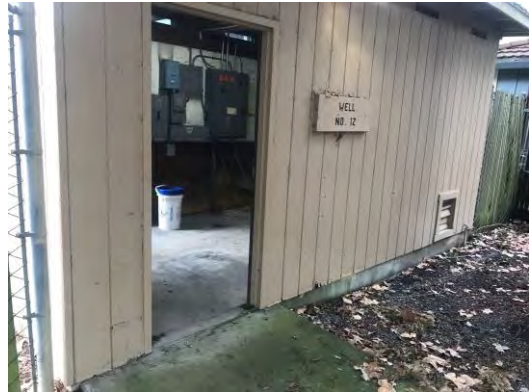
Deficiency Description: *Plywood siding is approaching the end of its useful life.*

Description of Work: *Remove and replace the existing plywood siding with new plywood siding. Prime and paint.*

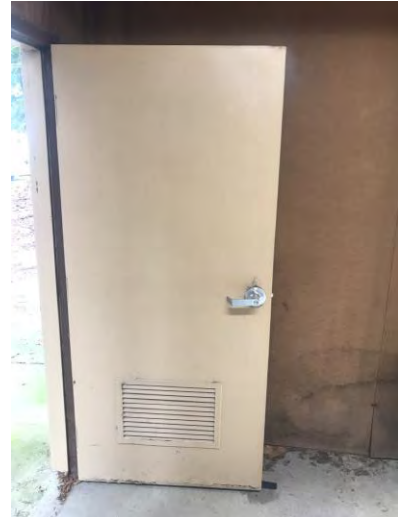
Deficiency Description: *The exterior door is approaching the end of its useful life.*

Description of Work: *Replace the door.*

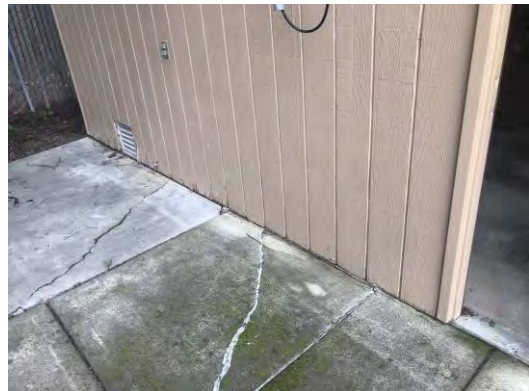
Deficiency Description: *Concrete pavement has major damage / structural failure.*

Description of Work: *Replace concrete and base to match existing.*

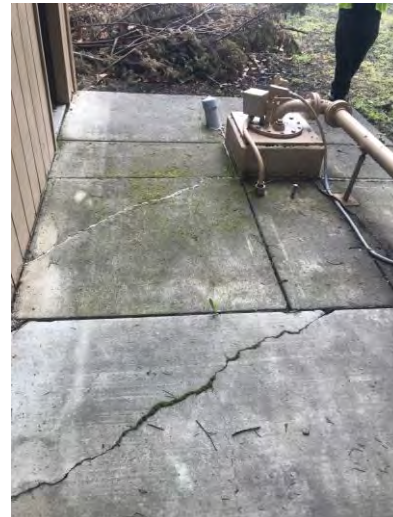
Record ID: 170  
 System: G2030 - PEDESTRIAN PLAZAS AND WALKWAYS  
 Year Installed / Industry Life / Remaining Useful Life: - / 30 / -  
 Item No.: G2030.10.005  
 Floor/Room: Site / Concrete Walkway  
**Priority:** 2  
 Quantity/Unit of Measure: 100/SF  
 Total Deficiency Cost: \$3,640  
 Deficiency Description: *Concrete pavement has major damage / structural failure.*

Description of Work: *Replace concrete and base to match existing.*

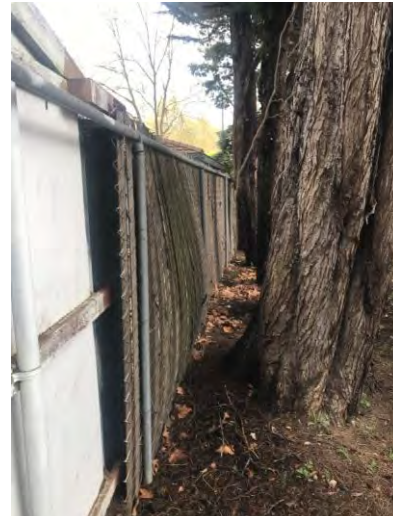
Record ID: 171  
 System: G2060 - SITE DEVELOPMENT  
 Year Installed / Industry Life / Remaining Useful Life: - / - / -  
 Item No.: G2060.20.020  
 Floor/Room: Site / Fencing  
**Priority:** 2  
 Quantity/Unit of Measure: 500/LF  
 Total Deficiency Cost: \$15,140  
 Deficiency Description: *Chain link fencing (up to 6 ft high) shows heavy damage and requires full replacement.*

Description of Work: *Replace entire fence, including mesh, posts, and concrete bases.*

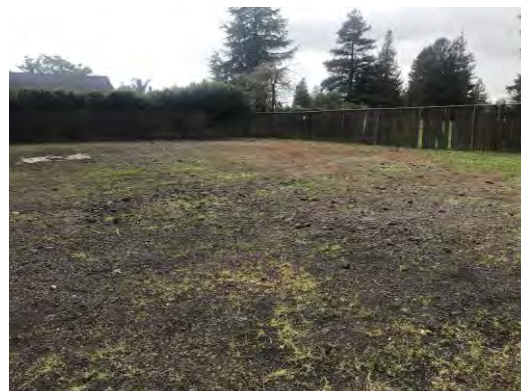
Record ID: 172  
 System: G2080 - LANDSCAPING  
 Year Installed / Industry Life / Remaining Useful Life: - / - / -  
 Item No.: G2080.20.002  
 Floor/Room: Site / Landscaping  
**Priority:** 3  
 Quantity/Unit of Measure: 1,000/SF  
 Total Deficiency Cost: \$4,380  
 Deficiency Description: *There are areas of dead grass and bare patches.*

Description of Work: *Recondition and install new grass seed.*

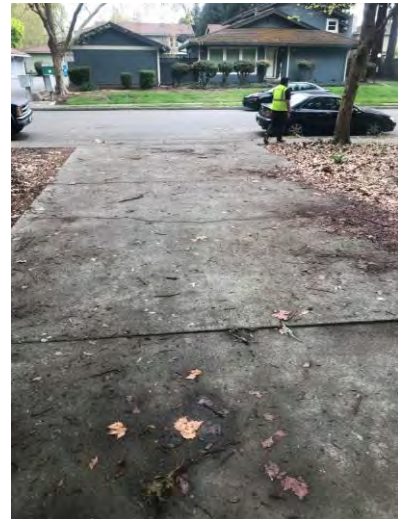
Record ID: 173  
System: G2030 - PEDESTRIAN PLAZAS AND WALKWAYS  
Year Installed / Industry Life / Remaining Useful Life: - / 30 / -  
Item No.: G2030.10.005  
Floor/Room: Site / Driveway  
**Priority:** 2  
Quantity/Unit of Measure: 800/SF  
Total Deficiency Cost: \$29,030  
Deficiency Description: *Concrete pavement has major damage / structural failure.*

Description of Work: *Replace concrete and base to match existing.*

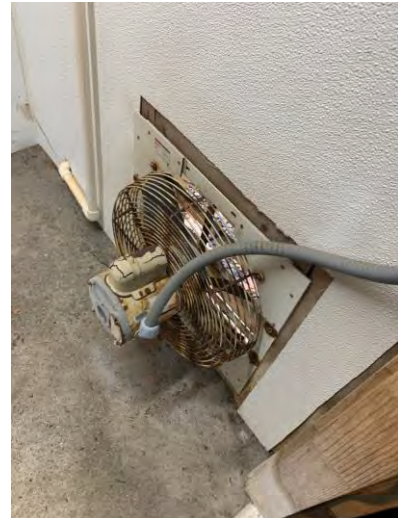
Record ID: 410  
System: D3060 - VENTILATION  
Year Installed / Industry Life / Remaining Useful Life: - / 20 / -  
Item No.: D3060.30.030  
Floor/Room: 1 / Pump House  
**Priority:** 3  
Quantity/Unit of Measure: 1/EA  
Total Deficiency Cost: \$12,370  
Deficiency Description: *Sidewall propeller fan is approaching the end of its expected useful life.*

Description of Work: *Provide equipment replacement and installation.*

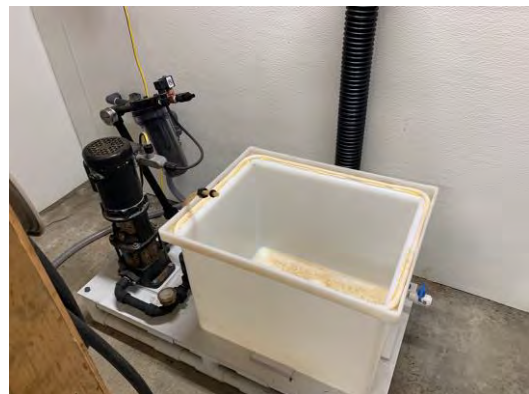
Record ID: 411  
System: D2010 - DOMESTIC WATER DISTRIBUTION  
Year Installed / Industry Life / Remaining Useful Life: - / 30 / -  
Item No.: D2010.20.012  
Floor/Room: 1 / Pump House  
**Priority:** 1  
Quantity/Unit of Measure: 1/EA  
Total Deficiency Cost: \$34,680  
Deficiency Description: *Water treatment system is at the end of its expected useful service life.*

Comments: *Appears offline*

Description of Work: *Provide equipment replacement and installation.*

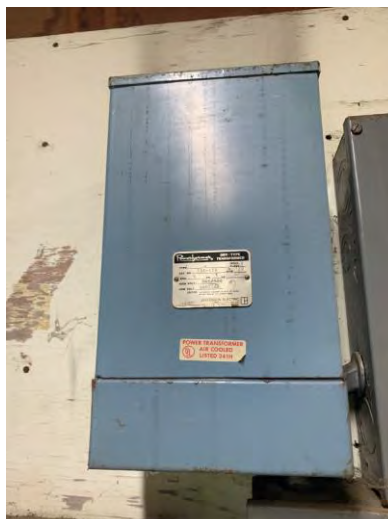
Record ID: 414  
System: D5020 - ELECTRICAL SERVICE AND DISTRIBUTION  
Year Installed / Industry Life / Remaining Useful Life: 1990 / 30 / -2  
Item No.: D5020.10.201  
Floor/Room: 1 / Pump House  
**Priority:** 1  
Quantity/Unit of Measure: 1/EA  
Total Deficiency Cost: \$5,470  
Deficiency Description: *The 5kVA transformer is past its expected useful life.*  
Description of Work: *Replace the existing transformer with a new transformer.*  
Comments: *Age is estimated.*

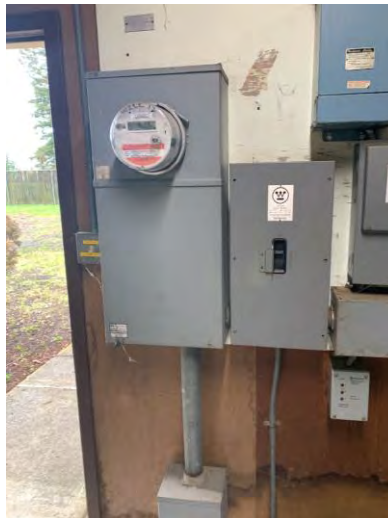
Record ID: 1791  
System: D5020 - ELECTRICAL SERVICE AND DISTRIBUTION  
Year Installed / Industry Life / Remaining Useful Life: 1990 / 30 / -2  
Item No.: D5020.10.001  
Floor/Room: 1 / Pump House  
**Priority:** 1  
Quantity/Unit of Measure: 1/EA  
Total Deficiency Cost: \$8,230  
Deficiency Description: *The all-in-one combination service entrance device is past its expected useful life.*  
Description of Work: *Replace the existing all-in-one combination service entrance device with a new all-in-one combination service entrance device.*  
Comments: *Age is estimated.*

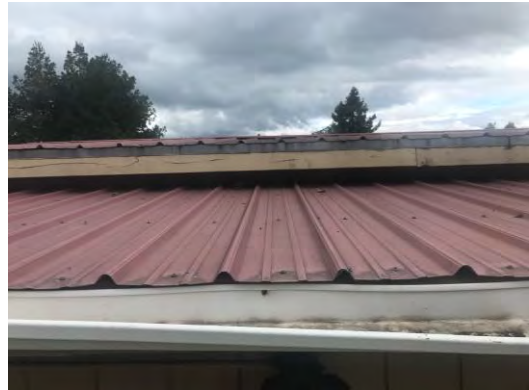
Item No. B3010.10.002  
Floor/Room: Roof / Roof  
**Priority:** 7  
Quantity/Unit of Measure: 300/SF  
Total Deficiency Cost: \$13,660  
Deficiency Description: *Metal roofing is approaching end of expected useful service life.*

Description of Work: *Remove and replace metal roofing.*

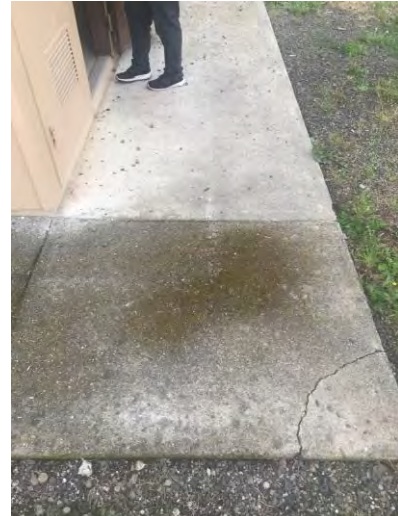
Item No. G2030.10.005  
Floor/Room: Site / Concrete Walkway  
**Priority:** 3  
Quantity/Unit of Measure: 100/SF  
Total Deficiency Cost: \$3,800  
Deficiency Description: *Concrete pavement has major damage / structural failure.*

Description of Work: *Replace concrete and base to match existing.*

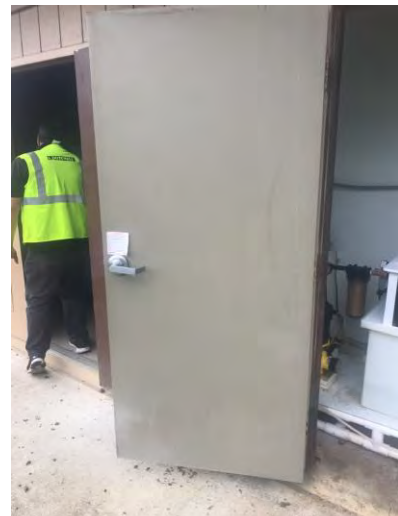
Item No. B2050.20.003  
Floor/Room: 1 / Exterior  
**Priority:** 3  
Quantity/Unit of Measure: 2/EA  
Total Deficiency Cost: \$24,580  
Deficiency Description: *Exterior doors, frames and hardware are approaching the end of their useful life.*

Description of Work: *Replace the exterior doors, frames and hardware.*

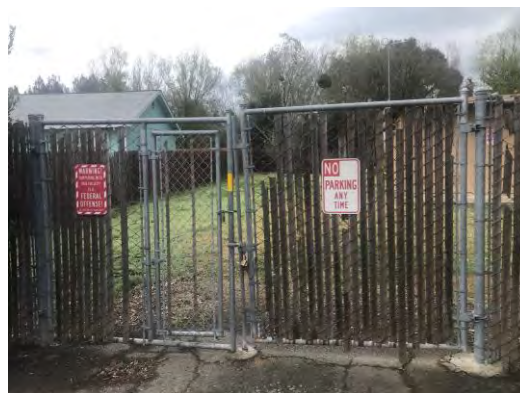
Record ID 135  
System G2060 - SITE DEVELOPMENT  
Year Installed / Industry Life / Remaining Useful Life - / - / -  
Item No. G2060.20.007  
Floor/Room: Site / Fencing  
**Priority: 2**  
Quantity/Unit of Measure: 100/SF  
Total Deficiency Cost: \$2,850  
Deficiency Description: *Privacy screening is missing or damaged.*

Description of Work: *Replace wood privacy slats.*
