# City of Rohnert Park

## Facility Condition Assessment

Final Report

October 17, 2022

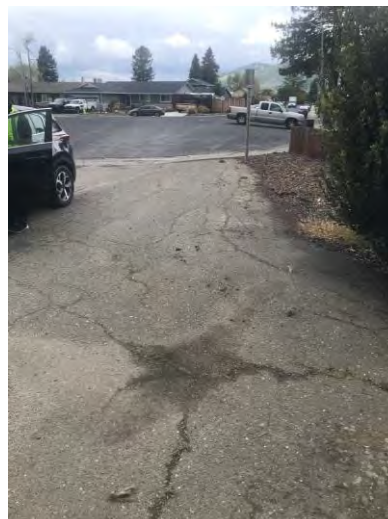
Record ID 136  
System G2020 - PARKING LOTS  
Year Installed / Industry Life / Remaining Useful Life - / - / -  
Item No. G2020.10.002  
Floor/Room: Site / AC Paving  
**Priority: 4**  
Quantity/Unit of Measure: 400/SF  
Total Deficiency Cost: \$12,740  
Deficiency Description: *AC paving shows evidence of weathering.*

Description of Work: *Replace AC pavement section.*

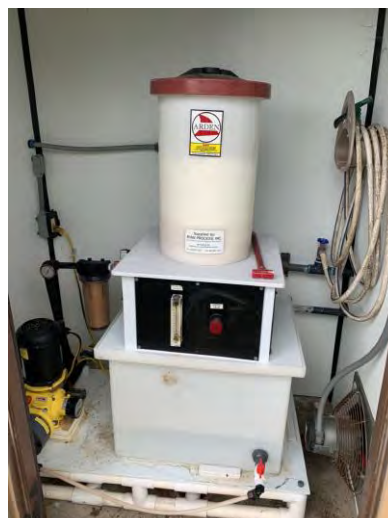
Record ID 375  
System D2010 - DOMESTIC WATER DISTRIBUTION  
Year Installed / Industry Life / Remaining Useful Life - / 30 / -  
Item No. D2010.20.012  
Floor/Room:  
**Priority: 7**  
Quantity/Unit of Measure: 1/EA  
Total Deficiency Cost: \$42,710  
Deficiency Description: *Water treatment system is at the end of its expected useful service life.*

Description of Work: *Provide equipment replacement and installation.*

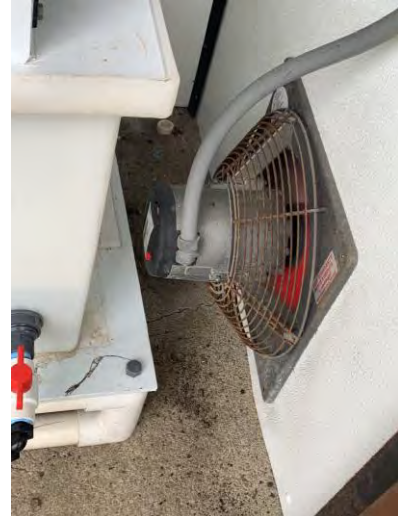
Quantity/Unit of Measure: 1/EA  
Total Deficiency Cost: \$13,420  
Deficiency Description: *Sidewall propeller fan is approaching the end of its expected useful life.*

Description of Work: *Provide equipment replacement and installation.*

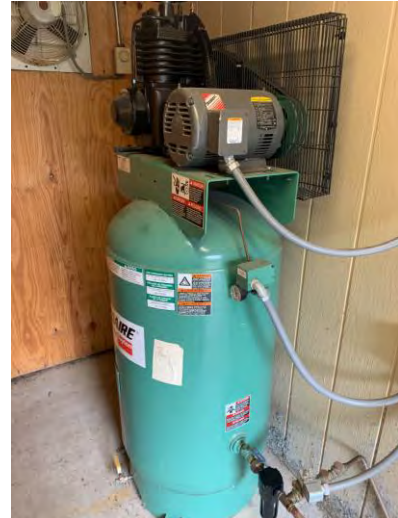
Quantity/Unit of Measure: 1/EA  
Total Deficiency Cost: \$19,810  
Deficiency Description: *Air compressor is approaching the end of its expected useful life.*

Description of Work: *Provide equipment replacement and installation.*

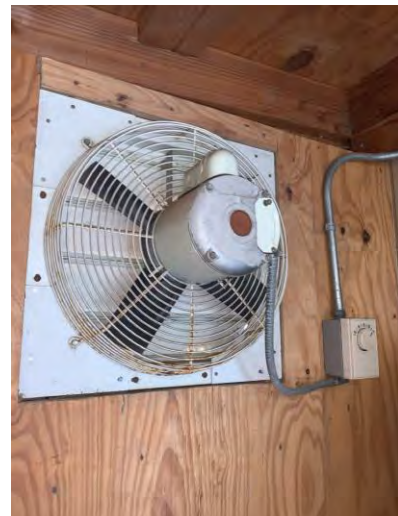
Quantity/Unit of Measure: 1/EA  
Total Deficiency Cost: \$13,940  
Deficiency Description: *Sidewall propeller fan is approaching the end of its expected useful life.*

Description of Work: *Provide equipment replacement and installation.*

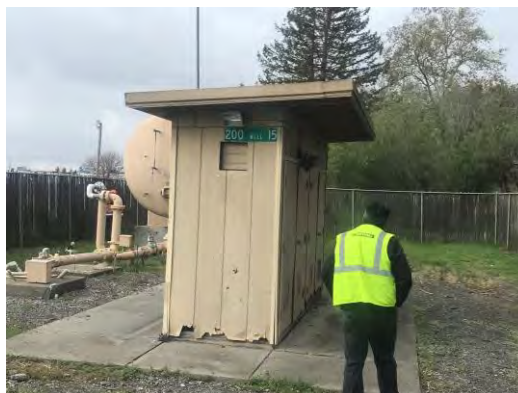
Deficiency Description: *Metal roofing is at or approaching end of expected useful service life.*

Description of Work: *Remove and replace metal roofing.*

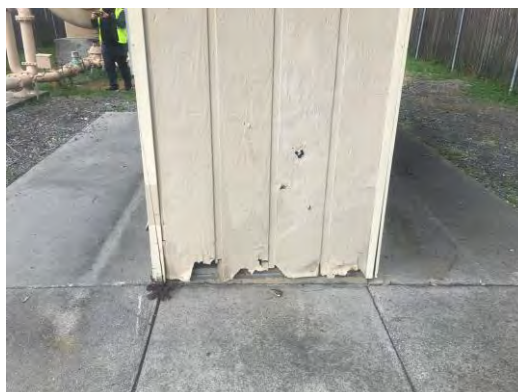
Deficiency Description: *Plywood siding is approaching the end of its useful life.*

Description of Work: *Remove and replace the existing plywood siding with new plywood siding. Prime and paint.*

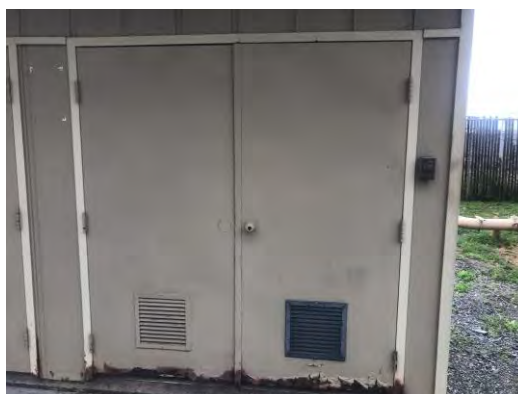
Deficiency Description: *Exterior wood utility door, frame and hardware are approaching the end of their useful life.*

Description of Work: *Replace exterior wood utility door, frame and hardware.*

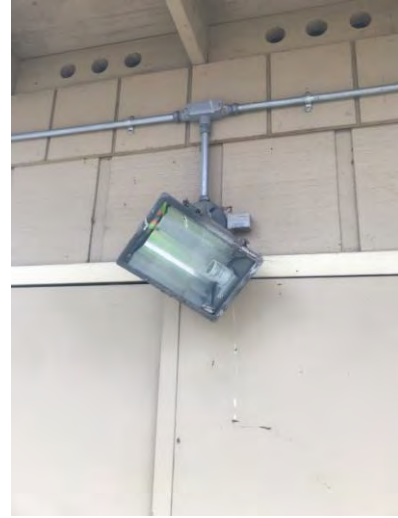
Deficiency Description: *The exterior light fixture is past its expected useful life and deteriorated.*

Description of Work: *Replace the existing light fixture with an LED lighting fixture.*

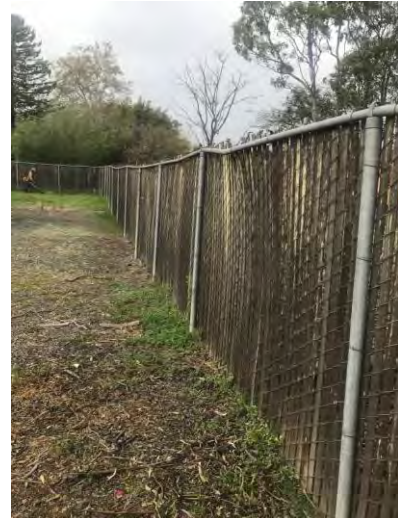
Deficiency Description: *Chain link fencing shows signs of wear.*

Description of Work: *Replace entire fence, including mesh, posts, and concrete bases.*

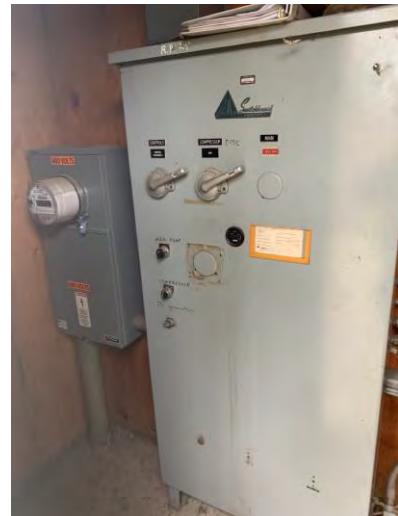
Deficiency Description: *The all-in-one combination service entrance device is past its expected useful life.*

Comments: *Age is estimated.*

Description of Work: *Replace the existing all-in-one combination service entrance device with a new all-in-one combination service entrance device.*

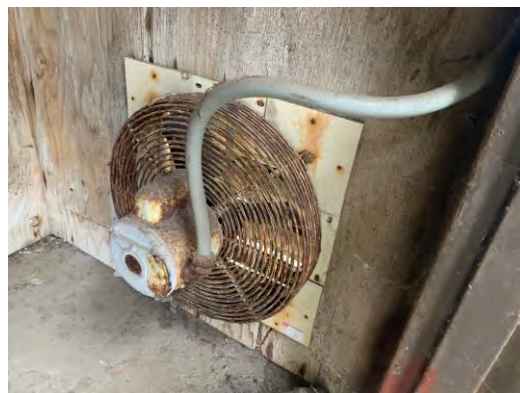
Deficiency Description: *Sidewall propeller fan is approaching the end of its expected useful life.*

Description of Work: *Provide equipment replacement and installation.*

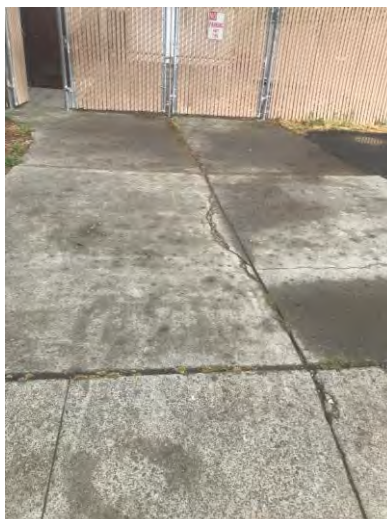
Record ID: 74  
System: G2030 - PEDESTRIAN PLAZAS AND WALKWAYS  
Year Installed / Industry Life / Remaining Useful Life: - / 30 / -  
Item No.: G2030.10.005  
Floor/Room: Site / Driveway  
**Priority:** 2  
Quantity/Unit of Measure: 200/SF  
Total Deficiency Cost: \$7,270  
Deficiency Description: *Concrete pavement has major damage / structural failure.*

Description of Work: *Replace concrete and base to match existing.*

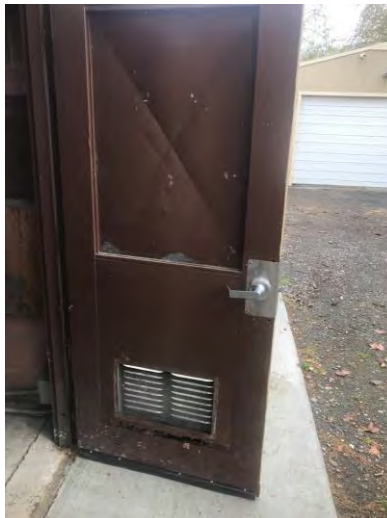
Record ID: 75  
System: B2050 - EXTERIOR DOORS AND GRILLES  
Year Installed / Industry Life / Remaining Useful Life: - / - / -  
Item No.: B2050.10.006  
Floor/Room: 1 / Exterior  
**Priority:** 1  
Quantity/Unit of Measure: 1/EA  
Total Deficiency Cost: \$7,070  
Deficiency Description: *Exterior aluminum entrance door, frame and hardware is approaching the end of its useful life.*

Description of Work: *Replace aluminum door, frame, and hardware.*

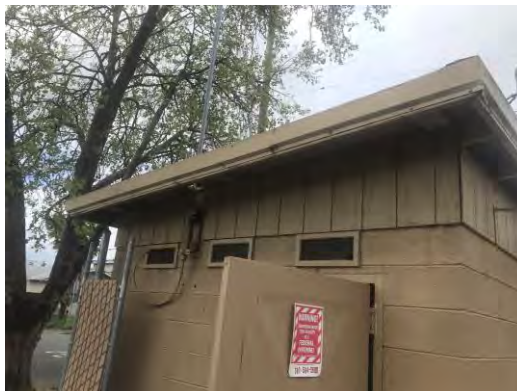
Record ID: 76  
System: B2010 - EXTERIOR WALLS  
Year Installed / Industry Life / Remaining Useful Life: - / 30 / -  
Item No.: B2010.10.001  
Floor/Room: 1 / Exterior  
**Priority:** 3  
Quantity/Unit of Measure: 100/SF  
Total Deficiency Cost: \$1,780  
Deficiency Description: *Plywood siding is approaching the end of its useful life.*

Description of Work: *Remove and replace the existing plywood siding with new plywood siding. Prime and paint.*

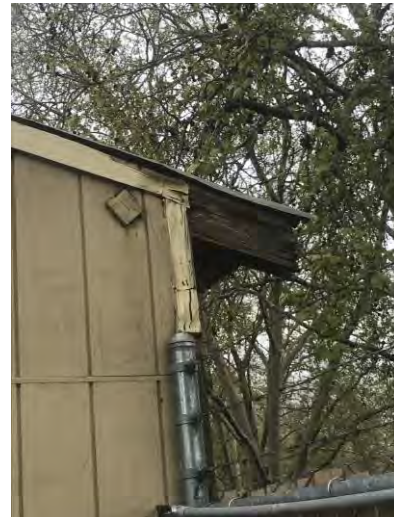
Deficiency Description: *The fascia appears to be deteriorated.*

Description of Work: *Selectively remove deteriorated fascia and replace with new material to match.*

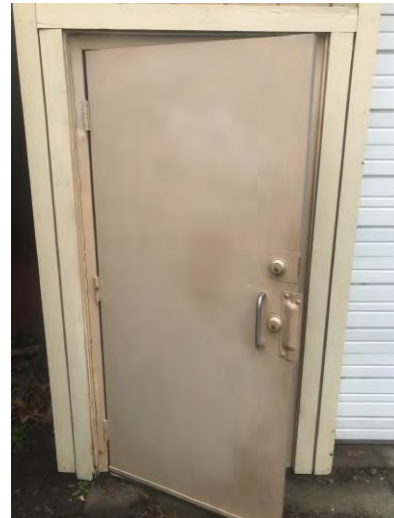
Deficiency Description: *Exterior aluminum entrance door, frame and hardware is approaching the end of its useful life.*

Description of Work: *Replace aluminum door, frame, and hardware.*

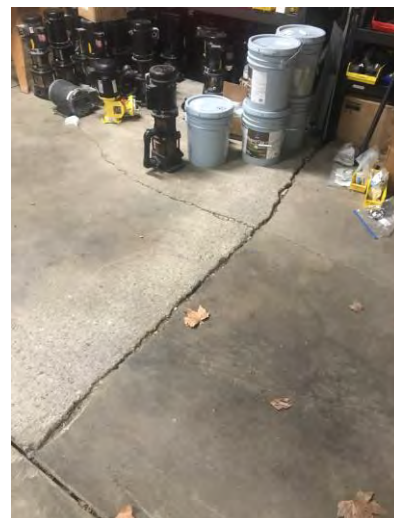
Deficiency Description: *Concrete floor is cracked.*

Description of Work: *Repair and refinish the concrete floor.*

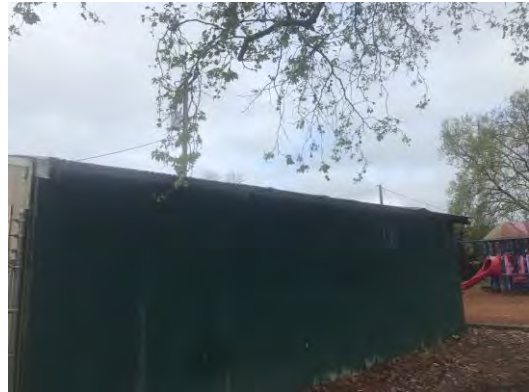
Item No.: B3010.10.002  
Floor/Room: 1 / Exterior  
**Priority:** 3  
Quantity/Unit of Measure: 900/SF  
Total Deficiency Cost: \$36,310  
Deficiency Description: *Metal roofing is at or approaching end of expected useful service life.*

Description of Work: *Remove and replace metal roofing.*

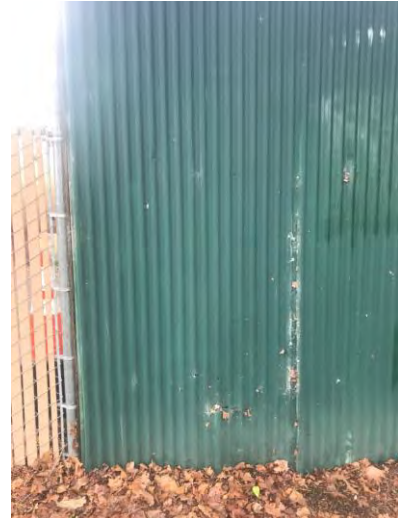
Item No.: B2010.10.012  
Floor/Room: 1 / Exterior  
**Priority:** 1  
Quantity/Unit of Measure: 300/SF  
Total Deficiency Cost: \$15,430  
Deficiency Description: *Metal siding panels damaged in several locations.*

Description of Work: *Replace damaged panels.*

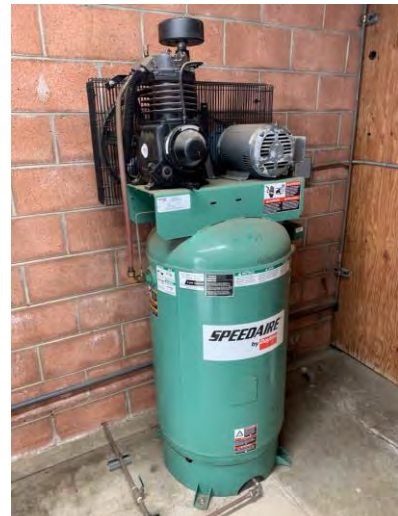
Item No.: D2060.10.001  
Floor/Room:  
**Priority:** 7  
Quantity/Unit of Measure: 1/EA  
Total Deficiency Cost: \$19,810  
Deficiency Description: *Air compressor is approaching the end of its expected useful life.*

Description of Work: *Provide equipment replacement and installation.*

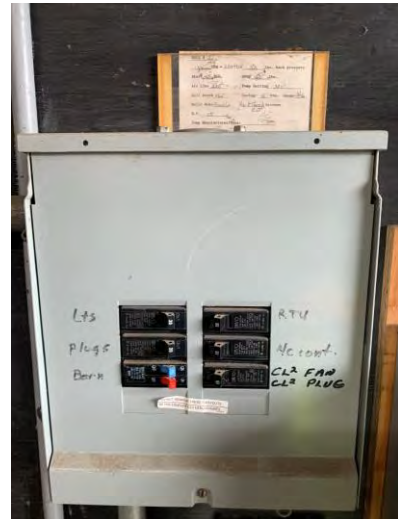
Record ID: 315  
 System: D5020 - ELECTRICAL SERVICE AND DISTRIBUTION  
 Year Installed / Industry Life / Remaining Useful Life: 1990 / 30 / -2  
 Item No.: D5020.30.4001  
 Floor/Room:  
**Priority:** 1  
 Quantity/Unit of Measure: 1/EA  
 Total Deficiency Cost: \$4,910  
 Deficiency Description: *The load center is past its expected useful life.*  
 Description of Work: *Replace the existing load center with a new load center.*  
 Comments: *Age is estimated.*

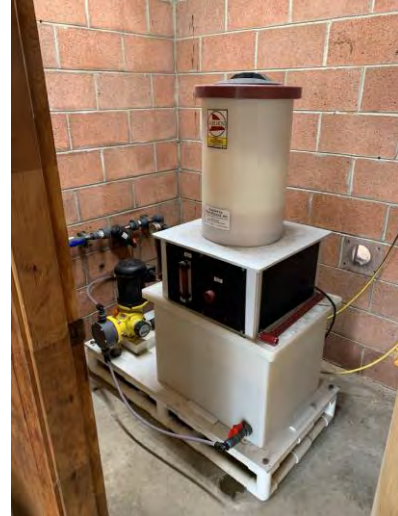
Record ID: 316  
 System: D2010 - DOMESTIC WATER DISTRIBUTION  
 Year Installed / Industry Life / Remaining Useful Life: - / 30 / -  
 Item No.: D2010.20.012  
 Floor/Room:  
**Priority:** 7  
 Quantity/Unit of Measure: 1/EA  
 Total Deficiency Cost: \$42,710  
 Deficiency Description: *Water treatment system is at the end of its expected useful service life.*  
 Description of Work: *Provide equipment replacement and installation.*  
 Comments:

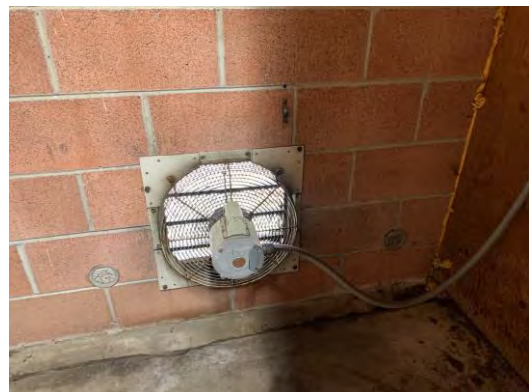
Record ID: 317  
 System: D3060 - VENTILATION  
 Year Installed / Industry Life / Remaining Useful Life: - / 20 / -  
 Item No.: D3060.30.030  
 Floor/Room:  
**Priority:** 7  
 Quantity/Unit of Measure: 1/EA  
 Total Deficiency Cost: \$13,940  
 Deficiency Description: *Sidewall propeller fan is approaching the end of its expected useful life.*  
 Description of Work: *Provide equipment replacement and installation.*  
 Comments:

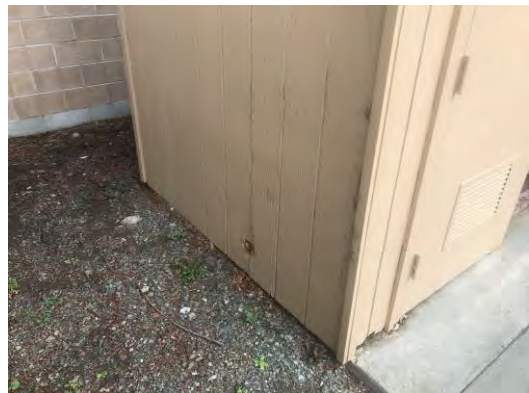
Deficiency Description: *Plywood siding is approaching the end of its useful life.*

Description of Work: *Remove and replace the existing plywood siding with new plywood siding. Prime and paint.*

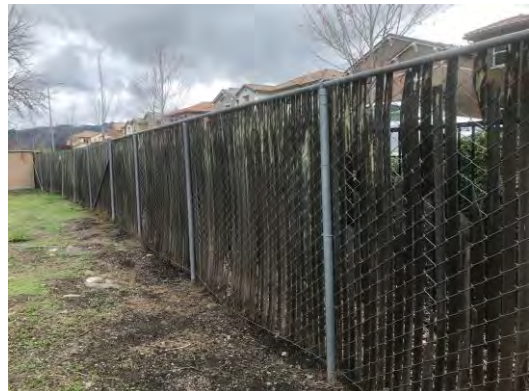
Deficiency Description: *Chain link fencing shows signs of wear.*

Description of Work: *Replace entire fence, including mesh, posts, and concrete bases.*

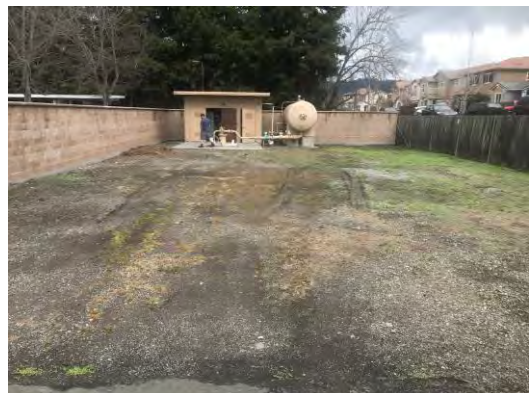
Deficiency Description: *There are dead areas and bare patches in the grass lawn.*

Description of Work: *Recondition and install new grass seed.*

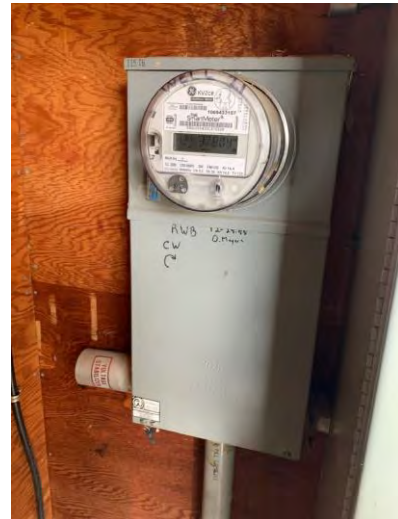
Record ID 349  
 System D5020 - ELECTRICAL SERVICE AND DISTRIBUTION  
 Year Installed / Industry Life / Remaining Useful Life 1990 / 30 / -2  
 Item No. D5020.10.001  
 Floor/Room: 1 / Pump House  
**Priority: 1**  
 Quantity/Unit of Measure: 1/EA  
 Total Deficiency Cost: \$8,230  
 Deficiency Description: *The all-in-one combination service entrance device is past its expected useful life.*  
 Description of Work: *Replace the existing all-in-one combination service entrance device with a new all-in-one combination service entrance device.*  
 Comments: *Age is estimated.*

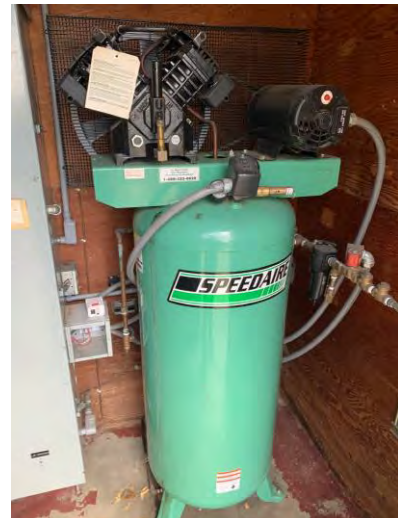
Record ID 350  
 System D2060 - PROCESS SUPPORT PLUMBING SYSTEMS  
 Year Installed / Industry Life / Remaining Useful Life - / 25 / -  
 Item No. D2060.10.001  
 Floor/Room: 1 / Pump House  
**Priority: 7**  
 Quantity/Unit of Measure: 1/EA  
 Total Deficiency Cost: \$19,810  
 Deficiency Description: *Air compressor is approaching the end of its expected useful life.*  
 Description of Work: *Provide equipment replacement and installation.*  
 Comments:

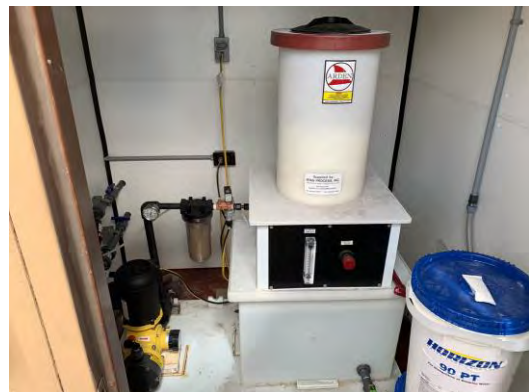
Record ID 351  
 System D2010 - DOMESTIC WATER DISTRIBUTION  
 Year Installed / Industry Life / Remaining Useful Life - / 30 / -  
 Item No. D2010.20.012  
 Floor/Room: 1 / Pump House  
**Priority: 7**  
 Quantity/Unit of Measure: 1/EA  
 Total Deficiency Cost: \$42,710  
 Deficiency Description: *Water treatment system is at the end of its expected useful service life.*  
 Description of Work: *Provide equipment replacement and installation.*  
 Comments:

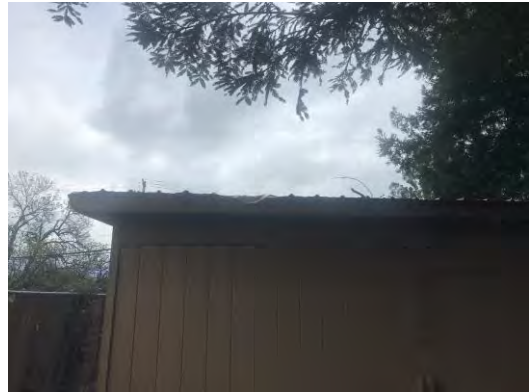
Item No. B3010.10.002  
Floor/Room: Roof / Roof  
**Priority:** 5  
Quantity/Unit of Measure: 150/SF  
Total Deficiency Cost: \$6,600  
Deficiency Description: *Metal roofing is at or approaching end of expected useful service life.*

Description of Work: *Remove and replace metal roofing.*

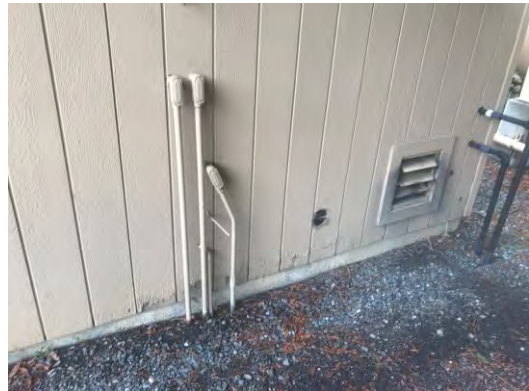
Item No. B2010.10.001  
Floor/Room: 1 / Exterior  
**Priority:** 5  
Quantity/Unit of Measure: 200/SF  
Total Deficiency Cost: \$3,840  
Deficiency Description: *Plywood siding is approaching the end of its useful life.*

Description of Work: *Remove and replace the existing plywood siding with new plywood siding. Prime and paint.*

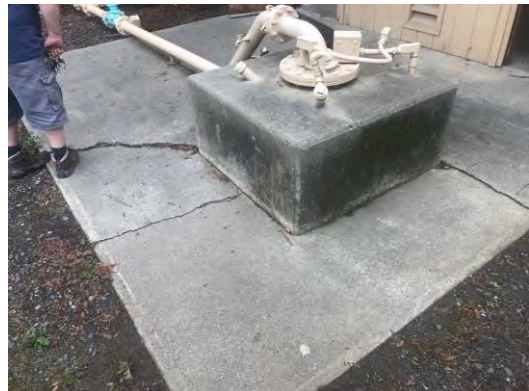
Item No. G2030.10.005  
Floor/Room: Site / Concrete Walkway  
**Priority:** 2  
Quantity/Unit of Measure: 100/SF  
Total Deficiency Cost: \$3,640  
Deficiency Description: *Concrete pavement has major damage / structural failure.*

Description of Work: *Replace concrete and base to match existing.*

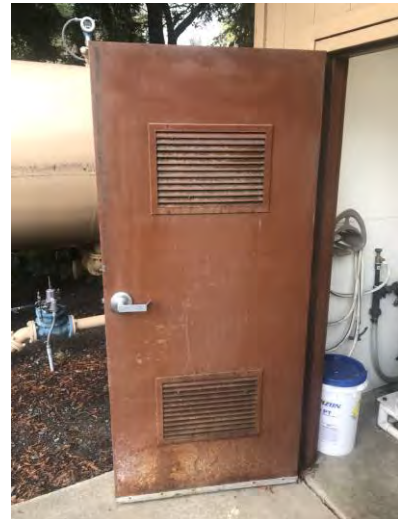
Year Installed / Industry Life / Remaining Useful Life - / 15 / -  
Item No. B2050.20.001  
Floor/Room: 1 / Exterior  
**Priority:** 3  
Quantity/Unit of Measure: 1/EA  
Total Deficiency Cost: \$12,300  
Deficiency Description: *The exterior door is showing signs of wear.*

Description of Work: *Replace metal door.*

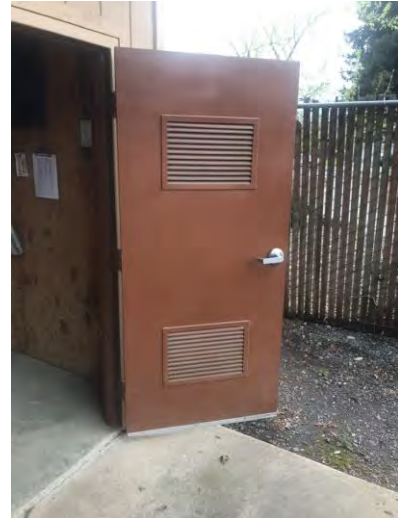
Year Installed / Industry Life / Remaining Useful Life - / 60 / -  
Item No. C1030.90.003  
Floor/Room: 1 / Exterior  
**Priority:** 5  
Quantity/Unit of Measure: 2/EA  
Total Deficiency Cost: \$1,920  
Deficiency Description: *Metal door and frames are showing signs of wear.*

Description of Work: *Repair and refinish the metal door and frames.*

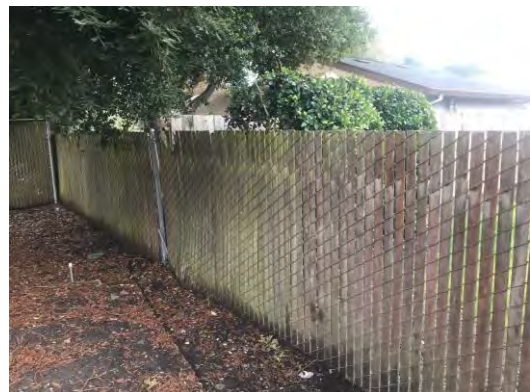
Year Installed / Industry Life / Remaining Useful Life - / - / -  
Item No. G2060.20.020  
Floor/Room: Site / Fencing  
**Priority:** 3  
Quantity/Unit of Measure: 200/LF  
Total Deficiency Cost: \$6,330  
Deficiency Description: *Chain link fencing is showing signs of wear.*

Description of Work: *Replace entire fence, including mesh, posts, and concrete bases.*

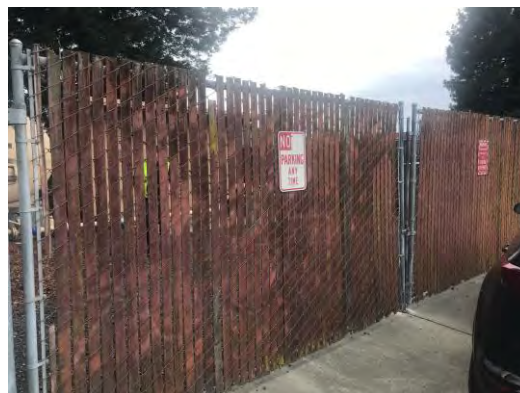
Quantity/Unit of Measure: 1/EA  
Total Deficiency Cost: \$10,120  
Deficiency Description: *Vehicular swing gate has major damage or missing portions.*

Description of Work: *Replace double vehicular swing gate.*

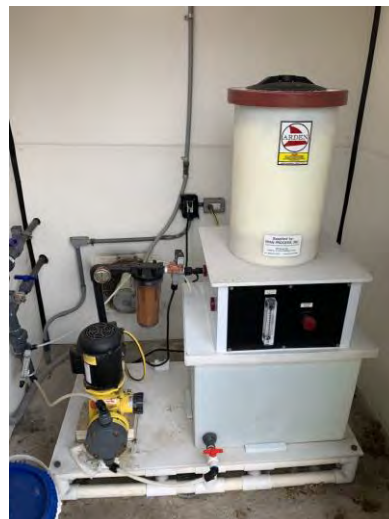
Quantity/Unit of Measure: 1/EA  
Total Deficiency Cost: \$42,710  
Deficiency Description: *Water treatment system is at the end of its expected useful service life.*

Description of Work: *Provide equipment replacement and installation.*

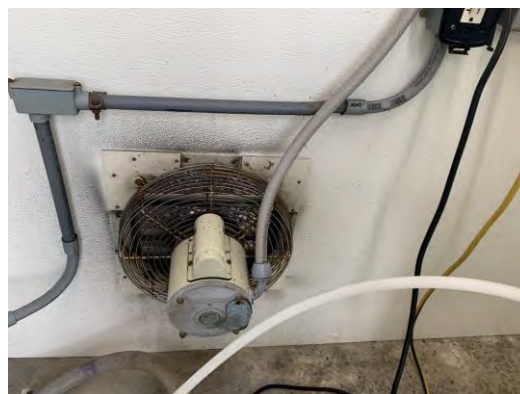
Quantity/Unit of Measure: 1/EA  
Total Deficiency Cost: \$12,370  
Deficiency Description: *Sidewall propeller fan is approaching the end of its expected useful life.*

Description of Work: *Provide equipment replacement and installation.*

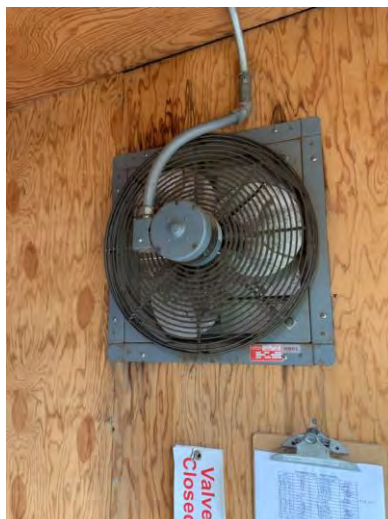
Deficiency Description: *Sidewall propeller fan is approaching the end of its expected useful life.*

Description of Work: *Provide equipment replacement and installation.*

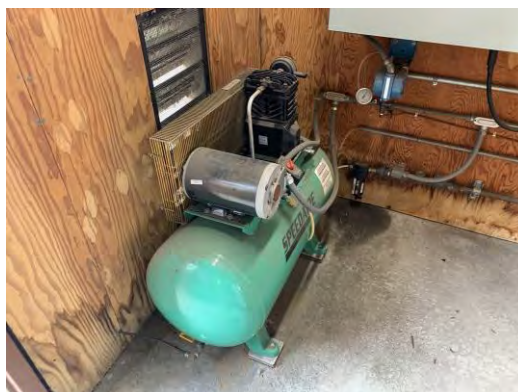
Deficiency Description: *Air compressor is approaching the end of its expected useful life.*

Description of Work: *Provide equipment replacement and installation.*

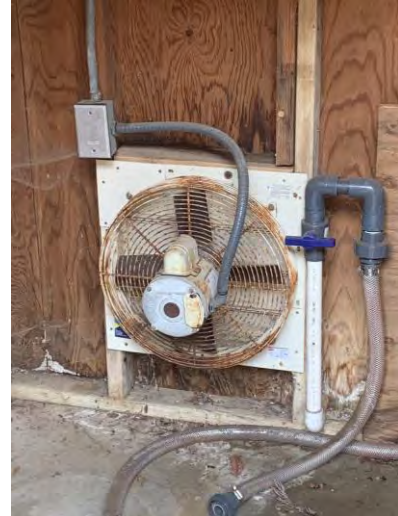
Quantity/Unit of Measure: 1/EA  
Total Deficiency Cost: \$11,850  
Deficiency Description: *Sidewall propeller fan is approaching the end of its expected useful life.*

Description of Work: *Provide equipment replacement and installation.*

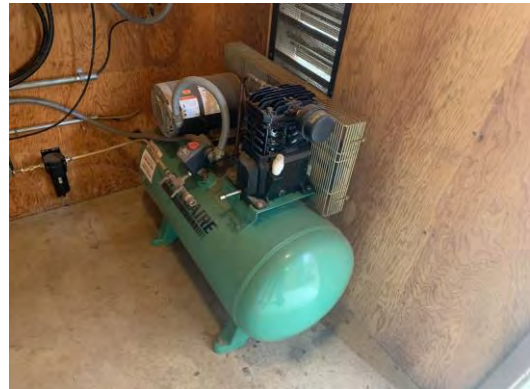
Quantity/Unit of Measure: 1/EA  
Total Deficiency Cost: \$19,810  
Deficiency Description: *Air compressor is approaching the end of its expected useful life.*

Description of Work: *Provide equipment replacement and installation.*

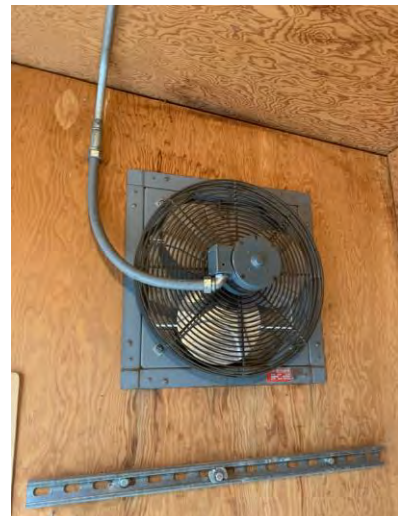
Quantity/Unit of Measure: 1/EA  
Total Deficiency Cost: \$13,940  
Deficiency Description: *Sidewall propeller fan is approaching the end of its expected useful life.*

Description of Work: *Provide equipment replacement and installation.*

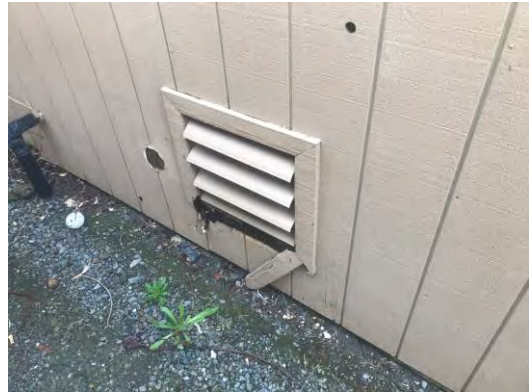
Deficiency Description: *Plywood siding is approaching the end of its useful life.*

Description of Work: *Remove and replace the existing plywood siding with new plywood siding. Prime and paint.*

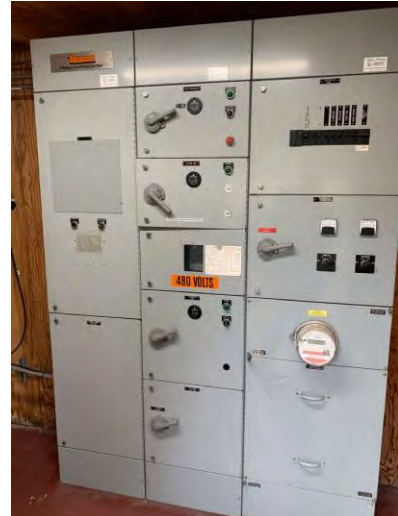
Deficiency Description: *The metered main switchboard is past its expected useful life.*

Comments: *Age is estimated.*

Description of Work: *Replace the existing metered main switchboard with a new metered main switchboard.*

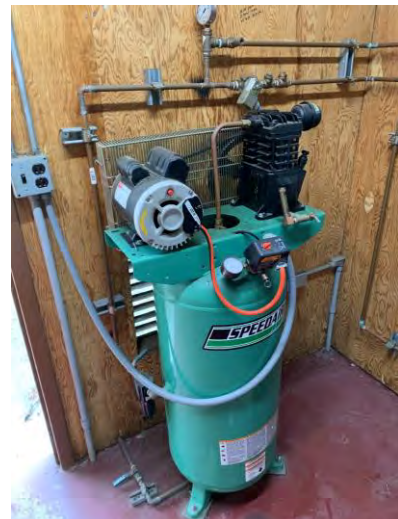
Deficiency Description: *Air compressor is approaching the end of its expected useful life.*

Description of Work: *Provide equipment replacement and installation.*

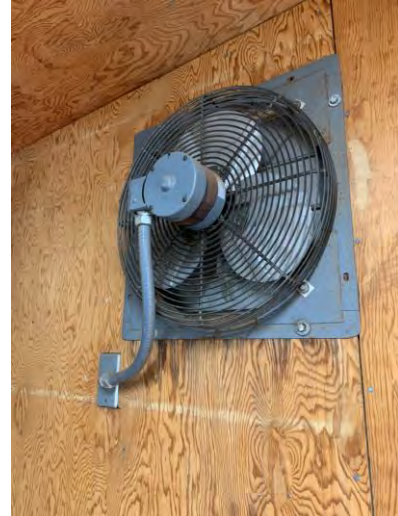
Deficiency Description: *Sidewall propeller fan is approaching the end of its expected useful life.*

Description of Work: *Provide equipment replacement and installation.*

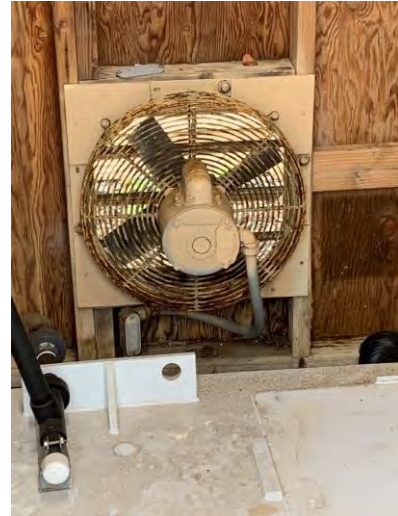
Deficiency Description: *Sidewall propeller fan is approaching the end of its expected useful life.*

Description of Work: *Provide equipment replacement and installation.*

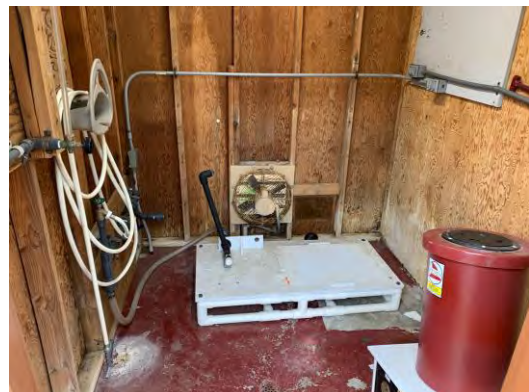
Deficiency Description: *Water treatment system is missing from building.*

Description of Work: *Provide equipment replacement and installation.*

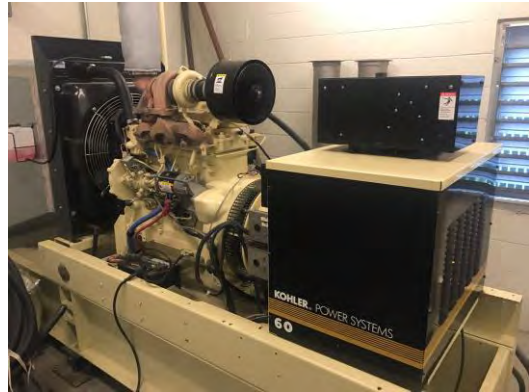
Quantity/Unit of Measure: 1/EA  
Total Deficiency Cost: \$118,230  
Deficiency Description: *The 60kW Diesel engine (including battery, charger, muffler, day tank) is at or is approaching end of its expected useful life.*

Description of Work: *Replace the existing generator with an appropriately sized new generator.*

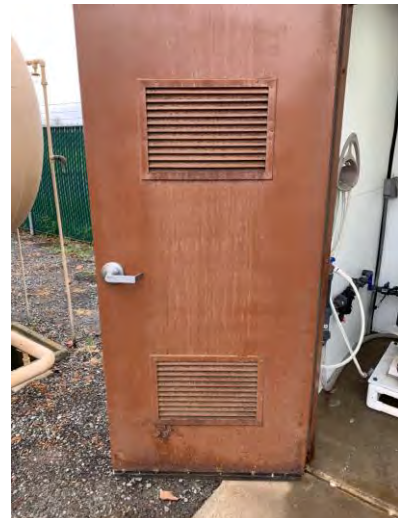
Quantity/Unit of Measure: 1/EA  
Total Deficiency Cost: \$4,050  
Deficiency Description: *Metal door is damaged or deteriorated.*

Description of Work: *Repair door and repaint.*

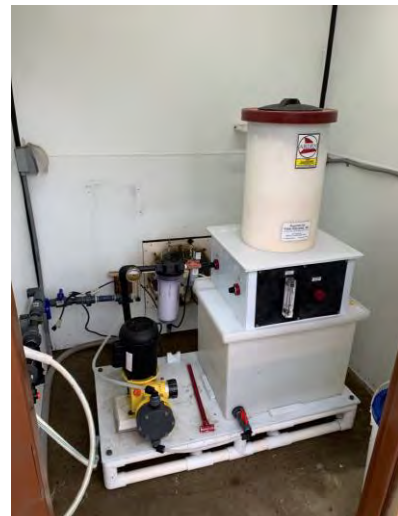
Quantity/Unit of Measure: 1/EA  
Total Deficiency Cost: \$42,710  
Deficiency Description: *Water treatment system is at the end of its expected useful service life.*

Description of Work: *Provide equipment replacement and installation.*

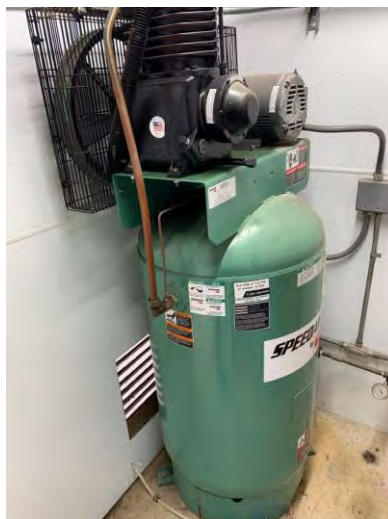
Record ID: 300  
System: D2060 - PROCESS SUPPORT PLUMBING SYSTEMS  
Year Installed / Industry Life / Remaining Useful Life: - / 25 / -  
Item No.: D2060.10.001  
Floor/Room: 1 / Pump House  
**Priority:** 7  
Quantity/Unit of Measure: 1/EA  
Total Deficiency Cost: \$19,810  
Deficiency Description: *Air compressor is approaching the end of its expected useful life.*

Description of Work: *Provide equipment replacement and installation.*

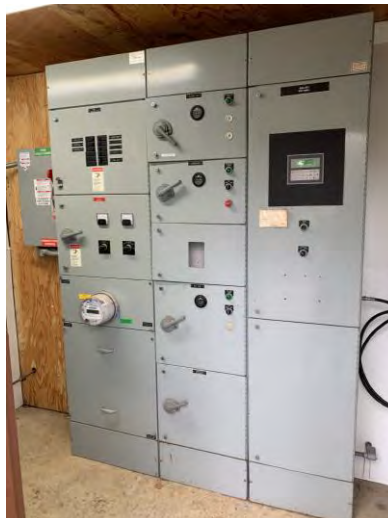
Record ID: 301  
System: D5020 - ELECTRICAL SERVICE AND DISTRIBUTION  
Year Installed / Industry Life / Remaining Useful Life: 1990 / 20 / -12  
Item No.: D5020.10.302  
Floor/Room: 1 / Pump House  
**Priority:** 1  
Quantity/Unit of Measure: 1/EA  
Total Deficiency Cost: \$17,750  
Deficiency Description: *The 400A metered main switchboard is past its expected useful life.*

Comments: *Age is estimated.*

Description of Work: *Replace the existing metered main switchboard with a new metered main switchboard.*

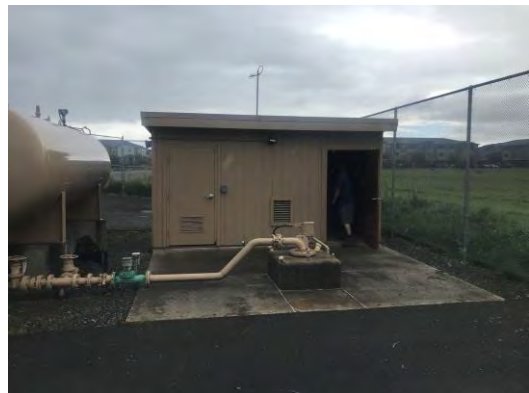
Item No. B3010.10.002  
Floor/Room: Roof / Roof  
**Priority: 4**  
Quantity/Unit of Measure: 150/SF  
Total Deficiency Cost: \$6,340  
Deficiency Description: *Metal roofing is at or approaching end of expected useful service life.*

Description of Work: *Remove and replace metal roofing.*

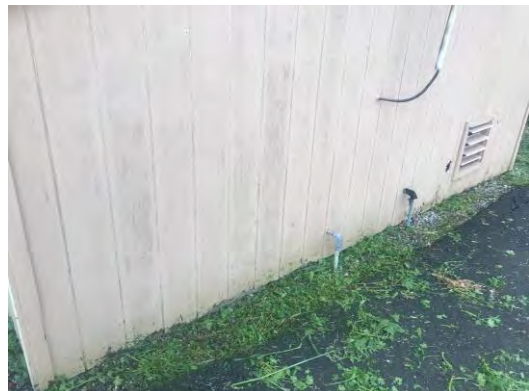
Item No. C2010.20.002  
Floor/Room: 1 / Exterior  
**Priority: 3**  
Quantity/Unit of Measure: 800/SF  
Total Deficiency Cost: \$7,030  
Deficiency Description: *The existing veneer plywood is damaged or worn.*

Description of Work: *Clean, prepare, and paint the plywood paneling.*

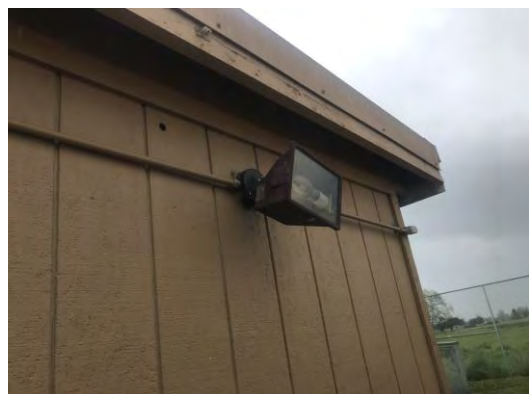
Item No. D5040.50.302  
Floor/Room: 1 / Exterior  
**Priority: 6**  
Quantity/Unit of Measure: 1/EA  
Total Deficiency Cost: N/A - See Executive Summary  
Deficiency Description: *The exterior light fixture is past its expected useful life.*

Description of Work: *Replace the existing light fixture with an LED lighting fixture.*

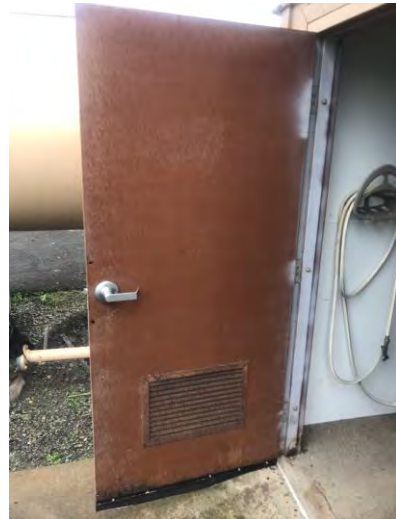
Deficiency Description: *The exterior door is approaching the end of its useful life.*

Description of Work: *Replace the door.*

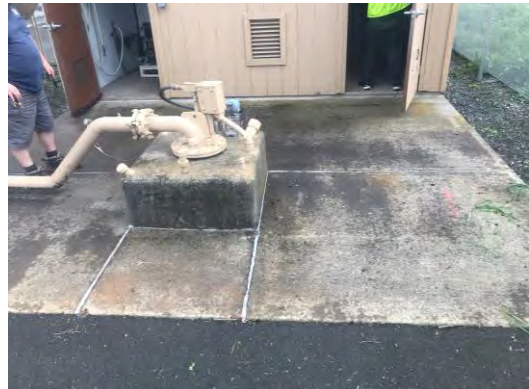
Deficiency Description: *Pervious concrete surface is clogged.*

Description of Work: *Power wash surface to remove debris.*

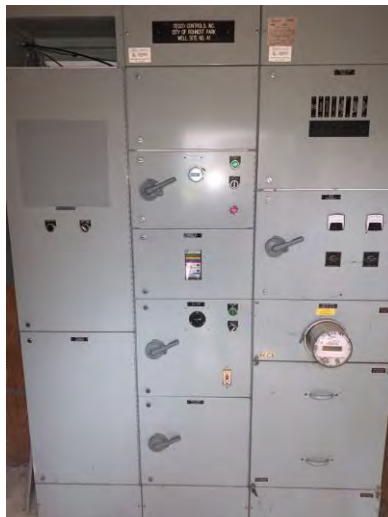
Comments: *Age is estimated.*

Description of Work: *Replace the existing metered main switchboard with a new metered main switchboard.*

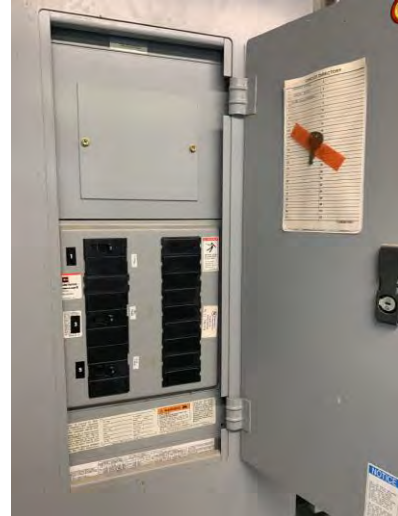
Record ID: 404  
 System: D5020 - ELECTRICAL SERVICE AND DISTRIBUTION  
 Year Installed / Industry Life / Remaining Useful Life: 1999 / 30 / 7  
 Item No.: D5020.30.1012  
 Floor/Room: 1 / Pump House  
**Priority:** 7  
 Quantity/Unit of Measure: 1/EA  
 Total Deficiency Cost: \$32,300  
 Deficiency Description: *The 225A panelboard is past its expected useful life.*

Description of Work: *Replace the existing panelboard with a new panelboard.*

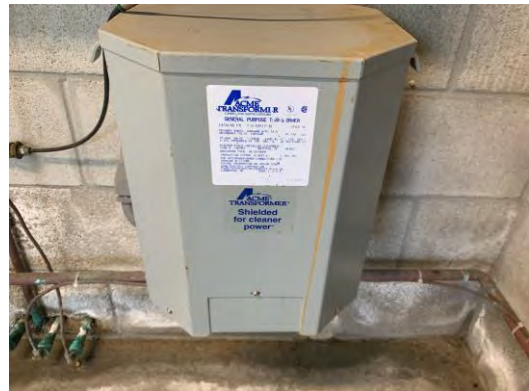
Record ID: 405  
 System: D5020 - ELECTRICAL SERVICE AND DISTRIBUTION  
 Year Installed / Industry Life / Remaining Useful Life: 1999 / 30 / 7  
 Item No.: D5020.10.214  
 Floor/Room: 1  
**Priority:** 7  
 Quantity/Unit of Measure: 1/EA  
 Total Deficiency Cost: \$11,960  
 Deficiency Description: *The 15kVA transformer is past its expected useful life.*

Comments: *Age is estimated.*

Description of Work: *Replace the existing transformer with a new transformer.*

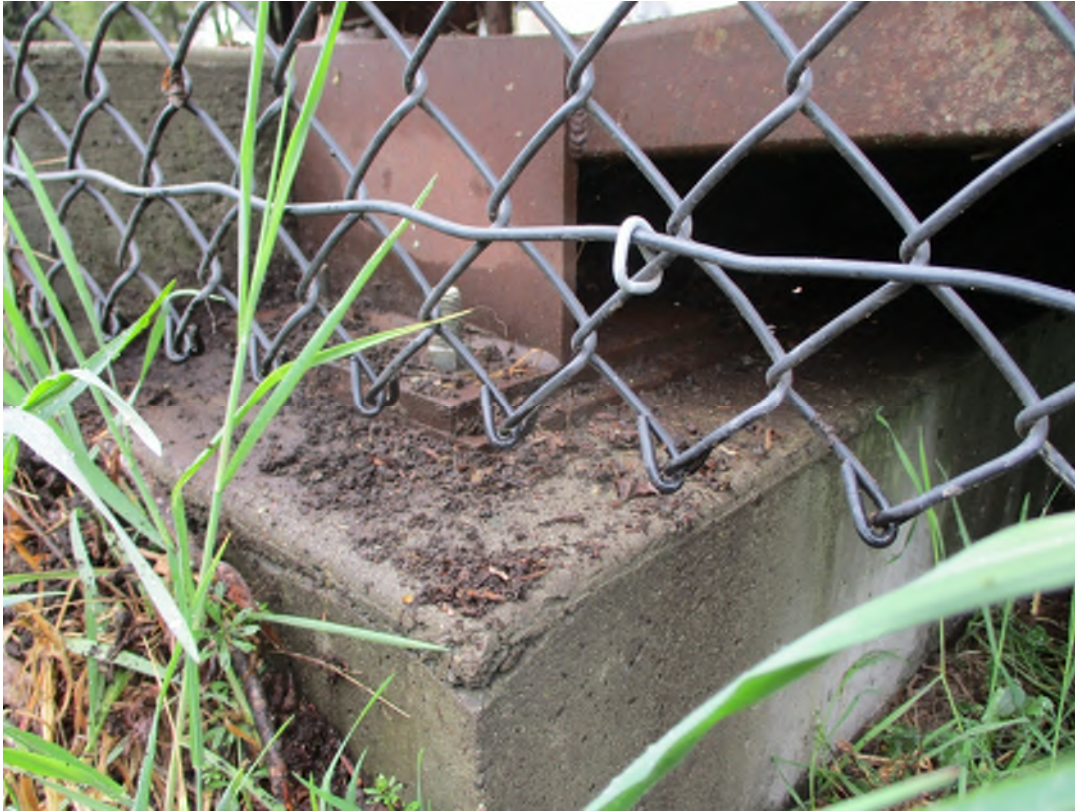
Image 11: Bearing Plate

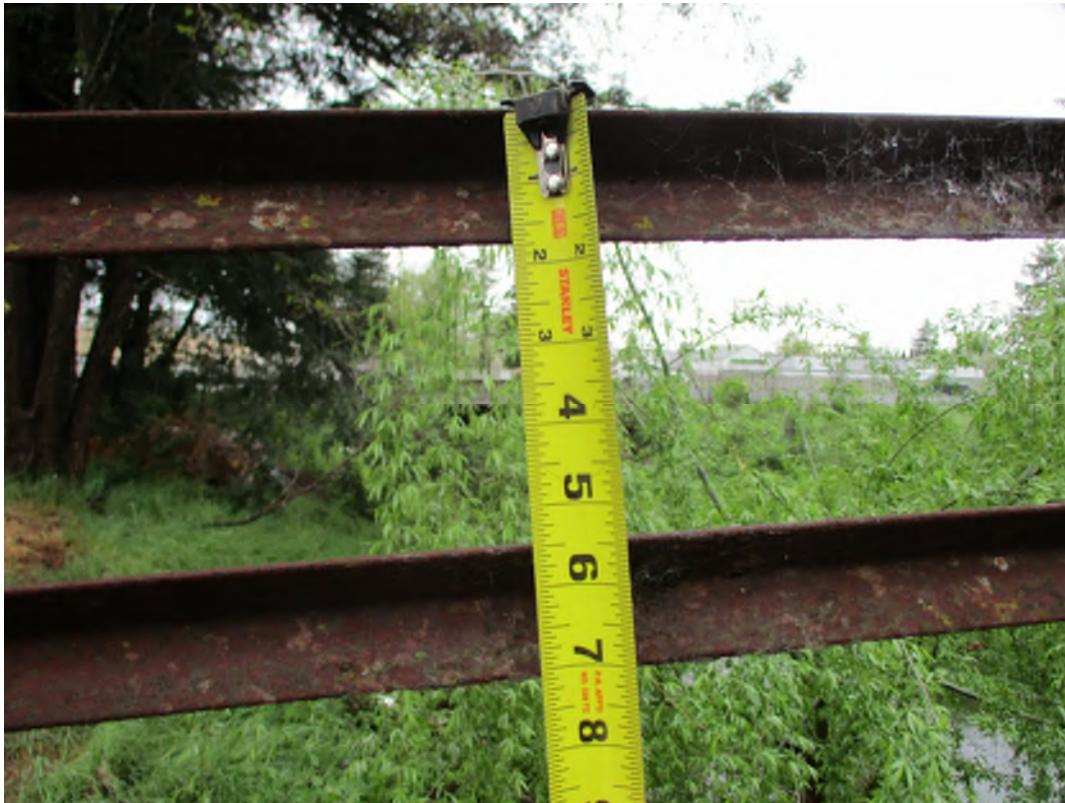
Image 15: Maximum Horizontal Member Spacing

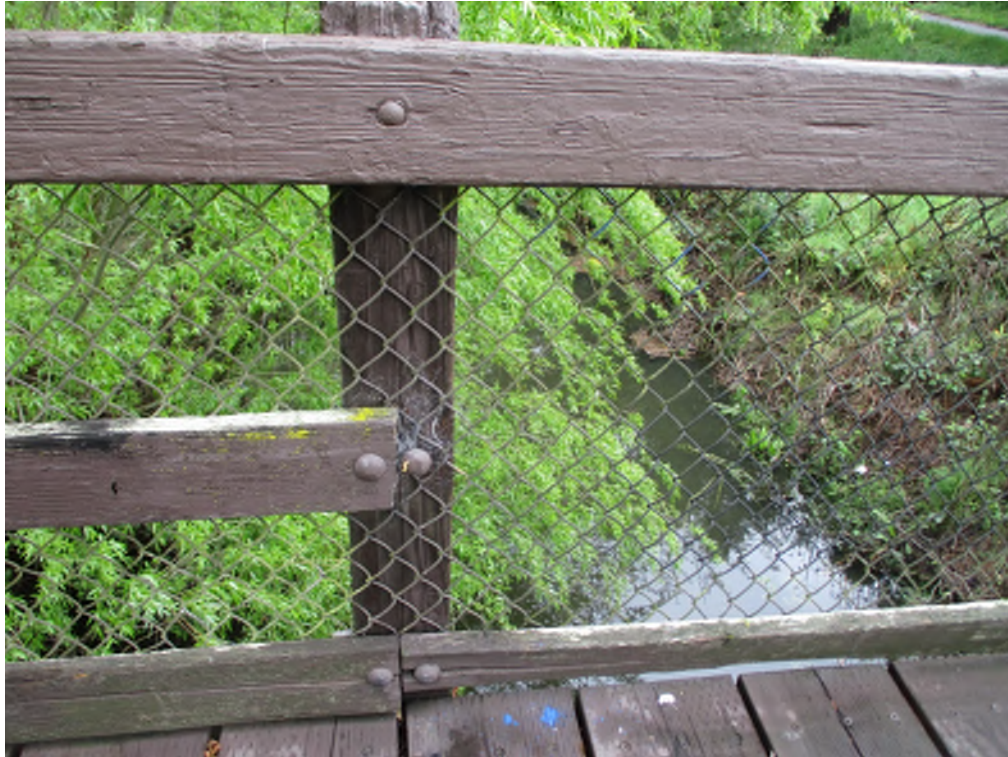
Image 5: Handrail Joints

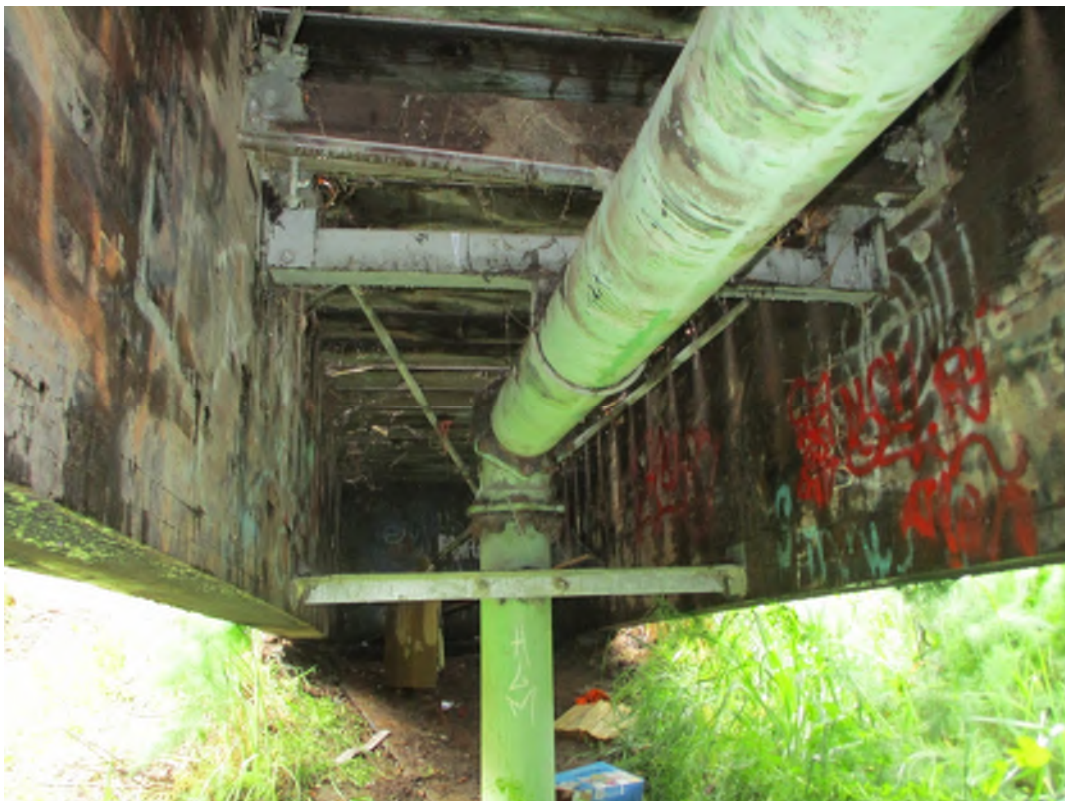
Image 12: Underside of Bridge

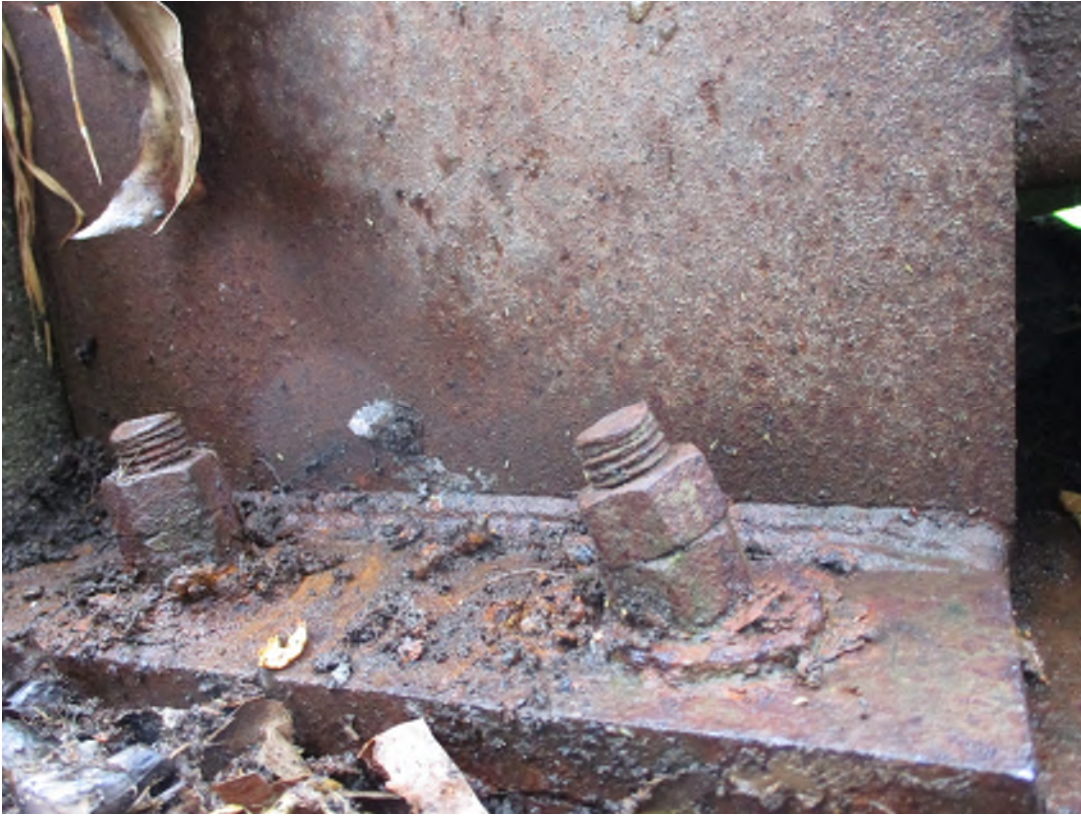
Image 11: Bearing Plate with Bent Anchor Bolts

- f. BENT ANCHOR BOLTS: At one bearing plate, the anchor bolt alignment or expansion slots were insufficient and resulted in slightly bent anchor bolts. This may have happened during construction.  
RECOMMENDATION: Monitor bent anchor bolts at regular inspections. If the bolts bend further, abutment anchorage connection strengthening will be required. *See image 11.*  
**PRIORITY: 4 Necessary – Long Term**
