# City of Rohnert Park

## Facility Condition Assessment

Final Report

October 17, 2022

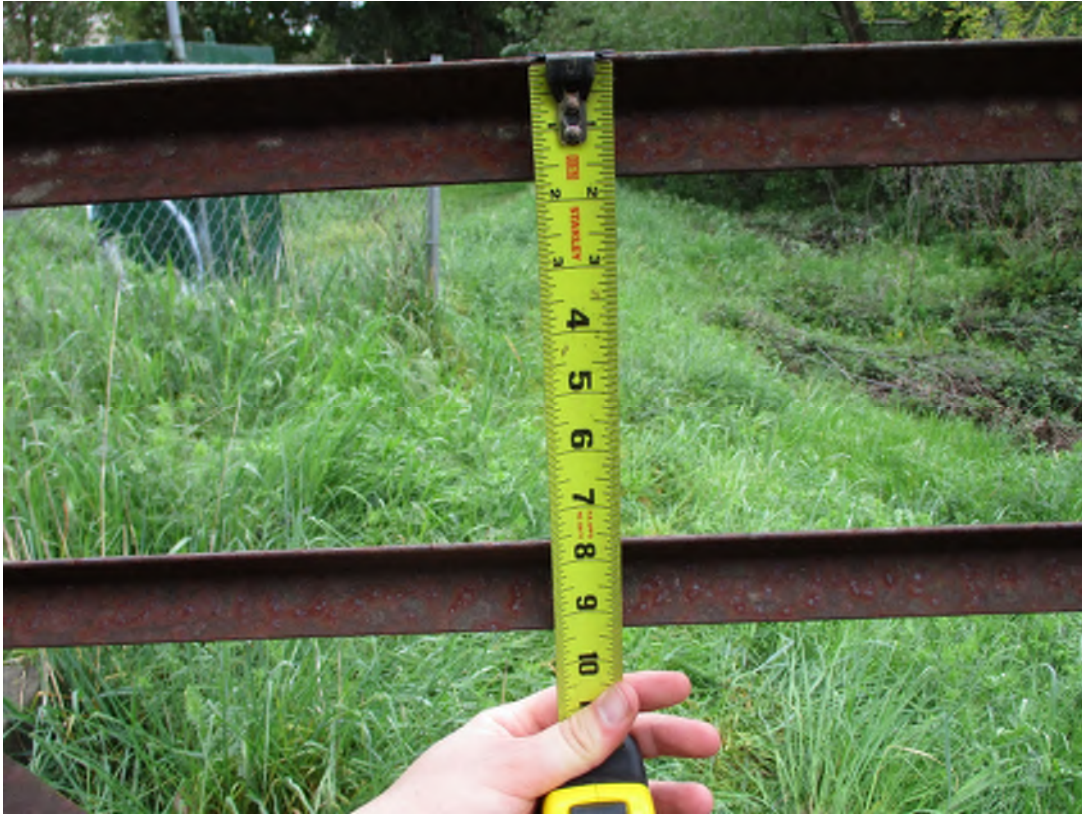
Image 15: Maximum Horizontal Member Spacing

- c. Guardrail Horizontal Member Spacing: Review maximum horizontal member spacing with current code requirements (non-structural). *See image 15.*  
RECOMMENDATION: Review code requirements and add additional members to limit gaps between members as needed to reduce risk of bridge users fitting through.  
**PRIORITY: 2 Crucial – Short Term**

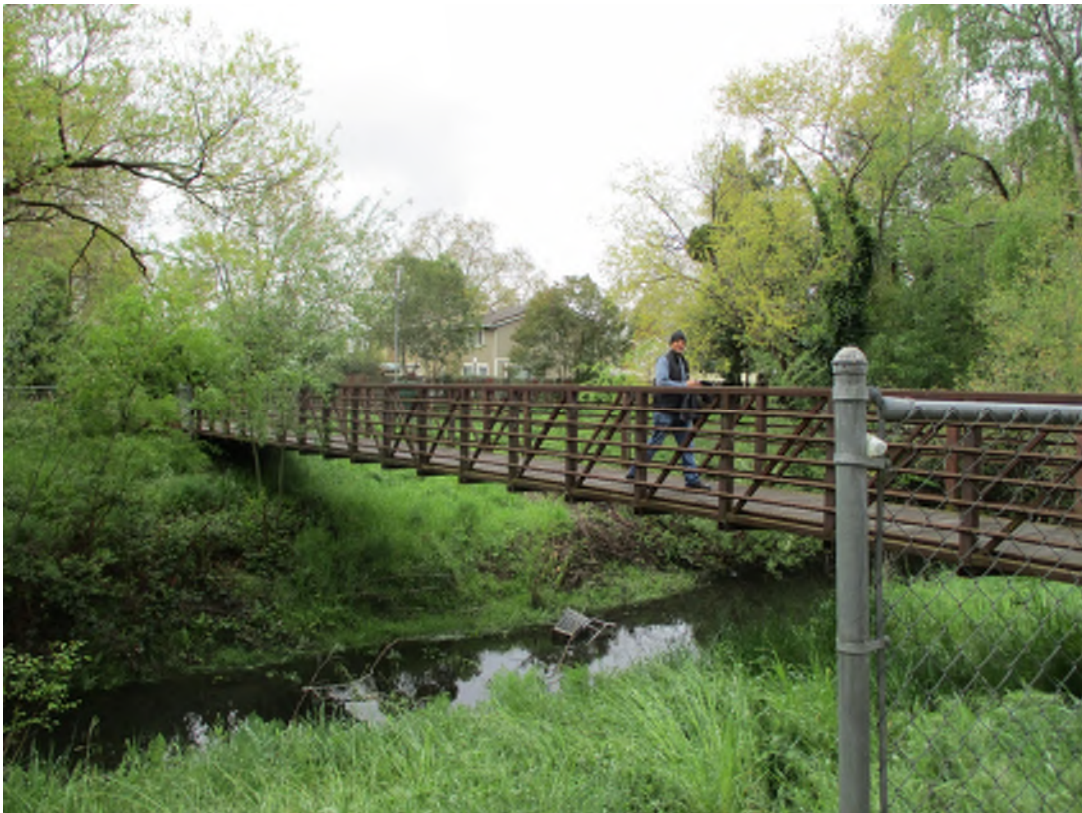
Image 16: Bridge Camber

- d. Long Term Deflection: Due to the long span and center splice, the bridge is essentially flat and does not retain a camber. Additionally, the bridge deflects horizontally when subject to user imposed horizontal momentum. *See image 16.*  
RECOMMENDATION: Regularly review measure bridge deflections. If additional deflections occur, bridge strengthening will be required.  
**PRIORITY: 3 Impending – Short Term**

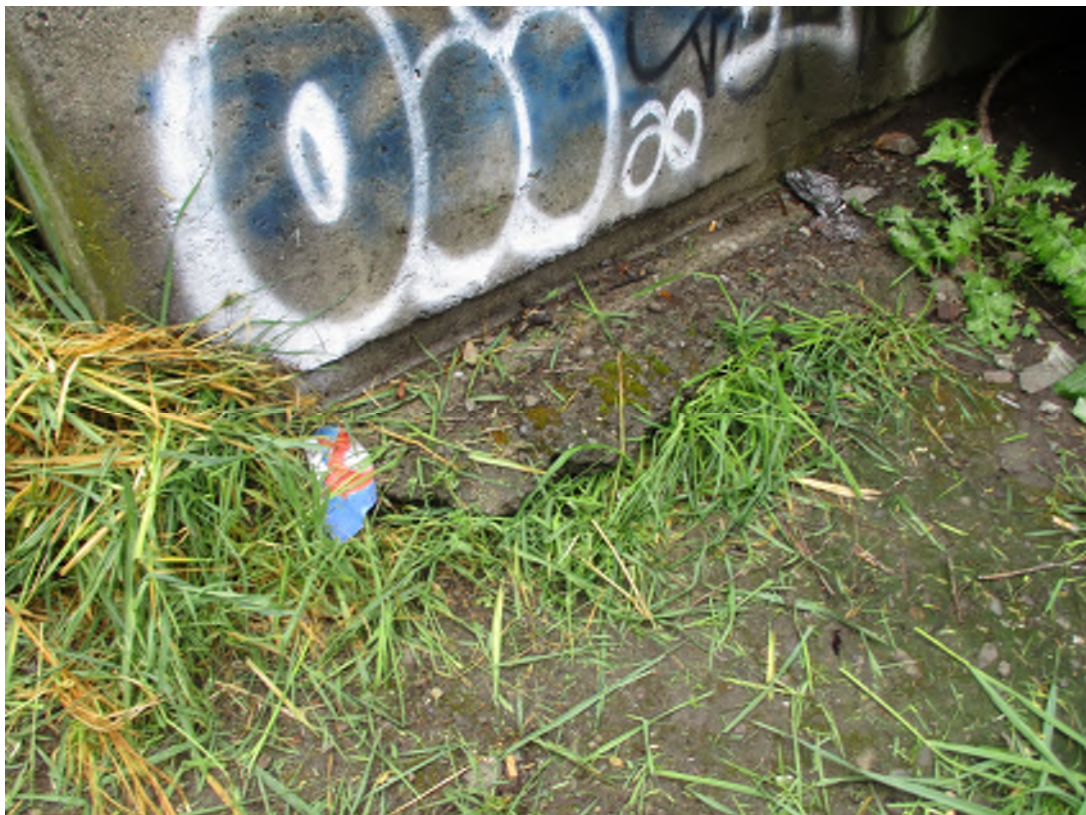
Image 12: Abutment Erosion

- a. **ABUTMENT EROSION:** The west abutment foundation shows minor signs of erosion at the base.  
**RECOMMENDATION:** Review west abutment foundation for the extent of scour / undermining at the next scheduled maintenance review. *See image 12.*  
**PRIORITY: 2 Crucial – Short Term**

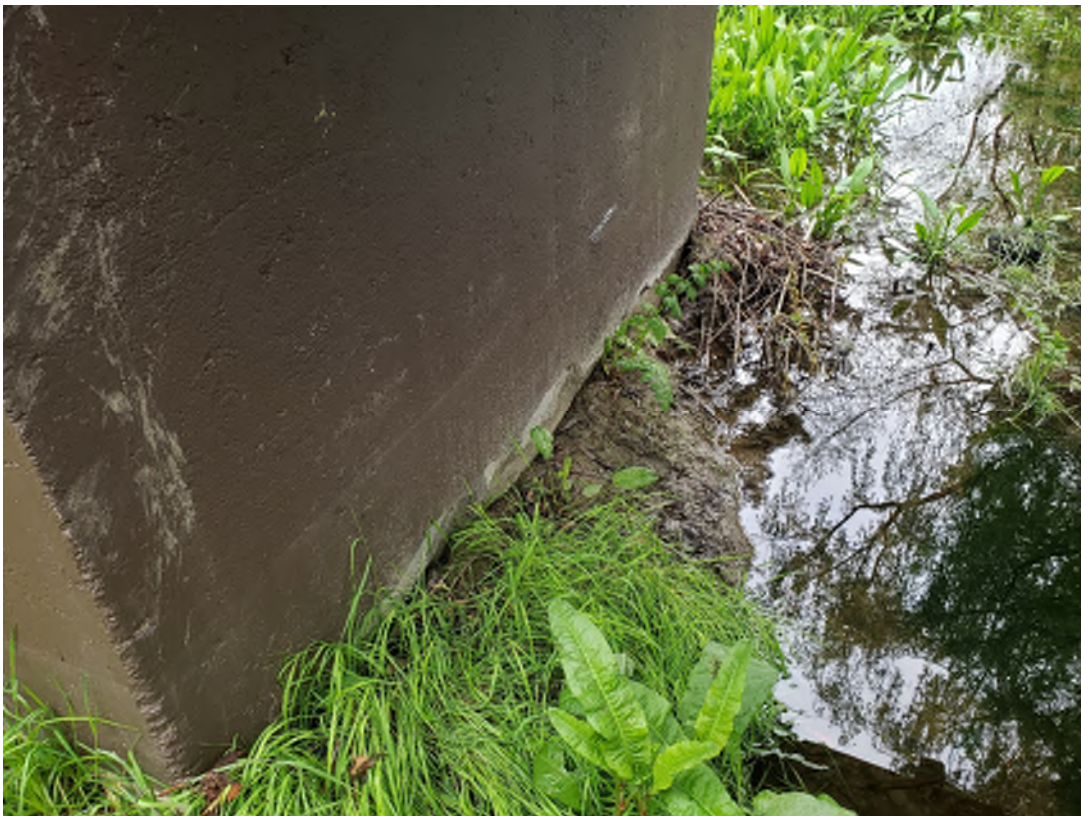
- g. CENTER SPAN SUPPORT EROSION: The Center span support foundation showed minor signs of erosion at the base. *See image 16.*

Image 16: Center Support

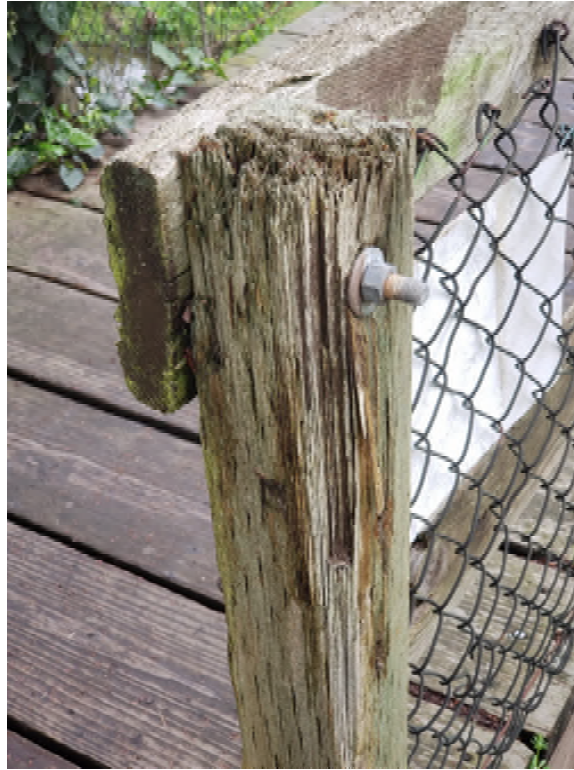
Image 9: Deteriorating Handrail Post

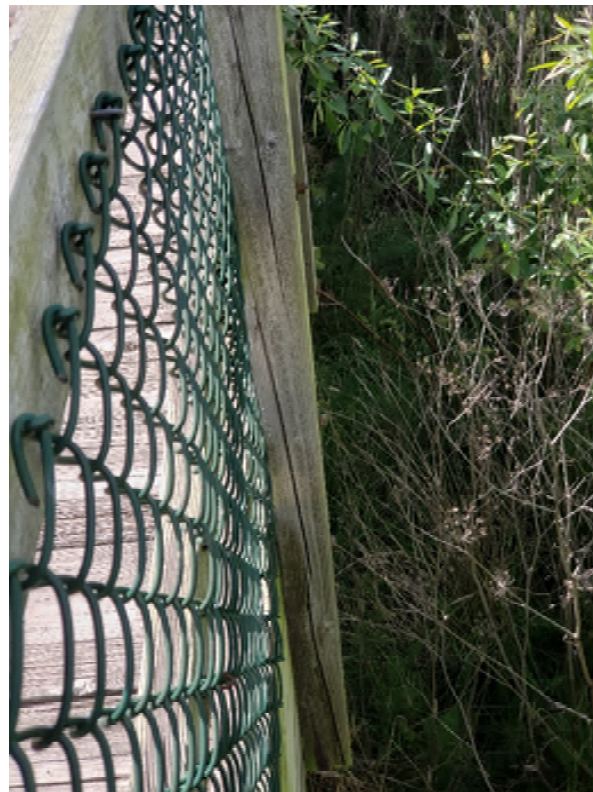
**PRIORITY: 1 Immediate – Short Term**
- b. **BRIDGE GUARDRAIL:** ~10% of the guardrail posts and horizontal members show signs of splitting, cracking, or rot. *See image 12.*

Image 12: Handrail Post Condition

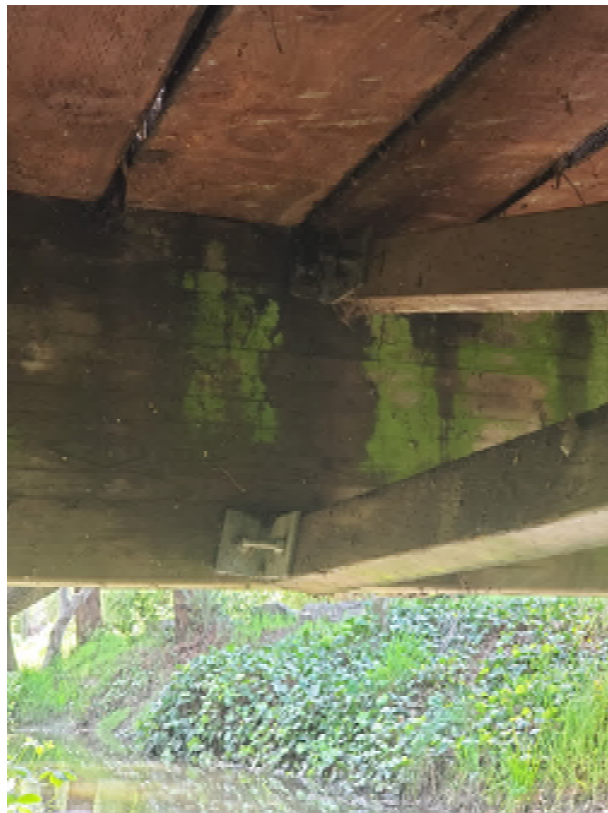
Image 12: Lateral Bracing

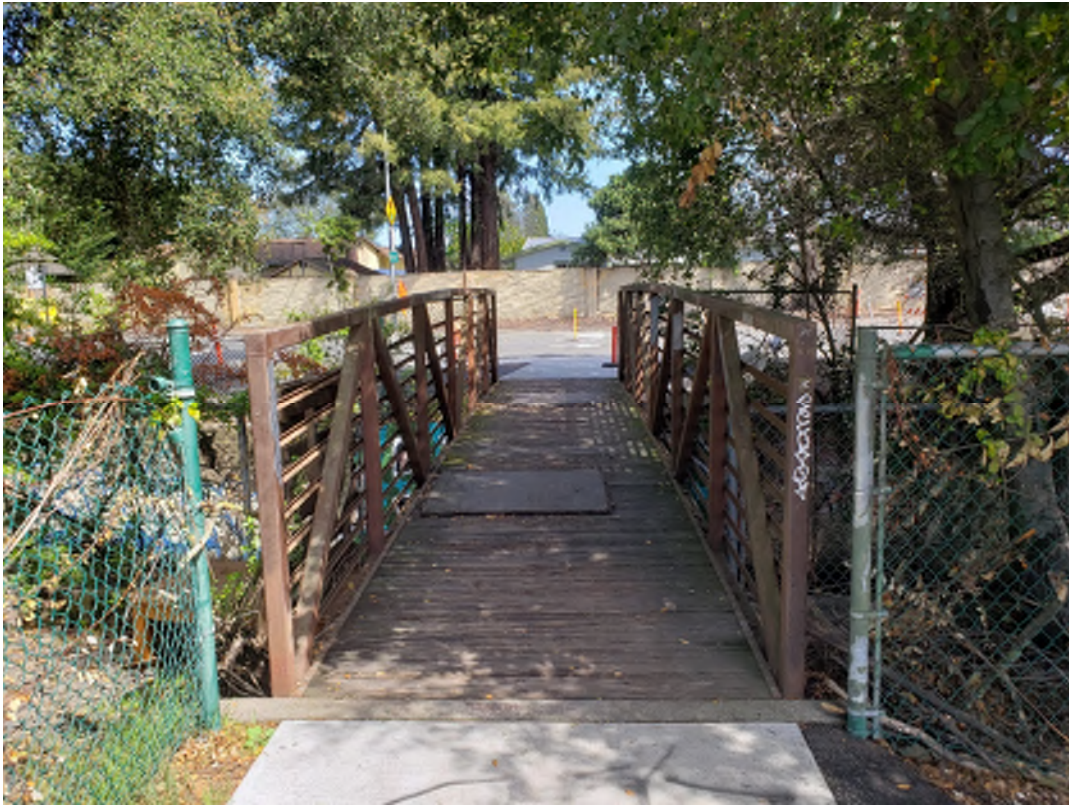
Image 1: West Elevation

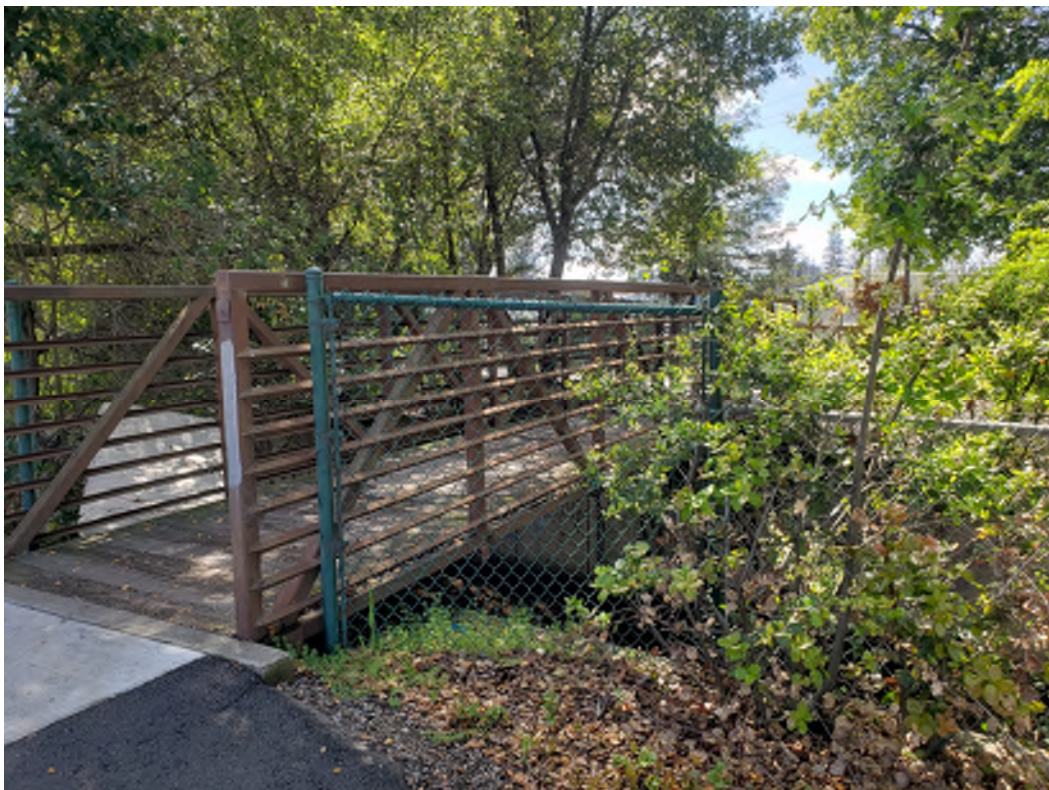
Image 2: North Elevation

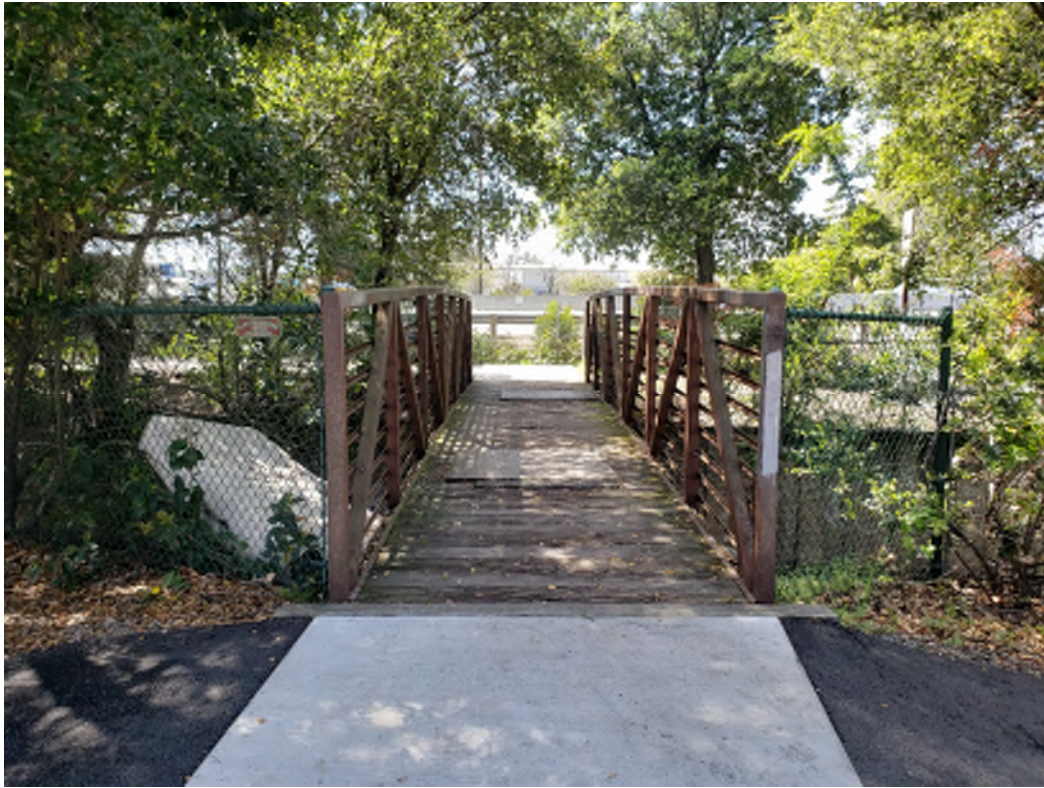
Image 3: East Elevation

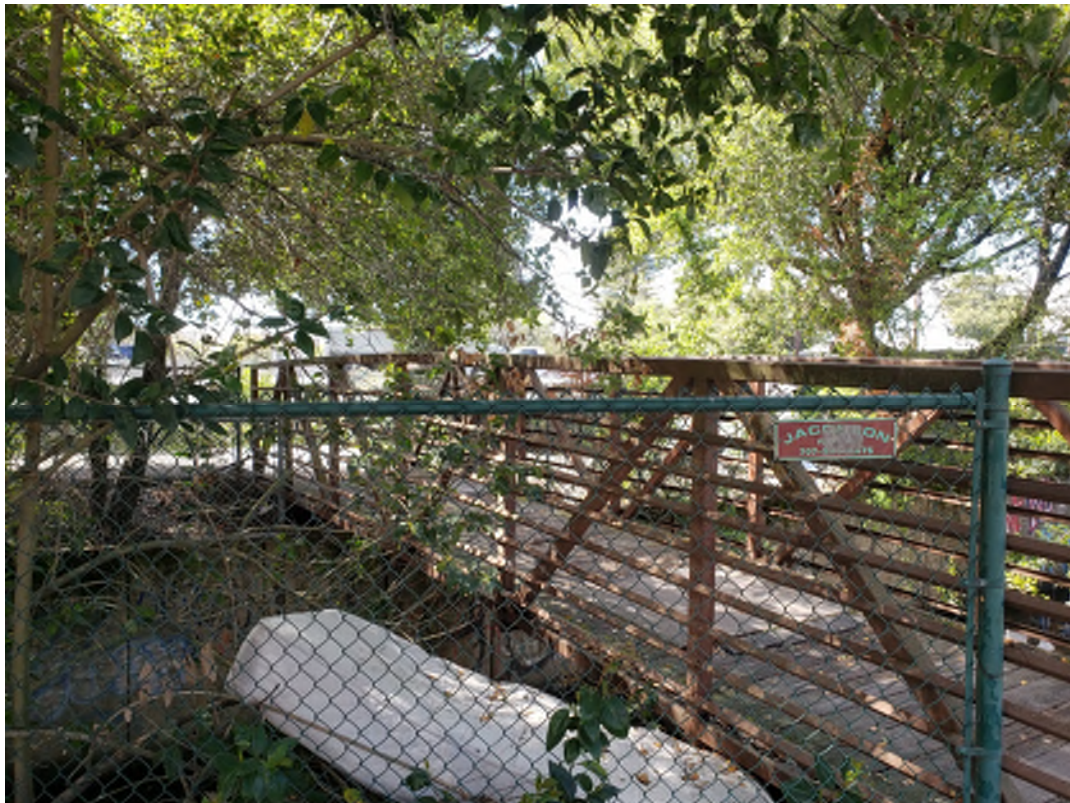
Image 4: South Elevation

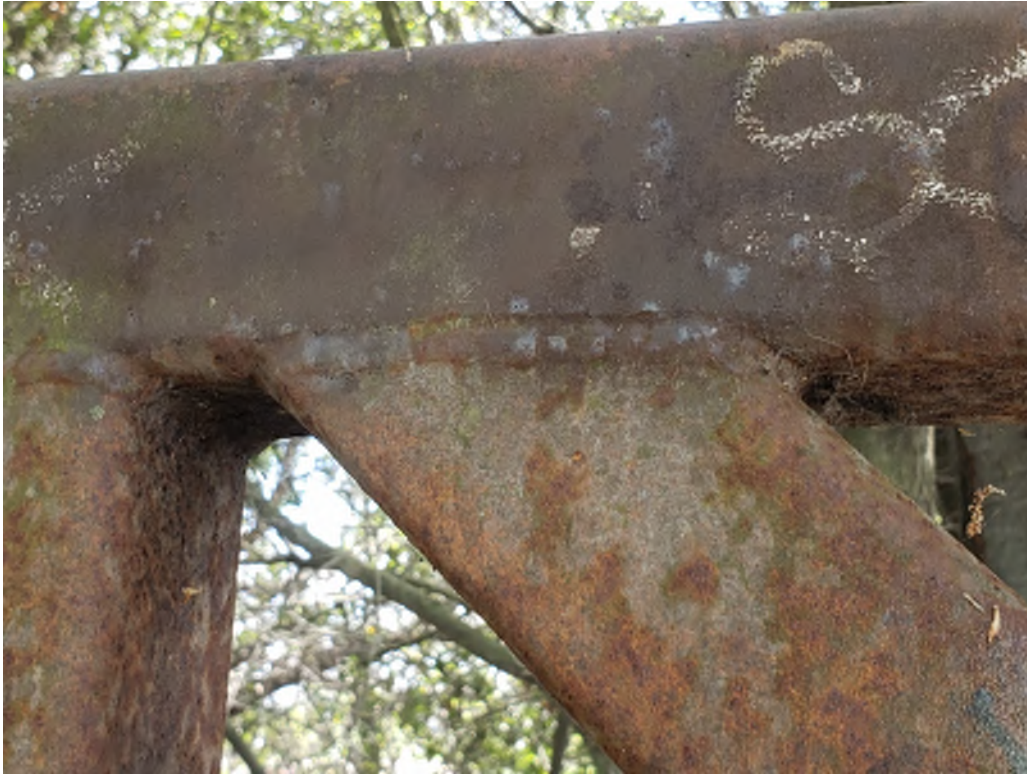
Image 5: Truss Typical Brace/Post Top Connection

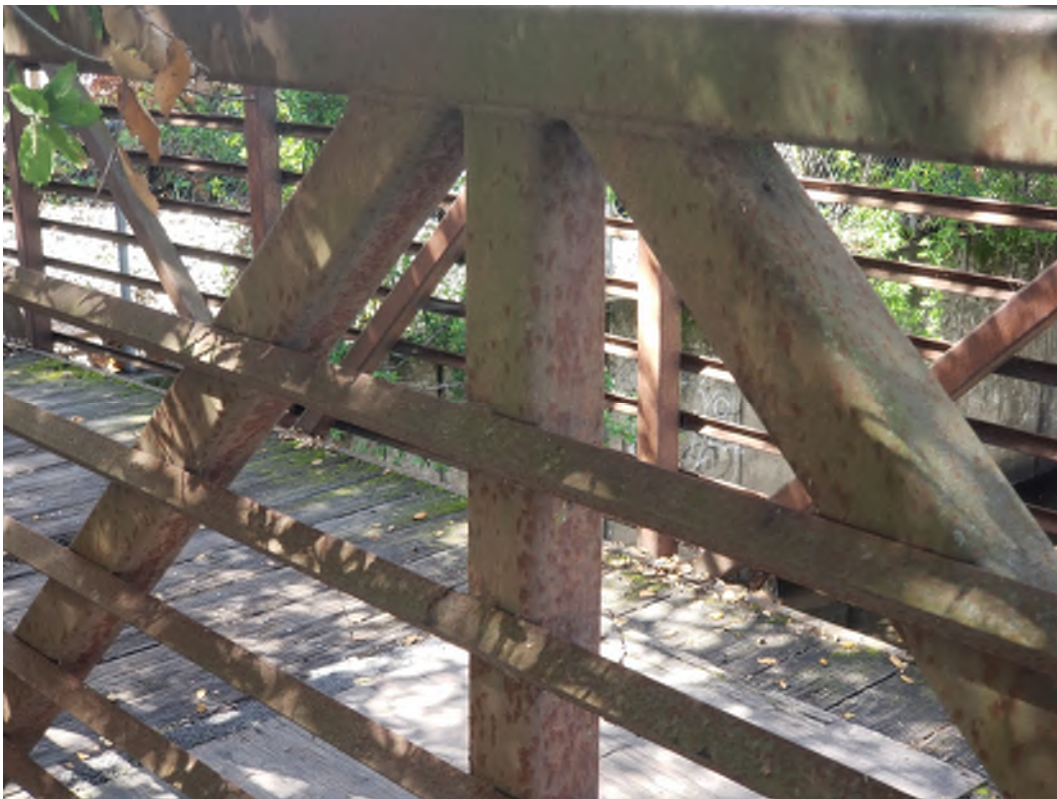
Image 6: Typical Handrail Member Weld

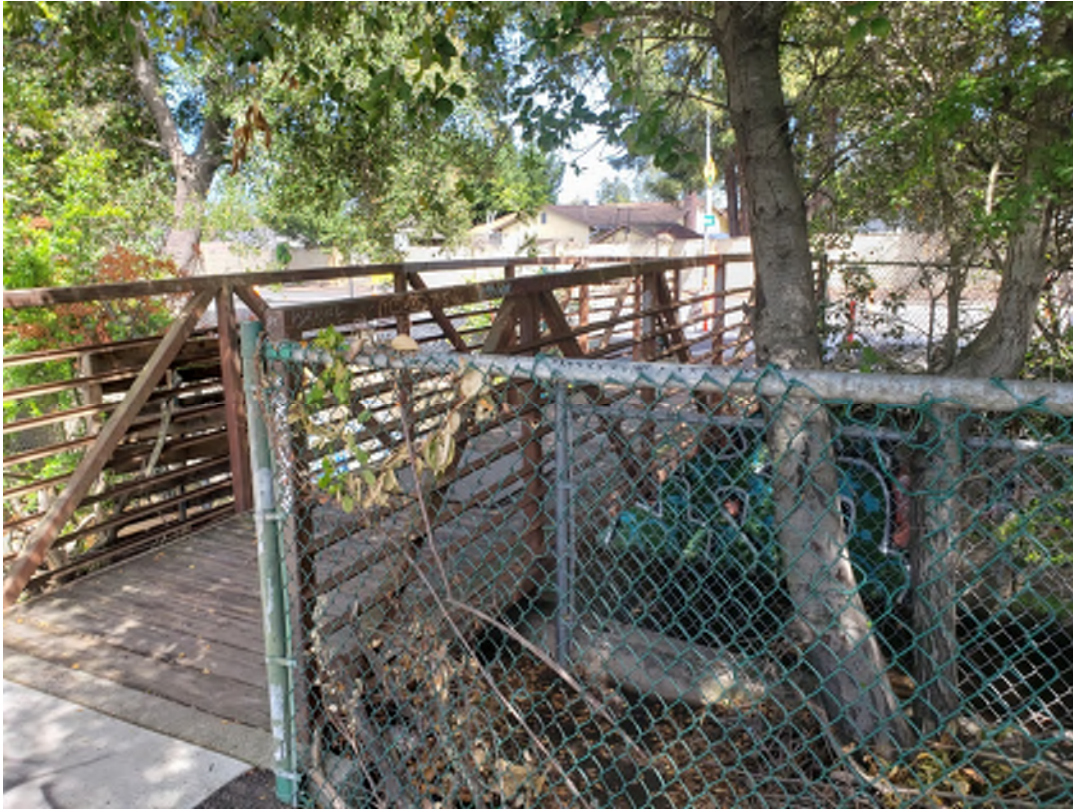
Image 7: Bridge End

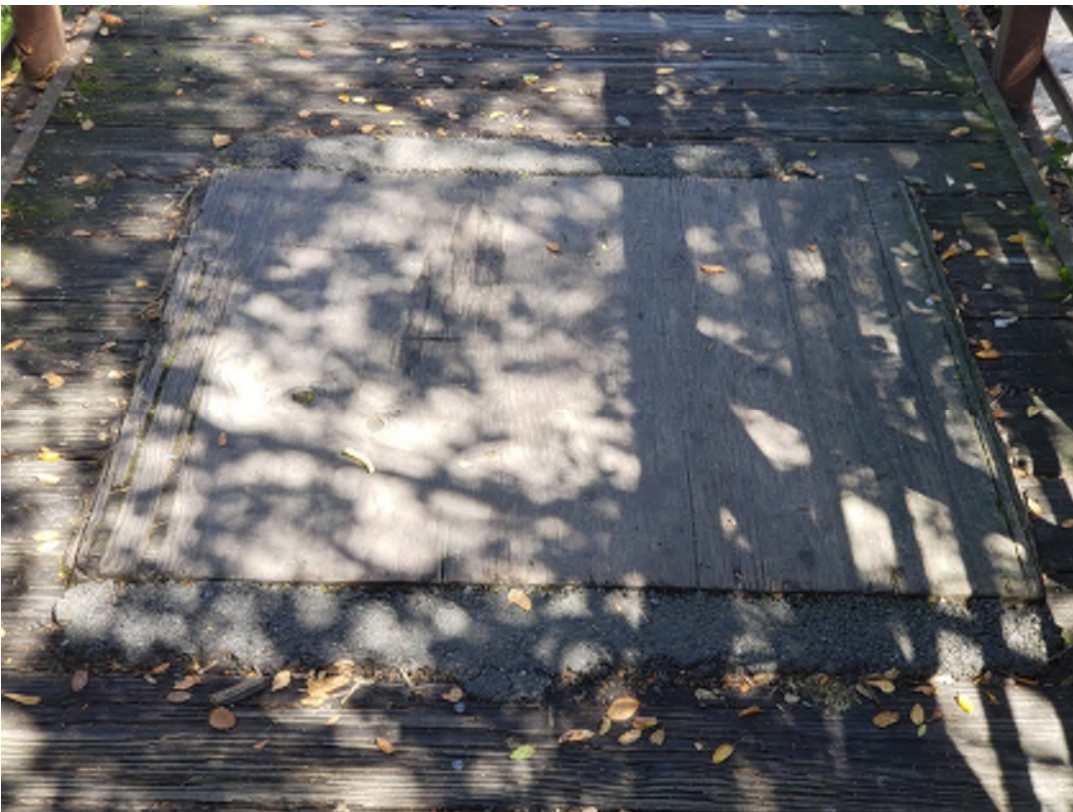
Image 8: Floorboard Patch

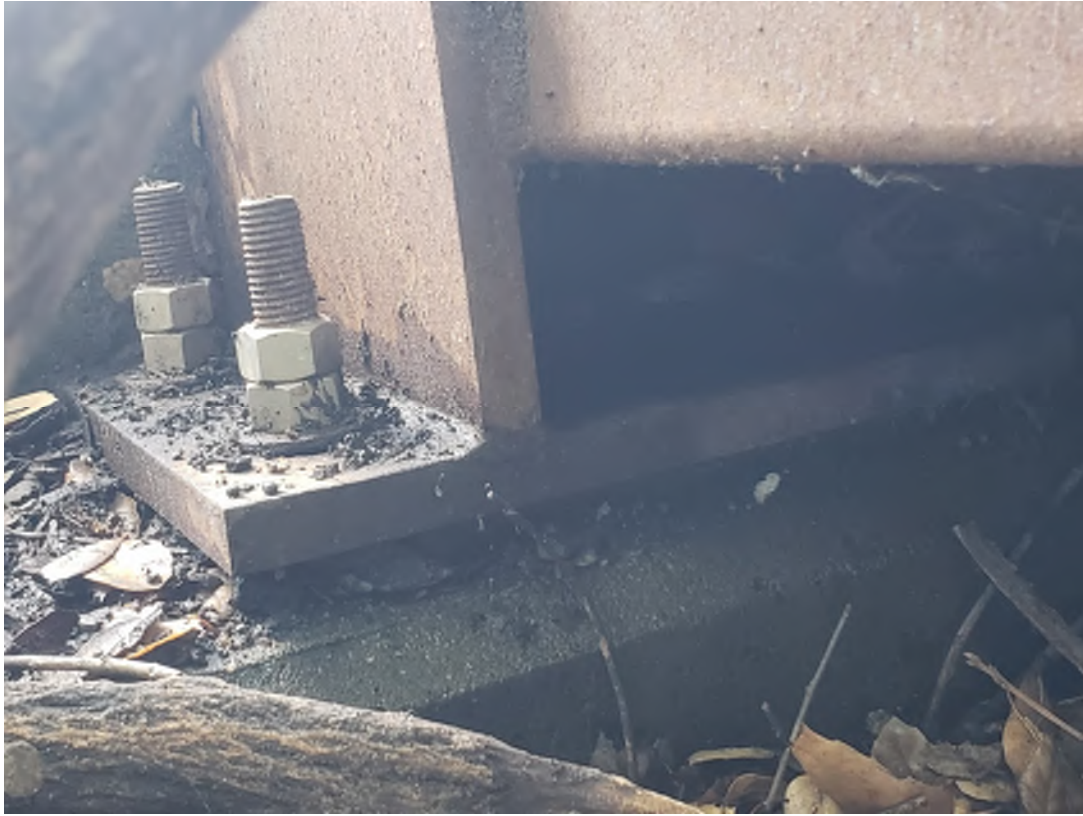
Image 11: Bearing Plate

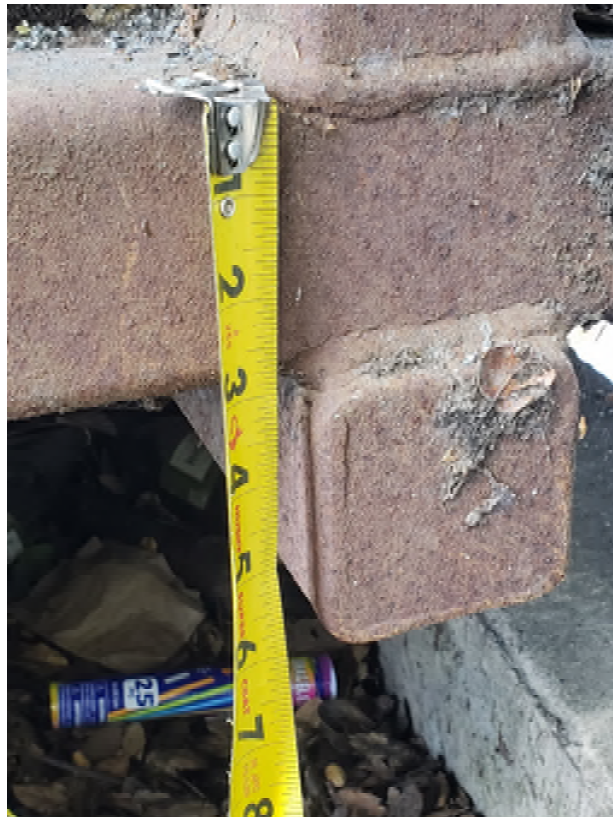
Image 12: Gravity Purlin Connection

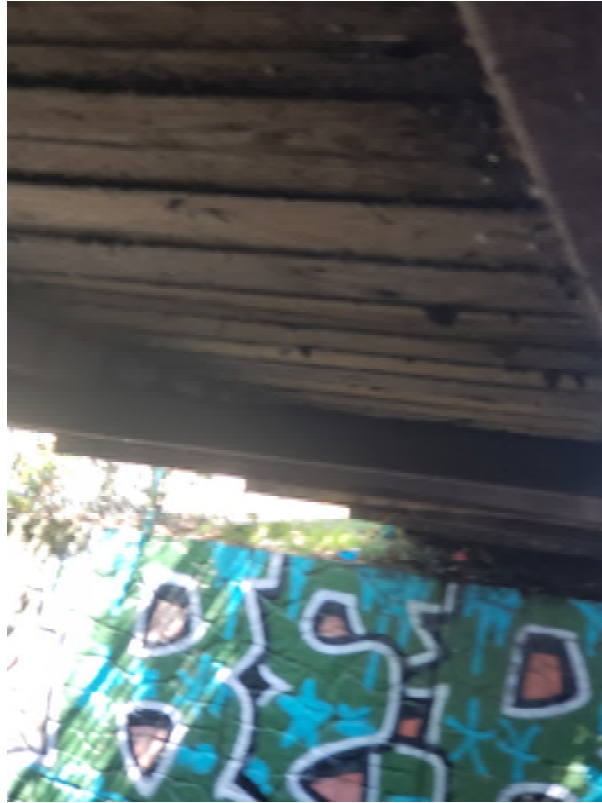
Image 13: Underside of Bridge
